STRUCTURAL SURVEY – BARN AT TIPPETS FARM

Structural survey of the Barn at Tippetts Shop and recommendations
for the conversion into a residential dwelling

JOB NO. SE23-119

20th June 2023

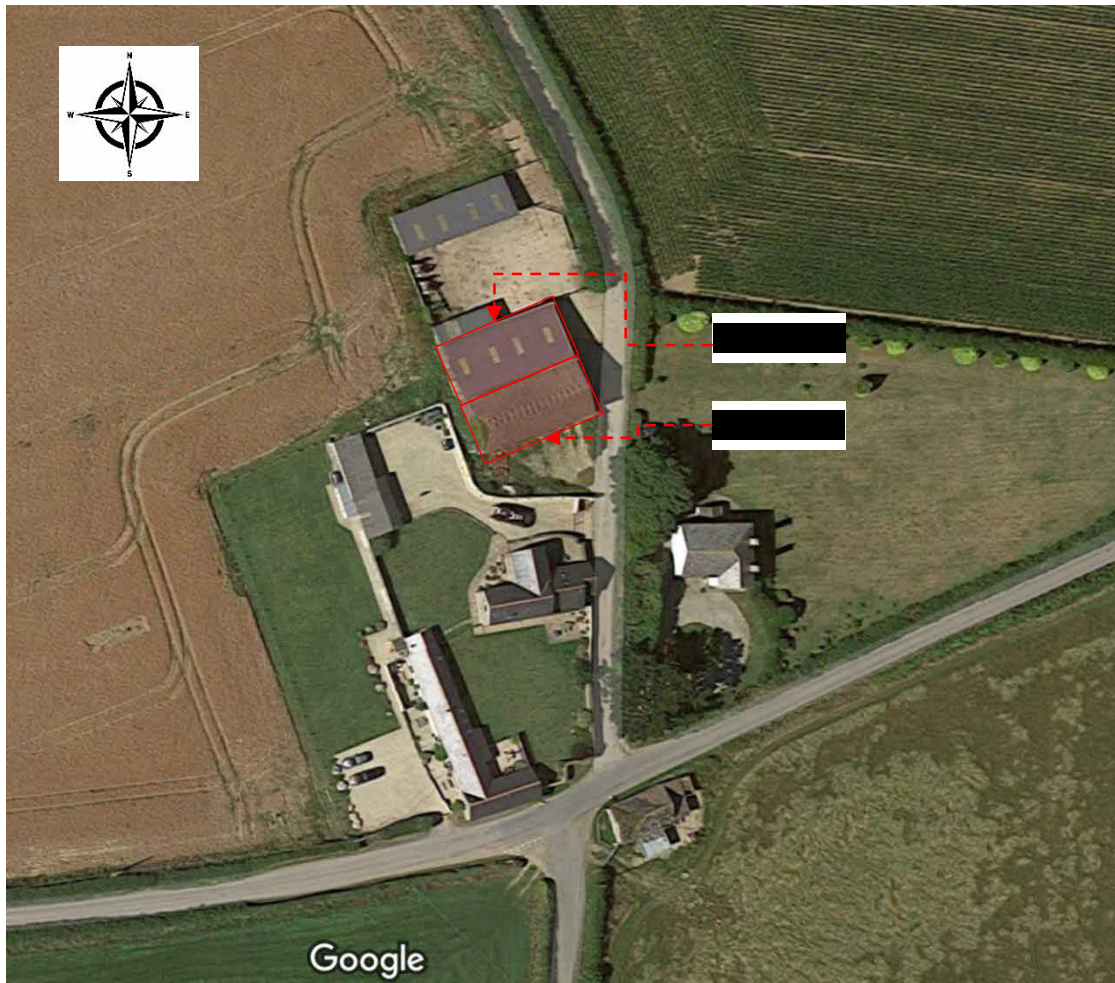
The barn consists of two areas labelled Barn 1 and Barn 2 shown *Figure 1*.

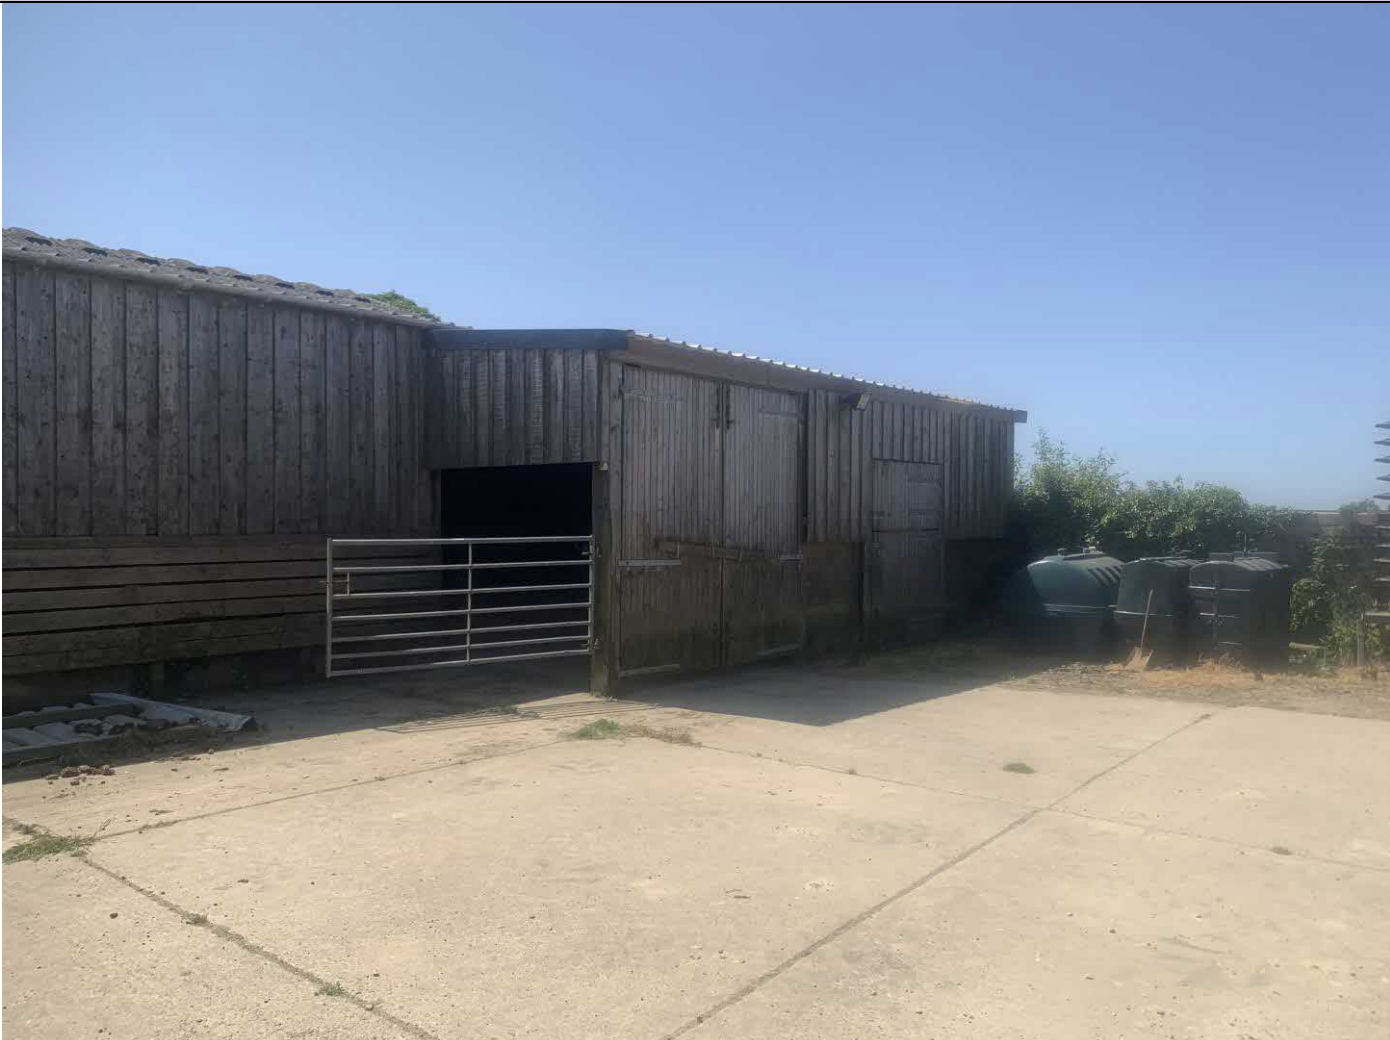
Reference	Photo
<p>Photo 1 - North Elevation Barn 1</p>

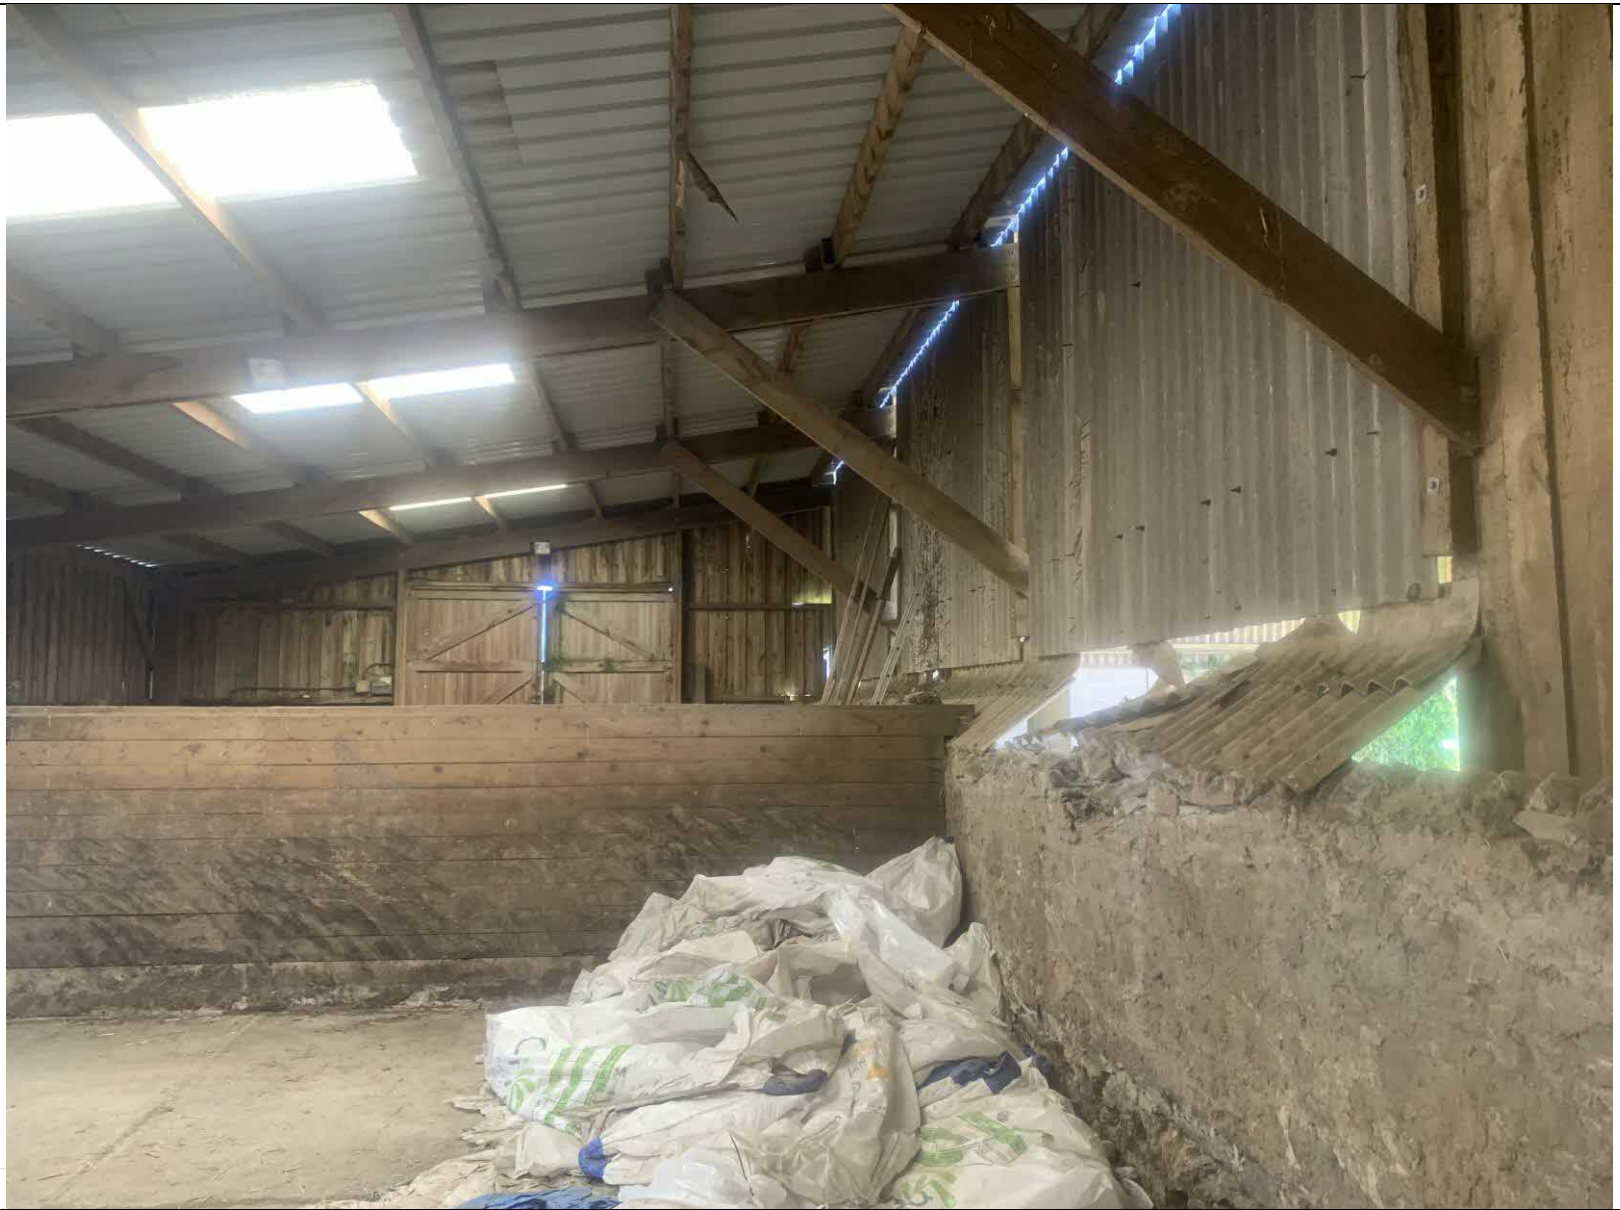
- 5.1.1 The barn has a series of timber frames supporting the main roof structure. A 2D analytical analysis of the timber frame has shown that the existing roof structure has capacity to support a lightweight roof and associated imposed loads as defined in the current building code of practice.
- 5.1.2 Bracing has been placed laterally and longitudinally throughout the barn. The braces are providing support to the main roof rafters and lateral restraint to the main timber frames.
- 5.1.3 The existing timber walls are formed from timber cladding rails and infill panelling. The cladding is agricultural and not load bearing.
- 5.1.4 The existing ground bearing slab has been capable of supporting agricultural loading and shows little sign of distress.
- 5.1.5 The main timber frames are plum and show no sign of over deflection or stress from excessive loading.

Photo 2 –
Internal
bracing barn 1

- 6.1.1 The existing timber frames will be suitable to support a lightweight roof, provided the main bracing remains in place.
- 6.1.2 The existing shell of the structure is suitable to be integrated with a residential dwelling, the existing cladding could remain insitu although, architecturally may not be appropriate.
- 6.1.3 The existing ground bearing slab has been used to support agricultural loadings therefore, should be capable of supporting residential loading.

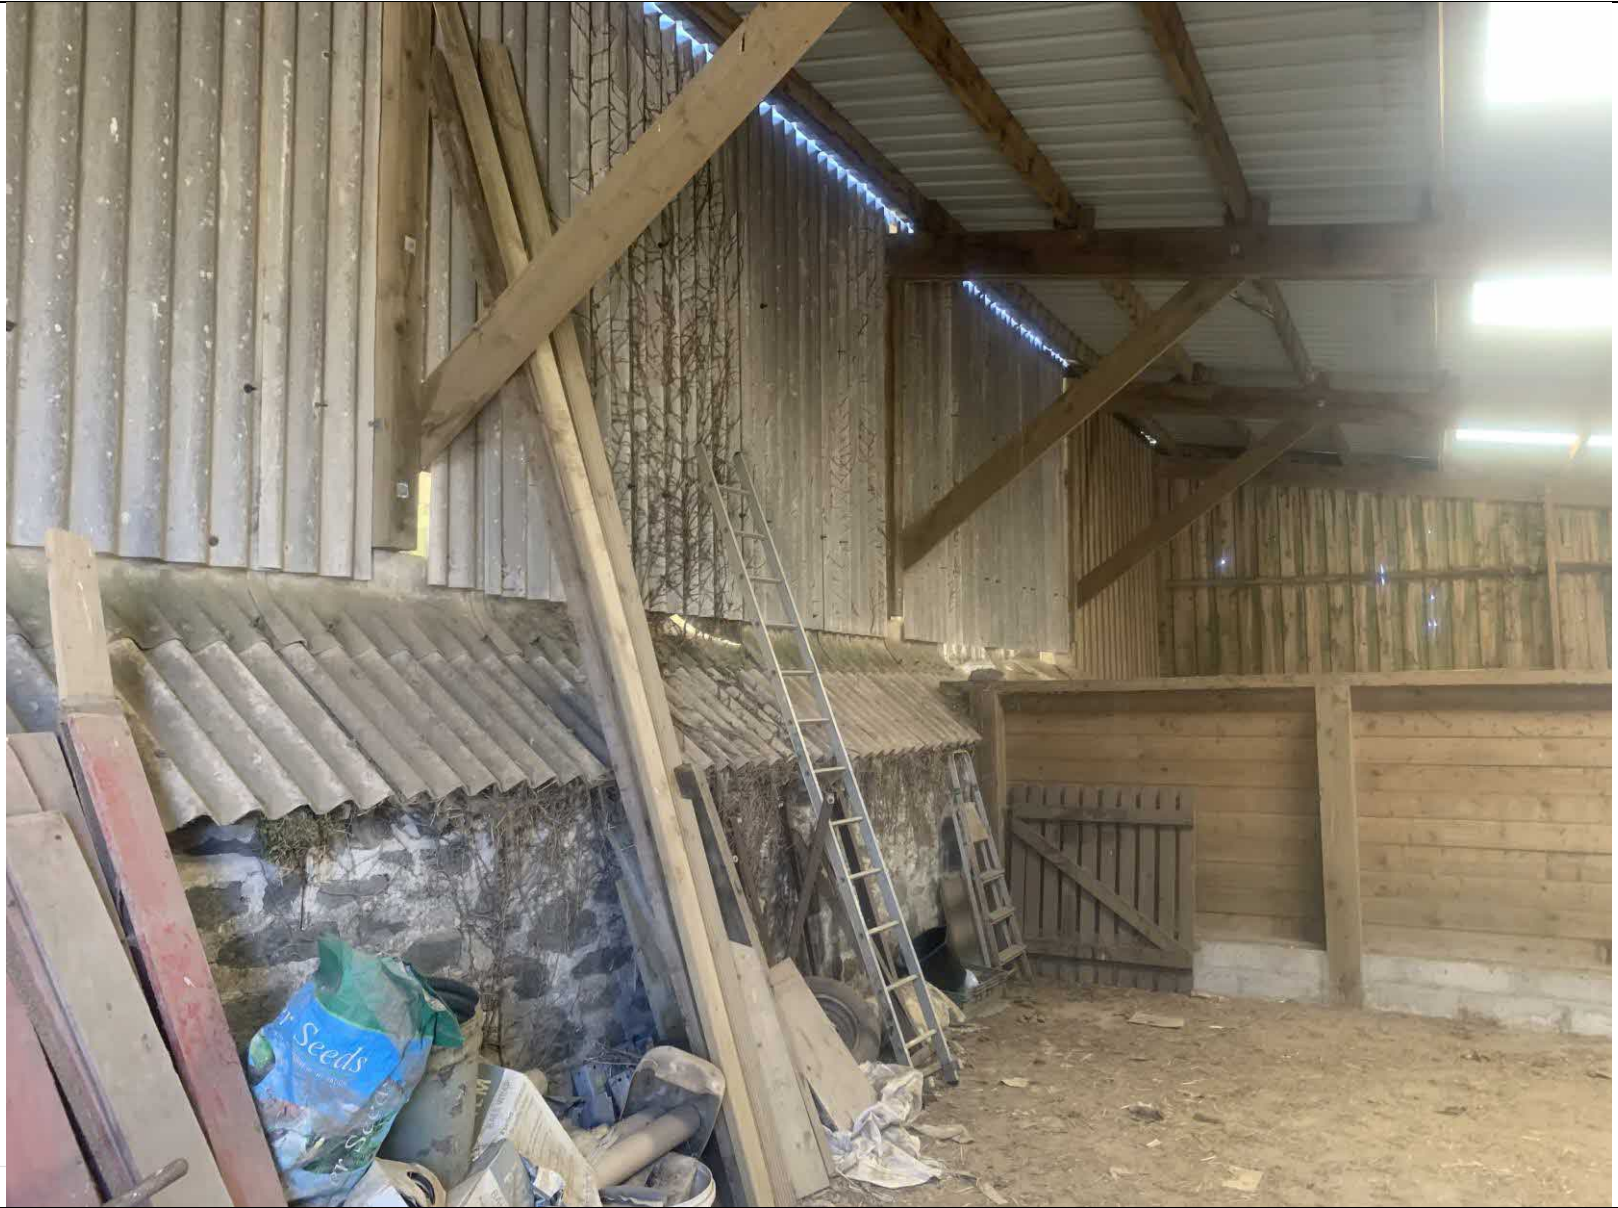
- 5.2.3 There is a stone wall located between the two walls which is in reasonable condition however, unlikely to have a concrete strip foundation.
- 5.2.4 The main concrete portal frames were in good condition. A couple of the cladding rail and purlins have some minor spalling. The main columns are cast into the ground in concrete pad foundations, there was no signs of distress on the concrete portal frames.

Photo 3 –
Stone dividing
wall

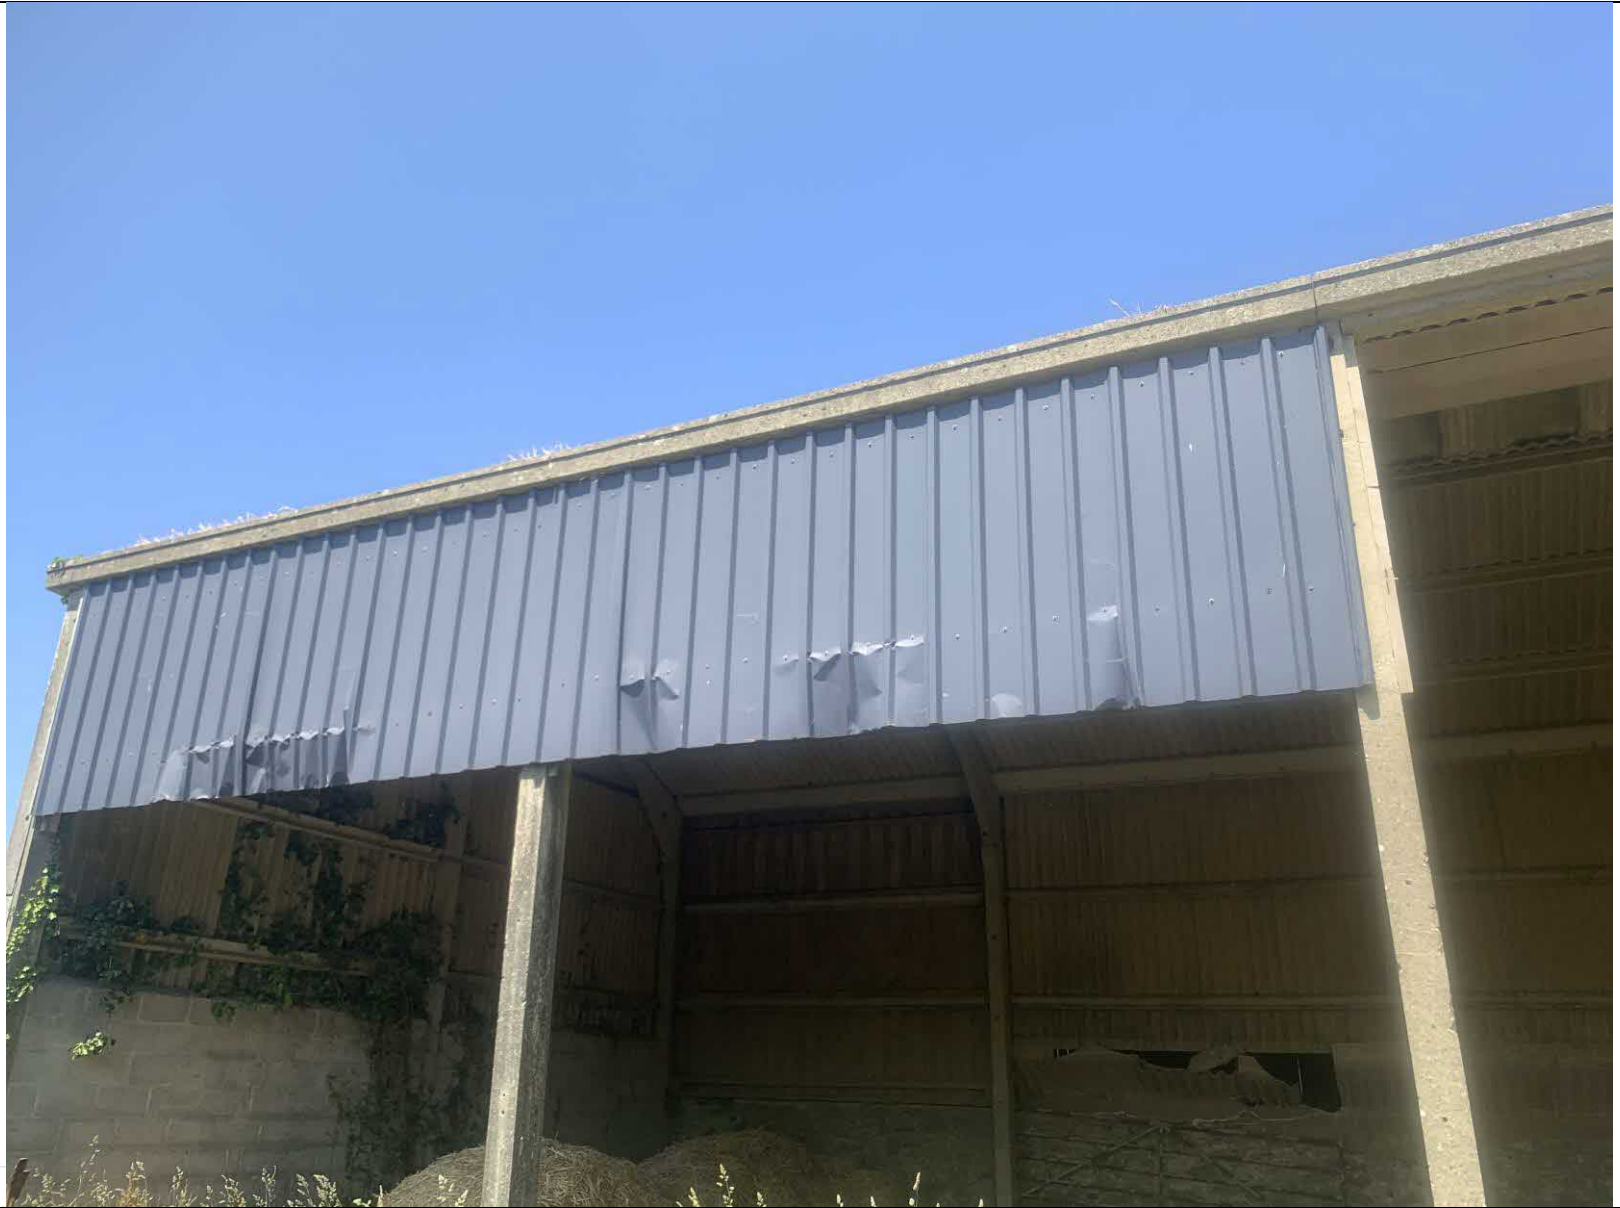
Photo 4 –
South
elevation Barn
2

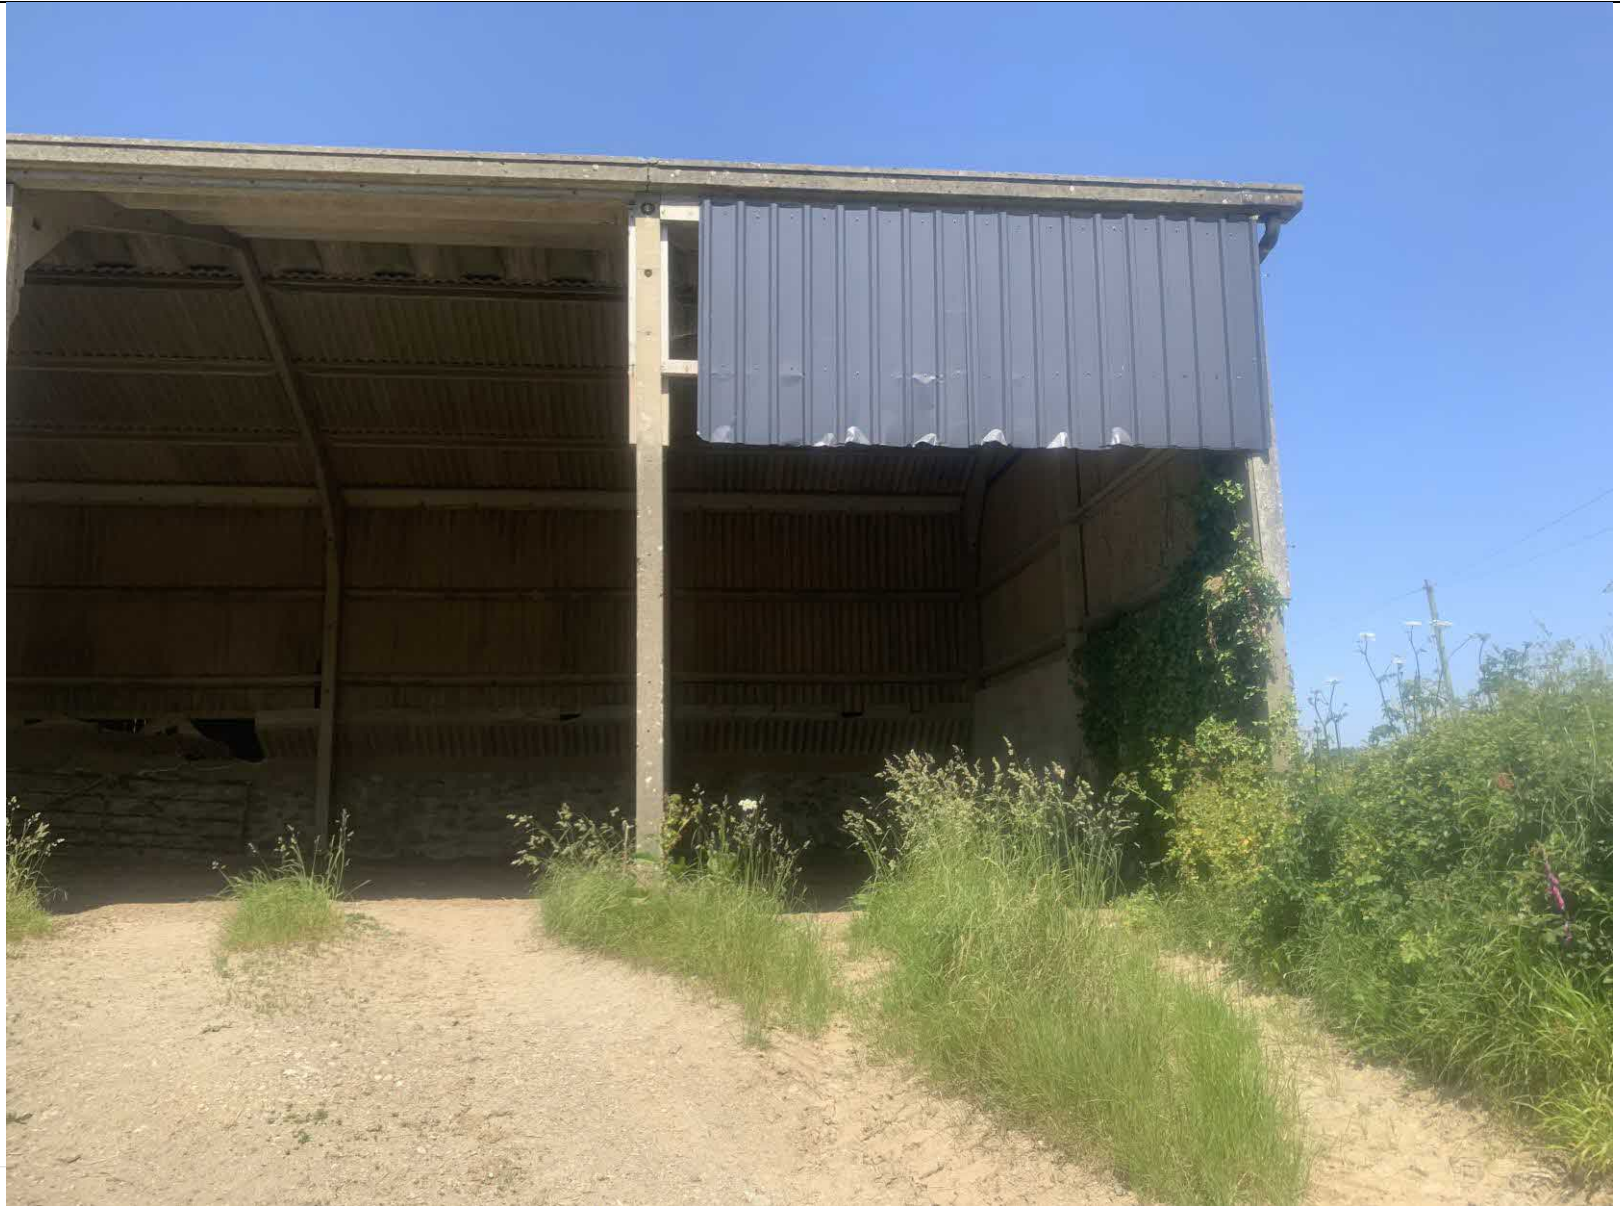
Photo 5 –
South
elevation Barn
2

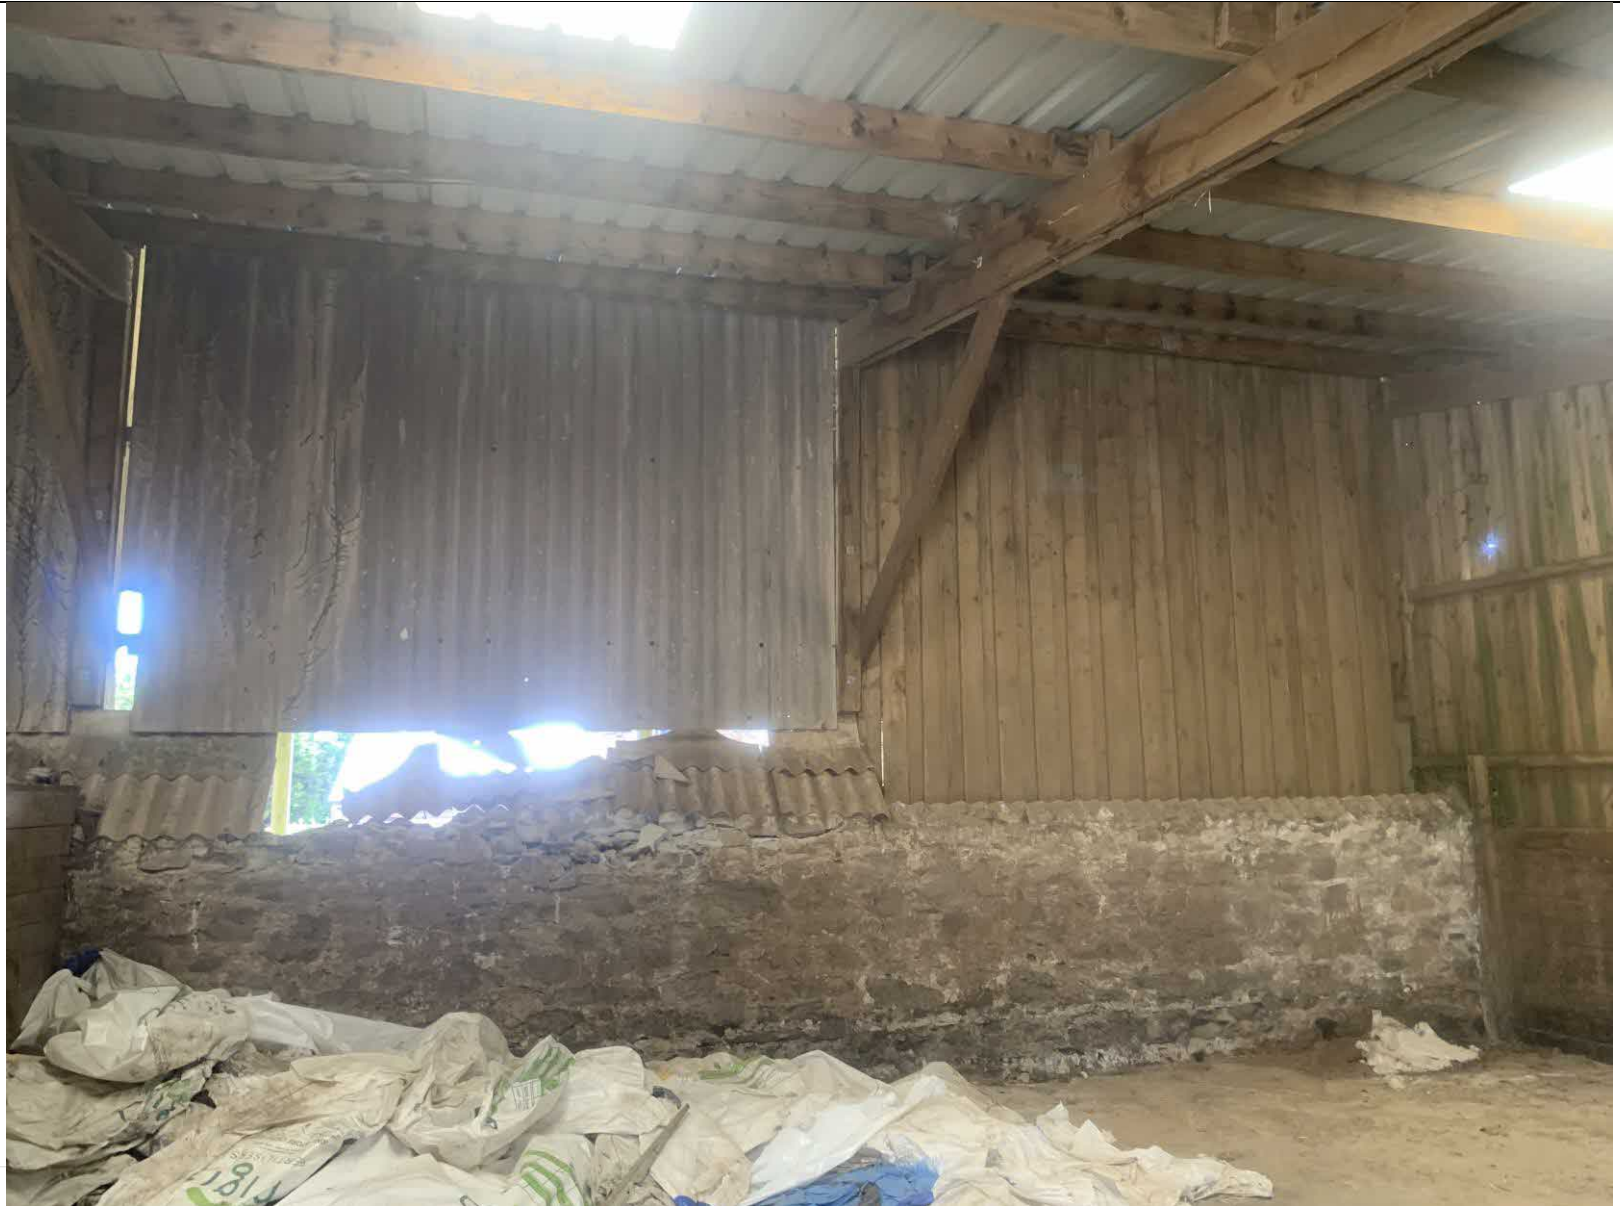
- 5.2.5 There was a small opening in the roof believed to be caused by machinery hitting the roof. There is also some damage to one of the clad walls again believe to be caused by machinery hitting the wall. The damage noted was non-structural.

Photo 6 –
Damage to
cladding Barn
1/2

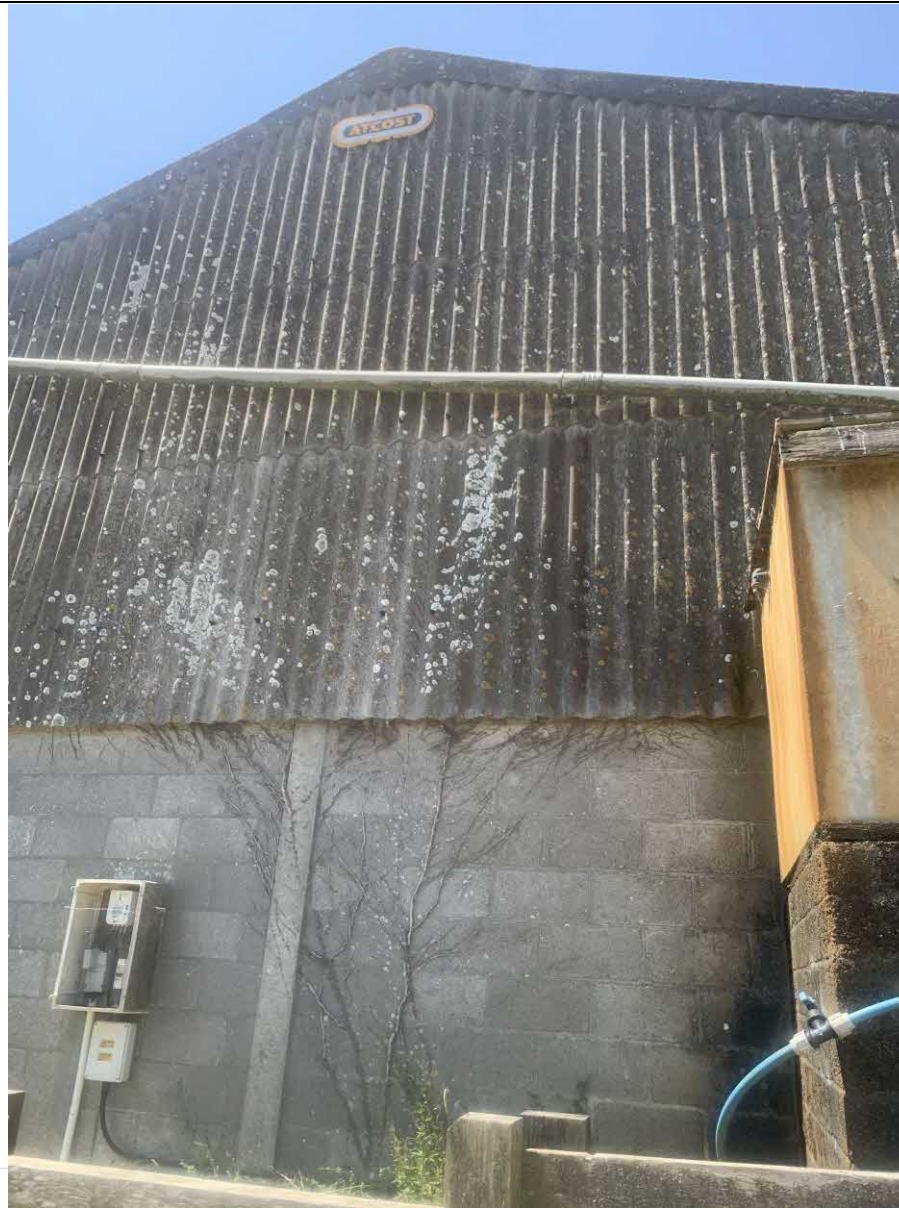
- 5.2.1 The open plan barn consists of 5 precast concrete frames. The frames provide both the lateral and gravitational load resisting system.
- 5.2.2 The Gable ends are constructed from block walls up to the mid height of the barn. The blockwork is in good condition.

Photo 7 –
Atcost Barn 2

- 6.2.3 At the time of construction Atcost frames were designed to resist loads of at least 80% of the stated loads, in the codes of practice at the time BS6399 (0.75kN/m²). Our current day codes of practice require the frames to resist (0.6kN/m²) which equates to 80% of 0.75kN/m². Therefore, the frames will be suitable to support the loads for a residential conversion.

- 6.2.4 Based on our survey and analysis the existing structure has the capacity to accommodate gravity, lateral and imposed loads required for a residential conversion without the need for structural strengthening.

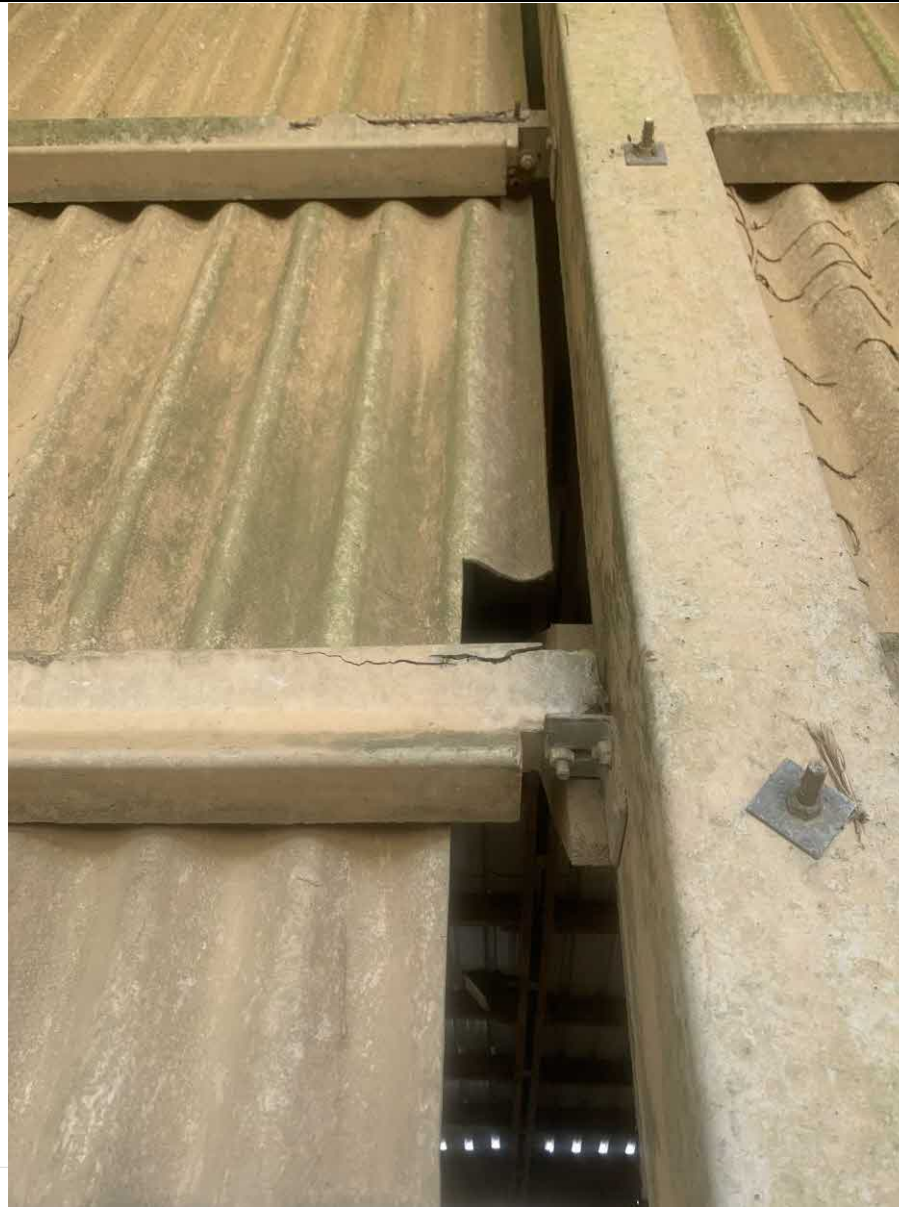
Photo 8 –
Spalling
concrete on
cladding rails

- 6.2.1 The existing precast concrete frames, purlins and cladding rails are in good condition. The main frames were plum and appeared not to be overstressed.
