David Wattam BSc(Hons)For-HND-Arb RIDINGS FORESTRY UK LTD
BS5837 2012 TREE SURVEY

Robson Architecture

New Dwelling, North Back Lane, Kilham, East Riding of Yorkshire, YO254RU.

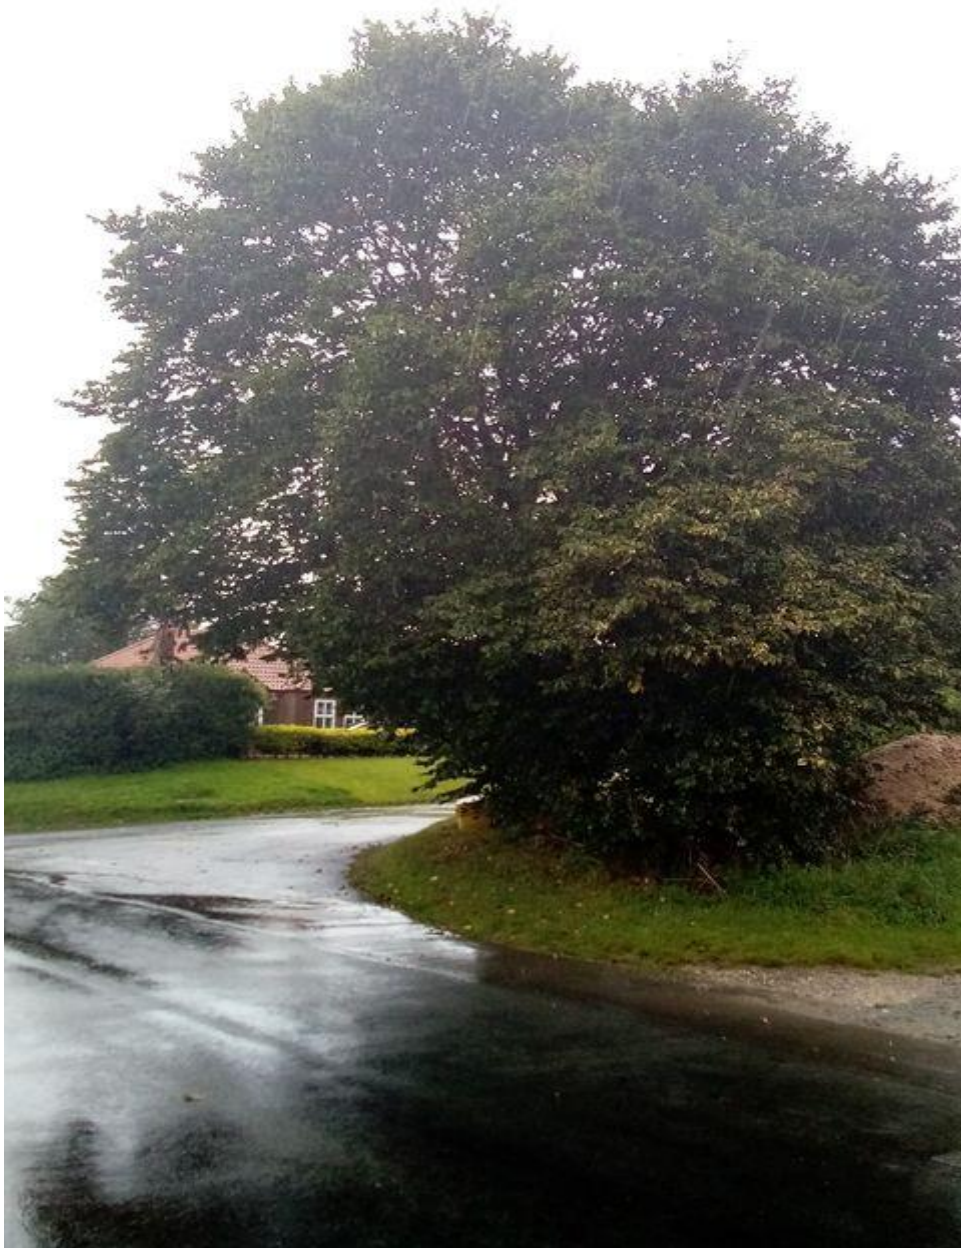
T001 Elm

T001 is visible within the street scene of the Conservation Area and is an important feature of the landscape. This tree has been classed as Grade A. See picture below.

The main issue regarding the development is the low canopy of T001 and its crown spread. See picture below.

T001 has been classed as Grade A and is a significant feature of the street scene. The RPA is slightly compromised by the foundations of the proposed development. I have recommended Class 1 protective fencing for the compromised area. This should mitigate any compaction and damage to the root system of the tree during the construction phase. I have also recommended that any excavations within or around the RPA should be done by hand only, avoiding damage to the protective bark covering larger roots. Roots, whilst exposed, should be wrapped in dry, clean hessian sacking to prevent desiccation and to protect from rapid temperature changes. Roots smaller than 25 mm diameter may be pruned back, preferably to a side branch, using a proprietary cutting tool such as bypass secateurs or handsaws. Roots larger than 25 mm should only be severed following consultation with an arboriculturist, as they may be essential to the tree's health and stability. Prior to backfilling, any hessian wrapping should be removed and retained roots should be surrounded with sharp sand (builders' sand should not be used because of its high salt content which is toxic to tree roots), or other loose granular fill, before soil or other material is replaced. This material should be free of contaminants and other foreign objects potentially injurious to tree roots. Please see picture below.

The lower portion of the crown would require crown lifting to facilitate the construction phase. A sympathetic crown reduction would also be required as there could also be an issue of the tree being overbearing and causing a nuisance, such as leaf litter and loss of light. This may cause issues with the homeowners and conflict with the local planning authority resulting in constant requests to heavily prune or fell the tree. Ideally, moving the house back away from the tree would alleviate the problems mentioned above. If that is not possible, I believe if pruning works are carried out sympathetically and by a professional competent arborist a satisfactory median can be achieved. A strong landscaping scheme is also advised to strengthen the trees lost on the eastern boundary.

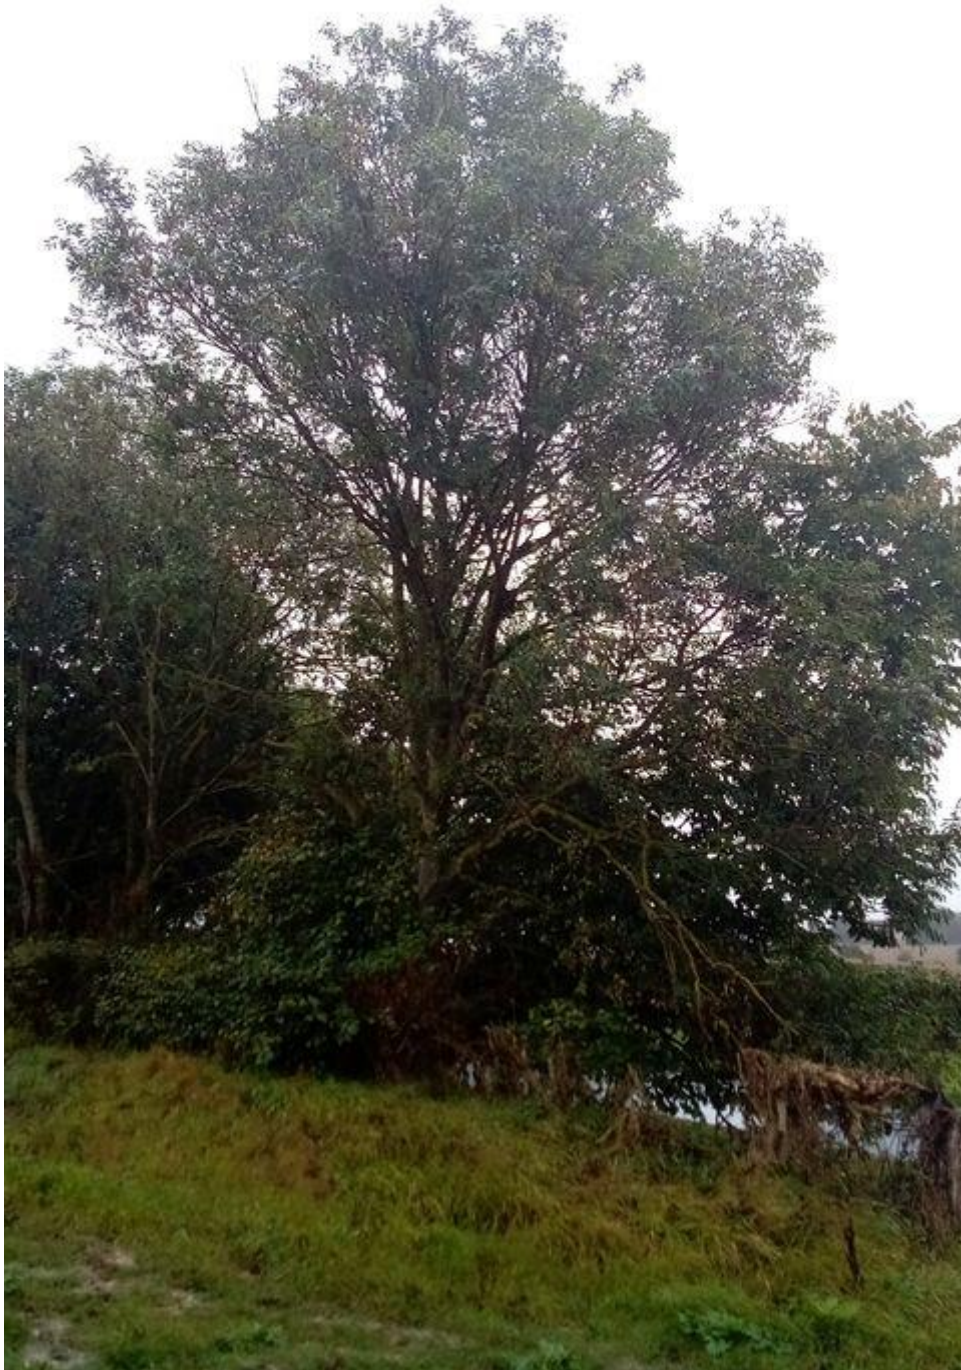
T002, T003 and T004 are hedgerow trees. All 3 trees are in a poor condition. T002 is an Ash Tree and has been heavily pruned on its eastern side. The tree is displaying signs of Ash Dieback 1-25%. These trees have been classed as Grade U. Please see picture below.

T002, T003 and T004 are in poor condition. I have recommended that these trees should be felled and replaced.

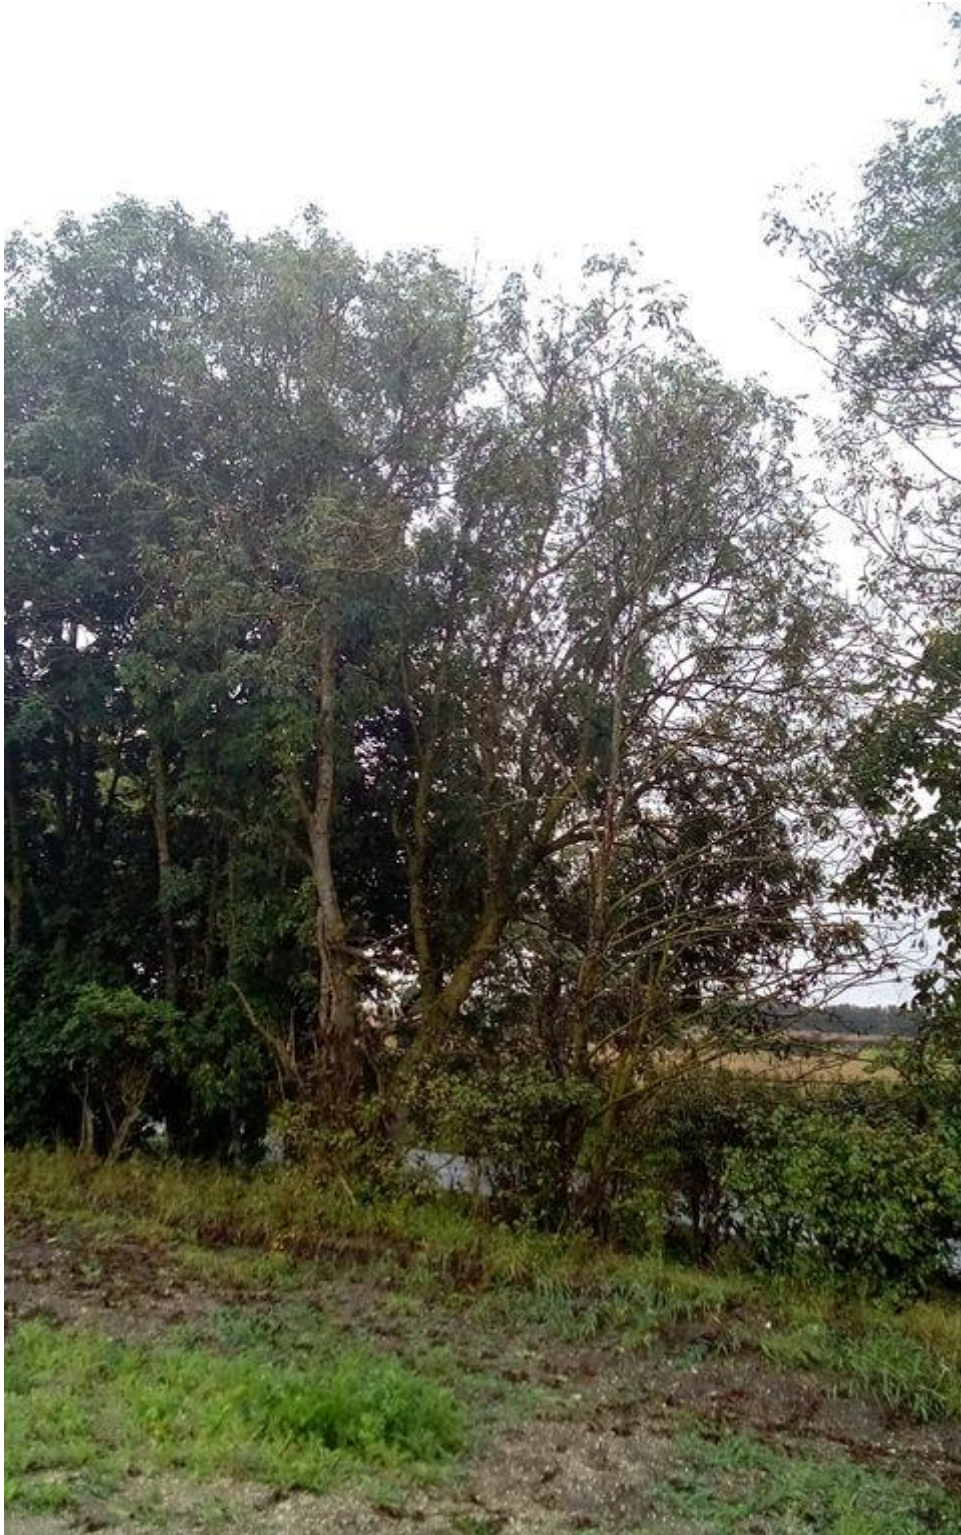
T003 is a dead Elm and T004 is an Ash. T004 is also infected by Ash dieback 25%. Please see picture below.
