Structural Engineers Inspection

Manor Farm House
Low Road
Besthorpe
Nottinghamshire. NG23 7BN

PCC Document Management	
Job Number:	10829
Date of Issue:	Sept 2023
Author:	Peter Cole

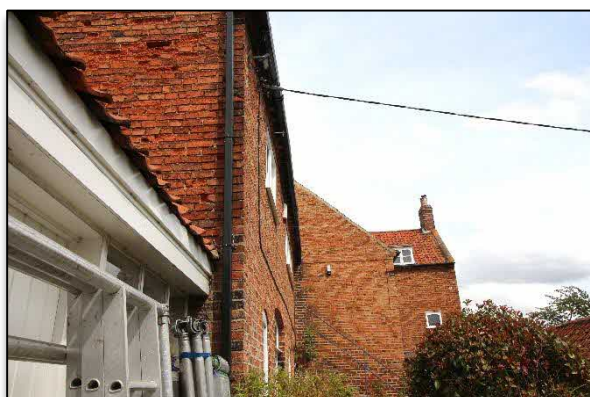
The form of the construction of the roof forming the two-storey section of the building would appear to be in the form of a rafter and purlin roof with ties beneath the purlin line. and at eaves level forming a triangulated structural form. External observations indicate a slight

dip in the line of the ridge and some indication of roof spread with slight convex curvature of the upper part of the wall construction. This form of distortion is not unusual on older structures and represents creep deflection of the timber elements forming the roof structure. The curvature will

not affect the structural performance of the roof. No remedial work is considered necessary.

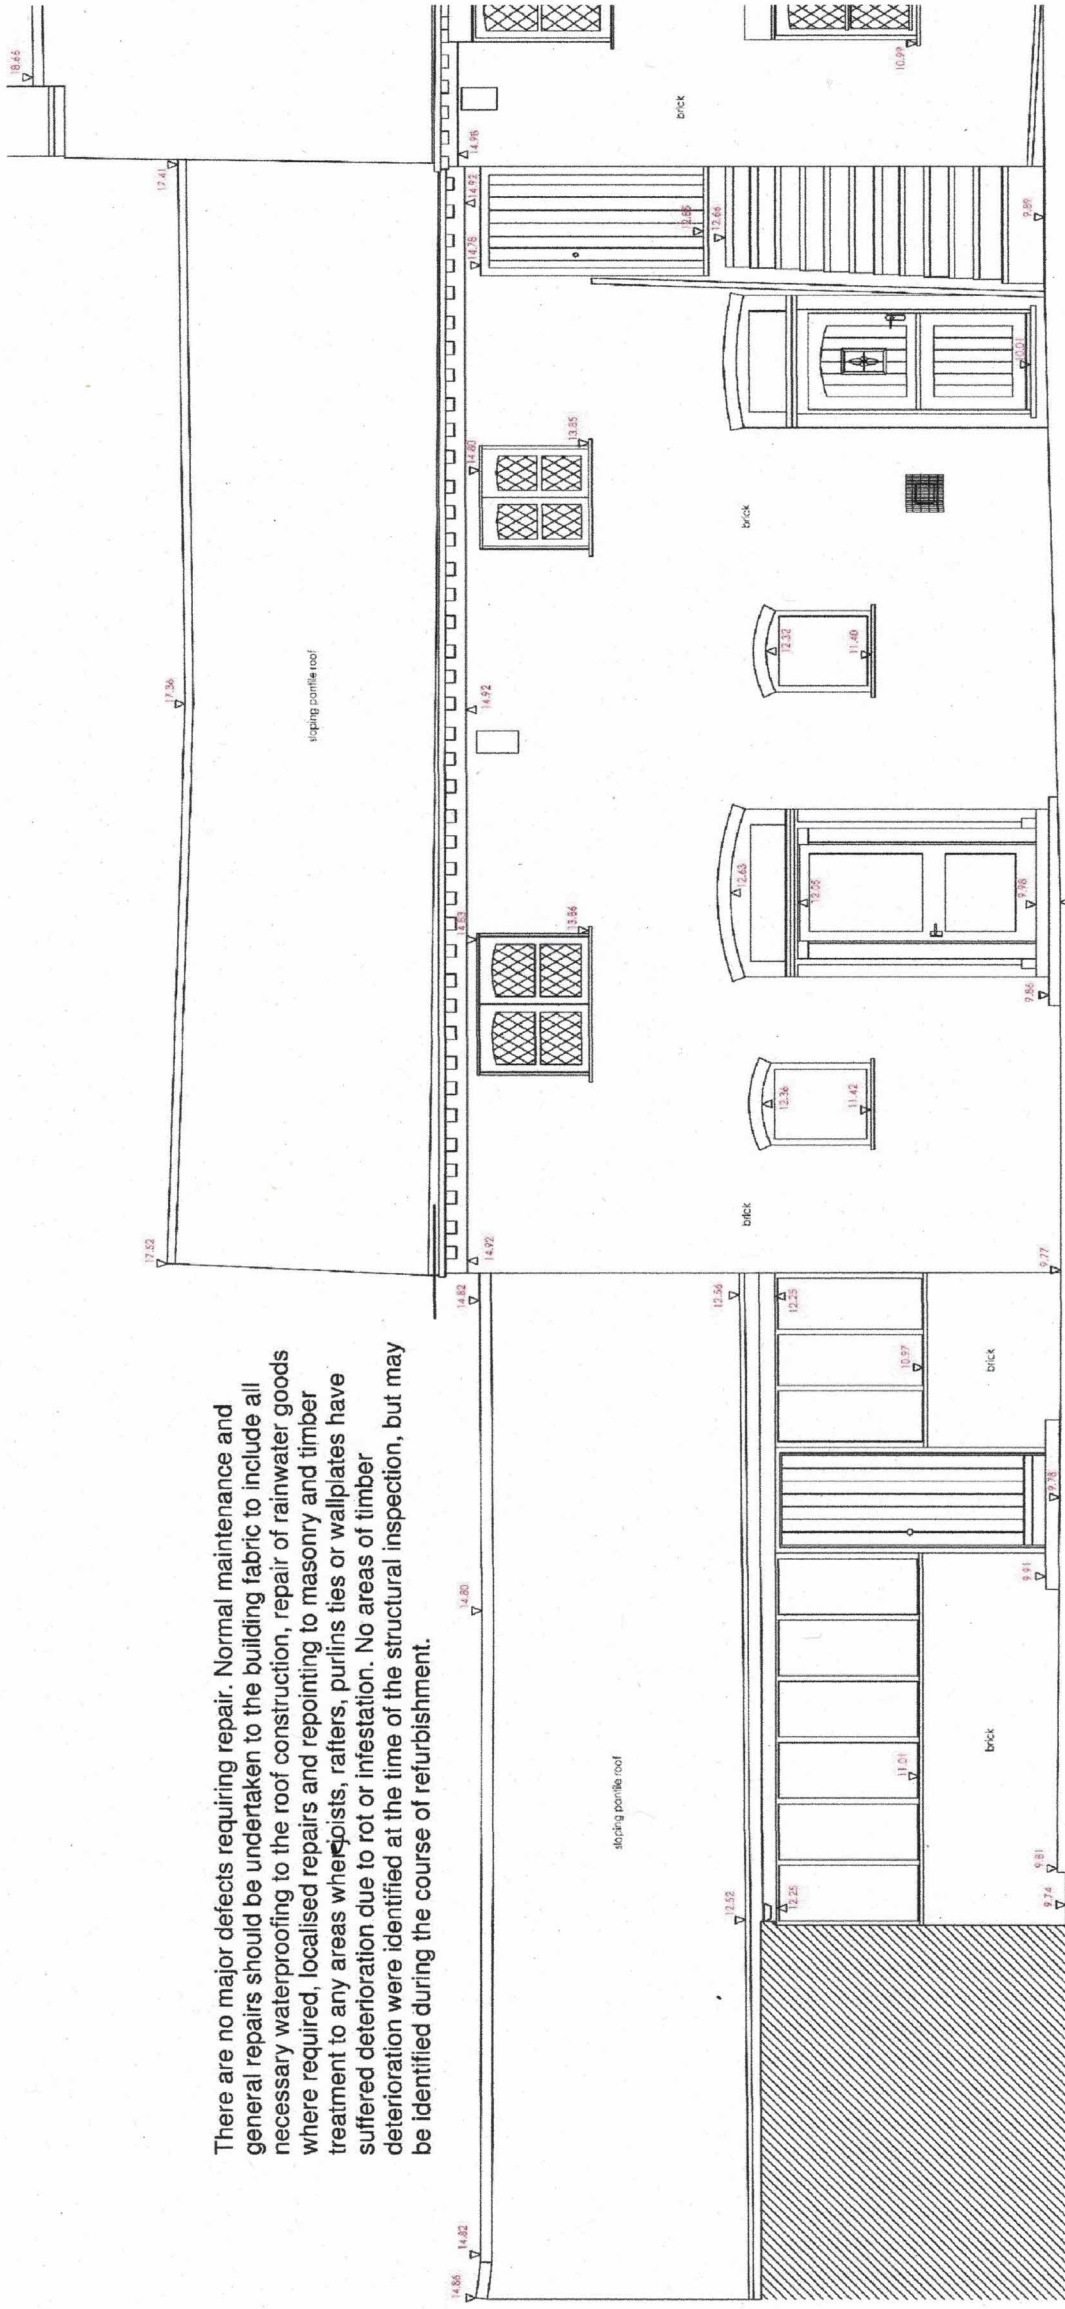
SOUTH ELEVATION (from inside courtyard)

There are no major defects requiring repair. Normal maintenance and general repairs should be undertaken to the building fabric to include all necessary waterproofing to the roof construction, repair of rainwater goods where required, localised repairs and repointing to masonry and timber treatment to any areas where joists, rafters, purlins ties or wallplates have suffered deterioration due to rot or infestation. No areas of timber deterioration were identified at the time of the structural inspection, but may be identified during the course of refurbishment.
