# Structural Engineers Inspection

Manor Farm House  
Low Road  
Besthorpe  
Nottinghamshire. NG23 7BN

PCC Document Management	
Job Number:	10829
Date of Issue:	Sept 2023
Author:	Peter Cole

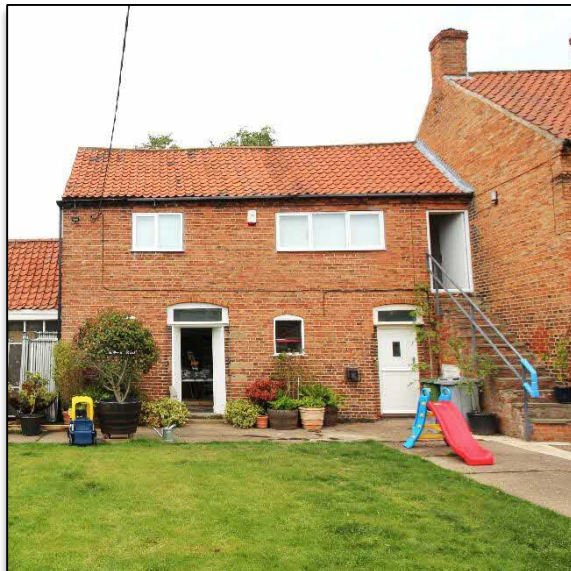
The two-storey outbuilding is constructed in brickwork with a pantile covered pitched roof. It is formed in masonry and is constructed with a suspended timber first floor. Historic maps indicate that the building was present in 1883 and may well be some years older than this. It is apparent that the building has been in use as a workshop and store and has been maintained in good condition.

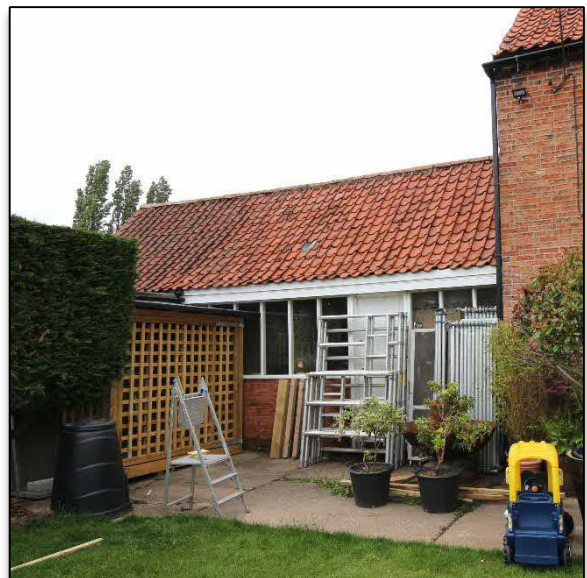
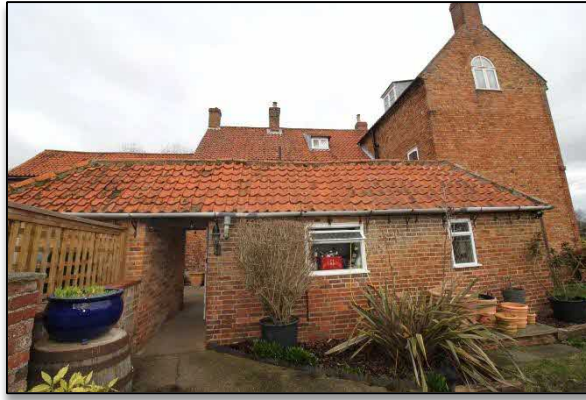
Adjacent to the two-storey outbuilding there is a single storey store and workshop formed with a pitched pantile roof and a dado wall with glazing above the dado wall. This section of the building is formed with raised ties and purlins with a single tie at eaves level. The structure has been maintained in good condition with no obvious indication of structural defect or significant erosion of the masonry. The age of this section of the building may be later than the two-storey outbuilding but is also at least 140 years old.

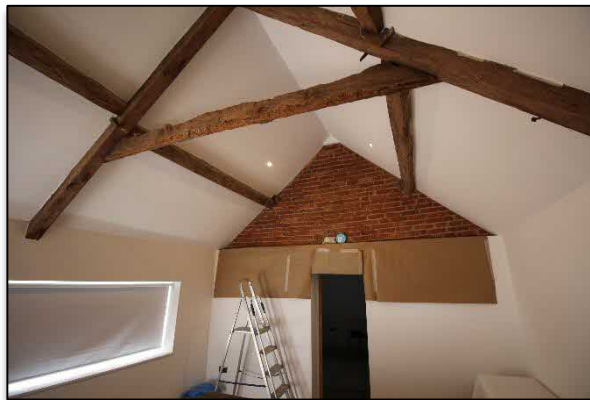
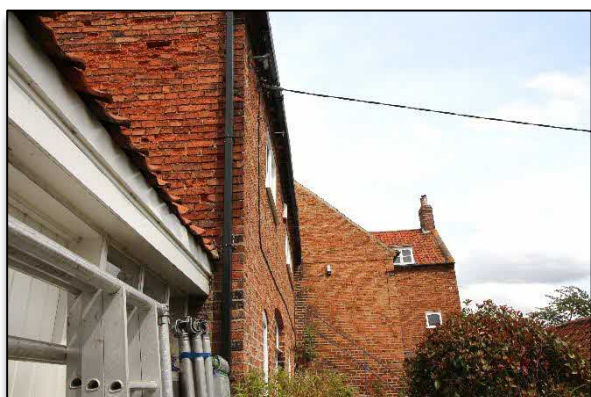
The form of the construction of the roof forming the two-storey section of the building would appear to be in the form of a rafter and purlin roof with ties beneath the purlin line. and at eaves level forming a triangulated structural form. External observations indicate a slight

dip in the line of the ridge and some indication of roof spread with slight convex curvature of the upper part of the wall construction. This form of distortion is not unusual on older structures and represents creep deflection of the timber elements forming the roof structure. The curvature will

not affect the structural performance of the roof. No remedial work is considered necessary.

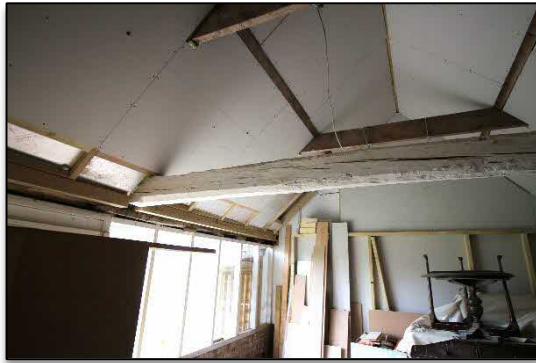
The workshop roof is formed with both eaves and purlin ties. The timber eaves beam appears to have performed well and the roof structure appears to be robust. The ridge line appears to be straight and true and there is no clear indication of convex distortion at eaves level. No remedial work is, therefore, required.

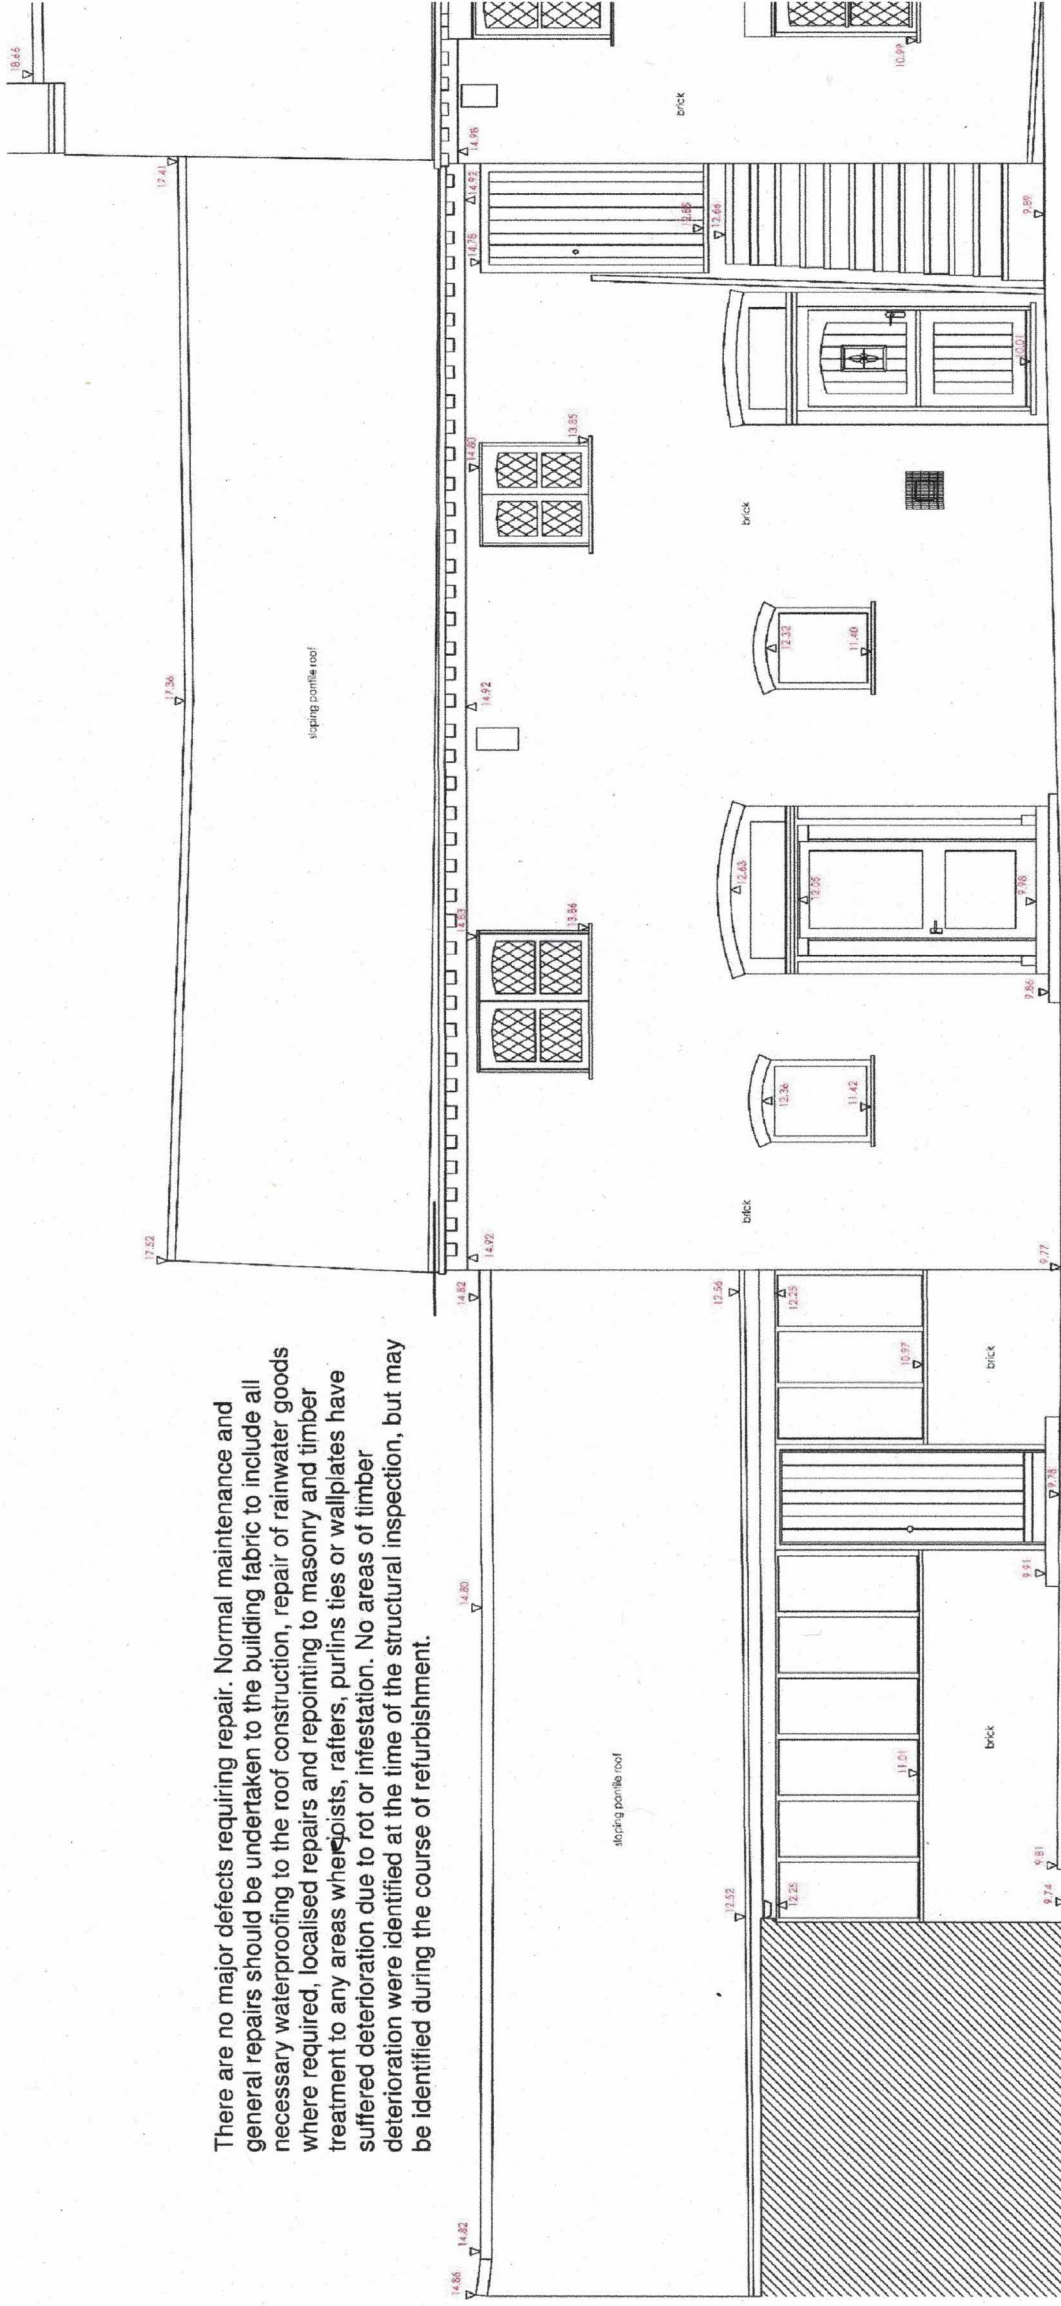
SOUTH ELEVATION (from inside courtyard)

There are no major defects requiring repair. Normal maintenance and general repairs should be undertaken to the building fabric to include all necessary waterproofing to the roof construction, repair of rainwater goods where required, localised repairs and repointing to masonry and timber treatment to any areas where joists, rafters, purlins ties or wallplates have suffered deterioration due to rot or infestation. No areas of timber deterioration were identified at the time of the structural inspection, but may be identified during the course of refurbishment.
