Re: ST PETER'S COTTAGE, 57- 61 MAIN STREET, ALDWINCLE NN14 3EL

Further to your recent instruction we confirm that our Mr Ken Porter visited the above property on the morning of Tuesday 14 March 2023, in order to carry out a visual inspection of the property with specific regard to items detailed in your email dated 7 March and as highlighted in the valuation report attached thereto.

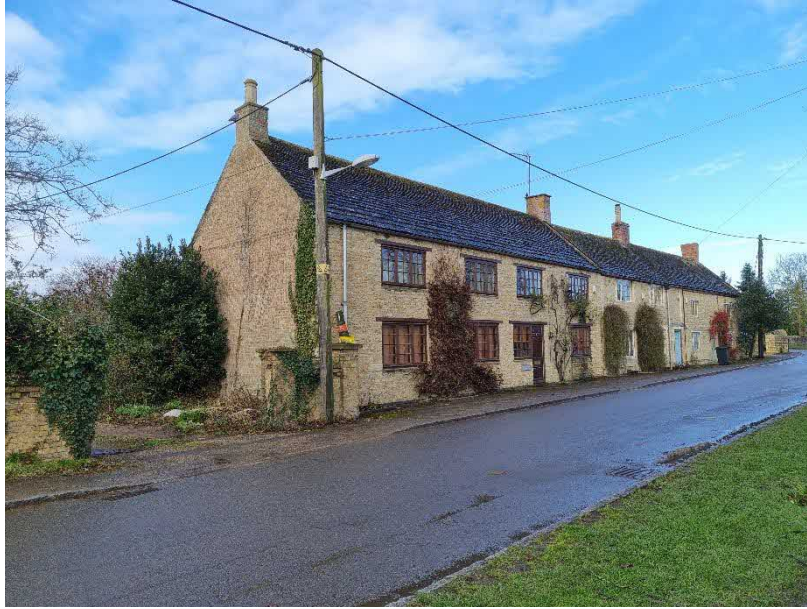
Plate 1. General View of St Peter's Cottage

- 1.1 St Peter's Cottage comprises a row of three former cottages (57, 59 & 61 Main Street), which have previously been altered internally and combined into a single residence.
- 1.2 The main range of the three cottages is aligned Northwest to Southeast and faces directly onto Main Street, Aldwinckle. (Photo 1).
- 1.3 To the right-hand end of the property, formerly No 61, a rear wing extends perpendicular to the main range.
- 1.4 Similarly, at the junction between the former cottage 57 & 59 an extension links the main building to a former outbuilding which now contains kitchen and boiler room.

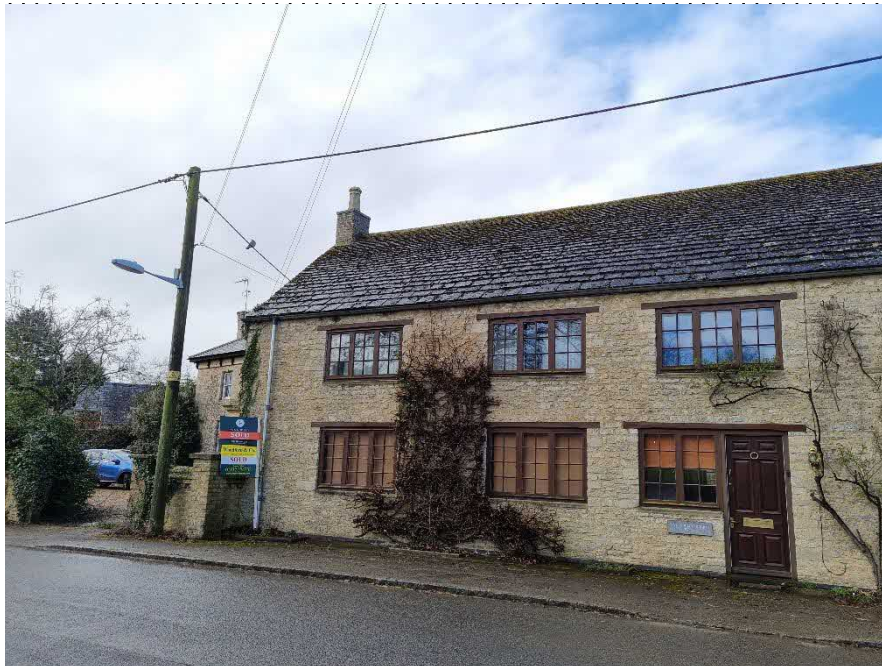
Plate 2. Roof over No.57

- 2.3 Viewed from the roadside, and from left to right, the roof over No 57 appeared in very good condition with no obvious sag in either ridge line or the plain of the roof. (Photo 2).

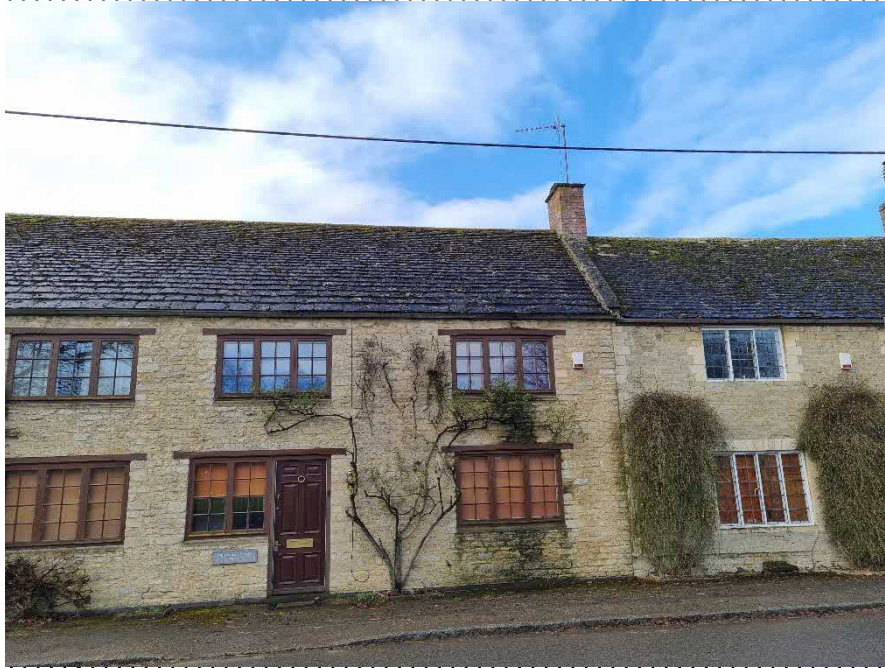
- 2.4 The front elevation stonework was also found to be in good order, with no signs of significant movement or disruption to cause major concern, though it is worthy of mention that the rainwater gutter above this section appears to be defective and is causing severe staining to the stonework and deterioration of timber windows (Photo 3).

Plate 3. Deterioration due to defective gutter.

- 4.7 We recommend that as part of any roof works in the future, the rainwater gutters be overhauled to ensure that they are running freely to the relevant downpipe.

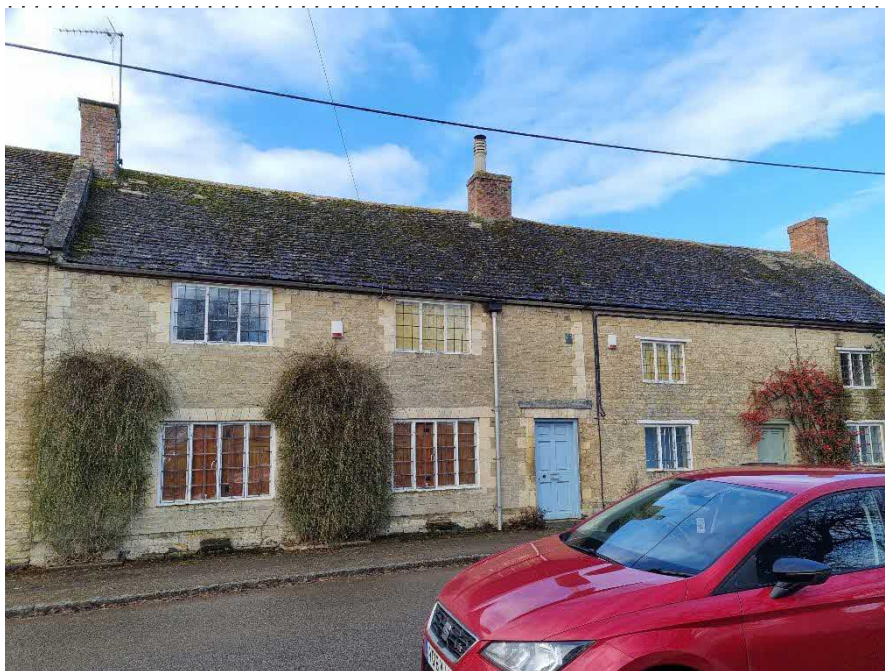
Plate 4. General View of No.59

- 2.6 The chimney above displayed severe weathering to the northerly facing brickwork.
- 2.7 The roof over No 59 exhibited slight undulations to both ridge and plane, together with evidence of historic repairs generally located close to the ridge and the chimneys at either end of this section. (Photo 4).

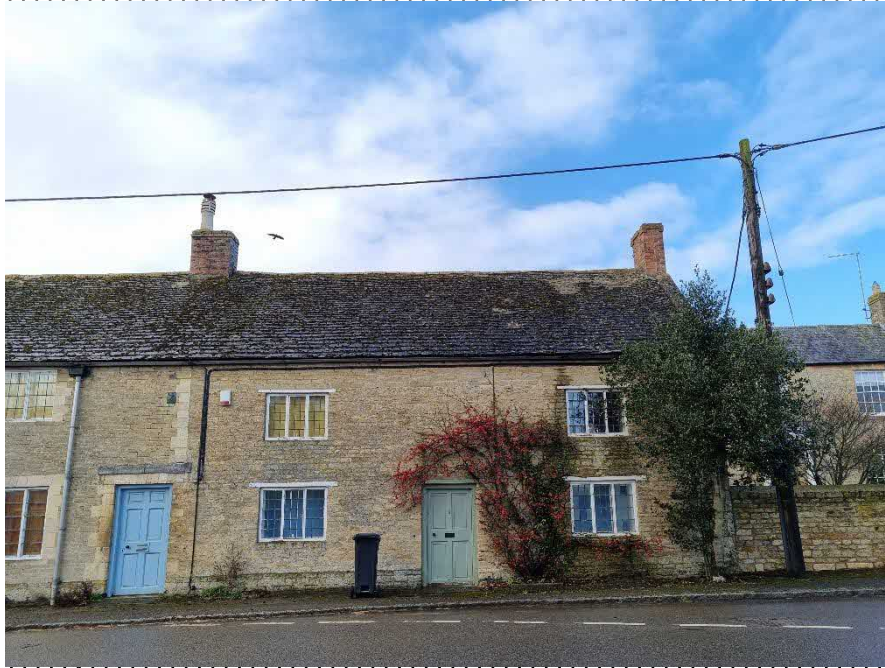
Plate 5. General View of No.61

- 2.10 The disruption noted above has the appearance of impact damage and may perhaps have been caused during previous works to the roof.
- 2.11 The roof over No 61 displays more obvious sagging along the ridge and throughout the plane. Appearing to worsen towards the right-hand end. (Photo 5).

- 2.12 Towards the right-hand end the ridge tiles exhibit signs of severe weathering and there is a large patch repair to the roof slates in the same area, together with the worst of the undulation of the roof.

- 2.15 As elsewhere the stonework was found to be in good condition with the exception of that below the area of defective guttering where, again, this is causing accelerated weathering and deterioration. (Photo 5).

- 2.16 It was noted that this has caused cracking within the stonework between ground and first floor windows due to the failure of the timber lintel.
- 2.17 The North gable (Photo 6) stonework exhibits minor cracking and many historic phases of repointing throughout.

- 4.4 Hence it would be prudent to strip and replace the roof covering here in the short to medium term in order to forestall future problems.
- 4.5 At the same time the opportunity should be taken to inspect the timber structure exposed by the work to ensure its good condition and treat/replace if necessary.

- 4.8 The timber lintel over the ground floor front window of No 61 will need to be replaced and the associated cracking above repointed.
- 4.9 The cracking to the North gable should be repointed, to prevent further damage due to weathering, as should the North and South chimneys and the small area of stonework at the top left corner of the front elevation No 59.

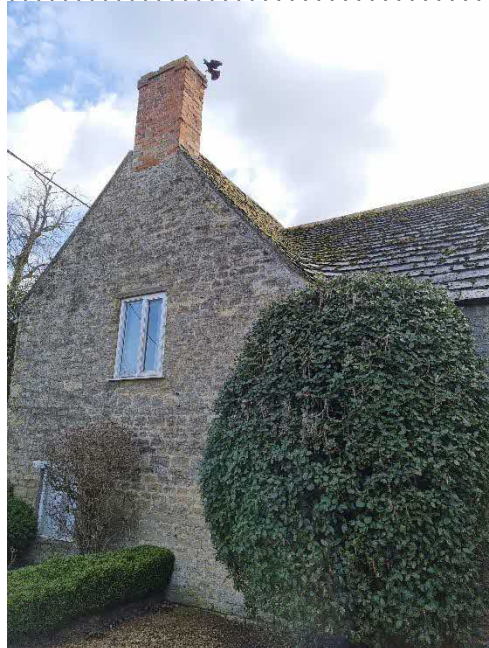
Plate 6. View of North Gable

- 2.19 We understand that the bottom left-hand corner was struck by a vehicle in the past and this seems consistent with the localised repointing here.

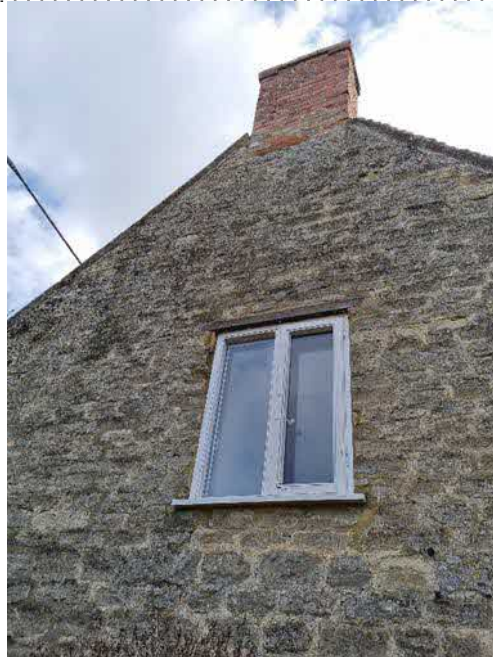
- 2.20 The nature of existing cracking is not indicative of foundation movement, but rather a combination of weather and use of incompatible mortars associated with historic repairs and modifications. (Photo 7).

Plate 7. Typical condition of North gable.

- 4.12 It should also be noted that this work should be carried out by an experienced stone mason using the correct, sympathetic mortar, failure to do so previously is the likely cause of most of the current cracking.

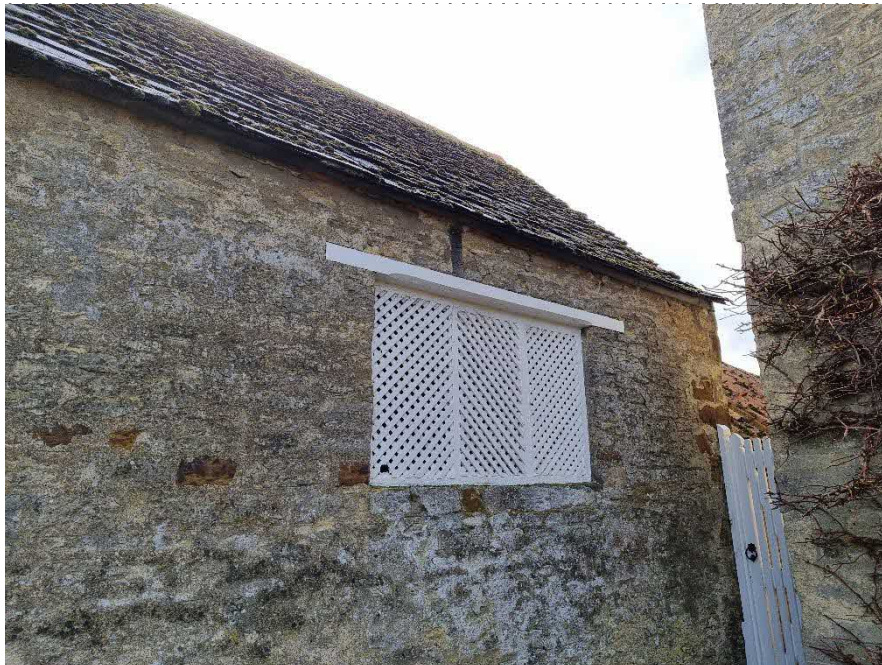
- 2.21 Rearward of the north gable is the side wall of a former barn. As elsewhere, the roof appears to be in adequate condition with no signs of significant damage or disruption to cause major concern. (Photo 8).

Plate 8. Barn attached rearward of North gable.

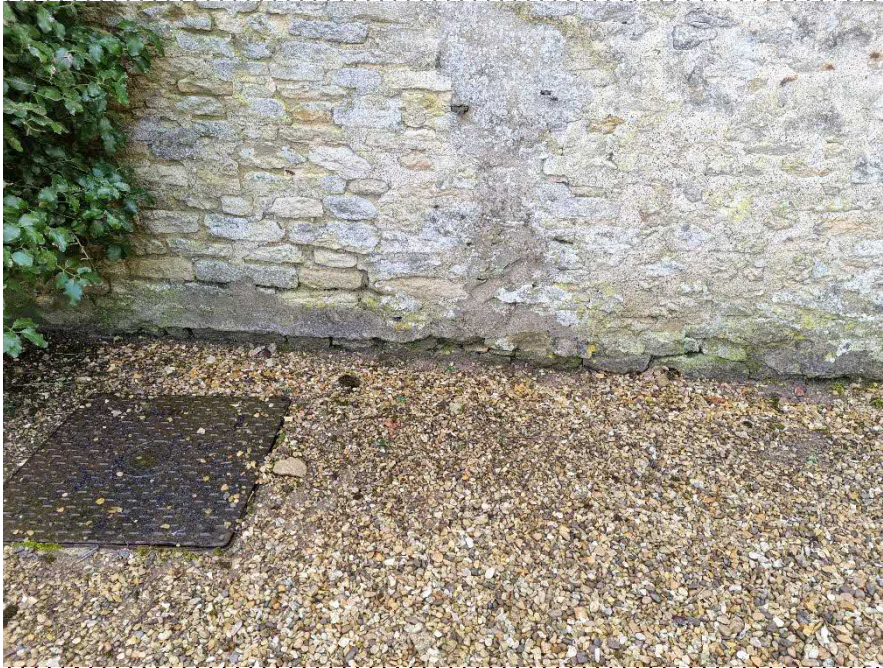
- 2.22 It should be noted that this section of roof has no gutter at eaves and that this is causing accelerated weathering to the masonry below, particularly at ground level. (Photo 9).

Plate 9. Accelerated weathering due to lack of gutter above

- 4.13 Consideration should be given to providing the attached barn with appropriate guttering to transport water effectively away from the building. Again, this will mitigate against further disruption to the stonework.

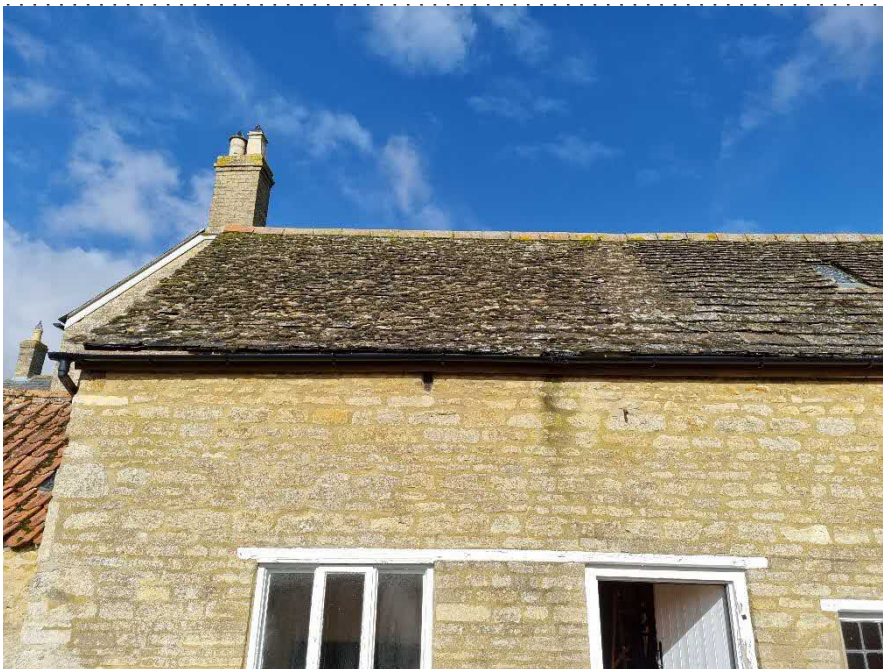
- 2.24 The rearward barn roof exhibited historic repairs, similar to elsewhere, as well as a slipped tile and defective gutter. (Photo 10).
- 2.25 The roof over No 61 displayed less disruption than on the front elevation, probably due to the stabilizing effect of the subsidiary roof over the adjoining barn. (Photo 11).

Plate 10. Former barn rearward of North gable

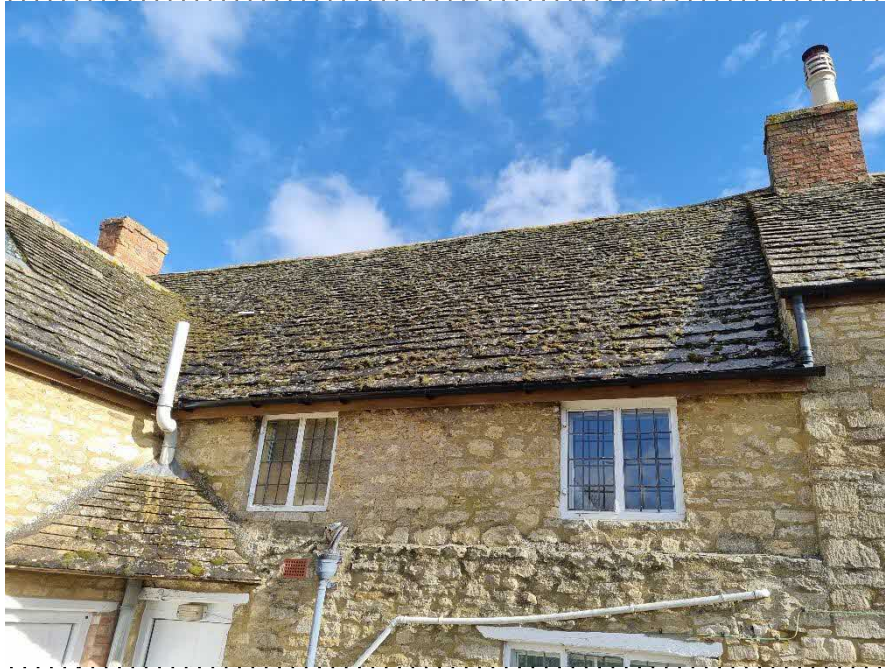
Plate 11. Rear elevation of No. 61

- 2.26 This section of roof was of slightly steeper pitch to the adjoining roof. It appears that the front elevation eaves were lifted at some point in the past to match that of No 59, but not the rear. (Though it does appear that the first-floor masonry on this rear elevation has been re-built at some point.

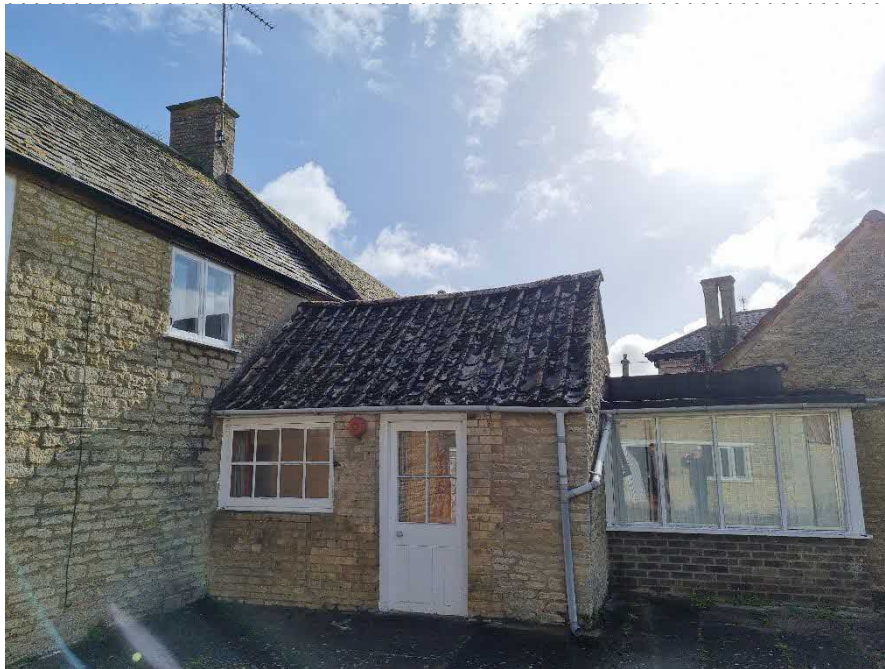
Plate 13. Rear link to kitchen

- 2.27 The pantile covered roofs over the link and kitchen (Photos 13 & 15) display severe sagging in both ridge and plane.
- 2.28 The link appears to have been constructed beneath an existing pantile roof, originally supported at its rearward end on a gabled stone wall with infill brickwork back towards the main building. There is a slight suggestion here of downward movement of the original stonework. (Photo 13).

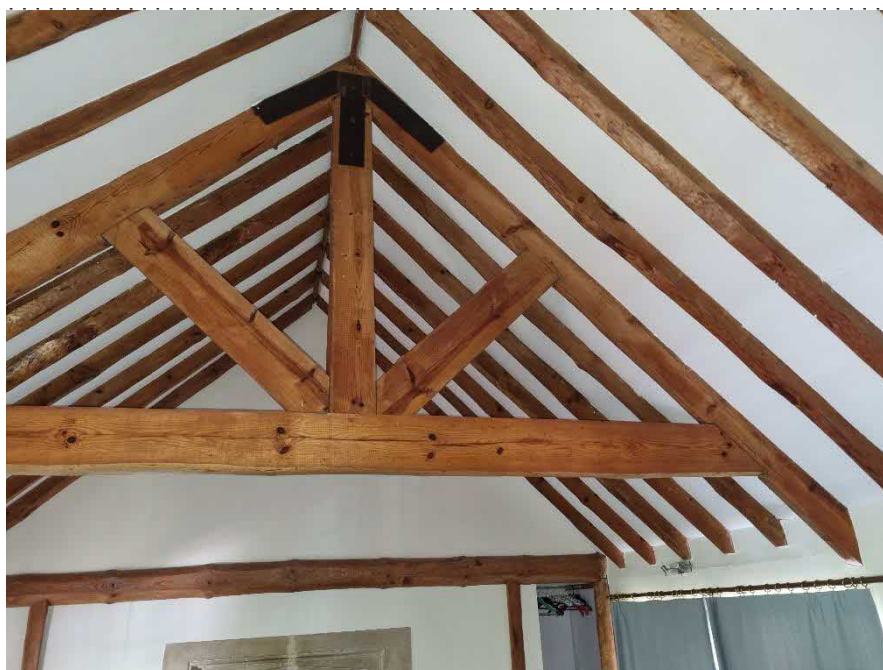
Plate 16. Roof over No.57

- 3.1 Where possible we were able to carry out a head and shoulder inspection inside the roof spaces. This was restricted to No 59 & 61 as within No 67 the large part of the roof is vaulted over the master bedroom and clear to view. (Photo 16).
- 3.2 The roof over No 57 appears to be supported off a central truss, though we would normally expect to see accompanying purlins and ridge beam which may be hidden beyond ceiling finishes. (Photo 16).
- 3.3 There is slight disruption to plastered finishes at rafter feet, but this is considered to be a result of thermal and moisture effects rather than indicative of a significant structural issue. (Photo 17).
- 3.4 Access was gained to the roof space over No 59 by means of a small hatch above the hallway.

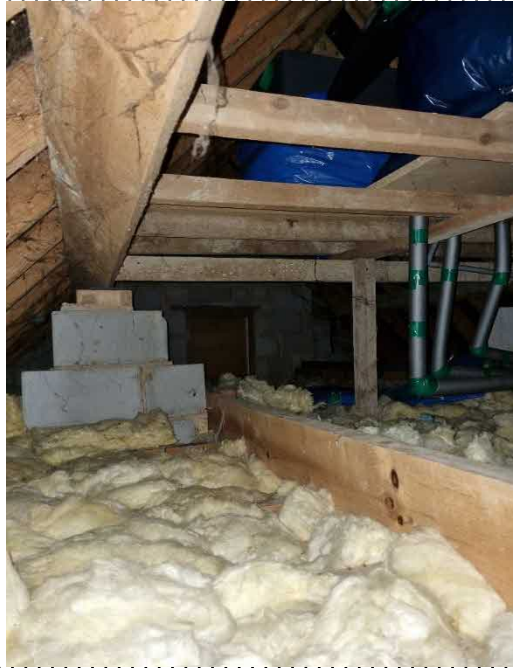
Plate 17. Minor disruption at wall plate.

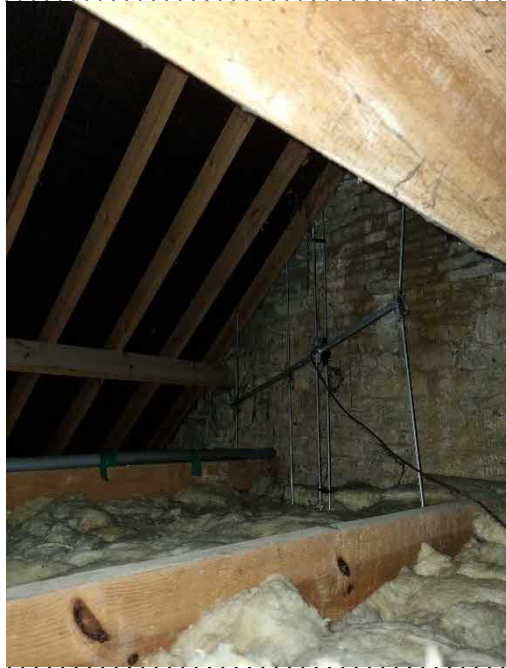
- 3.6 All timber appeared in good condition and the roof benefited from a relatively modern sarking felt (Photo 19) though daylight could be seen to one or two tears therein.

Plate 19. View of sarking felt.

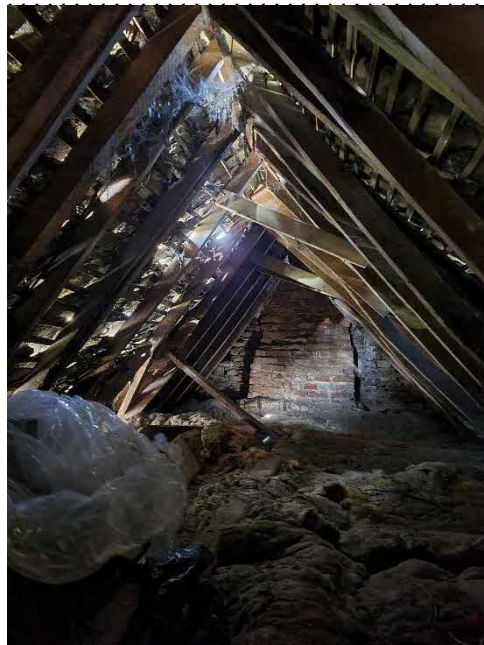
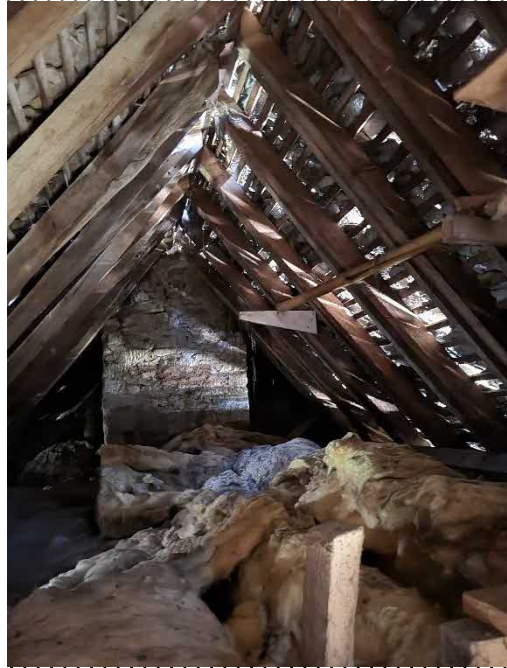
- 3.9 A small stain in the front left corner was indicative of a minor leak in the roof above.
- 3.10 A further loft hatch above the bathroom of No 61 provided access into this section of roof (Photos 20 & 21).

- 3.11 Viewed from the inside this revealed significant amounts of daylight entering through the roof covering throughout, though mainly from the rear slope.

- 3.12 The entire roof benefited from strengthening in the form of additional rafters alongside original rafters and at the Northerly end a number of bracing members were also in evidence.

- 3.13 There was a marked absence of pegs/nails securing the slates to the tile lathes throughout.
- 3.14 First floor ceilings within No 61 were in surprising, good condition given the likelihood of water ingress through the roof covering above.

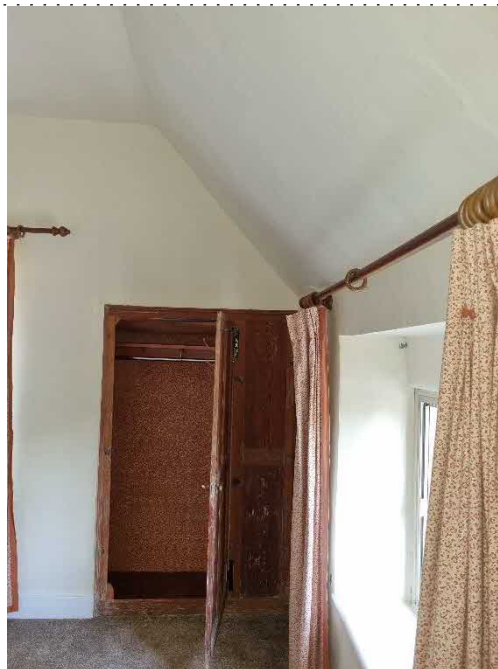
- 3.15 As elsewhere there was no significant damage or disruption to indicate major structural issue. (Photo 22).
- 3.16 Worthy of note is a large distortion of the doorframe in the hallway at the partition between the stairs and the bathroom, where the internal wall appears to have dropped significantly.

Plate 22. Typical view of No.61 1st floor finishes.

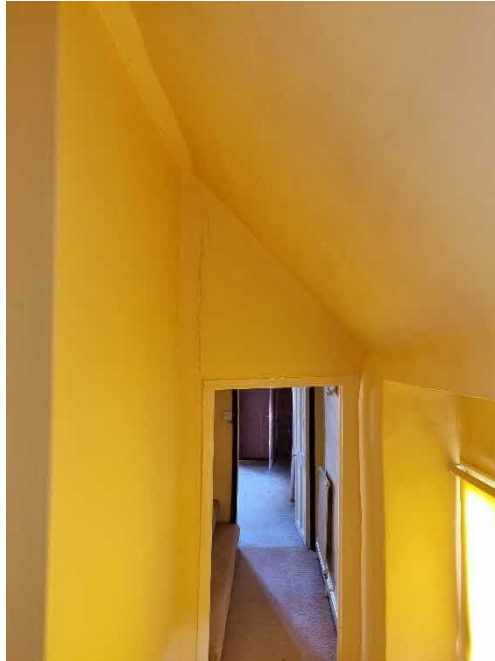
- 3.17 To the side of this opening is a tear in the finishes (Photo 23). This tear is not reflected in the door frame, or its gloss paint and it appears that this tear has been caused by a combination of thermal/moisture shrinkage and the presence of timber substrate adjacent to masonry and not indicative of structural movement.

Plate 23. Tear at junction.

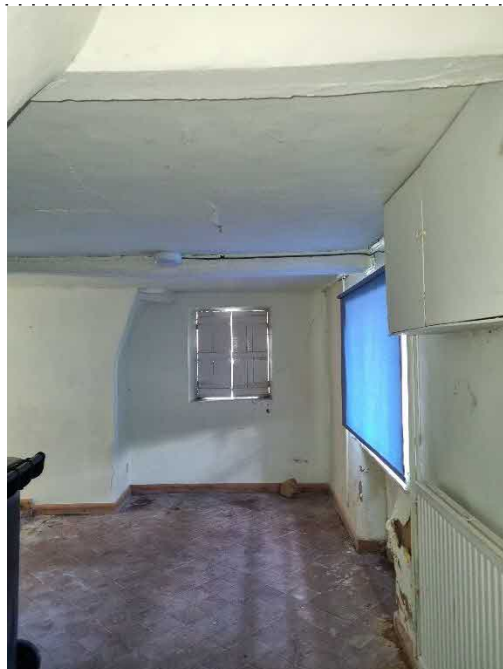
- 3.20 Within No 61, the ground floor accommodation is in relatively poor condition and in need of general refurbishment in order to bring it up to modern standards. (Photo 24).

- 3.21 In spite of this, and the likelihood of the presence of rising damp, there were no obvious structural issues in evidence.
- 3.22 Passing through the main range into the attached barn, this has been converted into habitable accommodation at some point in the past by means of a relatively modern suspended ceiling.

Plate 24. Typical view in No.61 Ground floor.

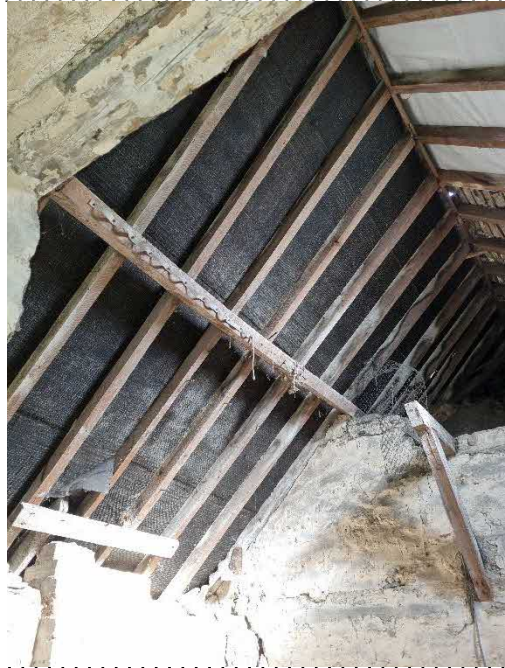
Plate 25. Barn roof.

- 3.23 Above this and viewed through a hatch is the original roof which comprises of common rafters and purlins. This roof is likely under-strength and would benefit from the installation of additional ties at eaves level to prevent potential roof spread. (Photo 25).

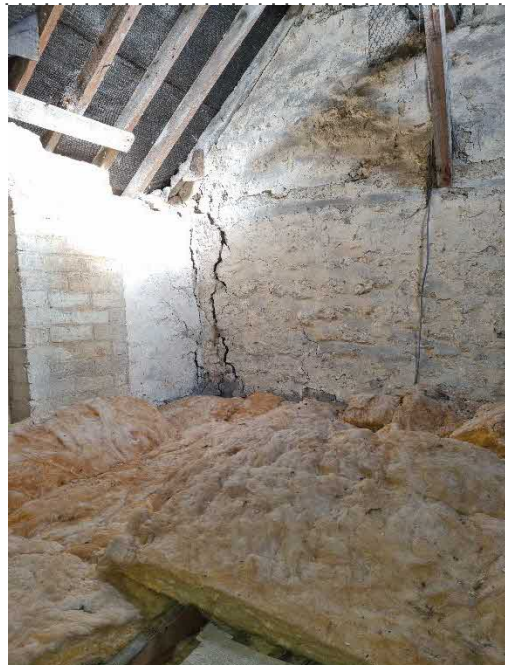
- 3.24 At the junction between the barn and the main range, a large crack is visible though this is clearly historic in nature, and not reflected internally, it would benefit from suitable restraining strapping to adequately tie the two leaves together. (Photo 26).

Plate 26. Historic crack

- 4.10 Restraint straps should be installed on the crack between the barn and the main body of No 61 in order to restore connectivity.
- 4.11 It should be noted that this repointing exercise is regarded as a preventive measure and is not indicative of structural issues.

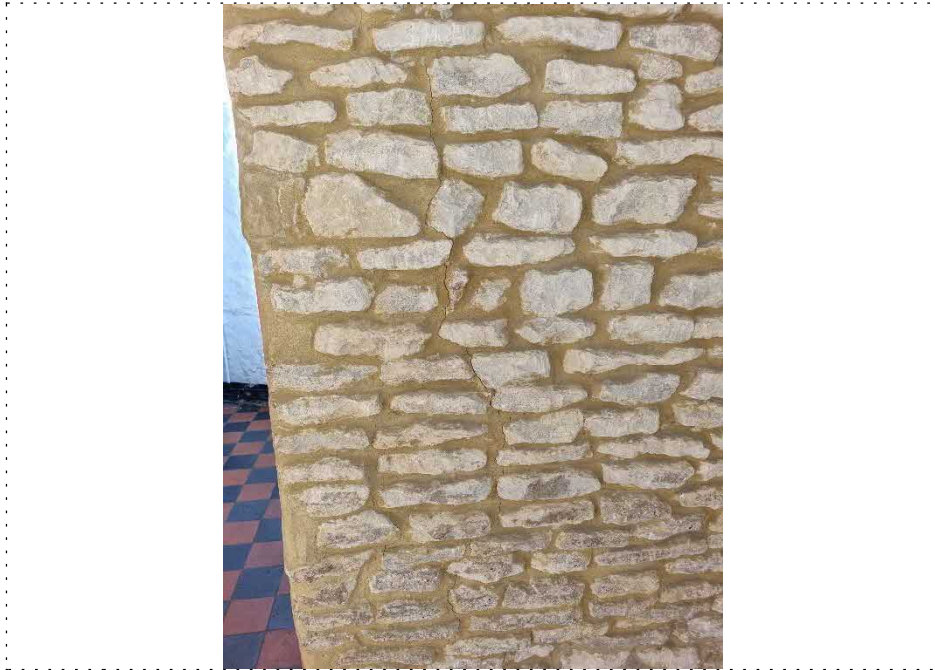
- 3.25 The link and kitchen/boiler house exhibit signs of minor movement particularly at the corner noted externally.
- 3.26 The original parts of these former outbuildings are likely to benefit from little or no significant foundation and hence will probably be prone to seasonal movement, but at present the effects are small and do not appear progressive.

Plate 27. Minor movement within link.

- 4.14 With regard to the linked outbuildings, it is likely that these are prone to seasonal movement due to inadequate foundations.
- 4.15 It should be noted that all buildings move to some degree and that this is not necessary indicative of significant structural problems, most commonly leading to minor cracking.
- 4.16 In our view the cracking noted here would not warrant underpinning the building and indeed it is likely that it would be more cost effective to demolish the outbuilding and replace if required.
