REPORT ON TWO BARNS,
 SHORNHILL FARM,
 SHORNHILL,
 WITHINGTON
 GL54 4BJ

JOB NUMBER 22 / 159
CLIENT Mr P O'Sullivan
DATE 8th June, 2022

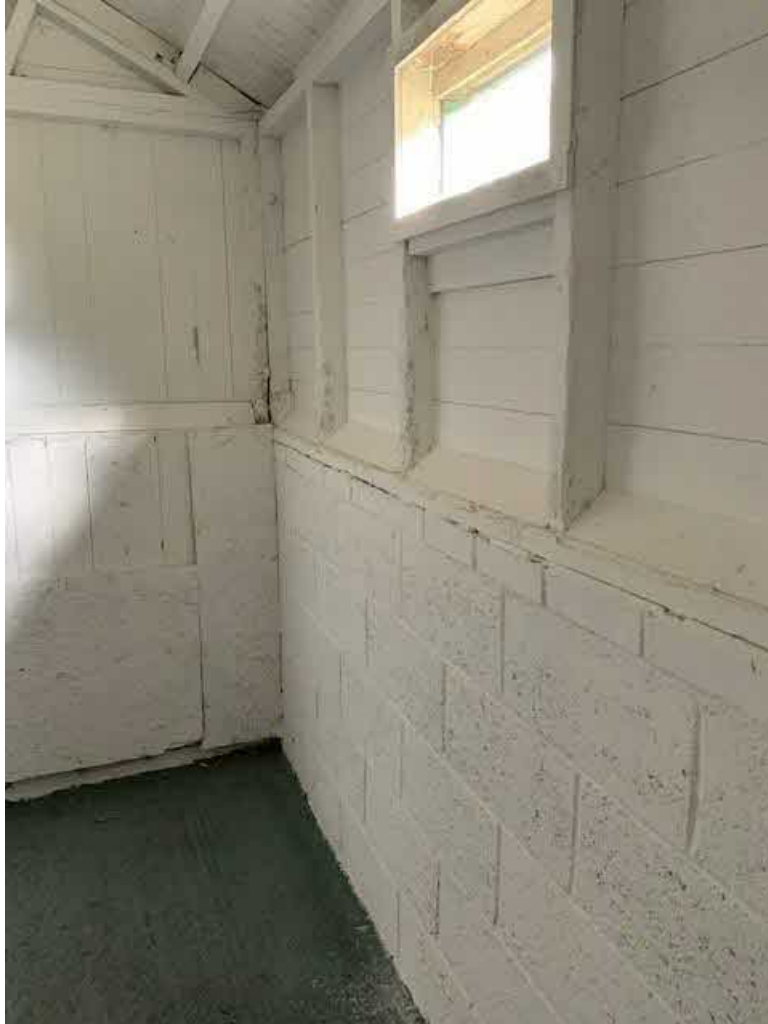
The walls comprise solid blockwork masonry varying in thickness between 100mm and 215mm but without stiffening piers. The masonry extends to about half height with timber studding above. [Plate J]. The walls are clad with profiled metal sheeting.

PLATE J -- EASTERN WALL
