Heritage Statement and Impact Assessment for Render Repair
Proposals at:

West Front Facade, Highclere Castle

Planning Issue - September 2023

Highclere Castle Estate

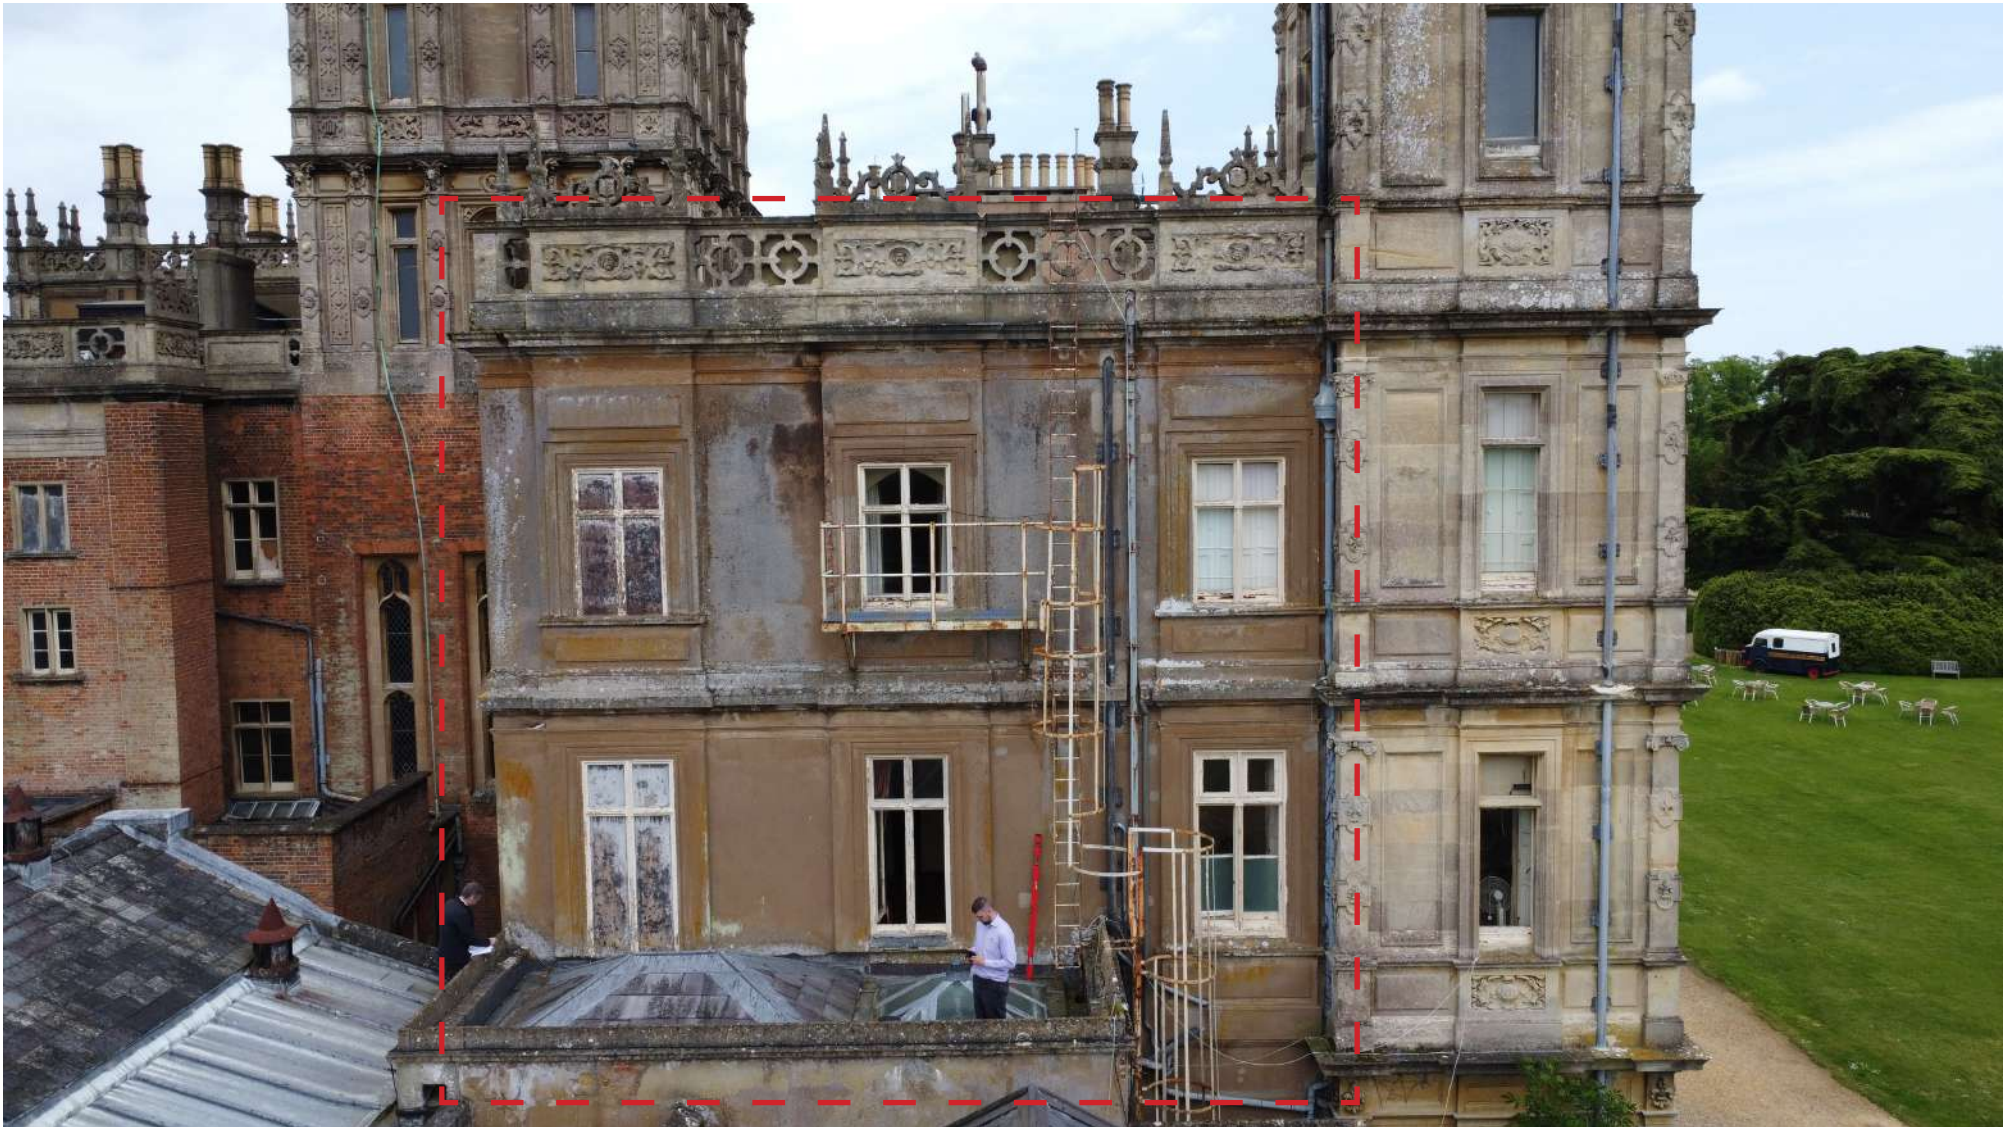
Fig. 5 (below) A drone captured view of the site. Note the stonework tower and turret of the south elevation. Note the discoloration of the West front render, and the high level parapet in stonework.

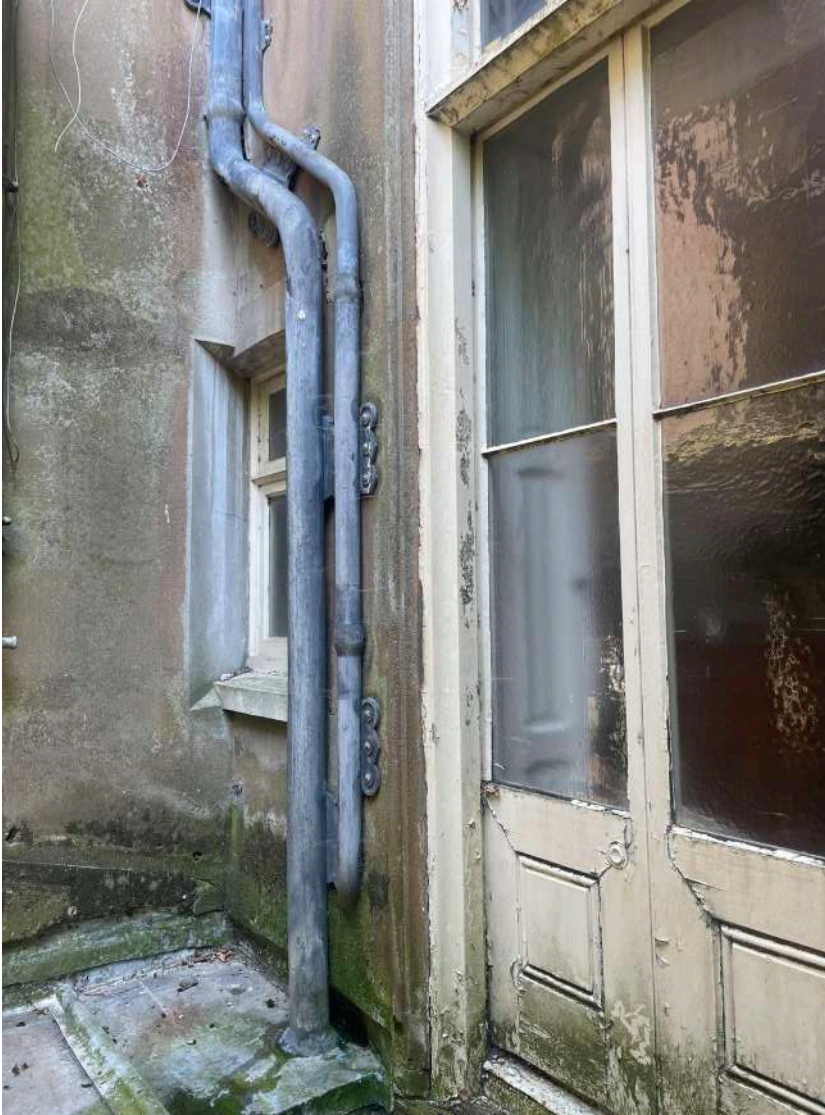
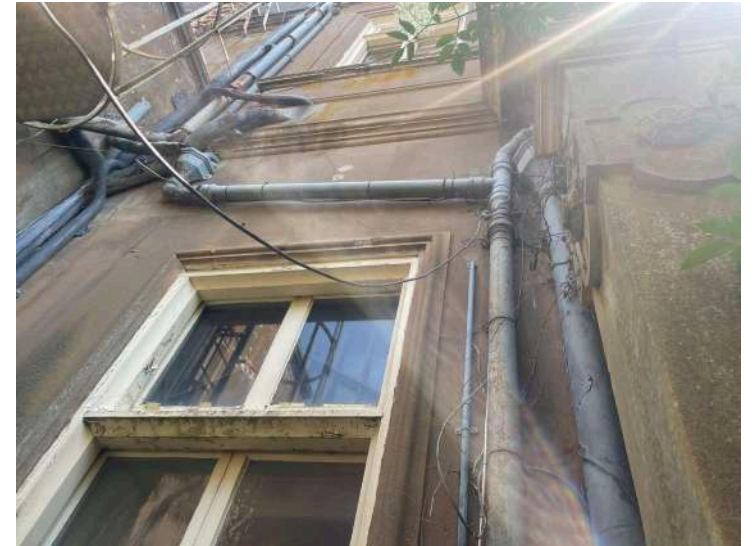
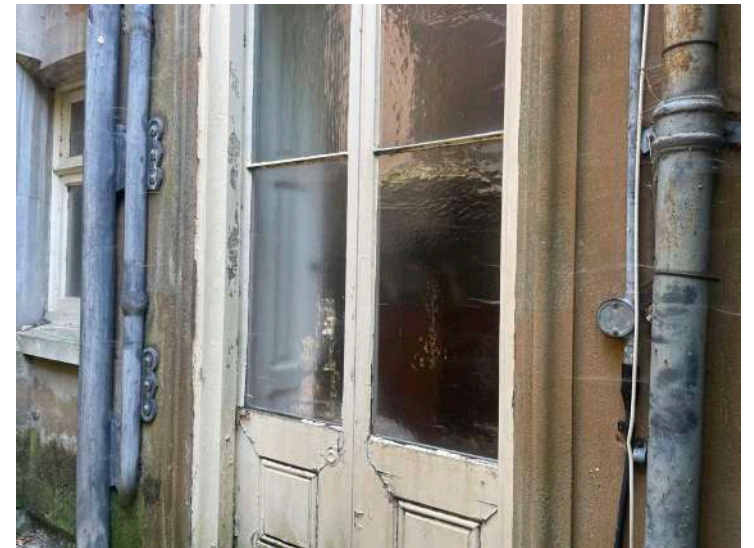
West Facade Elevation (Ground Floor only):

Fig. 8 (below) The glazed timber ground floor access door with timber framed WC window to left hand side.
Fig. 9 (right above) The fanlight glazing over the door with decorative render much concealed by drainage pipes.
Note the masonry of the south elevation tower to the right hand side. Fig. 10 (right below) Note the moldings of render to the door surround with similar failure patterns as the first and second floor.

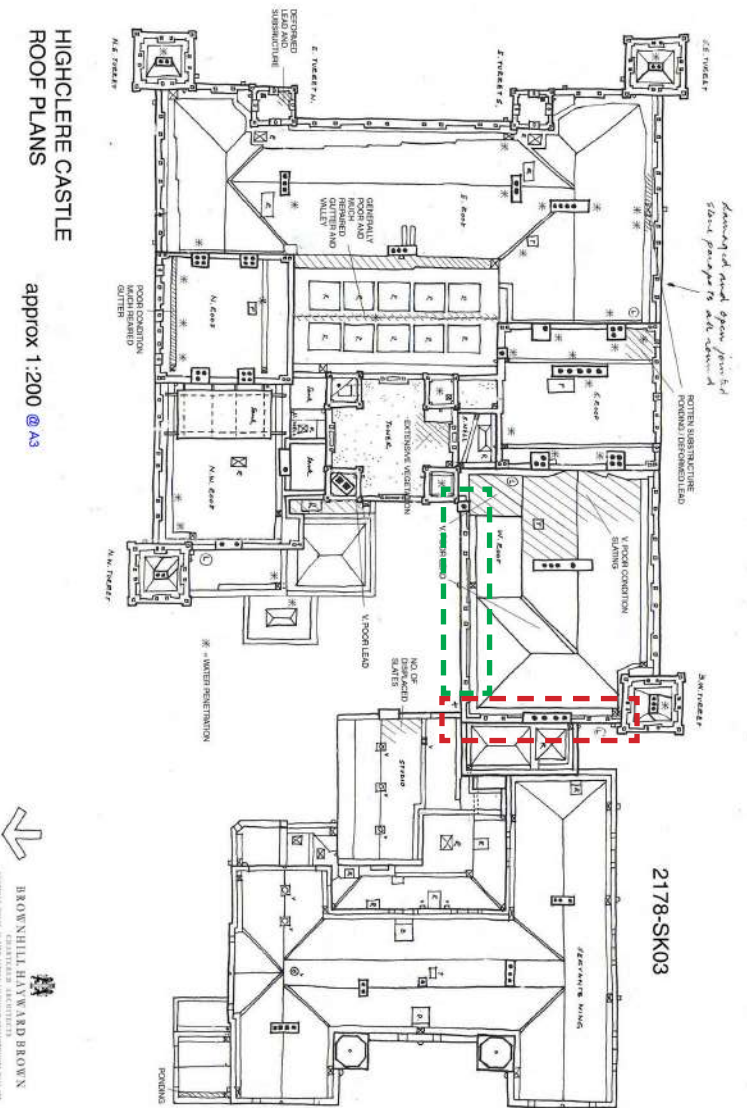
Fig.14. (Above) A sketch plan of the roof layout, showing the area of Barry's rendered facade to the West. The area coloured red is due for repair. The area returning along the North is not being considered for repair.

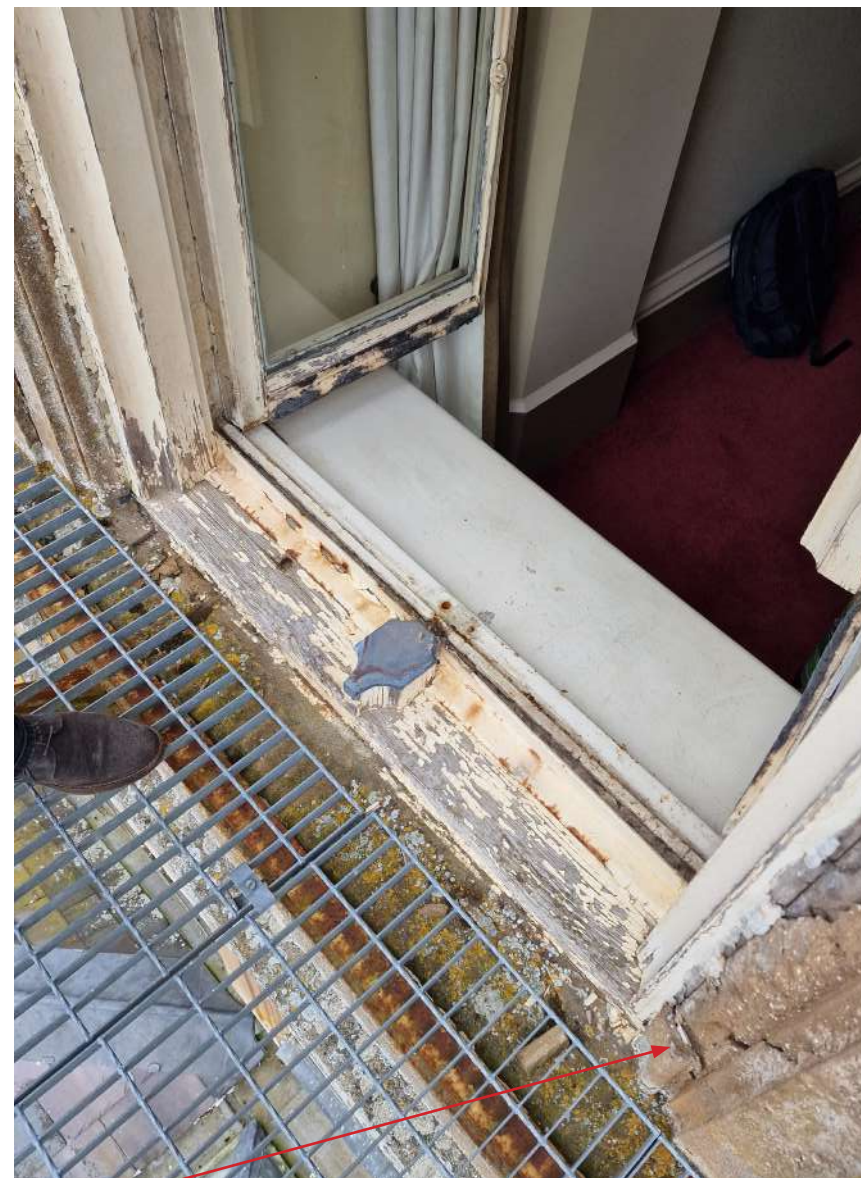
A sample of fallen render (refer to fig. 15) was taken for issue to the Scottish Lime Centre so that a laboratory test might provide greater clarity on the binder. Note other areas of the lower roofs had failing render surrounding the parapets concealed from ground level view (refer to fig XX).

Fig.15. (Above) The second floor gantry egress window. The red arrow indicates where the loose render sample originated from, to the right hand side of the window reveal.

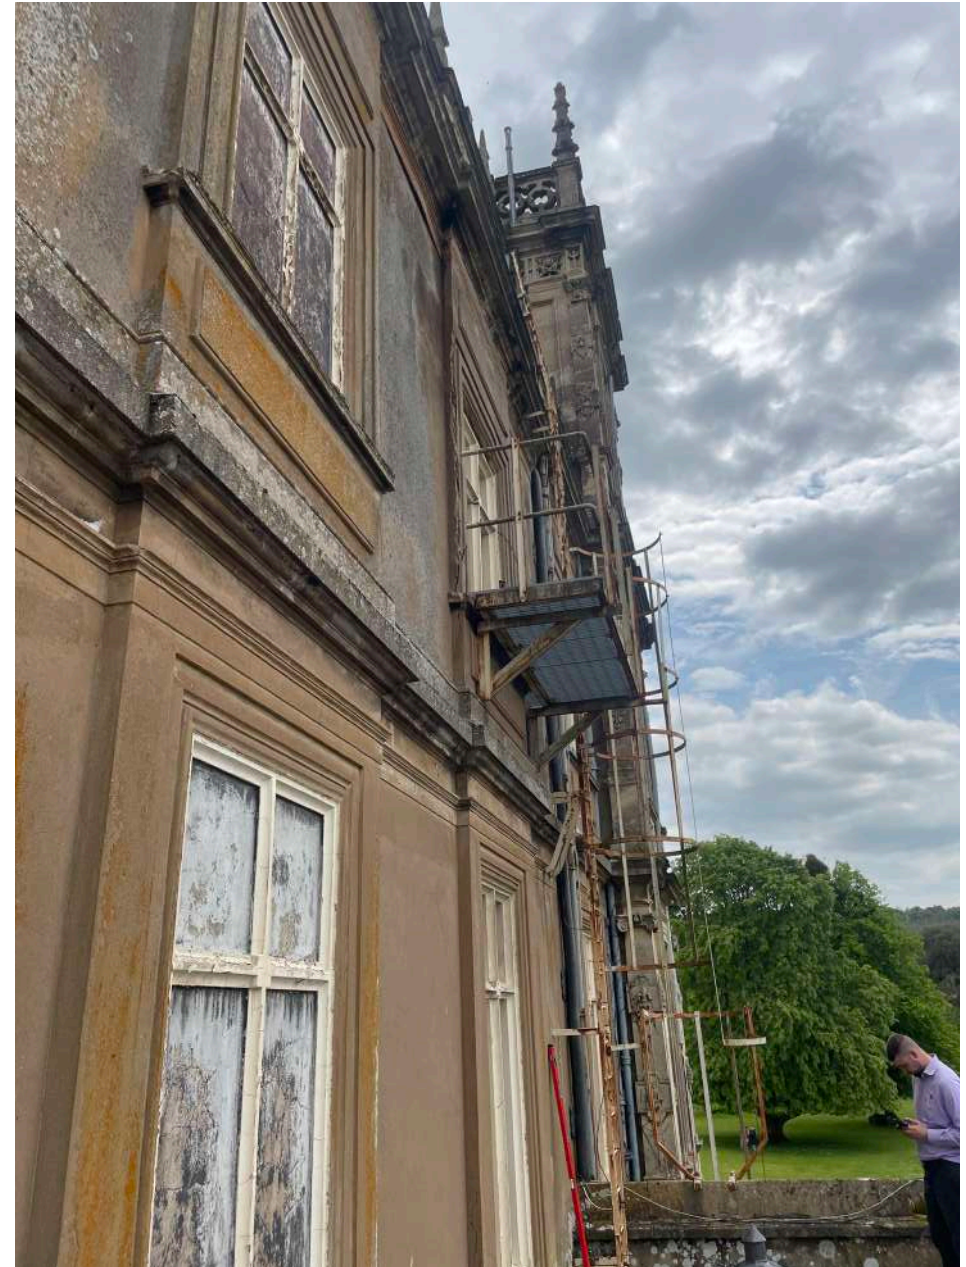
The condition of the render is very poor with numerous fissure cracks and areas of delamination. A large quantity of decorative render has fallen from the facade and there are areas of high discolouration and lichen growth. Following the archive research and the X-Ray diffraction test it is believed that the render is quite likely to be a Roman cement that has suffered from significant exposure to the elements which has affected the chemistry of the binder.

Fig.16. (Right) The facade viewed from the northwest. The warm tones of the Highclere Cement can be more easily seen in the lower levels that are more sheltered. The colourisation of the facade is not uniform and the mineral content is likely to vary across the facade.

Therefore the proposals seek to remove all the render and to reinstate it on a like for like basis. This work will be done by reusing the exact moulding profiles and dimensions as recorded to reinstate the same render material using the same methods with which it was originally installed.

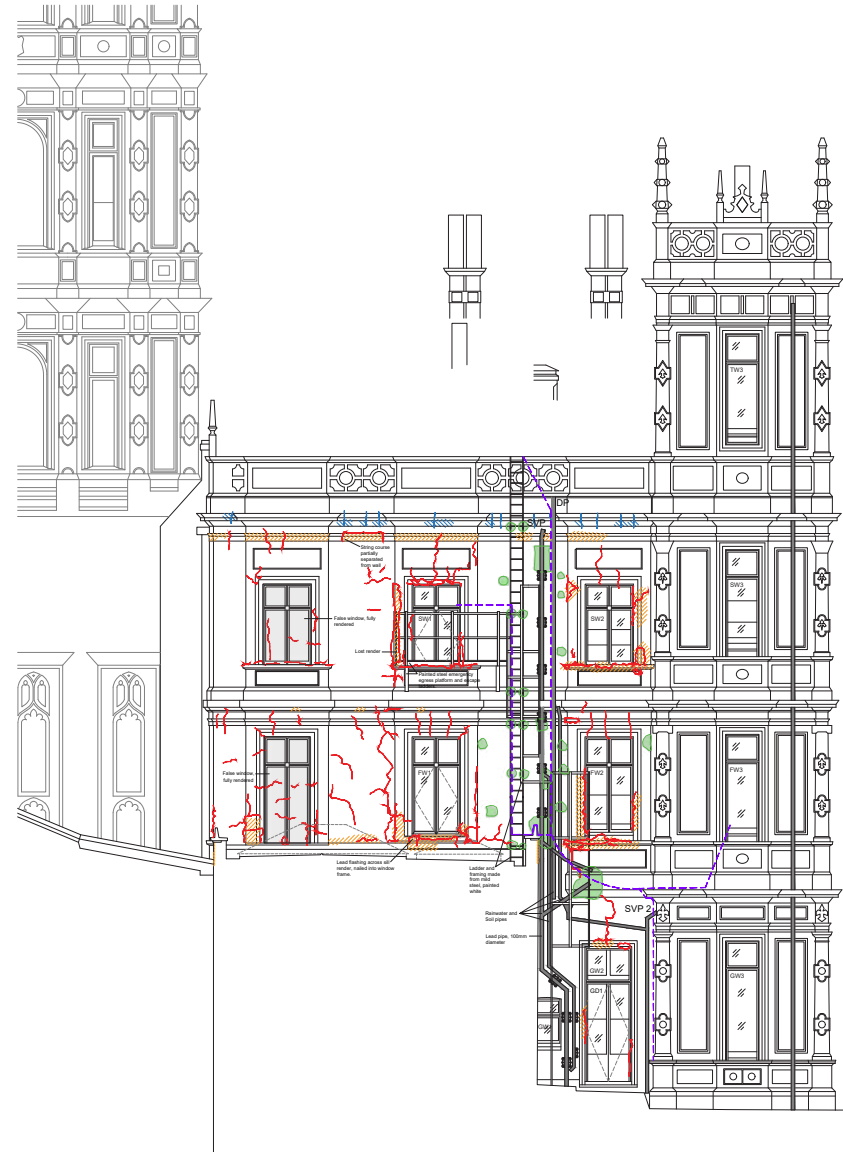
Condition Survey Elevation
Scale 1:50

Fig.17. (Right) The facade condition survey. (Refer to Architect's drawings). This drawing shows the degradation is most prominent in the more exposed locations. Areas of 20C patch repair show the failing integrity of the render has been an issue during recent decades.

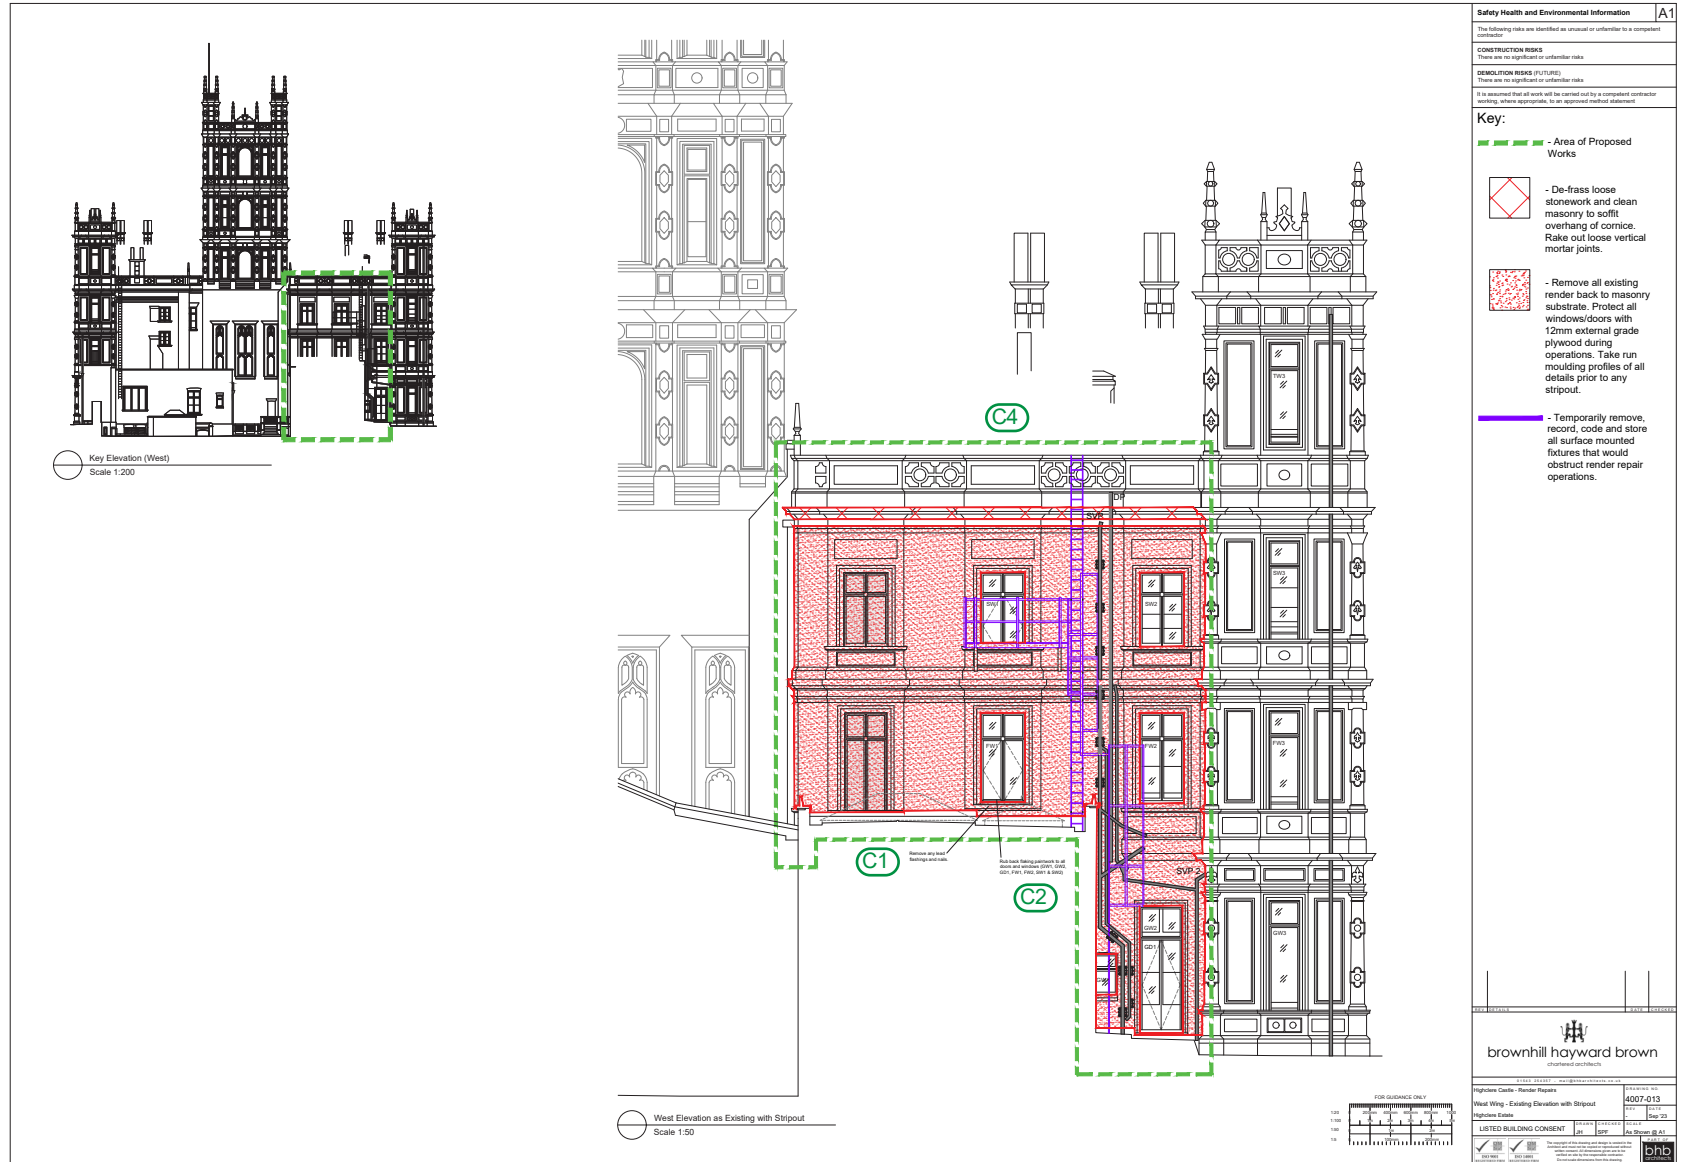
West Elevation as Existing - Demolitions and Stripout

Fig.18 (Below) Architect's drawing showing the areas of render removal to the Castle's West Elevation.

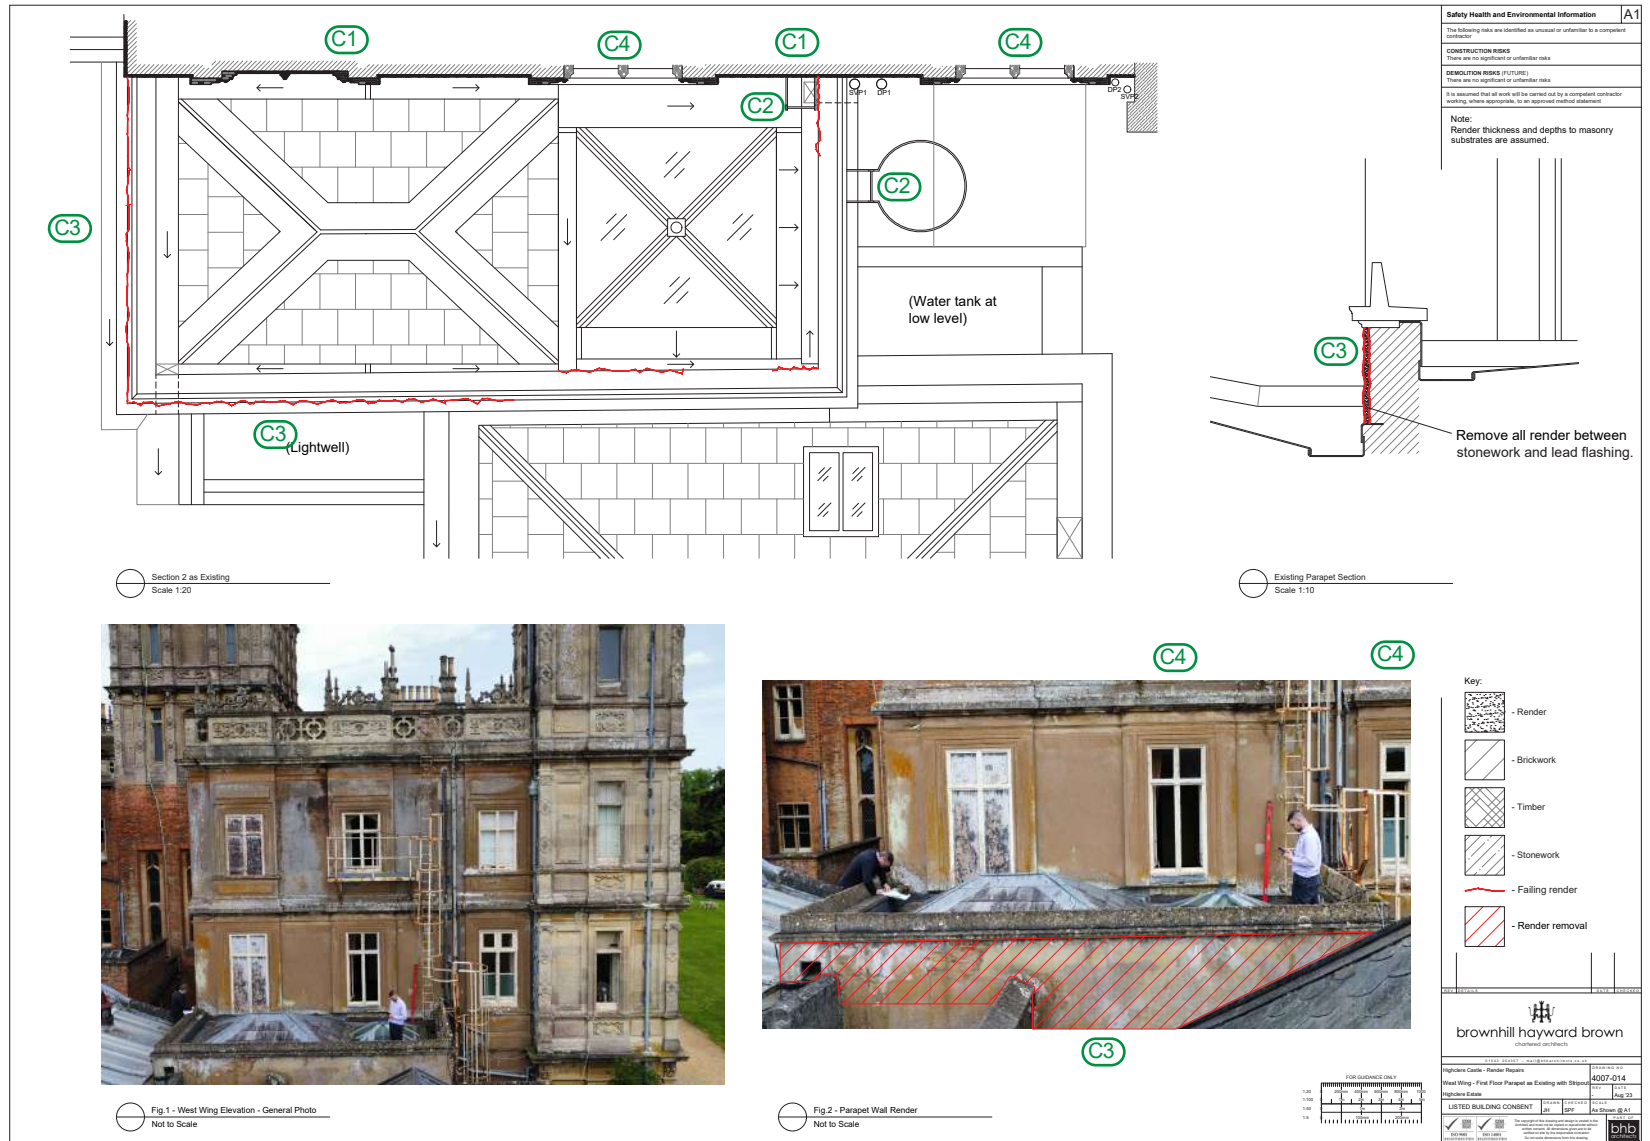
West Wing Roof Plan as Existing - Demolitions and Stripout

Fig.19 (Below) Architect's drawing showing the areas of render removal to the parapet walls of the West Wing roof (near the Castle's West Elevation).

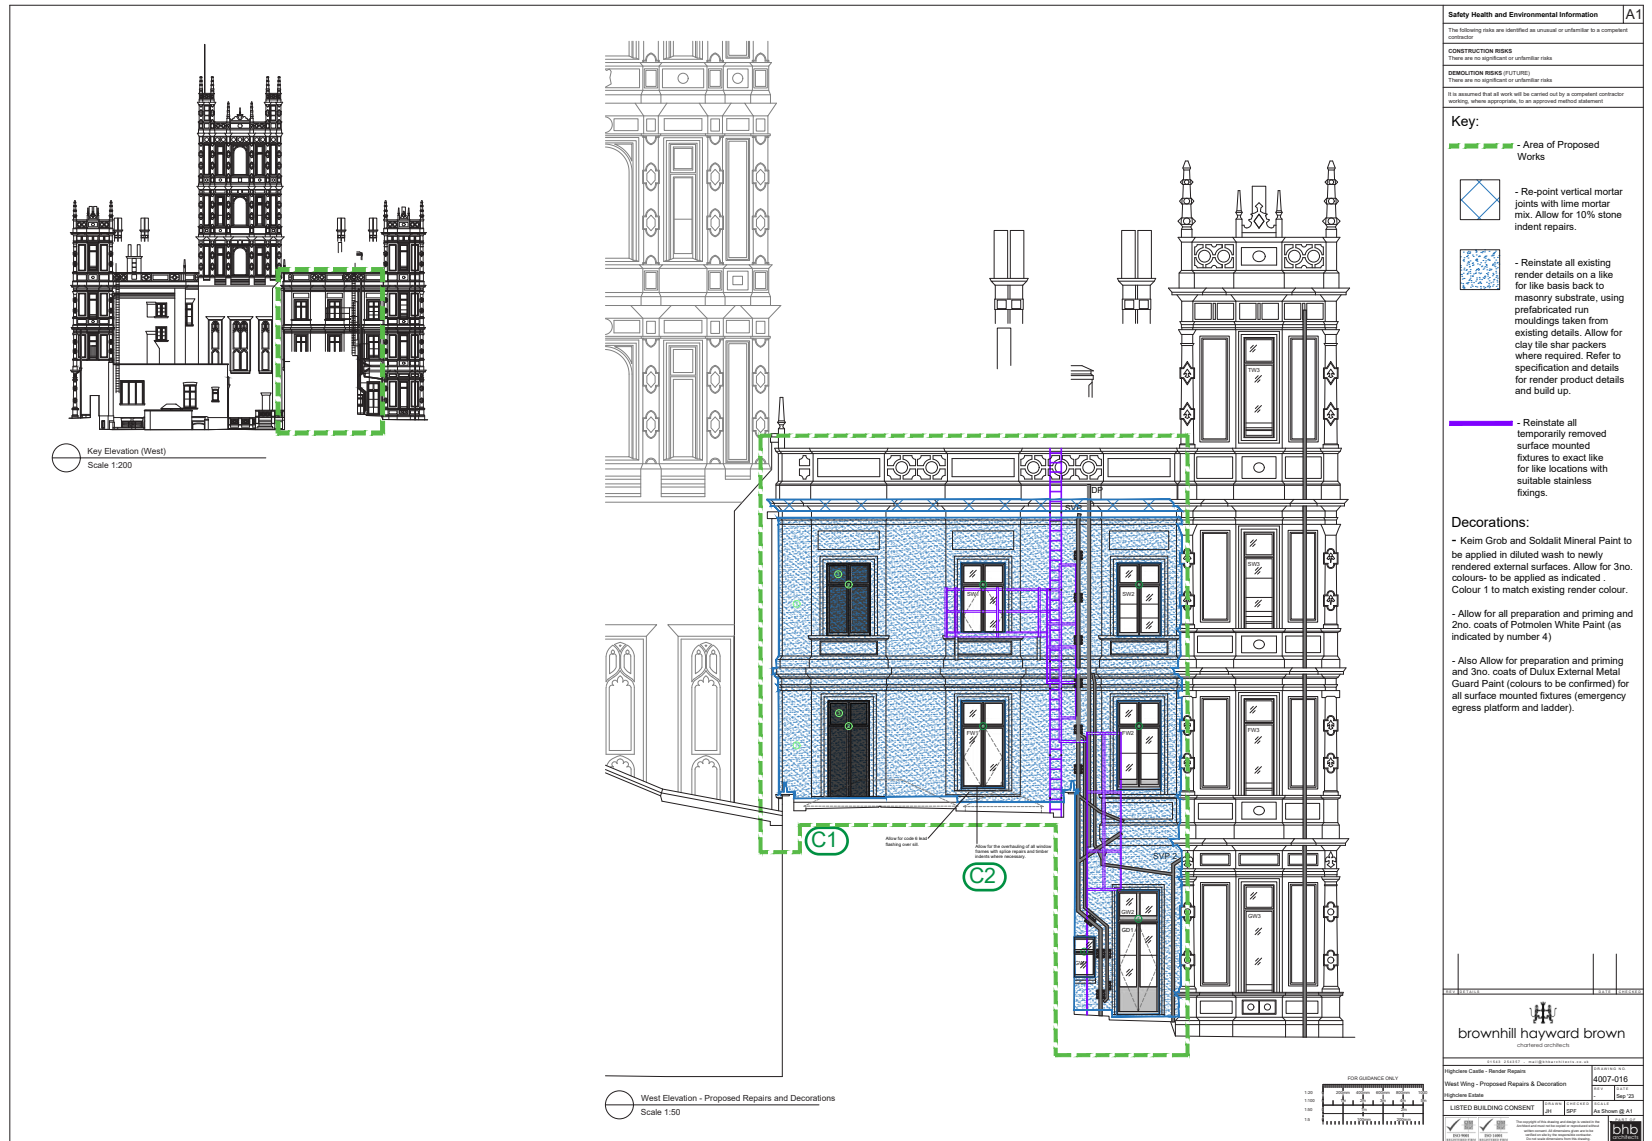
West Elevation as Proposed with Repairs

Fig.20 (Below) Architect's drawing showing the areas of render replacement to the Castle's West Elevation.

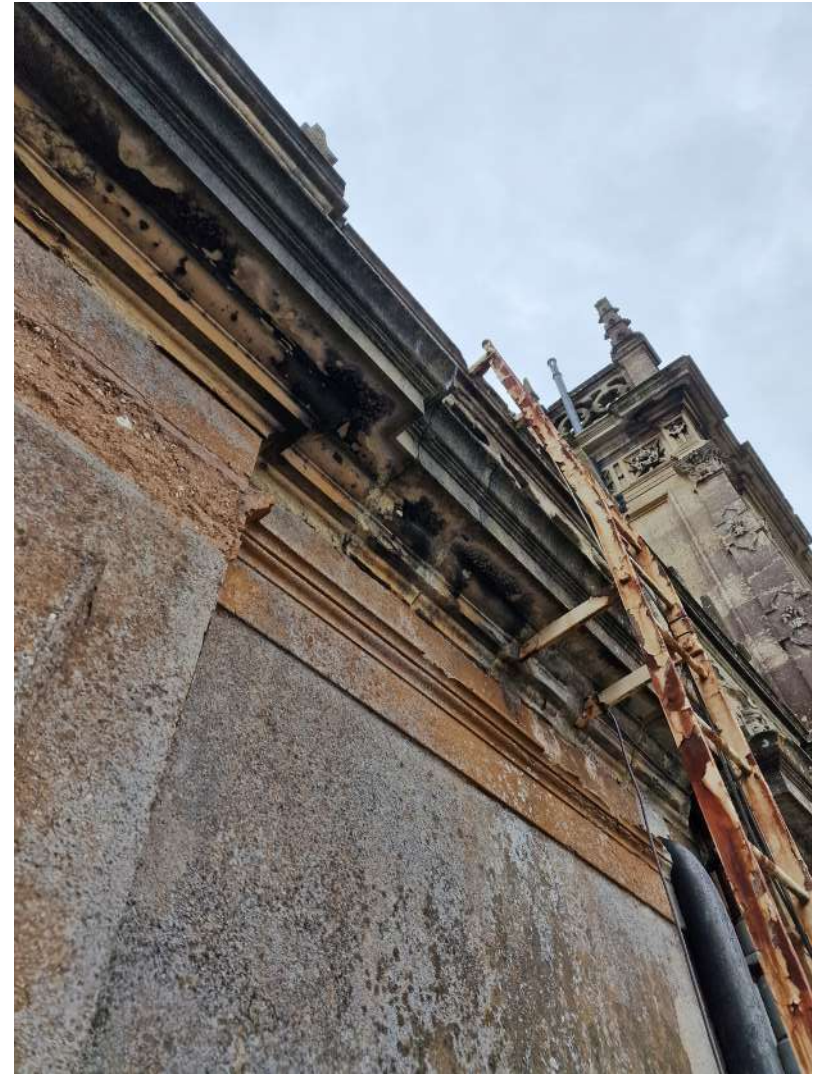
Fig.23 (above) Looking up at the West facade's stone cornice. Wash out of the vertical masonry joints can be seen alongside the soffit's discoloration.

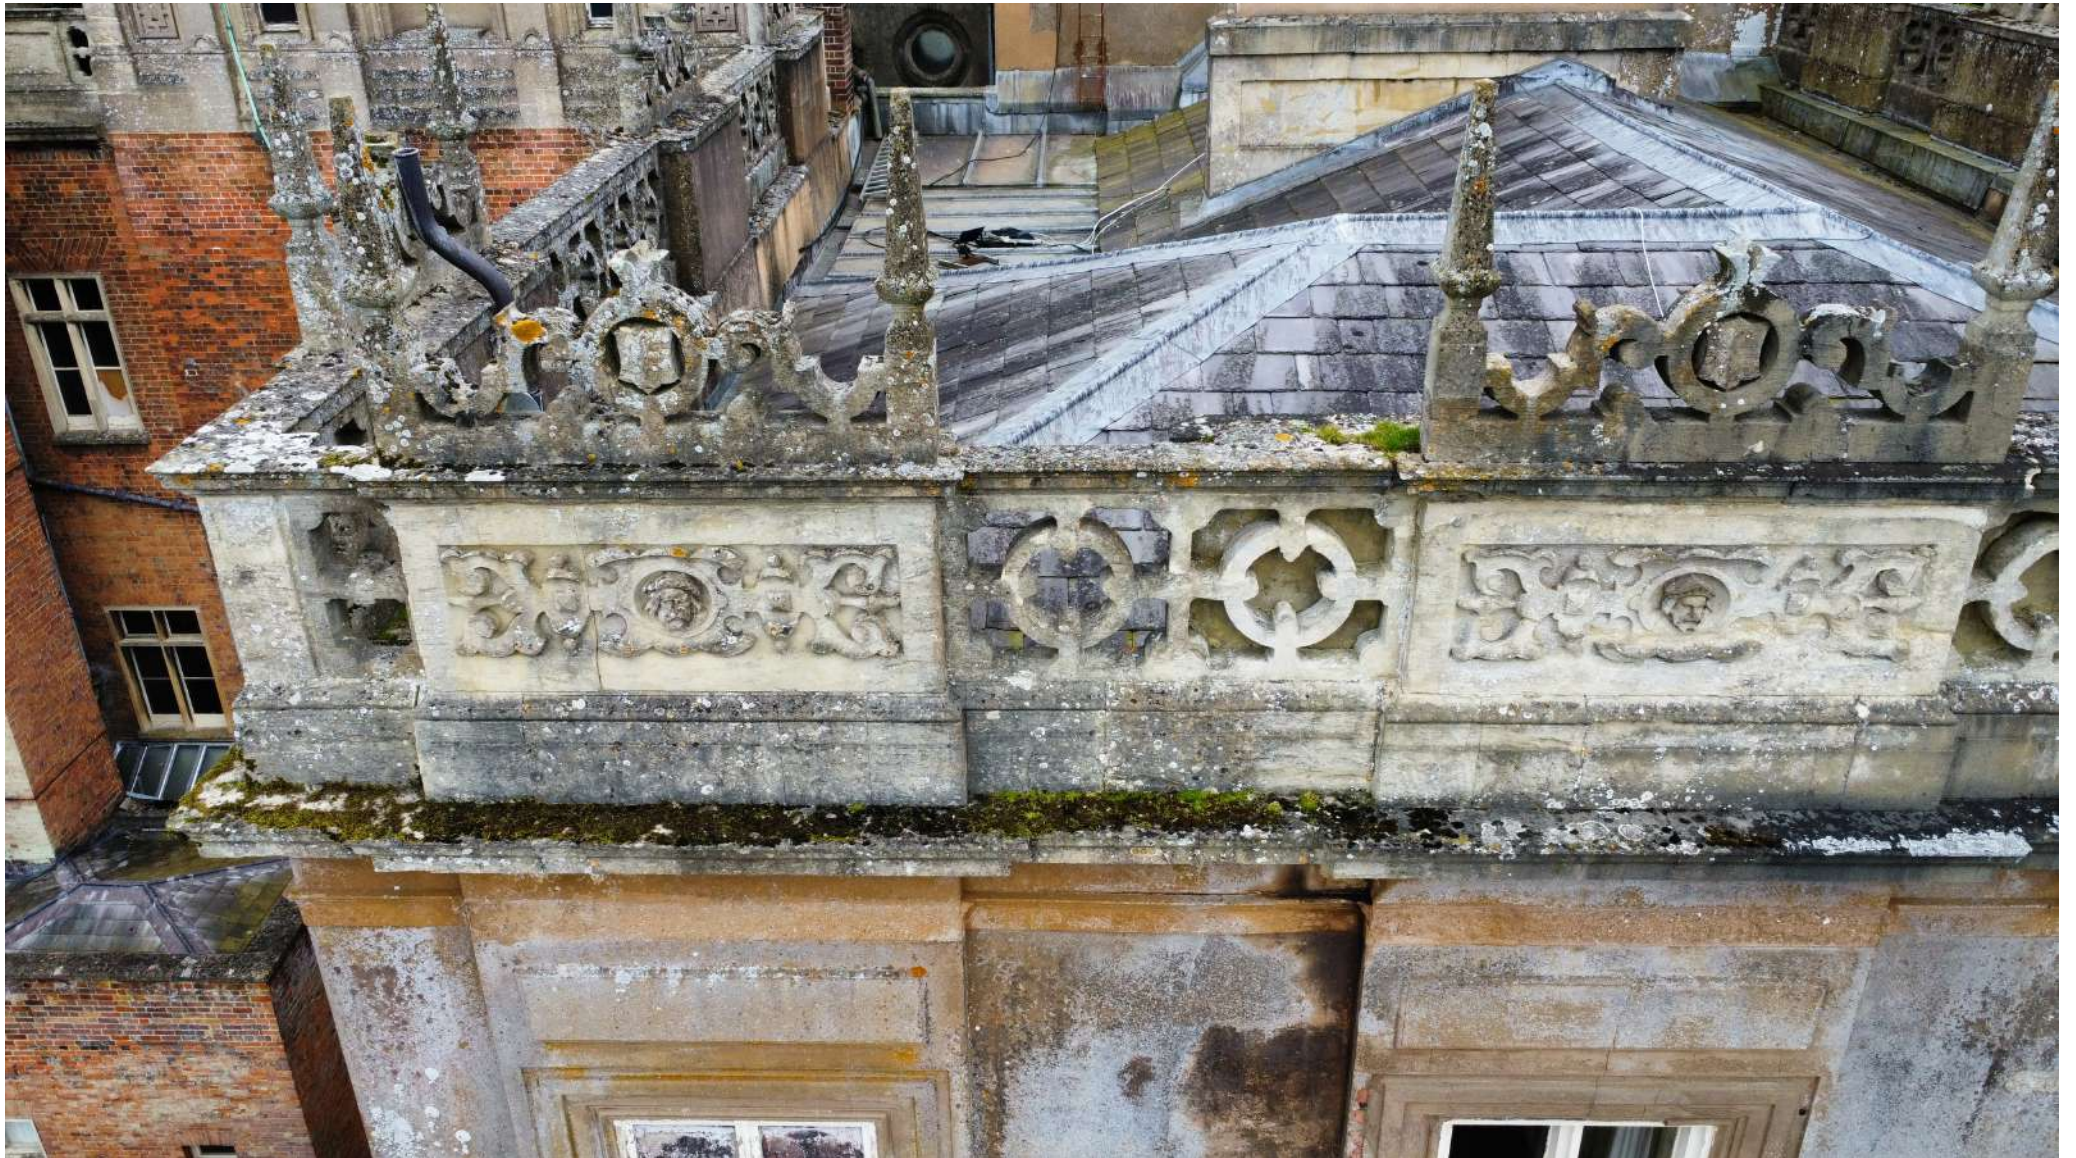
Fig.24 (right) A drone's view of the stonework parapet and cornice that shelters the render facade below.ttt

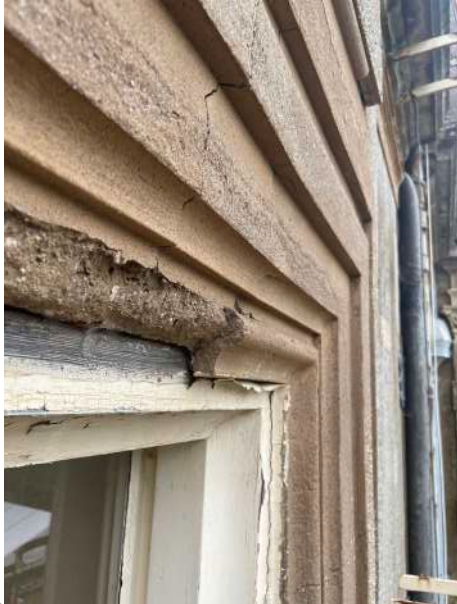
Fig. 29 An example of render falling around the gantry window head.

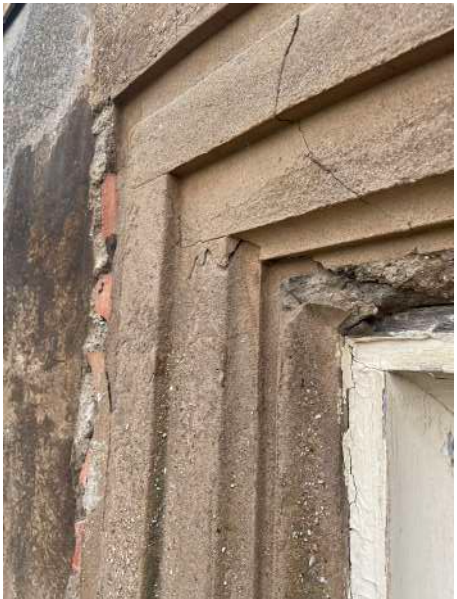
Fig. 31 Fissure cracks emanating from the corner stress lines.

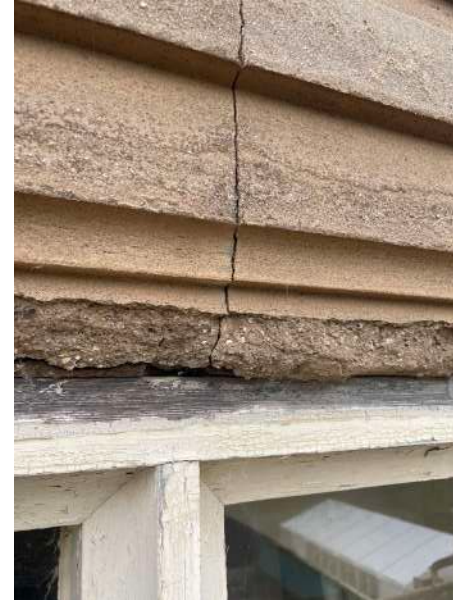
Fig. 30 Fissure cracks in the decorative render.

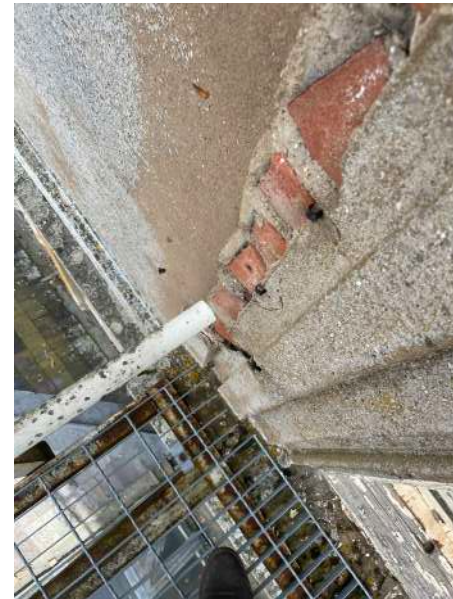
Fig. 32 Collapse of the render face to reveal the clay tile fragments used as packers.

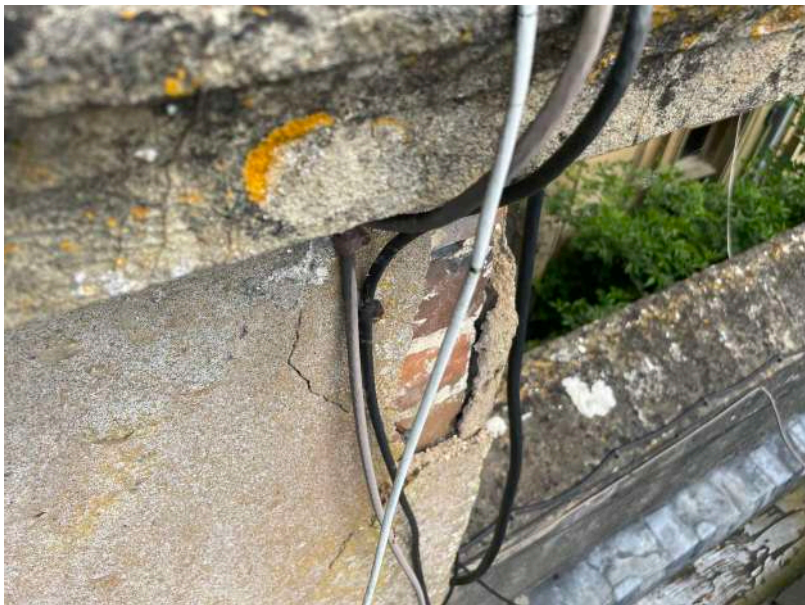
Fig. 33 Failure of the lower roof's parapet render towards the outside southwest corner.

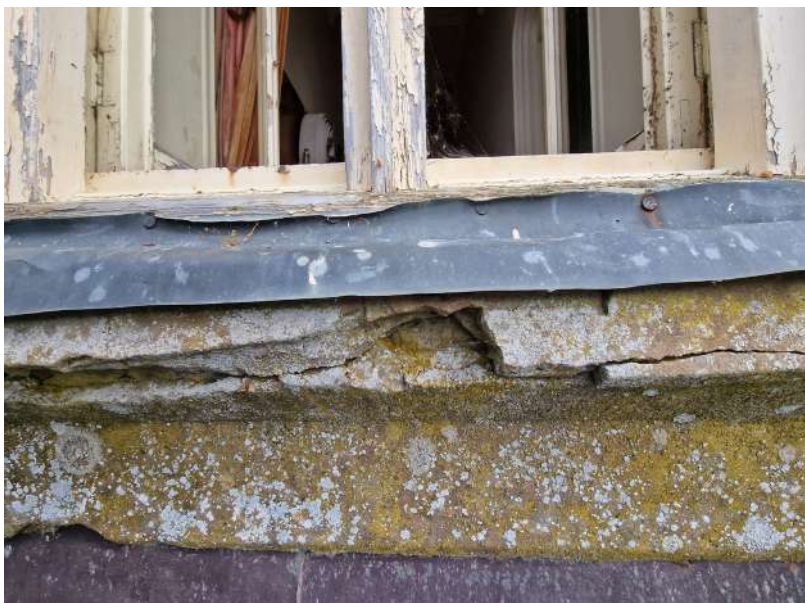
Fig. 35 The falling render flashed below the roof egress window to the first floor

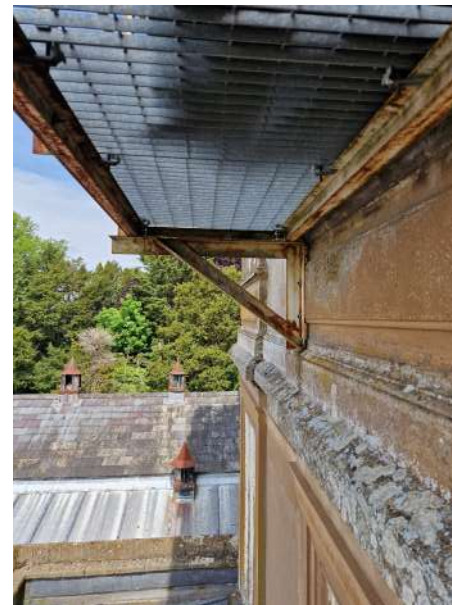
Fig. 34 The poor condition of the gantry steelwork decorations.

C2	18-22	The temporary removal and reinstatement of gantry ladders and drainage pipes to facilitate access to the render repair works. The overhauling and redecoration of the gantry ladder steelwork.	++	The ladders and gantry are not original and are a necessary requirement for the safe egress of occupants using the upper floors of the castle.	N	The proposed removal and reinstatement will be necessary to allow the render to be appropriately repaired. The steelwork is in very poor decorative condition, its redecoration will benefit the historic asset.	A, C, E
C3	18-22	The like for like replacement of failing and delaminating render to the parapet walls of the lower west wing roof identified on the drawings.	++	The render is probably original but it appears to have been patch repaired in some areas.	L	The render to the parapet walls cannot be seen from the ground level and often even from the windows, and it is largely utilitarian in its nature. By replacing the render the maintenance of the building can be secured for another generation.	B, D, F

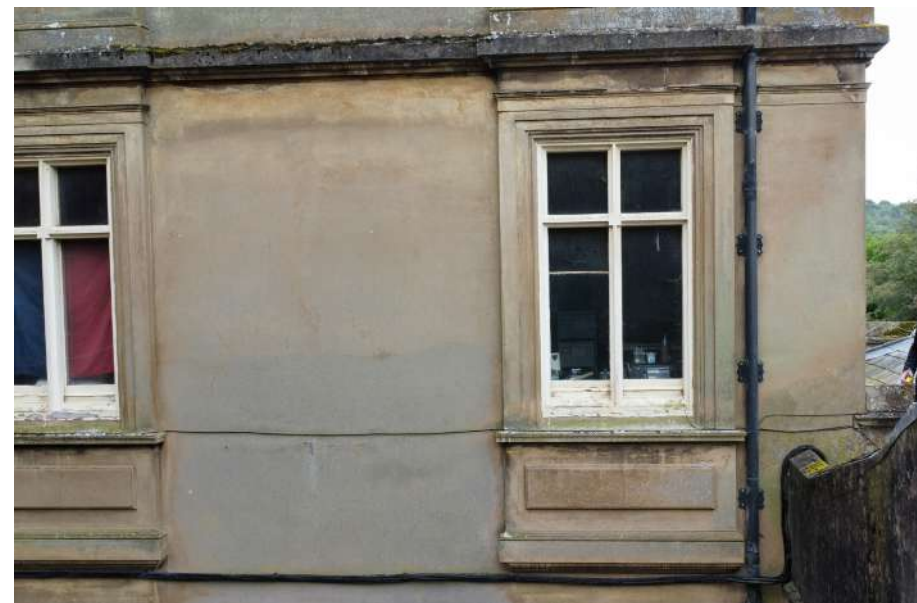
Fig. 36 The adjacent North facing facade in better condition.

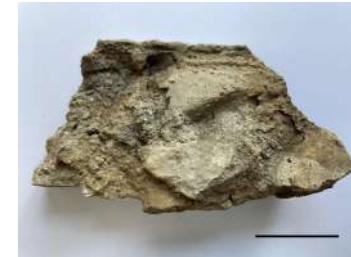
Plate 2. Image showing the underside of the sample as received. The sample shows signs of leaching and binder dissolution. Scale bar = 20mm.

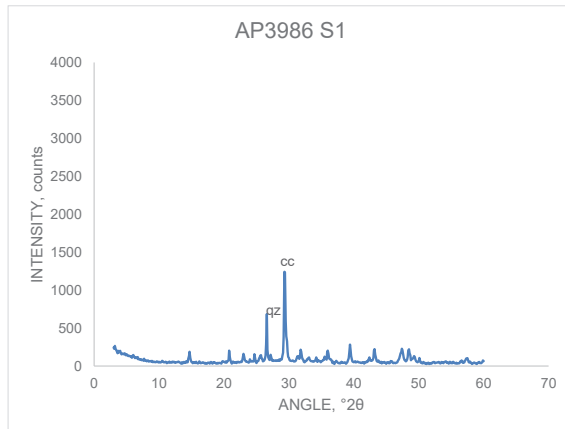
Figure No. 1: Mortar from Highclere Castle.

Component	% by mass
Calcite	61.2
Quartz	19.0
Bassanite	18.0
Hydrocerussite	1.6
Penninite	0.3
Total	100.0
