South end of Farmhouse
 The South end of Farmhouse appears to be a later extension to the original house.

PROJECT
 Yew Tree Farm
 Ward Green
 Old Newton
 IP14 4EZ

DRAWING
 South end of farmhouse showing repairs

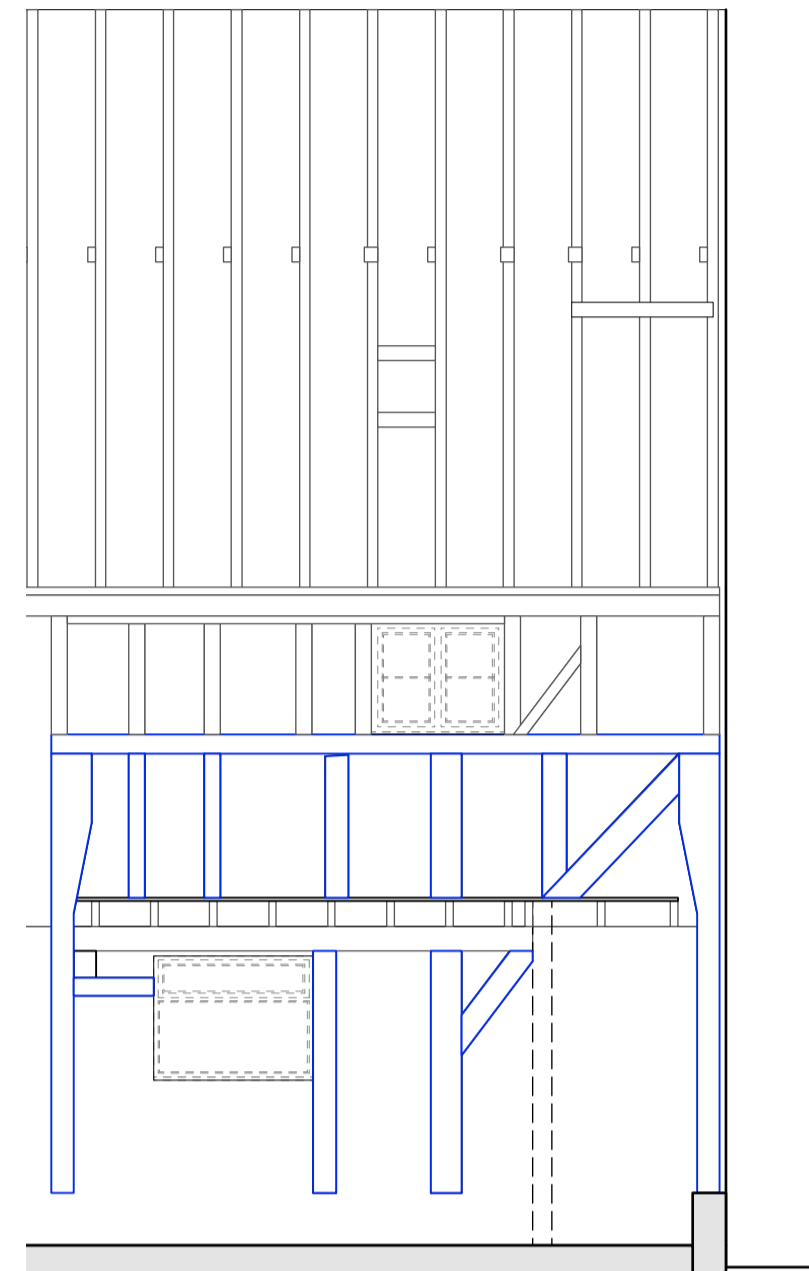
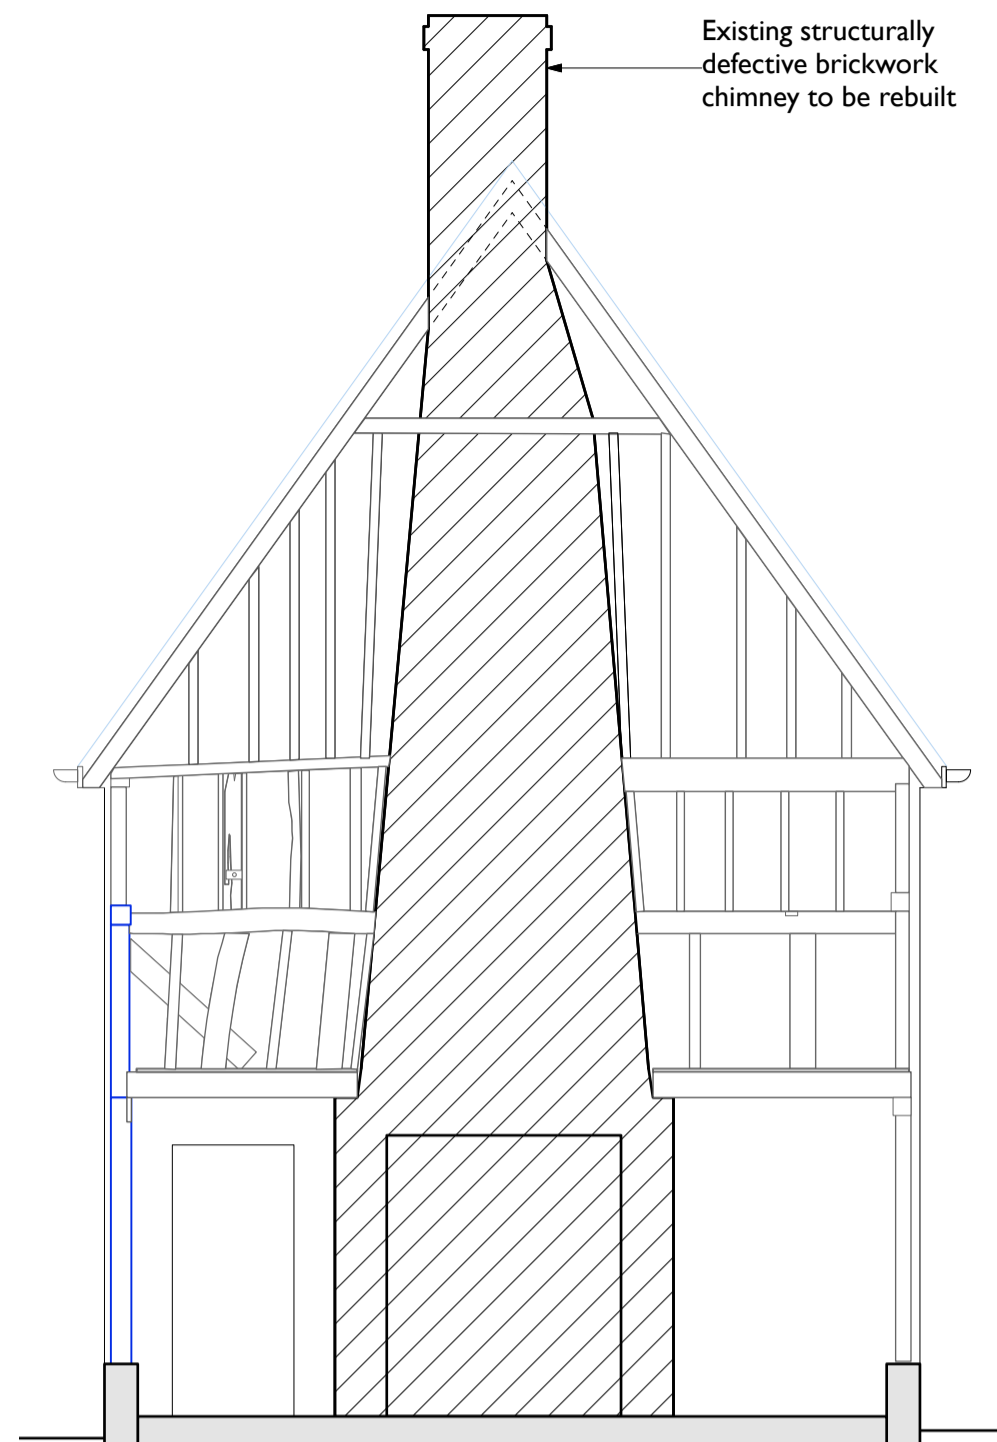
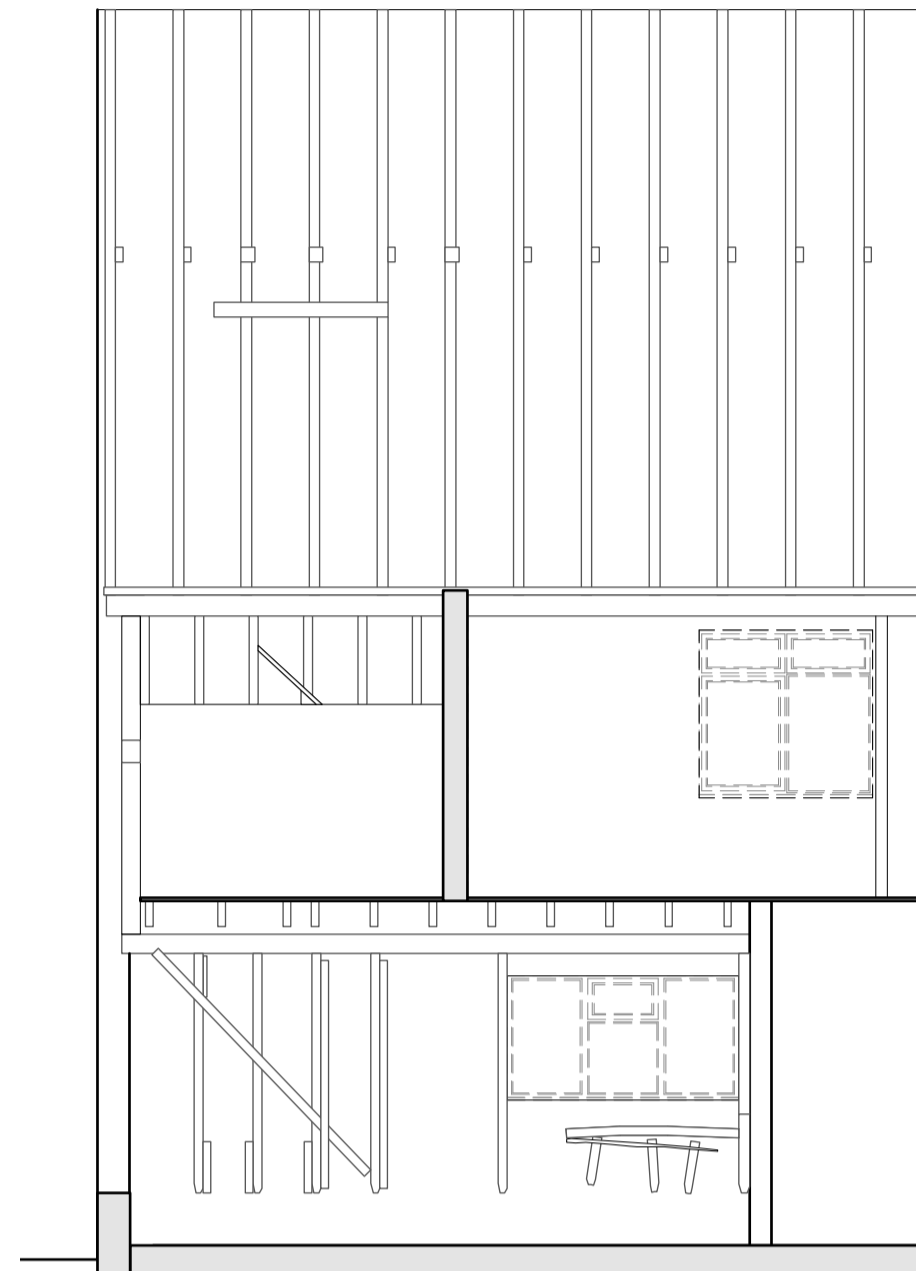
EXISTING

Removal of the existing internal and external linings (comprised of sand and cement render on metal lath) was commenced (previous Listed Buildings permission DC/20/03735) but this work had to be stopped when it became apparent that this end of the building is structurally unsafe.

Timber frame to the south end of the farmhouse:-
 West and south elevation timber frame is in 1970s softwood. It is structurally defective and in poor condition, with extensive decay. There is no sole plate or dpc.
 Most of the studs to the west elevation were found to have their bottom part missing and had been infilled at the bottom with concrete. These studs were nailed to diagonal bracing and were not load bearing.
 This wall is therefore structurally unstable and all timber framing needs to be replaced.
 East elevation timber frame includes some older oak timbers and these will be retained and repaired. This wall also has no sole plate or dpc.

South chimney: The brickwork chimney was found to be structurally unstable, please refer to Structural Engineer's report 'May 2023 Defects 5002-Report-160523'

The following actions are required to make the building structurally sound and solve the damp ingress:-
 Take down the unstable chimney.
 Remove the defective / decayed timber framing.
 Remove the defective plinth wall.
 Remove the modern softwood first floor joists.
