## SITE INVESTIGATION FACTUAL REPORT

Report No: SI-595596  
Client: Crawford Claims Management  
Site: The Elms, Badwell Road, Walsham-le-Willows  
Suffolk  
Client Ref: SU2205985  
Date of Visit: 25/04/2023

# Investigation Layout Plan

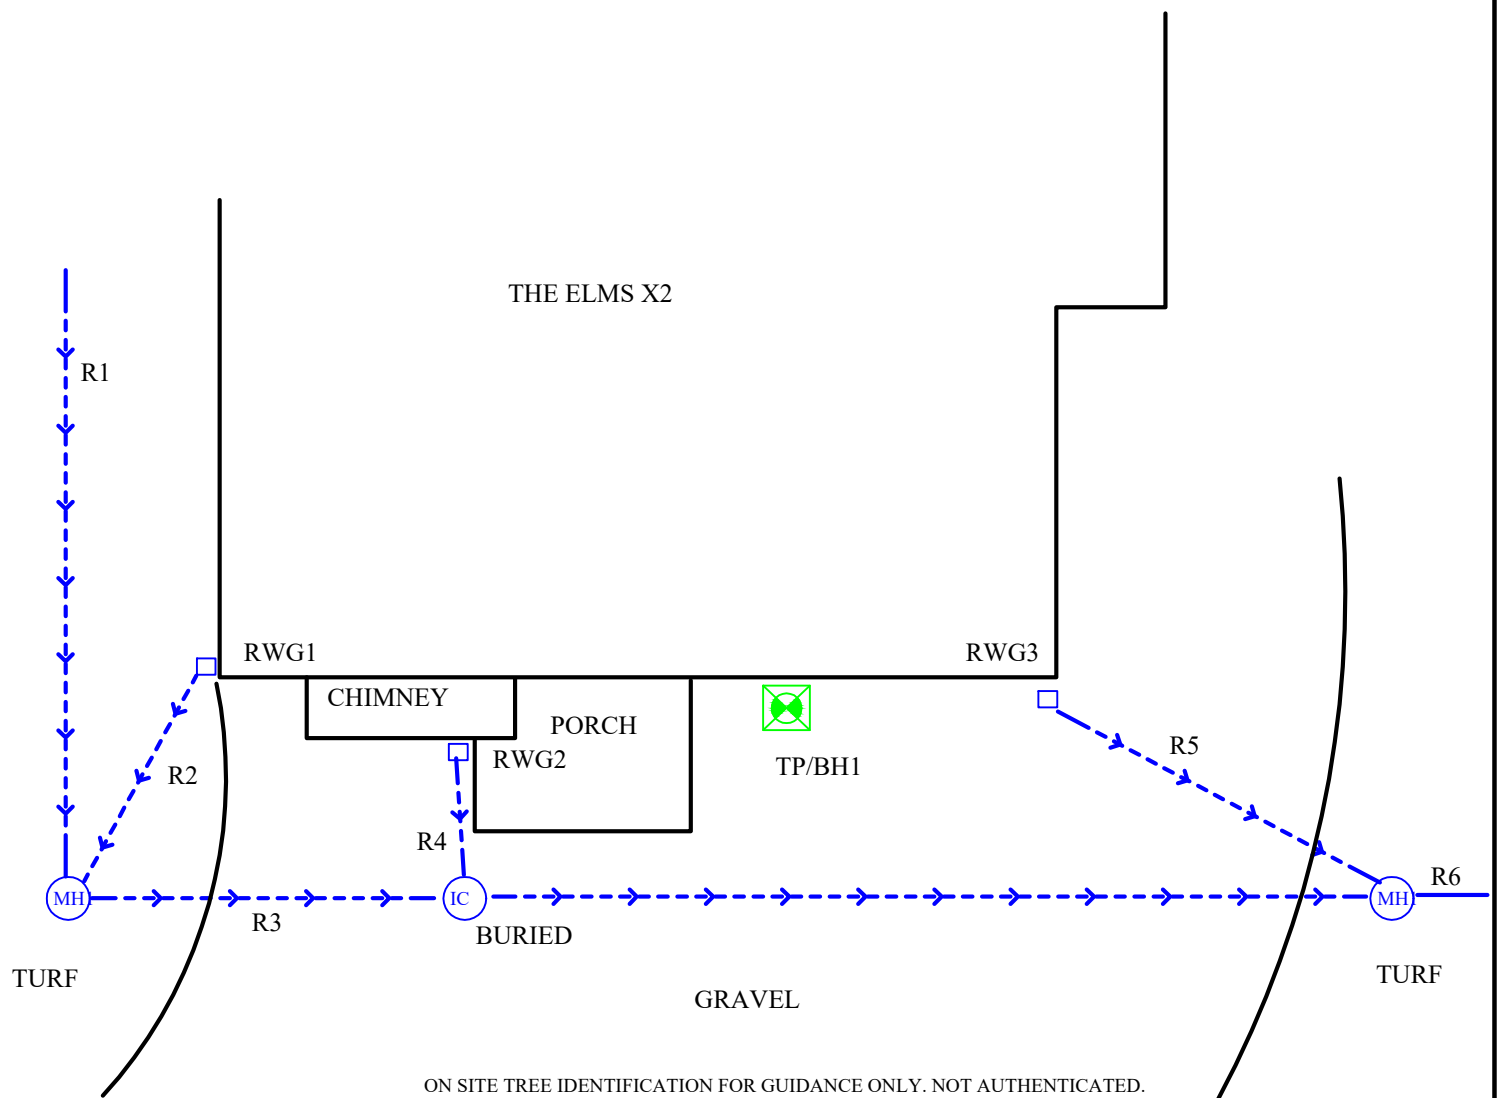
ON SITE TREE IDENTIFICATION FOR GUIDANCE ONLY. NOT AUTHENTICATED.

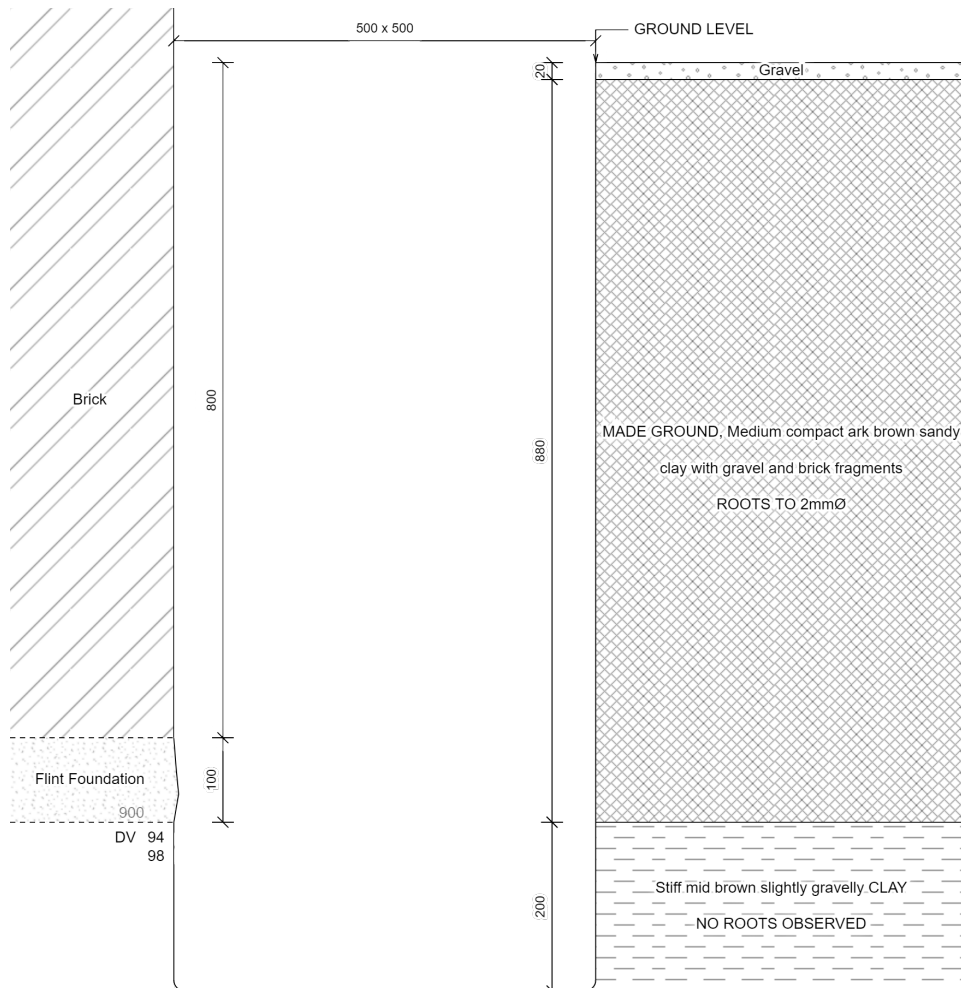
**TEST REPORT:** Trial Pit  
**REPORT NUMBER:** C1077197 / 253260.1.1.1  
**TRIAL PIT REF:** TP1 **DATE:** 11/05/2023  
**CLIENT:** Crawford & Co **SITE:** The Elms  
**JOB NO:** 595596 **WEATHER:** Dry  
**EXCAVATION METHOD:** Hand tools

For Strata below 1100mm see Bore Hole log

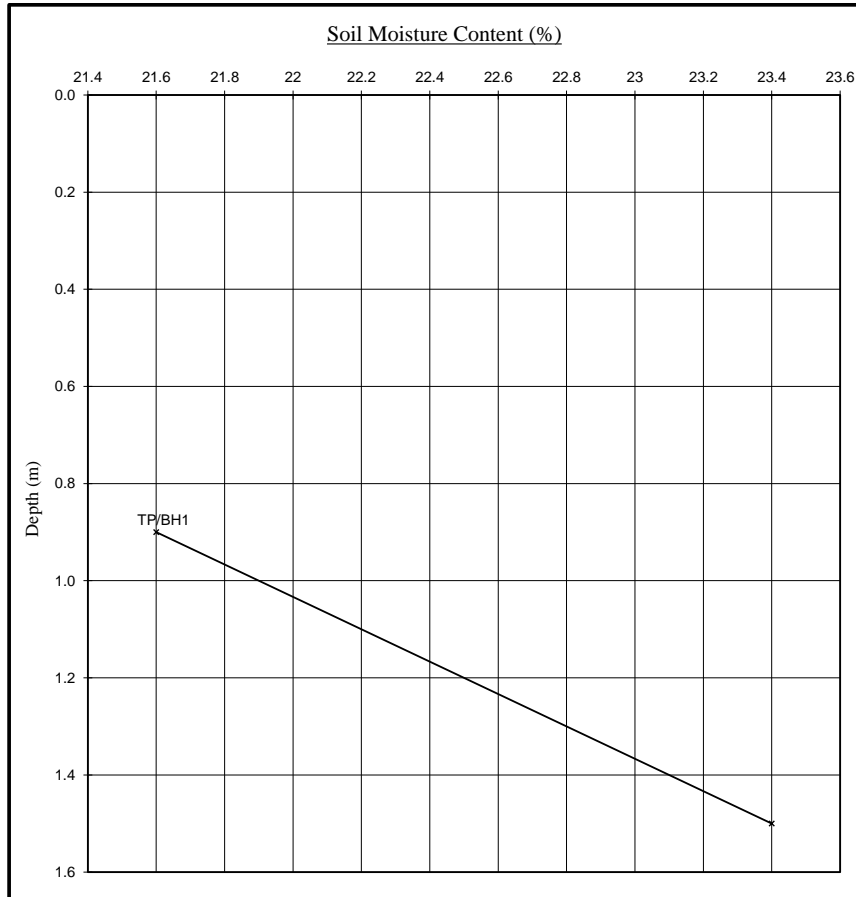
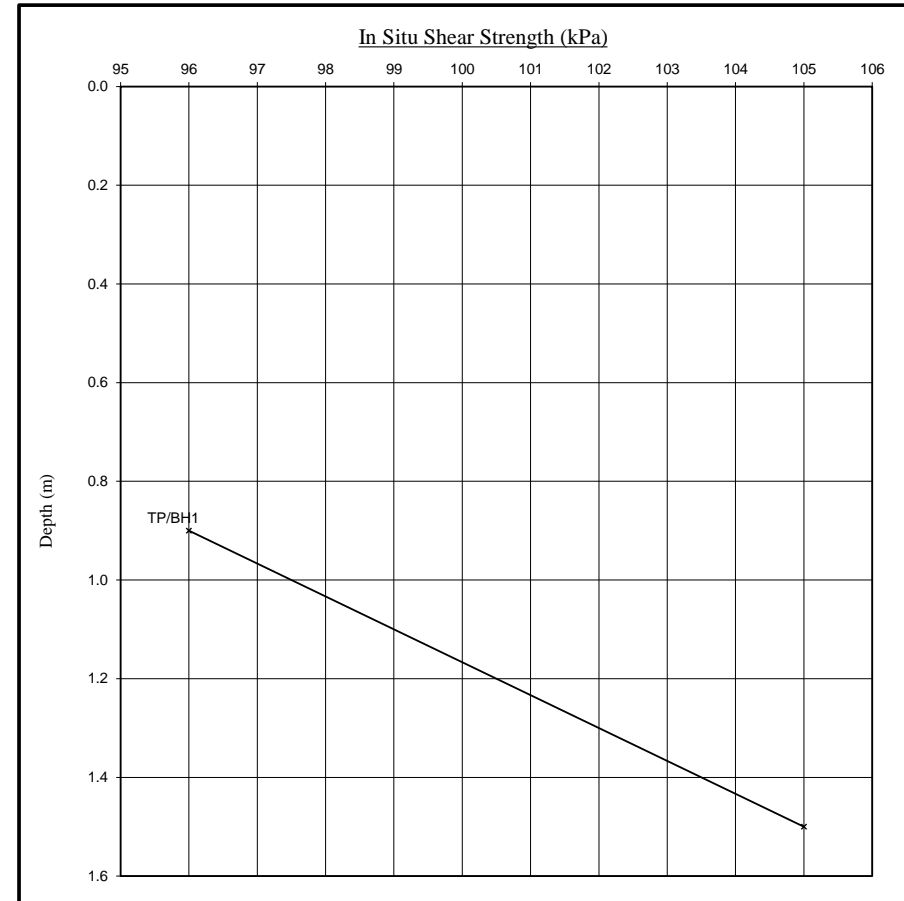
1. If plotted, 0.4 LL and PL+2 ( after Driscoll, 1983 ) should only be applied to London Clay ( and similarly overconsolidated clay) at shallow depths.
2. Unless specifically noted the profiles have not been related to a site datum.

1. Unless otherwise stated, values of Shear Strength were determined in situ by CTS using a Picon Hand Vane the calibration of which is limited to a maximum reading of 130 kPa.
2. Unless specifically noted the profiles have not been related to a site datum.
