Arboricultural Appraisal Report

Subsidence Damage Investigation at:

The Elms, Badwell Road
Walsham-le-Willows
Bury St Edmunds
IP31 3BT

| REPORT DATE: | 13/07/2023 |

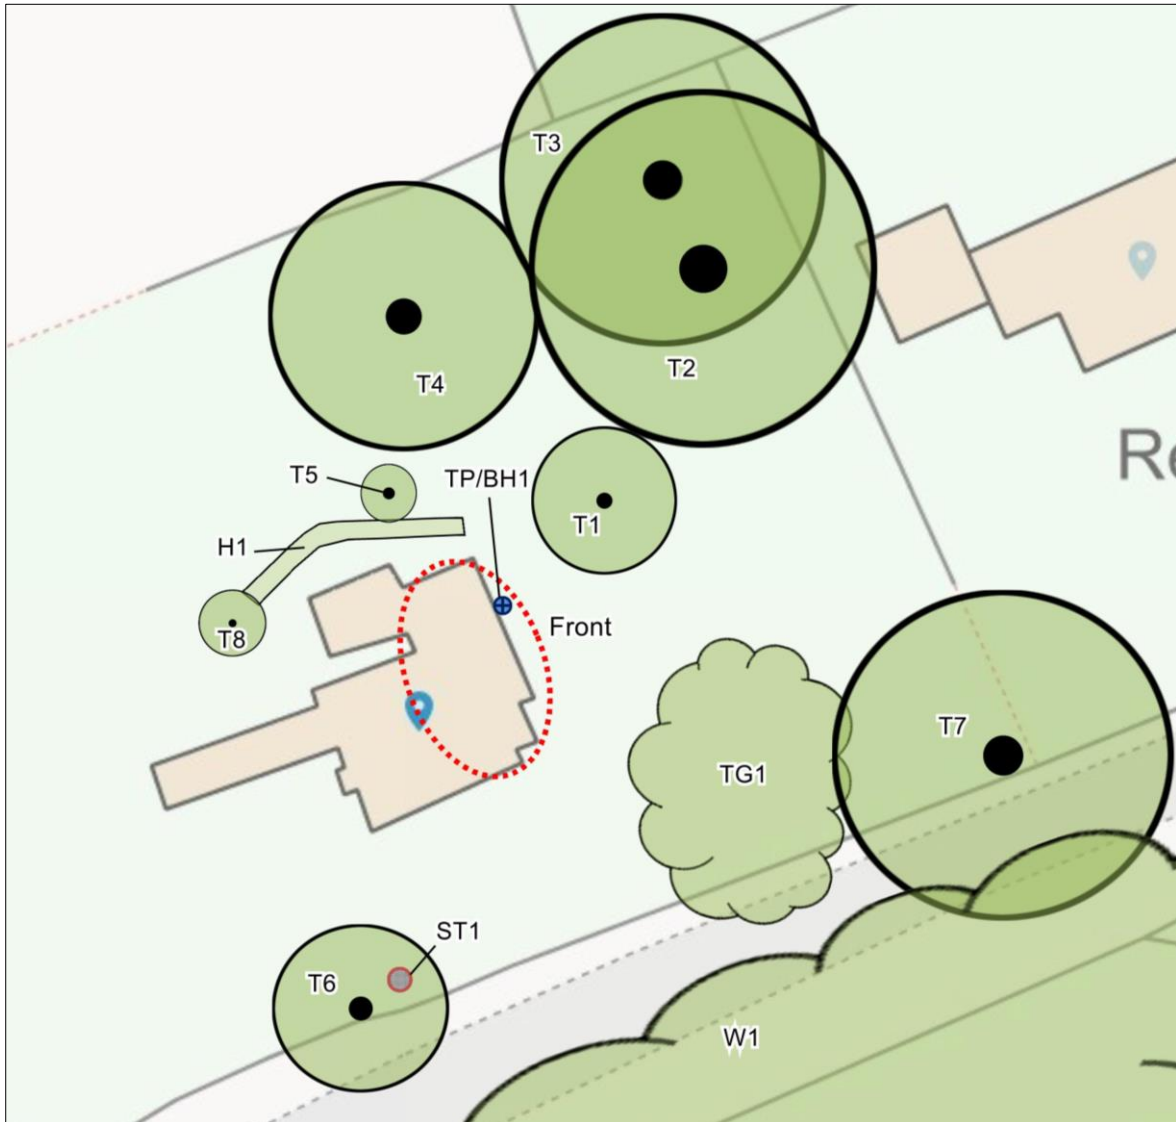
Site Plan

Approximate areas of damage
