ABBOTSFORD THORVERTON, DEVON

WINDOW AUDIT
September 2023

The Heritage Consultancy
www.theheritageconsultancy.co.uk

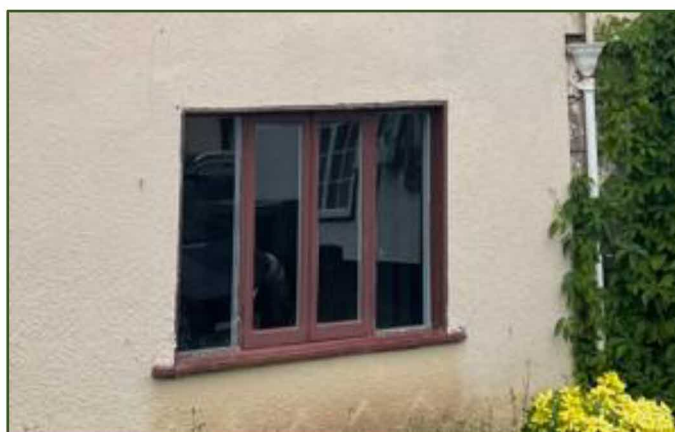
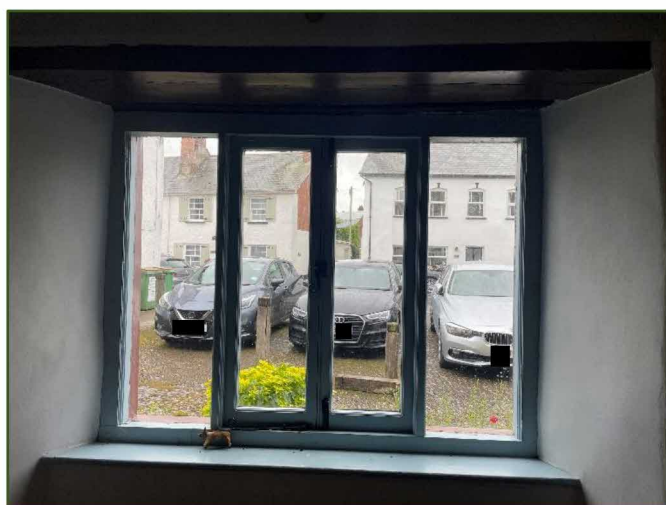
Window 1 - Sitting Room

The sitting room window is a simple, and economic replacement, comprising a soft wood frame of 4 lights with central opening casements (2 lights). The opening is operated by a simple swivel catch and stay. The window features an earlier embrasure as commented upon in the list description. The window frame is not historic, although the opening is likely to be of original proportion. Internally the timber frame appears to be in fair condition, although under thick layers of paint. Externally, cracked paint conceals the extent of weathering/damage, although 'soft' areas indicate rot underneath.

Figure 3. Sitting room window exterior

Figure 4. Sitting room window interior

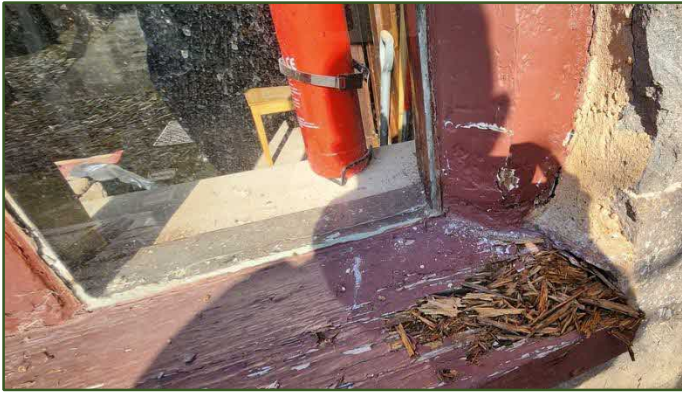
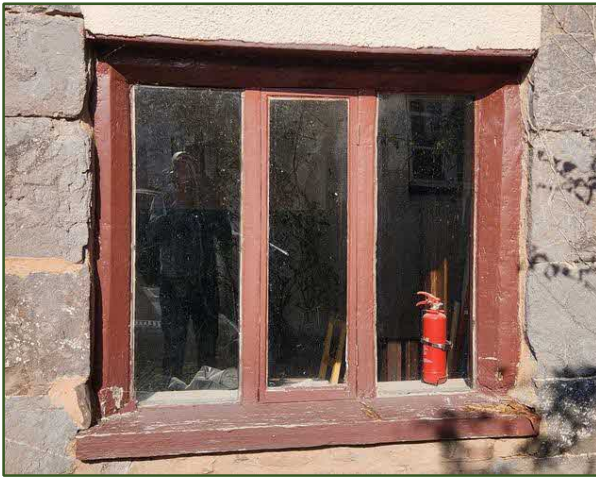
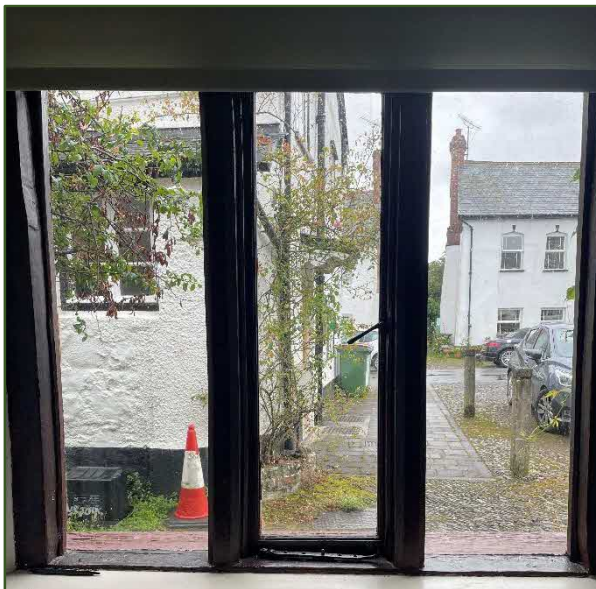
Window 2 - Dining Room

Externally, the dining room window frame and sill are in a parlous condition and are beyond the point of repair. The oak jambs are likely to be historic although it is not possible to state if they are original. It is the intention of the Applicant to investigate the condition of the jambs by the gentle removal of layers of paint, and to restore and maintain if viable, setting a new hard wood frame within. The existing C20 frame and sill are soft wood and have suffered water ingress over a prolonged period of time. Internally the frame is in fair condition. A modest straight latch, and a stay operate the single casement opening which is central within the single glazed, 3-light window. The opening is likely to be of original proportion; corresponding with the sitting room window.

Figure 5. Dining room window – rotted sill

Figure 6. Dining room window exterior

Figure 7. Dining room window interior

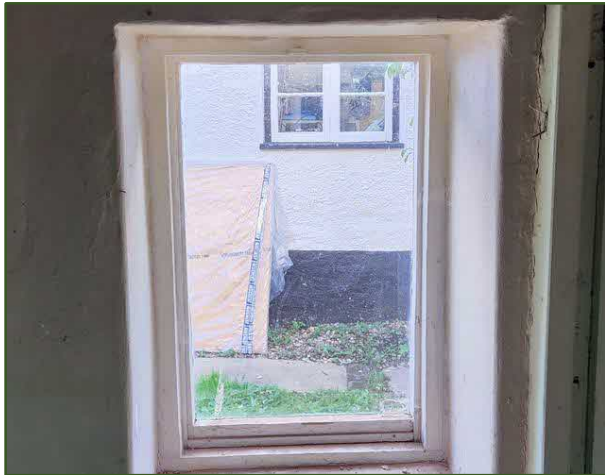
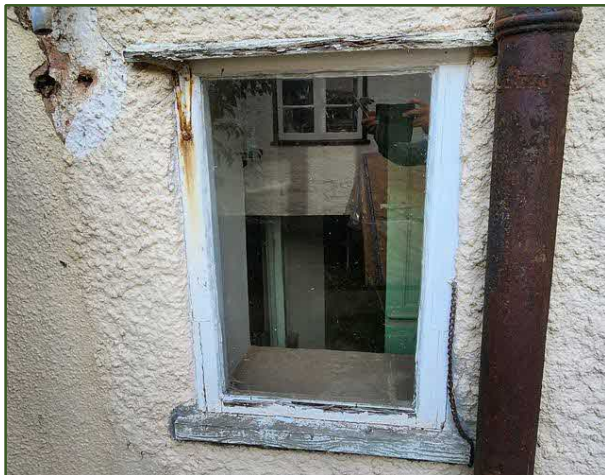
Window 3 – Kitchen

The kitchen window opening set within the principal façade is not original and has been crudely installed; no doubt purely to provide light into the room. The C20, single glazed window frame is of poor design and construction, and is unsympathetically located, providing a lack of harmonious symmetry, incongruous to the general design of the front elevation. Currently the window provides no means of ventilation as it is not an opening. The economic timber frame is weathered, the sill and lintel showing signs of rot, all require replacement or alteration to enhance the aesthetic and architectural value of Abbotsford.

Figure 8. Kitchen window interior

Figure 9. Kitchen window exterior

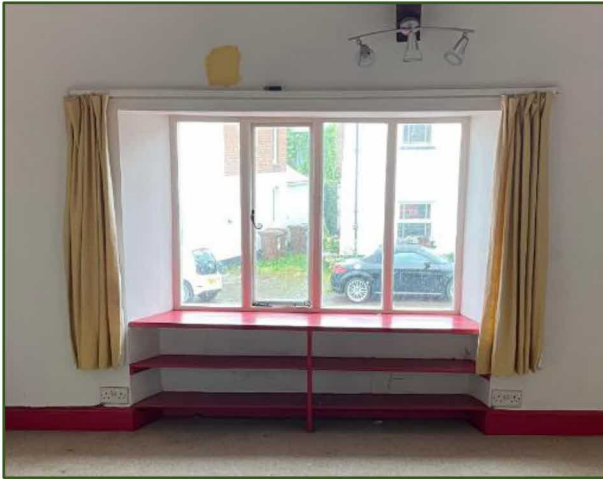
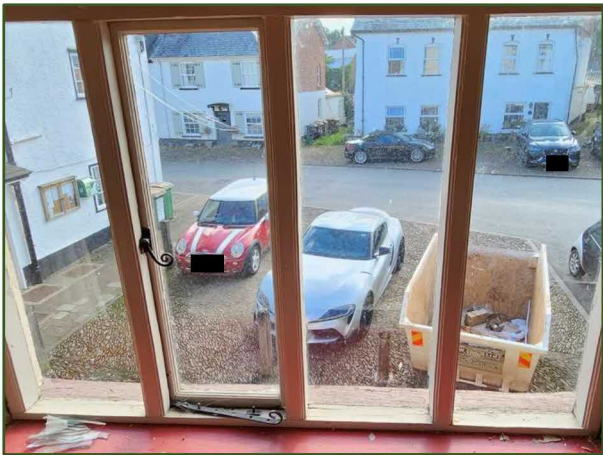
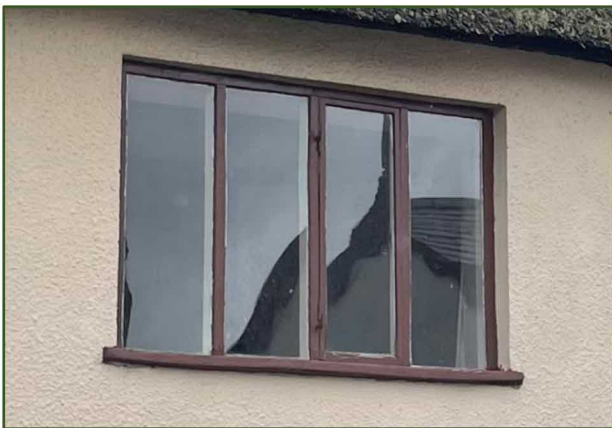
Window 4 - Bedroom 1

The window opening to the front of bedroom 1 comprises a single glazed, 4 light (with one opening) casement. The opening is not entirely consistent in proportion to the corresponding windows, i.e., sitting room, dining room or bedroom 2, and has likely been minimally widened. The frame is constructed of soft wood, and whilst internally the wood appears to be in fair condition, externally the sill is rotted along with the opening casement timber which is swollen due to water ingress and unable to close effectively. The simple swivel latch and stay do not appear to be original.

Figure 10. Bedroom 1 window interior

Figure 11. Bedroom 1 interior

Figure 12. Bedroom 1 exterior

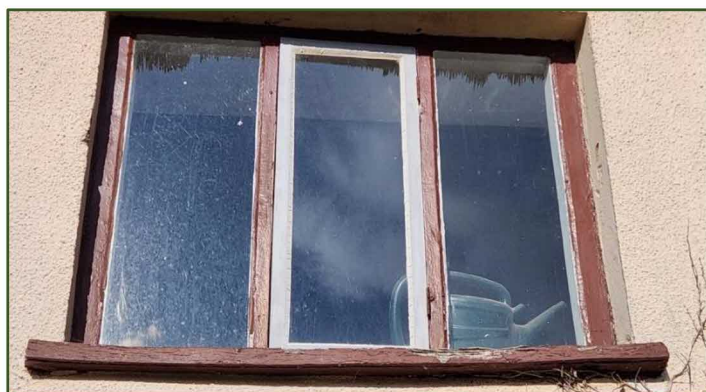
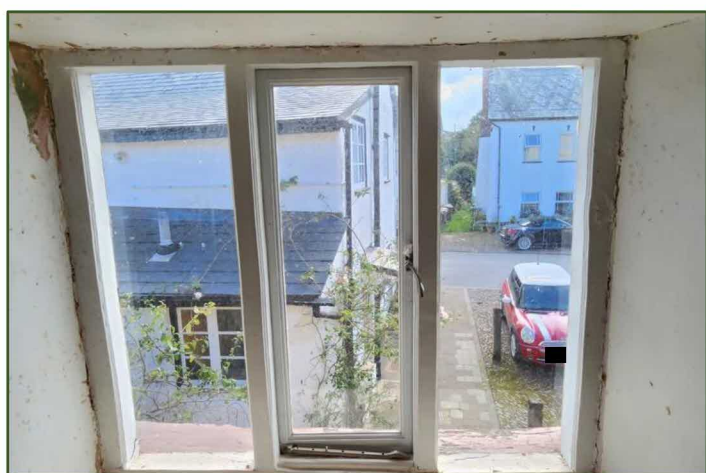
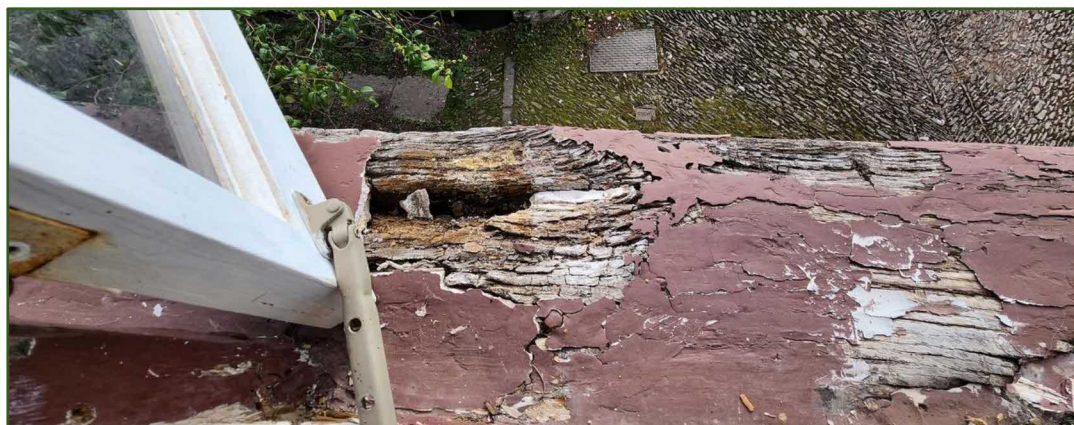
Window 5 - Bedroom 2

Bedroom 2 features a C20 window frame, comprising 3-lights. The opening casement, set centrally appears to be a C21 replacement and hosts economic window furniture. The sill which pre-dates the frame, is warped and rotten. The overall condition of the frame is fair, but the construction and quality are poor and makes for a negative aesthetic experience. This window opening is commented upon individually in the list description as *'First floor window right is a 4-light casement with glazing bars'*, clearly demonstrating its replacement post 1966.

Figure 13. Bedroom 2 exterior, note warped/dropped sill

Figure 14. Bedroom 2 interior

Figure 15. Bedroom 2 exterior sill demonstrating overall condition of sills throughout

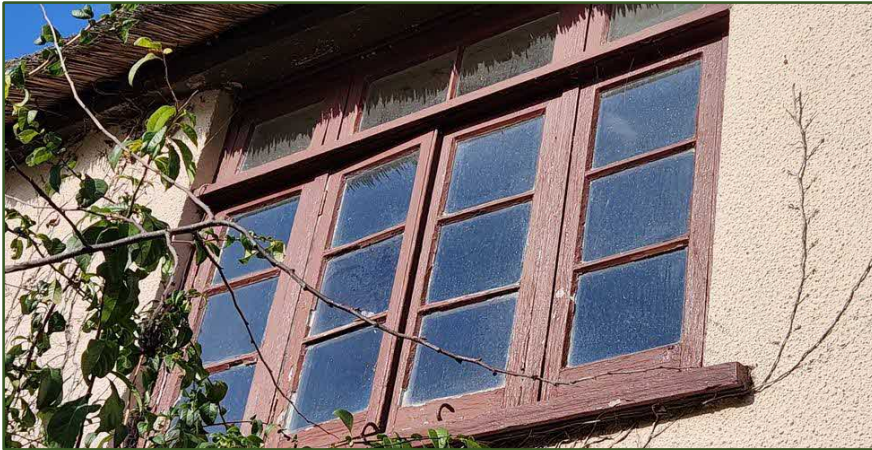
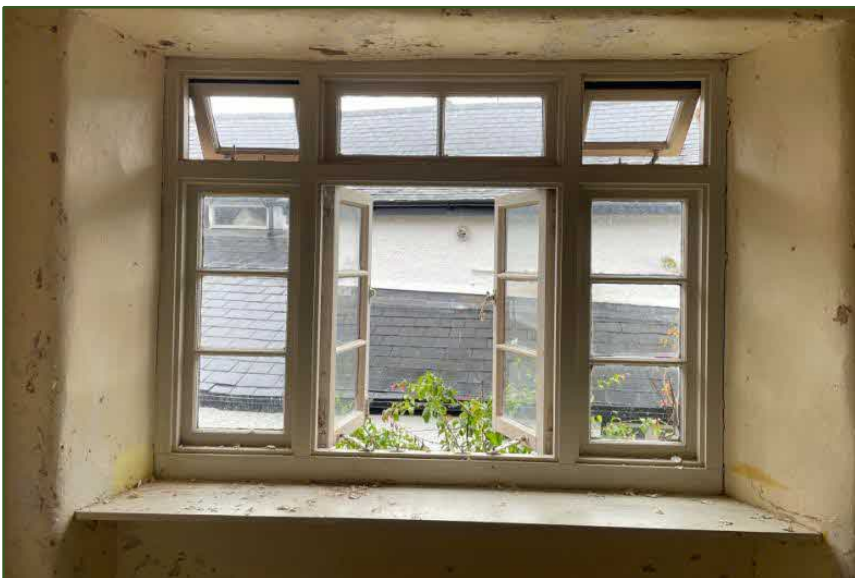
Window 6 - Bedroom 3

The single glazed window opening in bedroom 3 has been enlarged, raised to the eaves, and is of a design totally incongruous to the historic design and significance of Abbotsford. Consisting of soft wood, the window comprises 16 panes with glazing bars, 2 small openings to the top, and a double casement opening set centrally. The Pre-application Enquiry report understandably drew attention to the window in bedroom 3, commenting upon its unsympathetic alteration and design. Internally the frame is in fair condition, but externally the wood is weathered and rotten in places. The northernmost casement opening has warped and does not close properly. The Applicant intends to reduce this window to its original proportion in order that it is consistent with the corresponding windows.

Figure 16. Bedroom 3 exterior. Note enlargement and proximity to eaves

Figure 17. Bedroom 3 interior

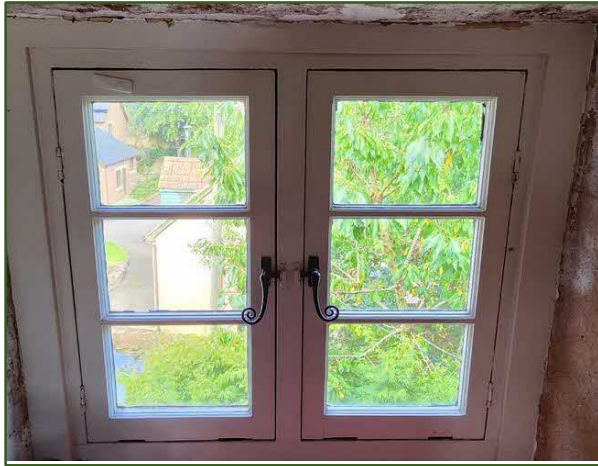
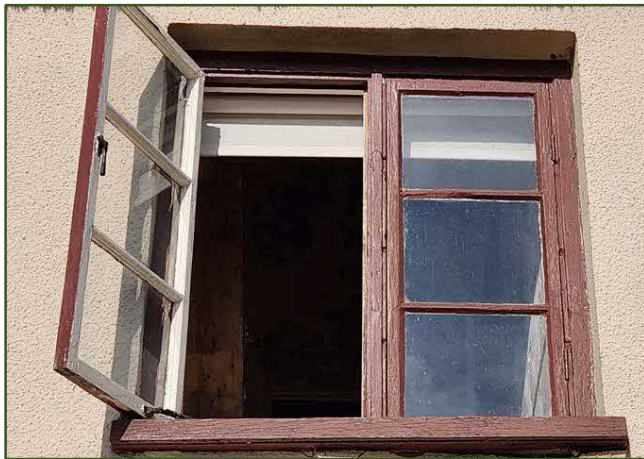
Window 7 - Family Bathroom

The C20 first-floor bathroom casement window is constructed of soft wood, with glazing bars and a single opening. The wood is weathered, and rotten in places, is in general poor condition and requires replacement to adequately serve a family bathroom.

Figure 18. Family bathroom window interior

Figure 19. Family bathroom window exterior

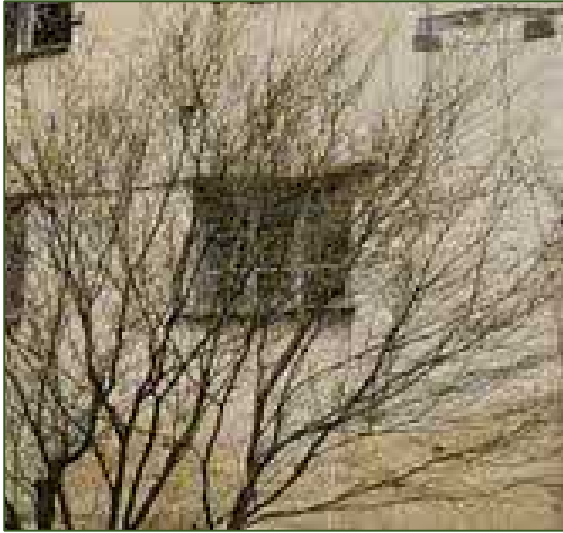
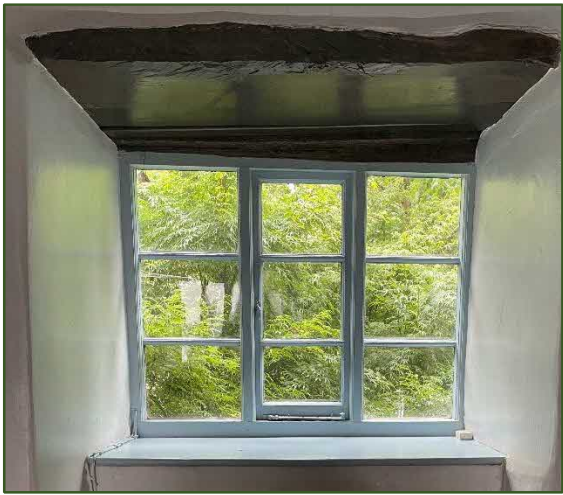
Window 8 - Sitting Room

The sitting room window comprises a single glazed, 3 light casement window with wooden glazing bars. During spring, summer and autumn, the window is concealed by foliage, which has contributed to the sill and exterior frame rotting; this also makes photographing the frame for the purposes of this audit difficult. The window is set underneath an aged wooden lintel.

Figure 22. Sitting room window exterior (partially concealed by vegetation)

Figure 23. Sitting room window interior

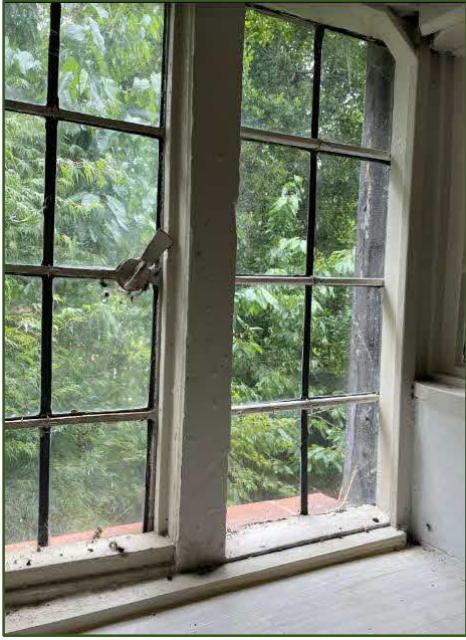
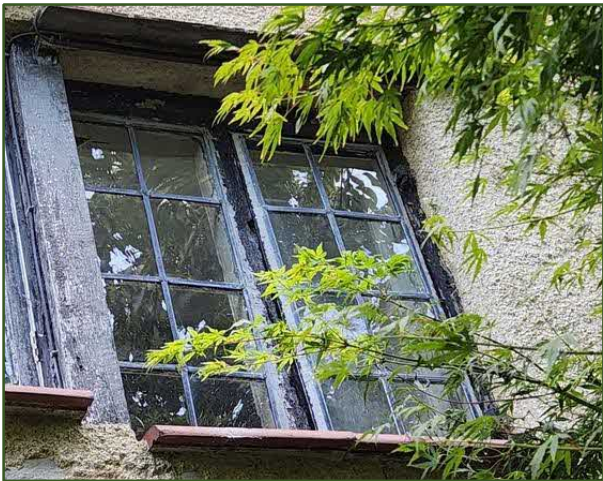
Window 9 - Under stairs space

The area identified as they under stairs space has a window unique to Abbotsford; the design inconsistent with all other windows to the front and rear elevations. The window sits beneath a shallow clay tile canopy with no timber lintel visible and comprises a double casement (single opening) with leaded lights. The sill is constructed on red clay tile as opposed to timber as with other openings. The timber frame is in fair condition internally, but is rotted to the exterior; the nearby foliage a contributing factor.

Figure 24. Under stairs space window interior

Figure 25. Under stairs space window exterior

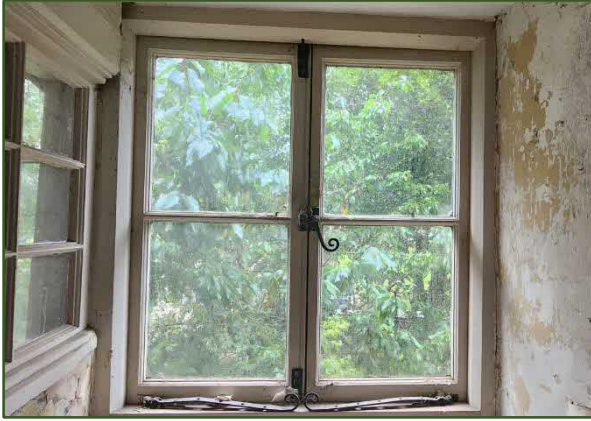
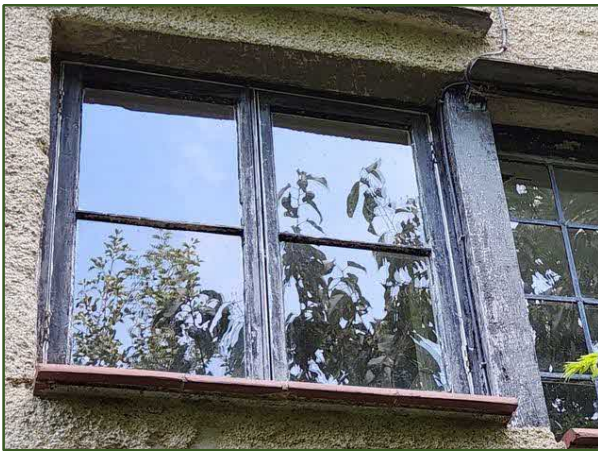
Window 10 – Dining Room

The dining room window sits directly to the south of the understairs space window; an upright timber providing support and separation between the 2. The modest, soft wood double casement, with single opening and central glazing bars is rotted and weathered, and is of poor and economic construction. As with the understairs window, a shallow clay tile canopy sits to the top, with no timber lintel visible; the area being rendered. Internally the frame hosts iron stays, a simple scroll latch and C20 locks.

Figure 26. Dining room interior

Figure 27. Dining room window exterior

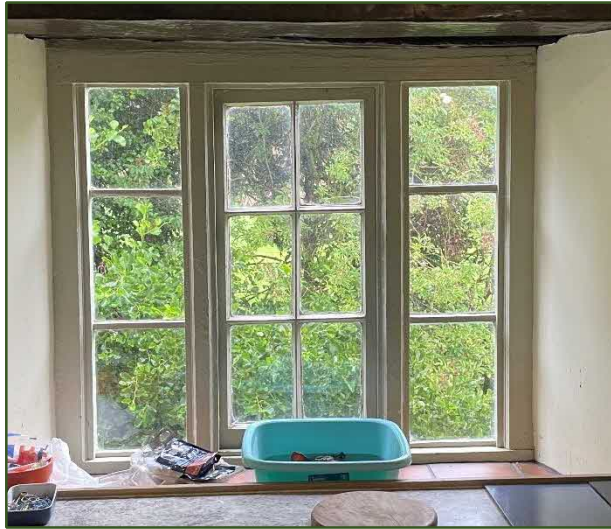
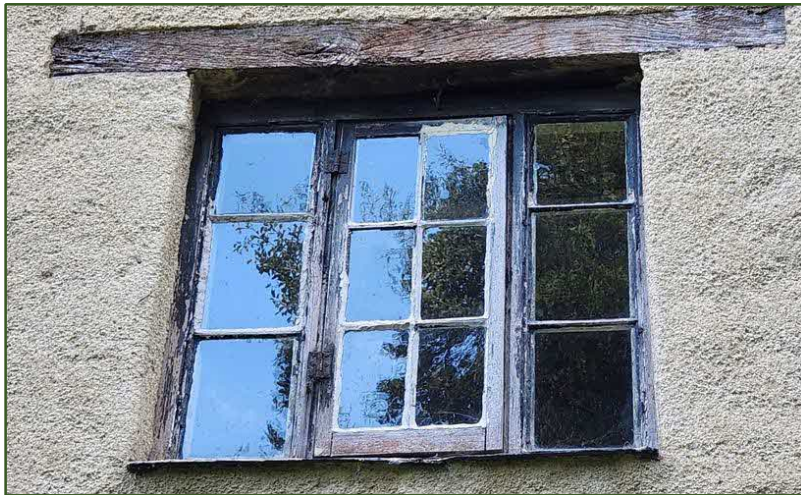
Window 11 – Kitchen

The kitchen window comprises 3 lights; the outer 2 with 2 glazing bars, the central opening of alternate design. The frame, most notably the central opening, is in parlous condition, the timber evidentially suffering a lack of maintenance over a long period of time which has resulted in a degree of warping and rot; the opening cannot close flush within its frame. The iron hinges are rusted, which have contributed to the degradation of the wood in which they are secured. The window sits underneath a timber lintel, the modest sill made of slate tile. Internally, there is no window furniture to secure the window closed.

Figure 28. Kitchen window interior

Figure 29. Kitchen window exterior

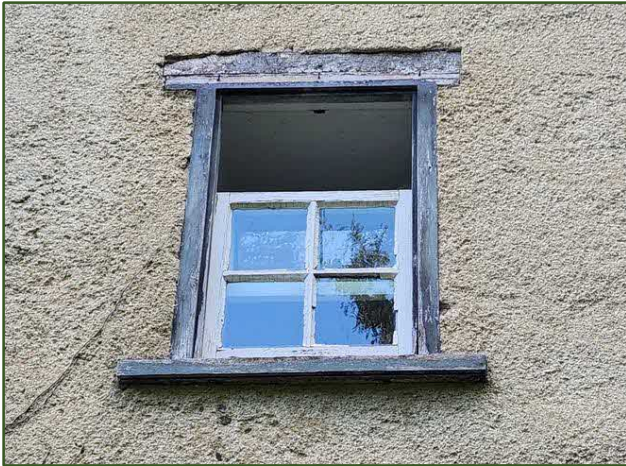
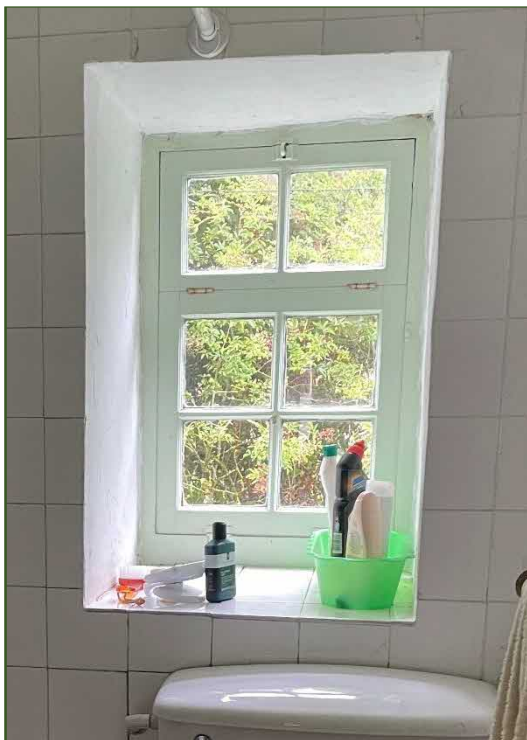
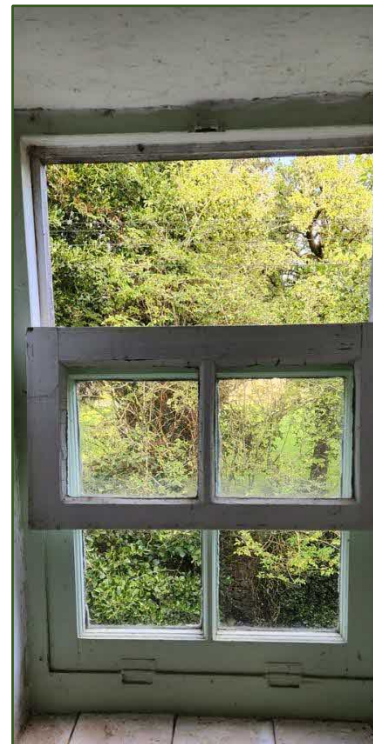
Window 12 - W.C./Shower room

The W.C./Shower room located on the ground floor, features a small window constructed of soft wood timber with 6 panes within glazing bars, the top 2 within the opening which is hinged internally to allow the window to fold back internally. The window frame is an ad hoc insertion which is not consistent with the age or patina of the outer timbers, which are clearly more aged, and of poor condition. The window frame has been painted white, and as with other windows, the lack of maintenance has accommodated water ingress and rot.

Figure 30. W.C./Shower room exterior

Figures 31 above and 32 right. W.C./Shower room interior

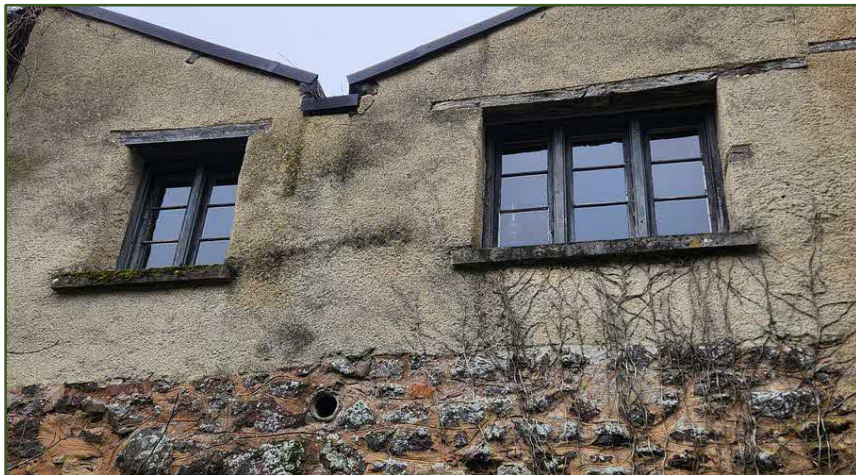
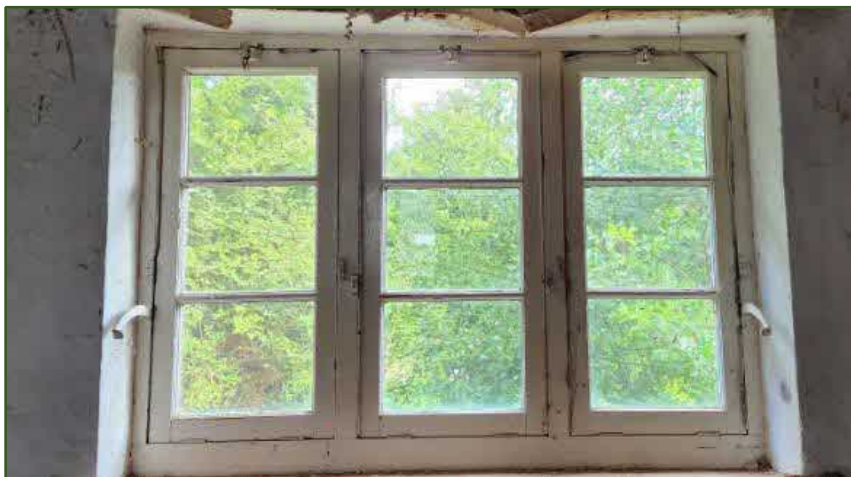
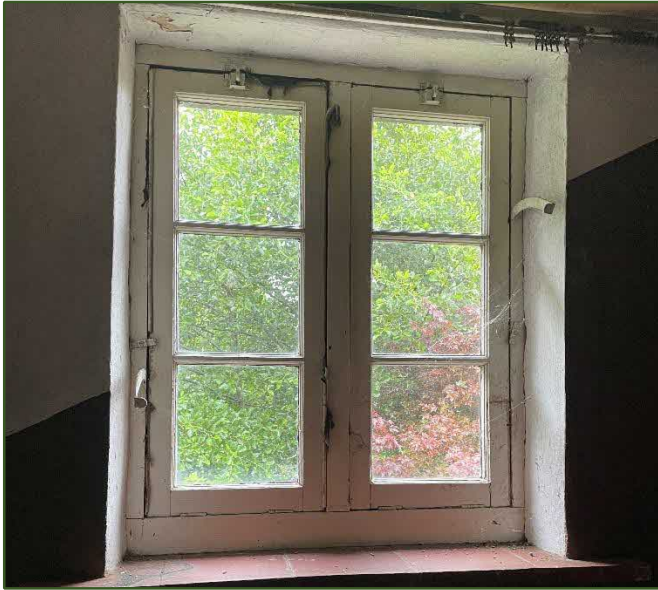
Windows 13 & 14 - Workshop/store room

The store/workshops windows are of consistent design to each other, one being a 3-light casement, the other being 2. Both windows have glazing bars, are constructed of soft wood and are of a later installation. Internally both windows are hinged to the base, opening inwards, being restricted by curved supports. Both windows show signs of weathering and rot. Neither window fits flush within the frame, with crude attempts to fill the gaps with material or 'stick on' foam insulation evident, in attempt to minimise draughts or water ingress. Both windows sit beneath timber lintels and have timber sills; the latter being rotted to a similar degree to that of the front dining room window, exacerbated by the presence of moss as seen in figure 33 (left hand side sill).

Figure 33. Workshop/store windows exterior

Figure 34. Workshop/store window (number 13) interior

Figure 35. Workshop/store window (number 14) interior

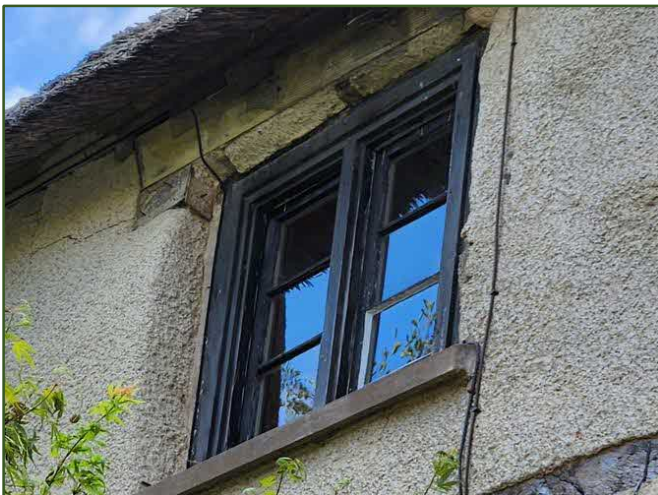
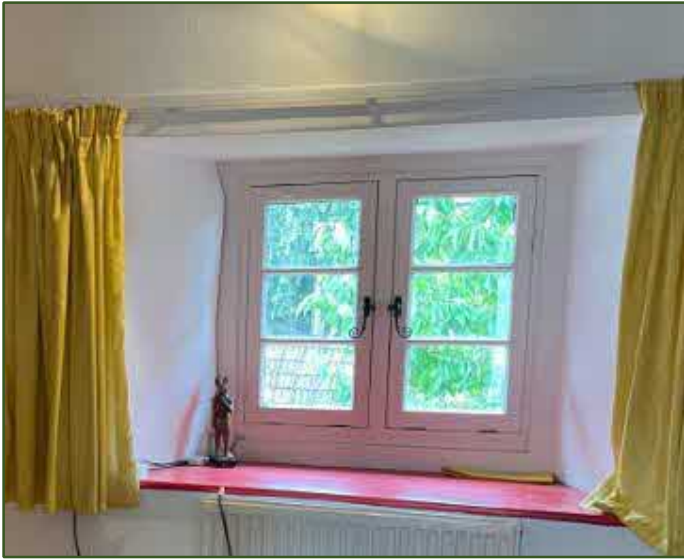
Window 15 – Bedroom 1

The rear facing window in bedroom 1 is a double opening casement with glazing bars constructed of soft wood. Internally the window is in fair condition, yet externally shrinkage to the top of the northernmost opening is visible (fig.36), which has allowed water ingress. The first-floor window has fared better than the sitting room window below, due to the lack of immediate foliage, but the condition is sadly consistent with all other windows at Abbotsford, being beyond reasonable or viable repair. Internally, 2 iron scrolled latches operate the opening. There are no stays or locks.

Figure 36. Bedroom 1 exterior

Figure 37. Bedroom 1 interior

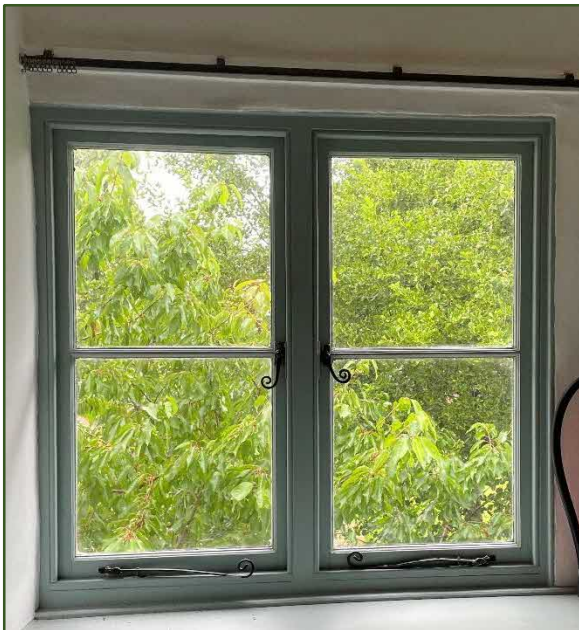
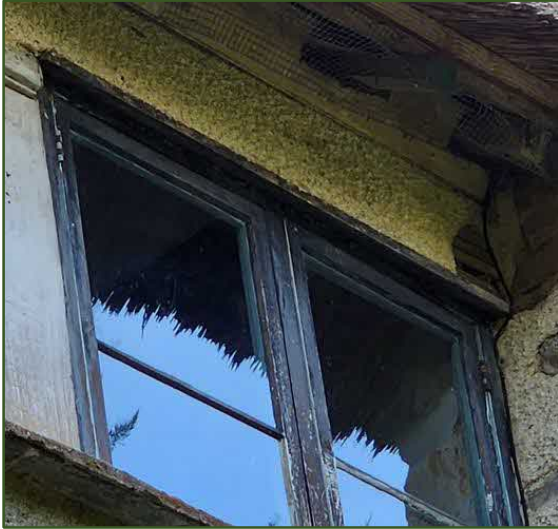
Window 16 - Landing

The window overlooking the rear situated in the landing, is constructed of soft wood, underneath a slim timber lintel which is inconsistent in proportion to the other lintels throughout the property. The sill is constructed of red clay tile and runs continuously underneath the window to bedroom 5. The double opening casement, with glazing bars is in fair condition internally, but is weathered externally with signs of rot and shrinkage. The window is furnished with 2 scroll latches, and 2 aged, scrolled stays.

Figure 38. Landing window interior

Figure 39. Landing window exterior

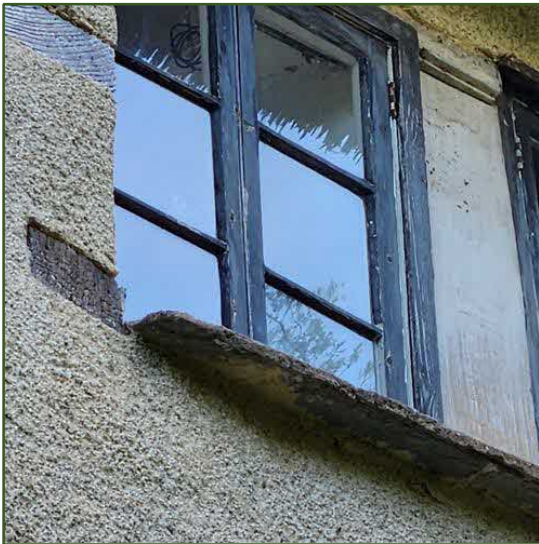
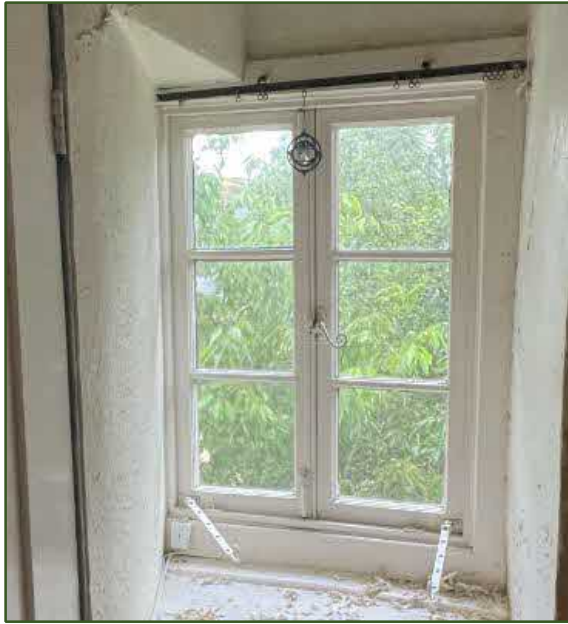
Window 17 – Bedroom 5

Bedroom 5 features a soft wood framed, double casement, single opening window, with glazing bars. A single red clay tile sill serves both this window and the landing window to the immediate north. Whilst the design of the neighbouring windows may differ slightly, the condition is the same, in that whilst the frame may be in fair condition internally, externally the wood is weathered and lacking in maintenance which has resulted in the frame being beyond means of reasonable or viable restoration or repair. The window is secured by a simple scrolled iron latch and 2 metal stays, all of which have been painted white.

Figure 40. Bedroom 5 window exterior

Figure 41. Bedroom 5 interior

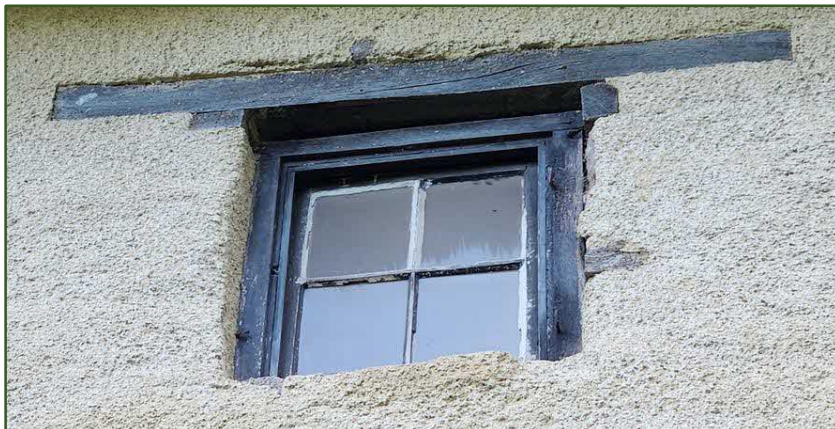
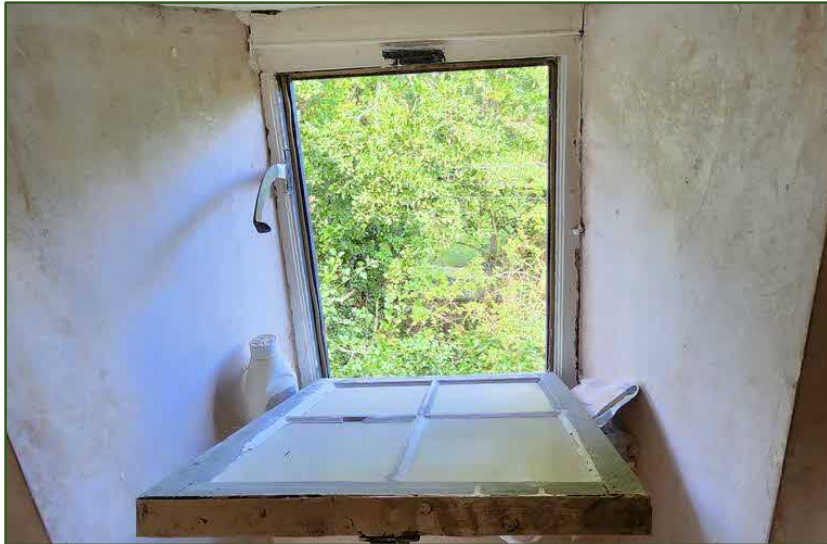
Window 18 - Bedroom 4

The rear facing window in bedroom 4 is a small opening, with glazing bars. The window is hinged at the base, opening inwards, supported by curved brackets (as seen below in the workshop/store). The glazing bars have seen basic attempts at maintenance, with the application of putty over the timber underneath. Externally, the surrounding timbers appear to be of an earlier period than that of the window, and features 3 wrought iron fixings. The window and frame are all of different periods and condition, yet are weathered and in need of replacement; gaps to the northernmost mortar/render have allowed water ingress into the surrounding frame, causing rot.

Figure 42. Bedroom 4 exterior

Figure 43. Bedroom 4 interior

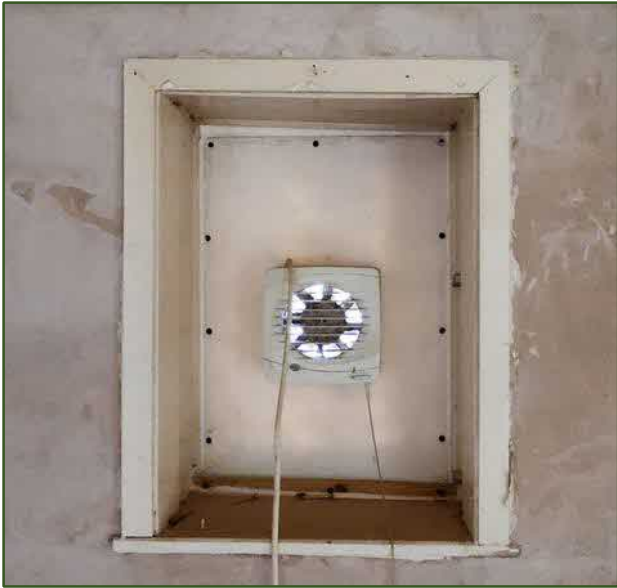
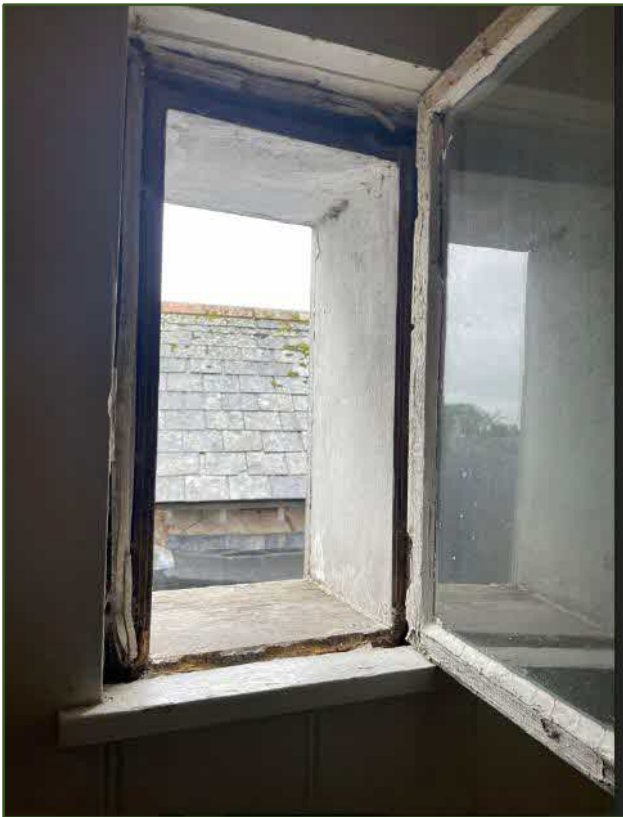
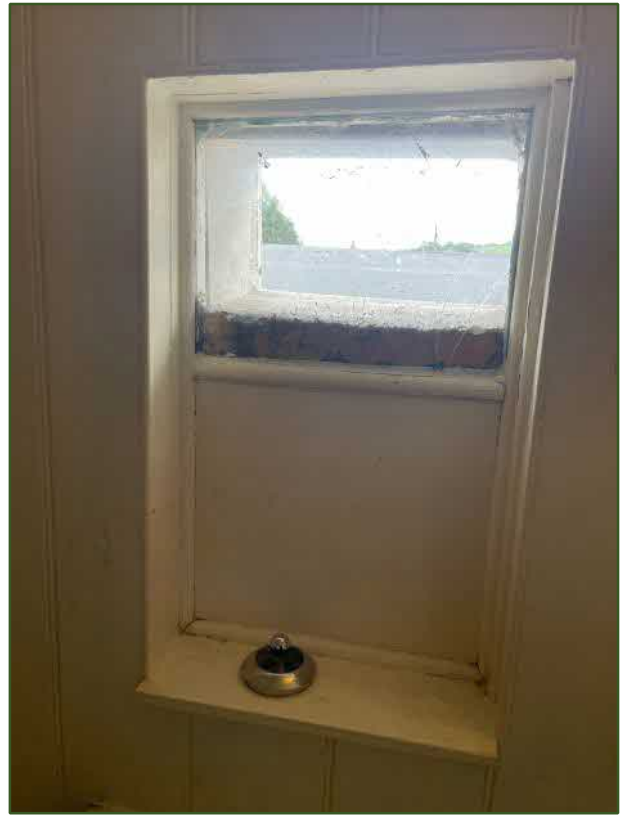
Windows 19, 20 & 21 - Bedroom 4 & Ensuite

The southern elevation comprises 3 small openings of differing proportion, each having the opening fully boarded with economic timber board so that the surrounding stonework cannot be assessed. The windows have not been professionally fitted. Externally, the frames are constructed of timber which has been fitted over the corrugated sheeting attached to the southern elevation.

Bedroom 4 (window 19) has been boarded and an extractor fan fitted. Window 20 in the ensuite is a single opening casement of extremely poor construction and condition, as is window 21 which appears to suggest that a once larger opening has been partially blocked. It is impossible to tell if there has been alteration to the openings, or if they are historic due to the corrugated sheeting on the exterior wall. The 3 openings in the southern elevation require attention/alteration to benefit and compliment the grade II listed house, and to comply with Building Regulations.

Figure 45. Bedroom 4 interior

Figures 46 & 47. Windows 21 left and 20 right; ensuite bathroom interior
