TIMBER SURVEY

BRADES FARM, BRADES ROAD, PREES, WHITCHURCH, SY13 2DX

APPLICANT: MR. & MRS. ROGER FORD

DATE: JULY 2023 (REV B)

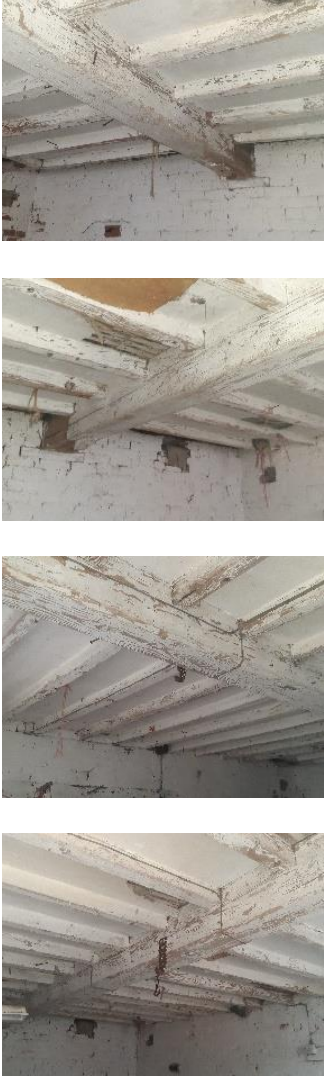
<p>AGJ</p> <p>The exposed joists and beams are covered in white paint, albeit in good condition.</p> <p>Once the paint is removed they will be treated with a suitable treatment as described within section 2.</p> <p>Plaster boards will be scribed around these beams to allow them to become a feature.</p>

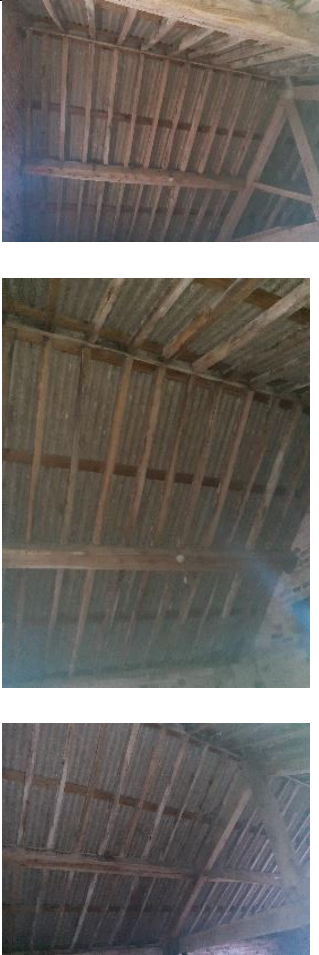
<p>AFRP</p> <p>The building has been roofed with a modern box profile metal sheeting which has protected the timber rafters and purlins.</p> <p>The rafters requiring replacement due to damage will be replaced in line with Section 2.</p> <p>Many of these rafters can be protected in line with Section 2.</p> <p>No primary timbers are to be removed or modified and they will be protected in line with Section 2.</p>

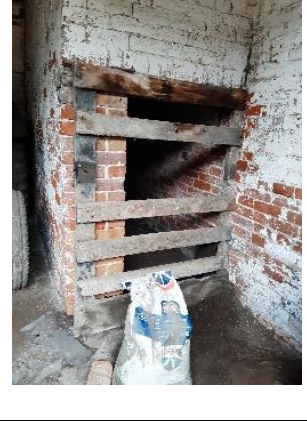
<p>BGX</p> <p>These timbers were placed to prevent stock entering the void space and although not structural are key to the current use of the building.</p> <p>These modern timbers, non-structural timbers are to be removed, without damaging the brick work and this area infilled.</p>
 	<p>BFX1</p> <p>The exposed timber balustrade is badly affected by woodworm and as such will be removed. Floorboards will extend over the staircase void to form bed 3.</p>
 	<p>BFX2</p> <p>This timber is a modern addition to facilitate the positioning of a water tank.</p> <p>This timber will be removed without impacting the original timbers.</p>
 	<p>BFFI.</p> <p>The items within the building inhibit the examination of the floorboards</p> <p>On the whole the floorboards appear strong but there is evidence of some degradation which has led to gaps within the boards which would require repair / replacement.</p>

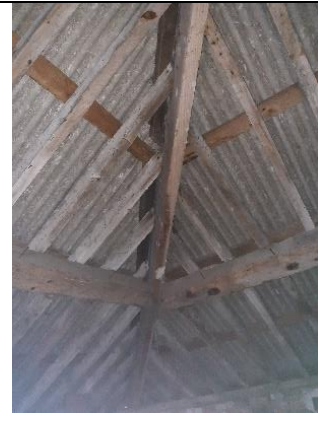
<p>BGP1</p> <p>The primary timber will remain in situ and will be treated in line with Section 2</p>

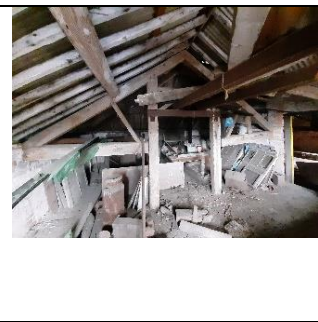
<p>BGP2</p> <p>The primary timber will remain in situ and will be treated in line with Section 2</p>

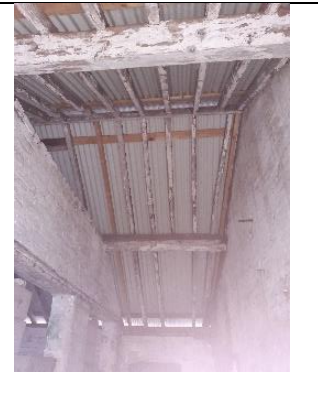
<p>BF</p> <p>These is an exposed timber on the eaves on Barn B</p> <p>This appears to be a modern timber placed when works to the roof was completed and will be removed / rectified once the roof is replaced.</p>

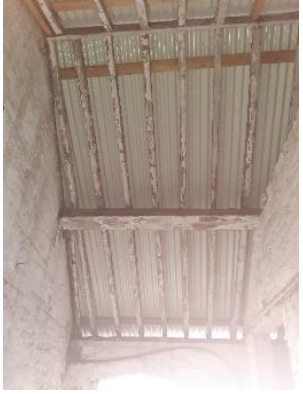
<p>CGRP</p> <p>The rafters requiring replacement due to damage will be replaced in line with Section 2.</p> <p>Many of these rafters can be protected in line with Section 2.</p> <p>No primary structural timbers are to be removed or modified and they will be protected in line with Section 2.</p>

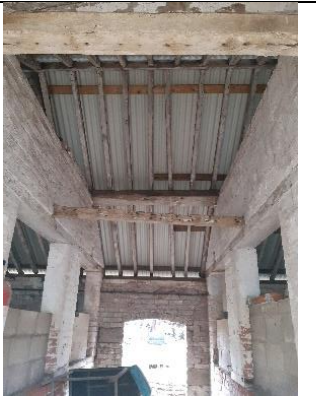
<p>EGT1</p> <p>The internal wall will be modified to create a divisional wall within Unit 2.</p> <p>The bonding timer will be lost and a suitable replacement will be utilised within the works.</p> <p>No primary timber is affected.</p>

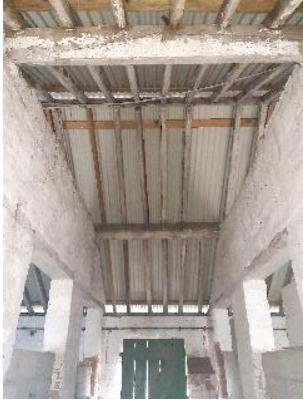
<p>GGT1</p> <p>The internal wall will be modified to create a divisional wall within Unit 2.</p> <p>The bonding timer will be lost and a suitable replacement will be utilised within the works.</p> <p>No primary timber is affected.</p>

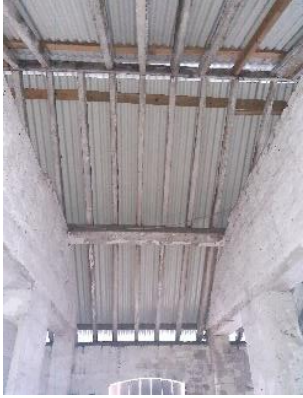
<p>GGRP</p> <p>The rafters requiring replacement due to damage will be replaced in line with Section 2.</p> <p>Many of these rafters can be protected in line with Section 2.</p> <p>No primary timbers are to be removed or modified and they will be protected in line with Section 2.</p>

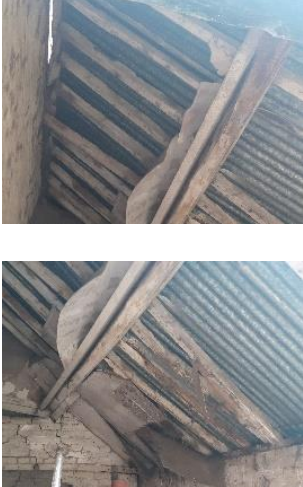
<p>HGX</p> <p>The timber in the plasterboard will be scribed around this featured to allow become a feature in the dwelling</p>

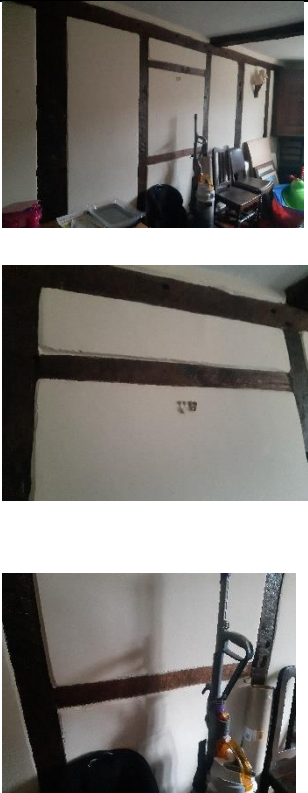
<p>Ho Dr X 1</p> <p>This is located in the dining room of the house. Much of the timbers are new timber, following works to the dwelling in the latter part of the 20th Century. Which were done to match the original 16th Century Timbers</p> <p>The original timber will not be affected</p>

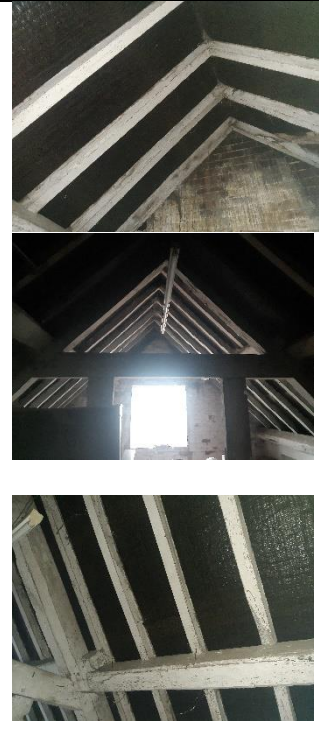
<p>Ho At RP 1</p> <p>The rafters and purlins in the attic, currently used for Storage are in good condition and are not considered to require any further work.</p>
---	--
