Our Ref: JBA 23/183 ECO01 AW

9<sup>th</sup> June 2023

## **RE: Preliminary ground level assessment of potential bat roost features of buildings at The Old Rectory, Norton Road, Tostock, Suffolk.**

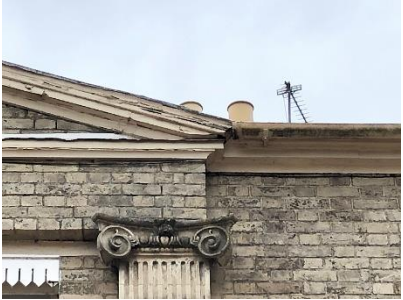
Holes in wooden fascia

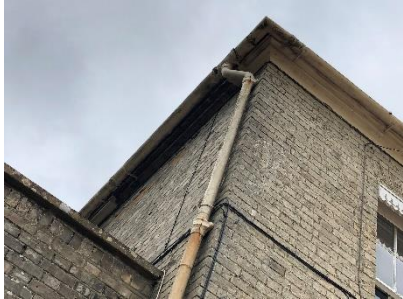
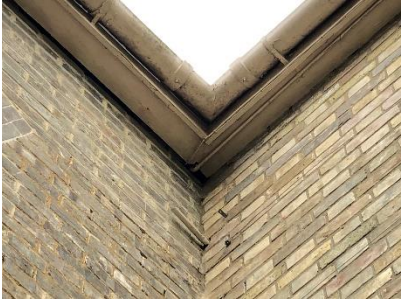
Assessment of the exterior of the building found gaps around facias, multiple windows and metal cladding. It was noted that the brickwork of the building and associated pillars had some degradation with gaps between the brickwork and the buildings soffits, providing suitable roosting features. Some of the building's soffits had holes and in some places the soffit was missing.

Missing soffit	Gap between soffit and brickwork

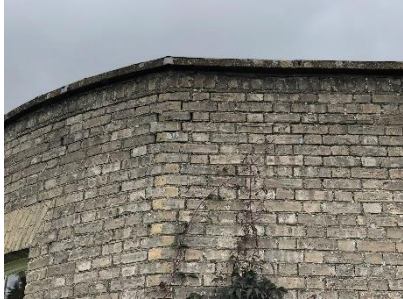
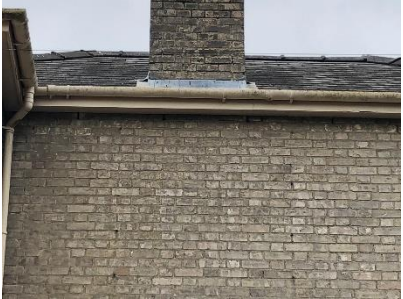
Gaps in brickwork

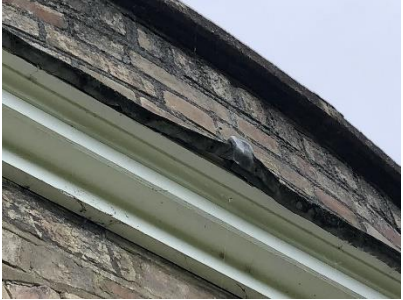
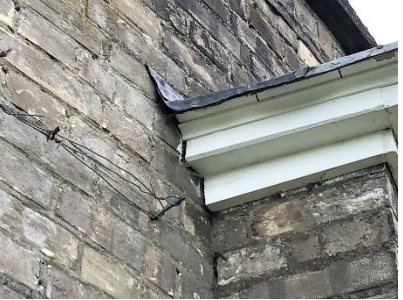
Lifted metal cladding

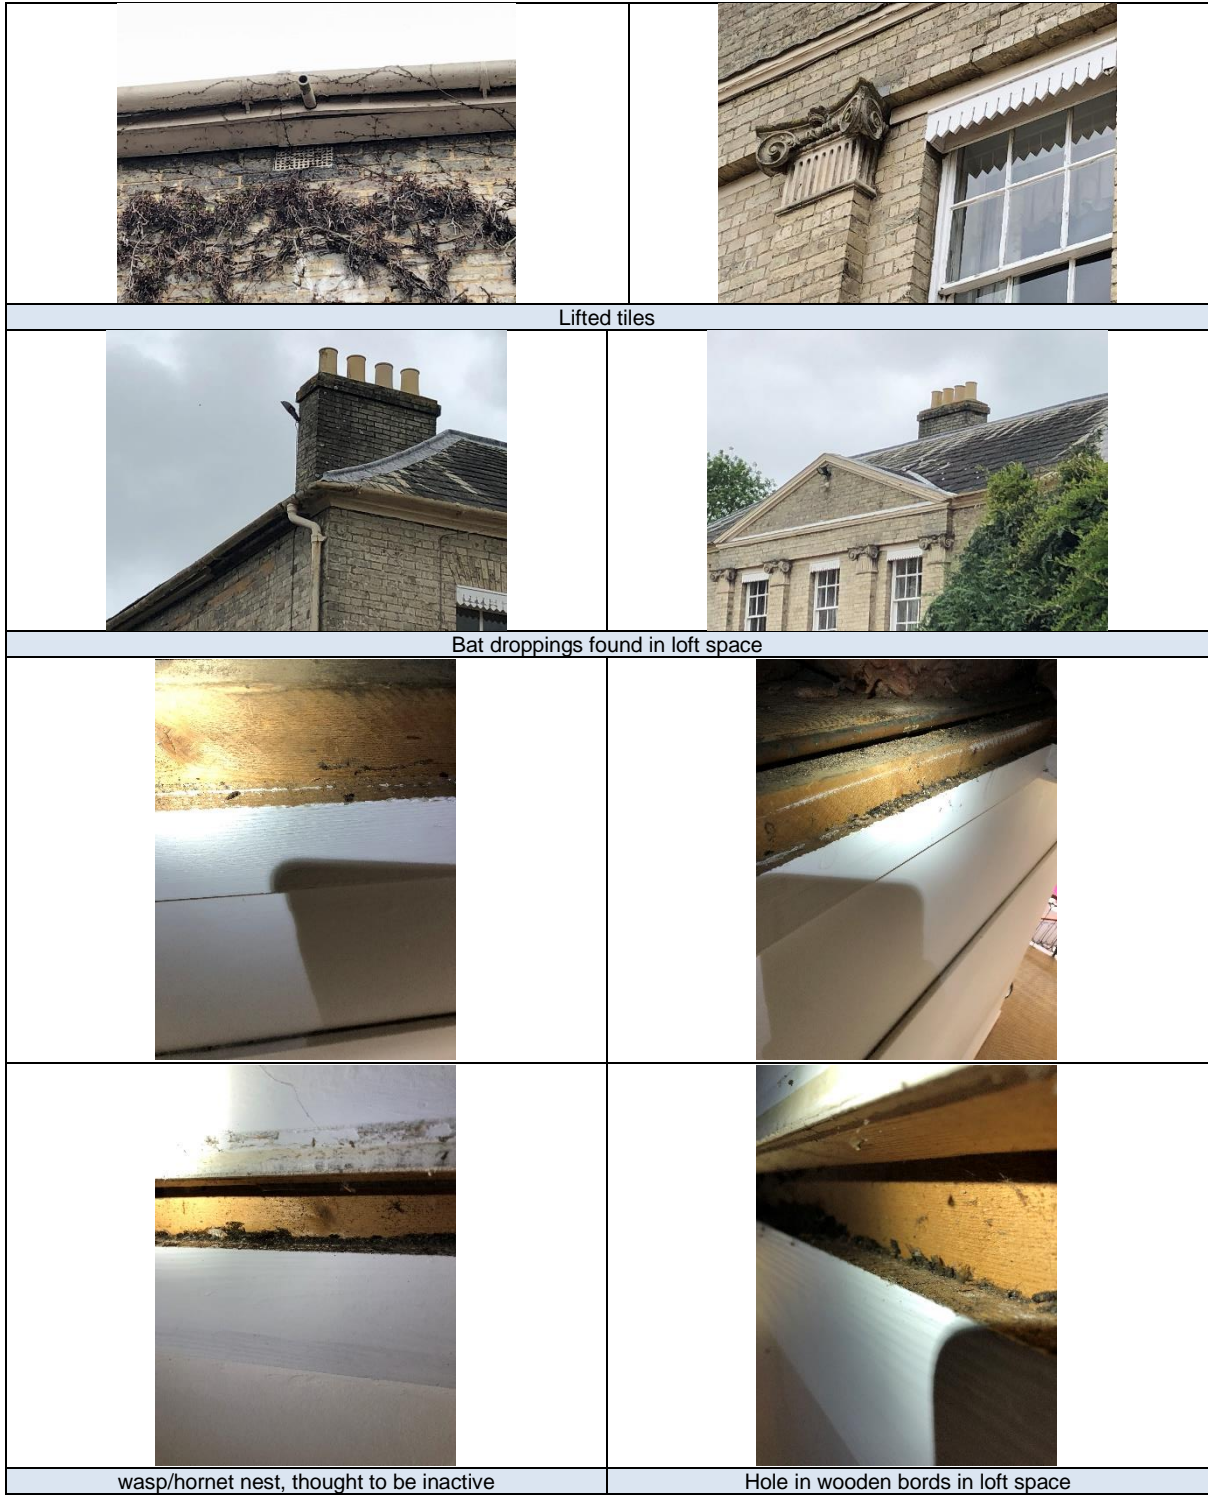
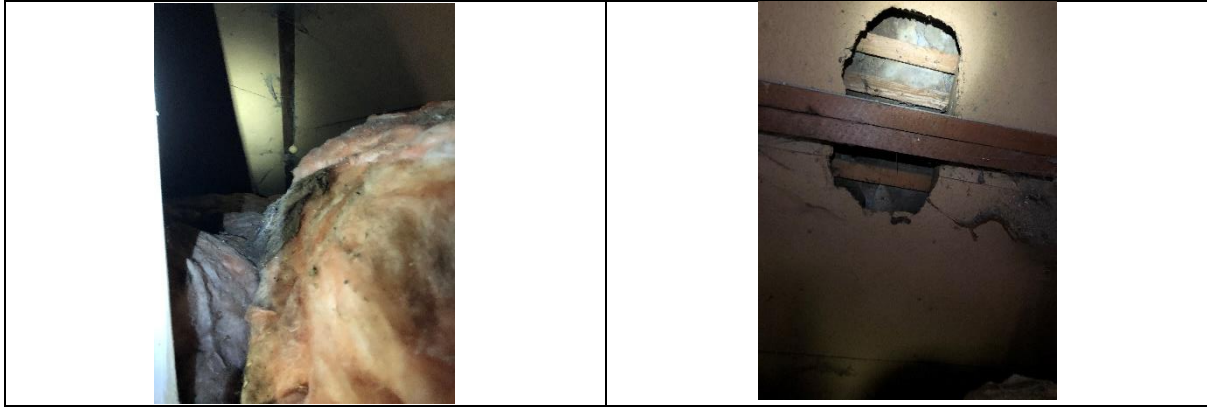
The buildings woodwork has also started to show signs of degradation with the separation and holes providing roosting features. Lifted slate roof tiles were present across the whole buildings roof.

Seperated wood	Gaps around brick pillars
