STRUCTURAL ASSESSMENT REPORT

Green Oak Barn, Stonham Road, Mickfield

Date: October 2022

Reference: GT/2170/srep02

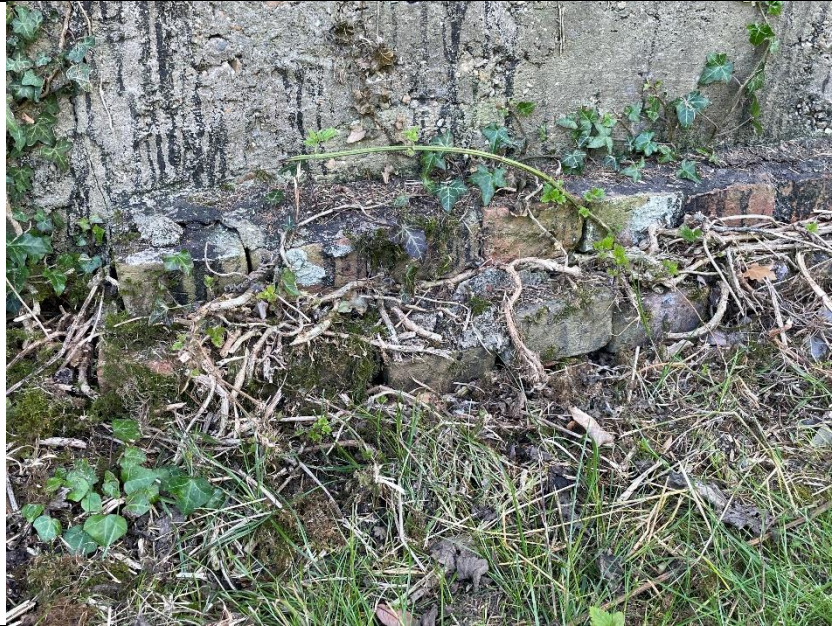
- 3.2 The weatherboard cladding has deteriorated, with extensive ivy growth externally around the perimeter of the barn on all elevations.
- 3.3 The roots of the vegetation extend into the mortar joints of the brick plinth and has caused distortion to the brickwork.

Photograph 05
Brick Plinth North Elevation

- 4.8 Vegetation should be cut back and allowed to die off before it is removed to prevent further damage from occurring to the barn
- 4.9 It is my conclusion that the barn, can be repaired and converted into a singular residential accommodation. To ensure the building, long-term has a viable use the frame can be repaired. The overall structural integrity of Green Oak Farm Barn, I believe can accommodate a single-use residential dwelling within the existing building envelope without significant loss to the historic fabric.

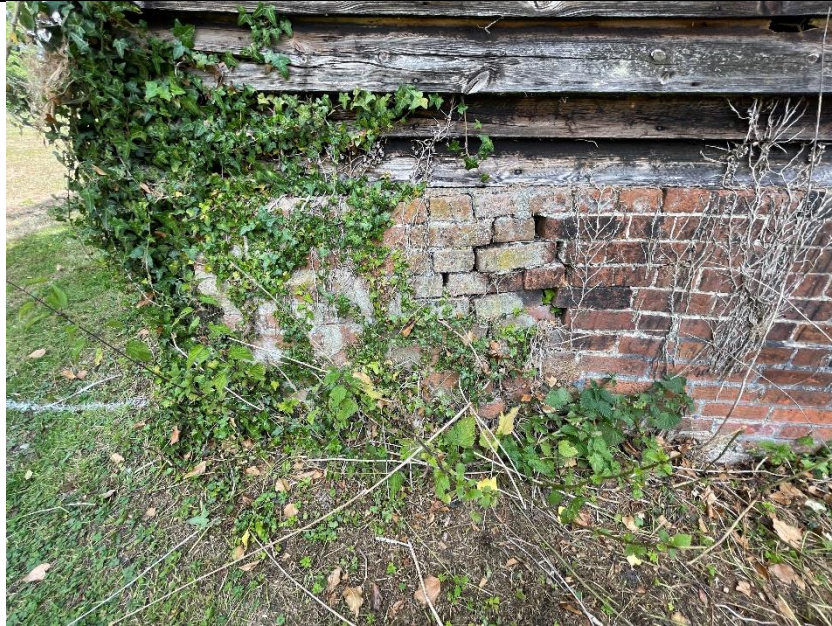
Photograph 06
Brick Plinth West Elevation

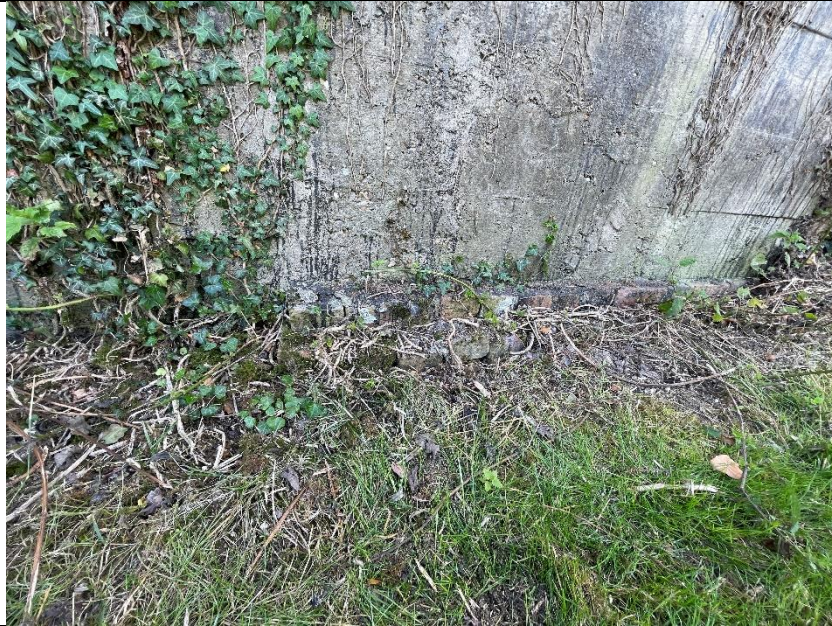
- 3.4 The brick plinth has been historically repaired with concrete along the north elevation over half its length. The repair has been carried out in a manner of shuttering the existing walls and pouring concrete in situ to stabilise the brickwork and timber. This repair continues at plinth level along the east elevation and to the mid-stray outshoot on the south elevation.

Photograph 07
Concrete Repair to Plinth North Elevation

- 4.2 The principal timber members can be splice repaired and the masonry walls locally rebuilt and repointed using like for like materials. It is expected that the areas of brickwork encased in concrete will require rebuilding off their existing footings. With new sole plates and splice repairs to the timber frame studwork and posts. There was no current indication of subsidence and there would be no requirements to underpin the structure.

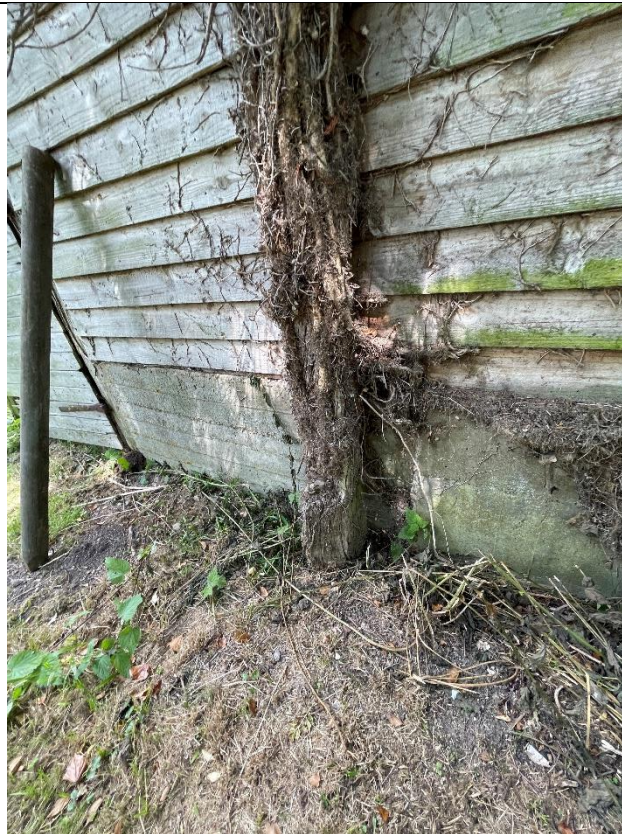
Photograph 08
Concrete Repair to Plinth South Elevation

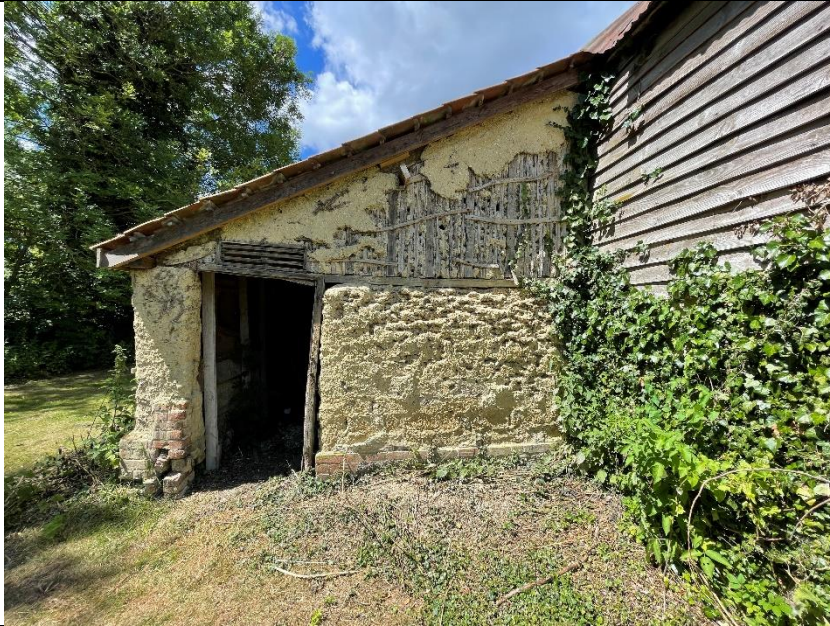
- 3.5 The shelter coat to the clay lump has eroded on the lean-to, on both the east and south elevations.
- 3.6 The southeast corner of the lean-to, the brickwork at low level has been dislodged.

Photograph 09
East Elevation of Lean-To

- 4.5 The clay lump is stable and can be repaired using patch repair and cut out for the larger areas, reusing the material onsite with additional straw to prevent shrinkage.

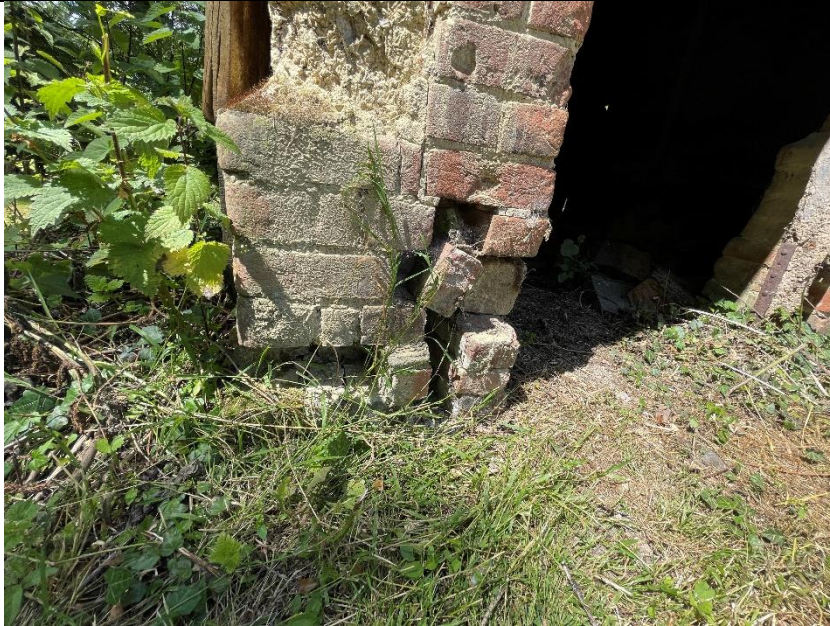
Photograph 10
Plinth South East Corner

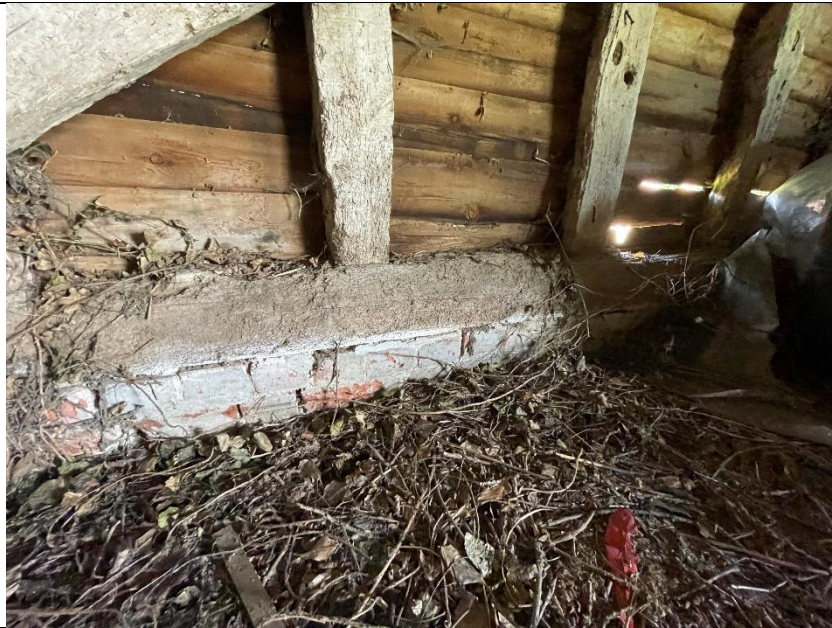
- 3.7 Internally the ground levels have been raised with the insertion of a concrete floor slab. The soleplate sits approximately 150mm above the top of slab level.

- 3.16 The sequencing and type of repairs indicate there has been decay to the sole plate, allowing the sole plate to roll, this has facilitated the racking of the roof. Concrete, poured directly around the plinth and timbers has encased the timber frame.

Photograph 11
Sole Plate West Elevation

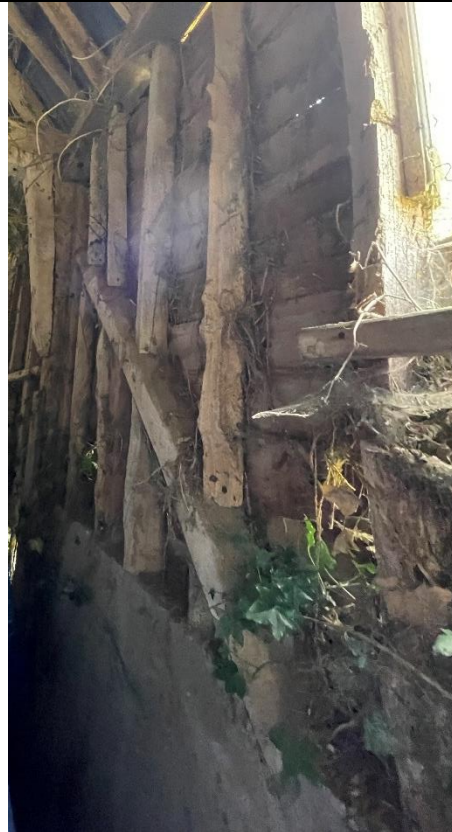
Photograph 12
Concrete Repair to Plinth North Elevation

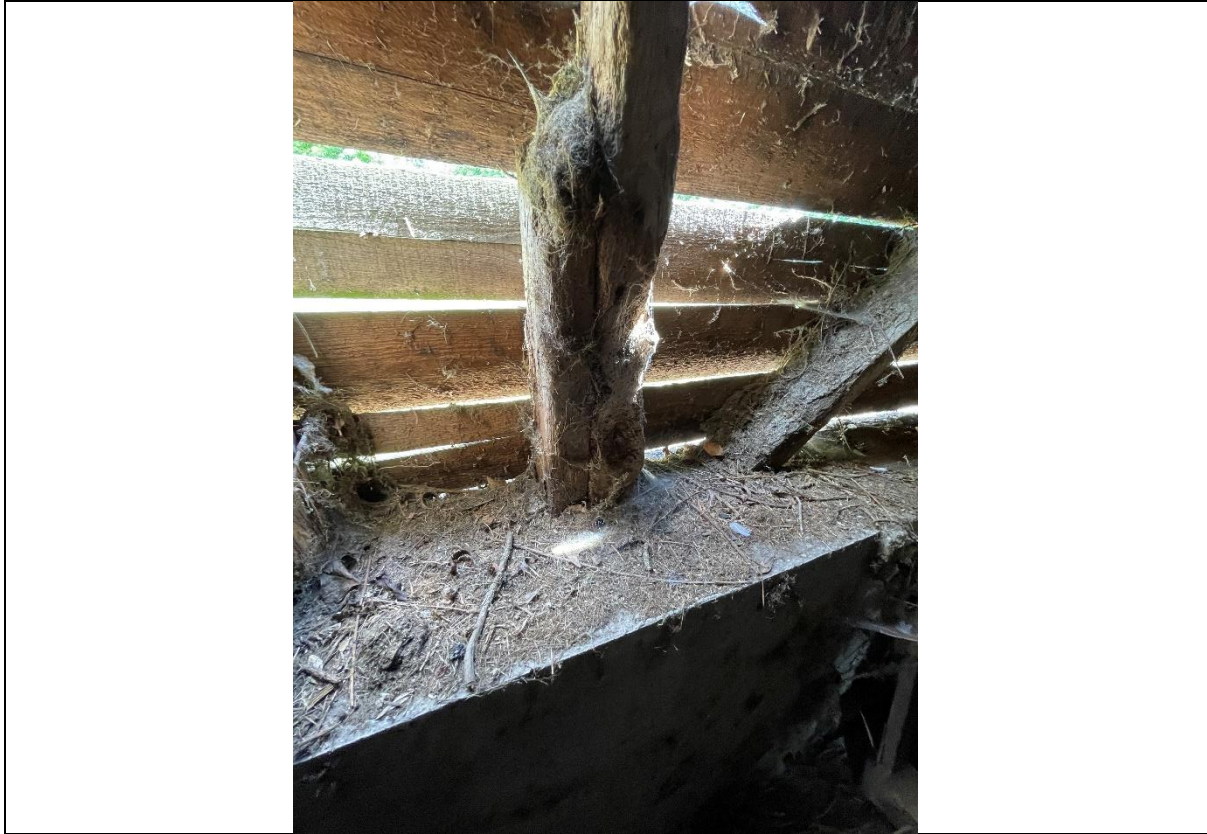
- 3.8 The concrete plinth repair has been cast around the timber frame. Partner timber repairs have been introduced alongside posts and studs.
- 3.9 The roof structure over the three western bays has been replaced. The eastern two bays, the timbers show evidence of racking.

Photograph 13
Concrete Repair to Plinth and Partner Repair to Stud East Elevation

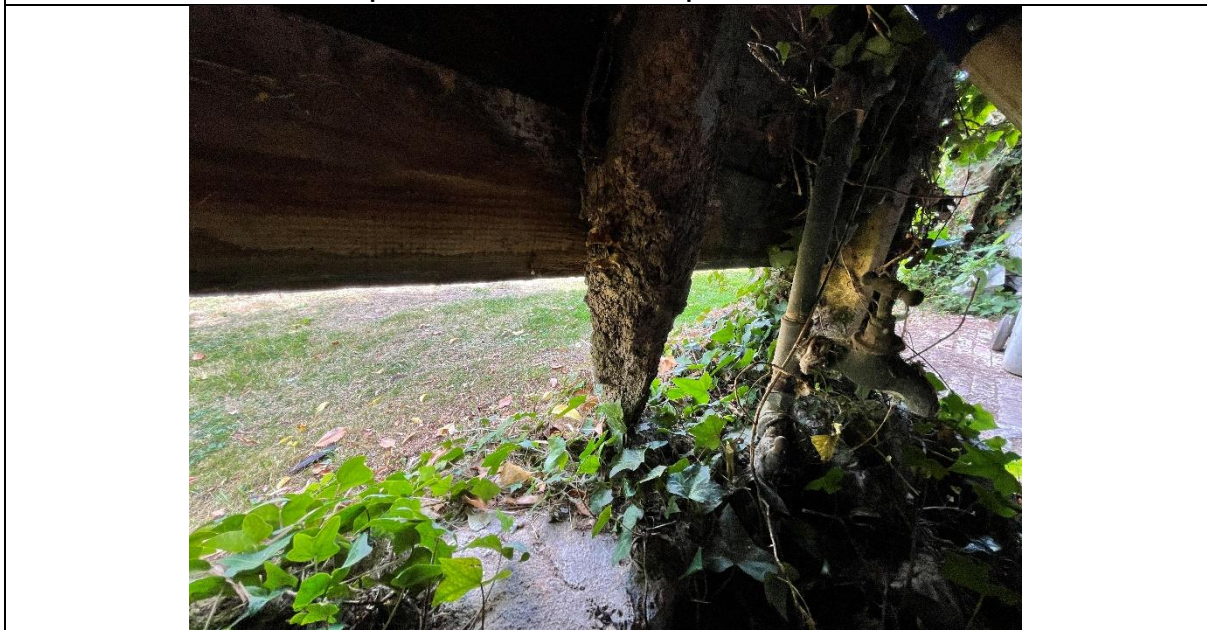
Photograph 14
Post Decay North Elevation

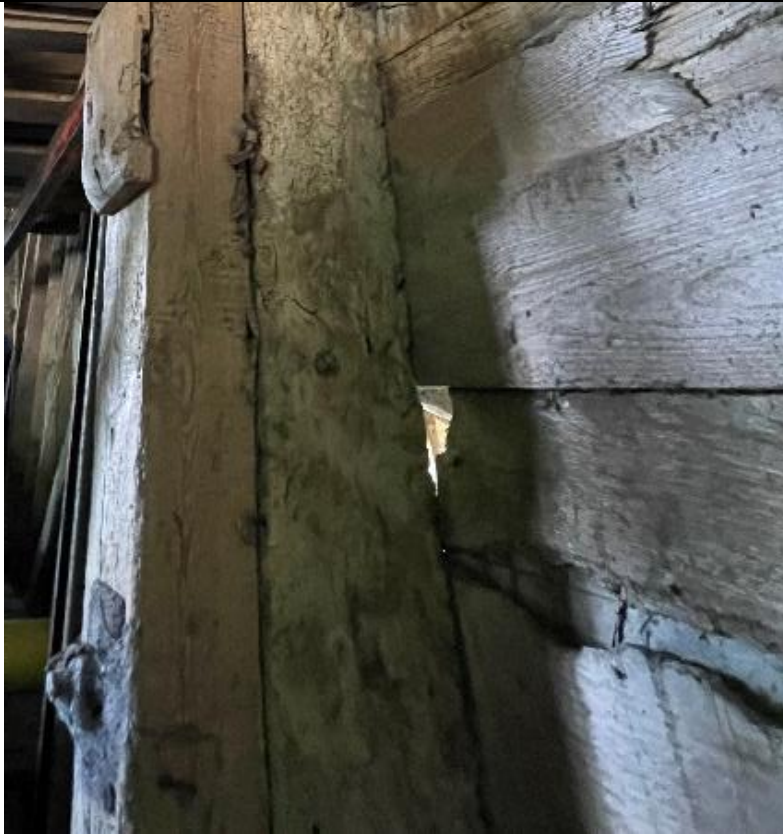
Photograph 15
Partner Repair to Post

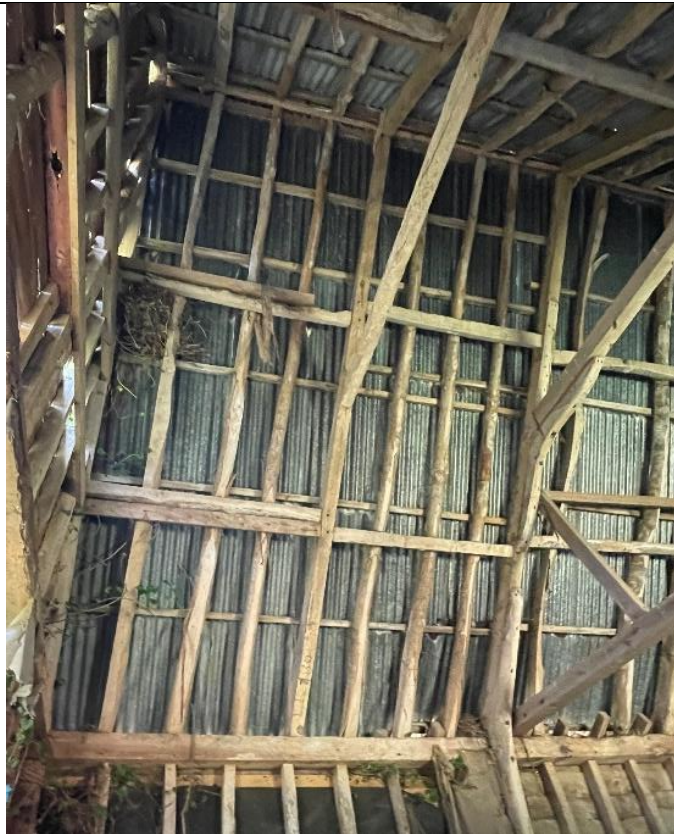
Photograph 16

Partner Repairs to Purlin

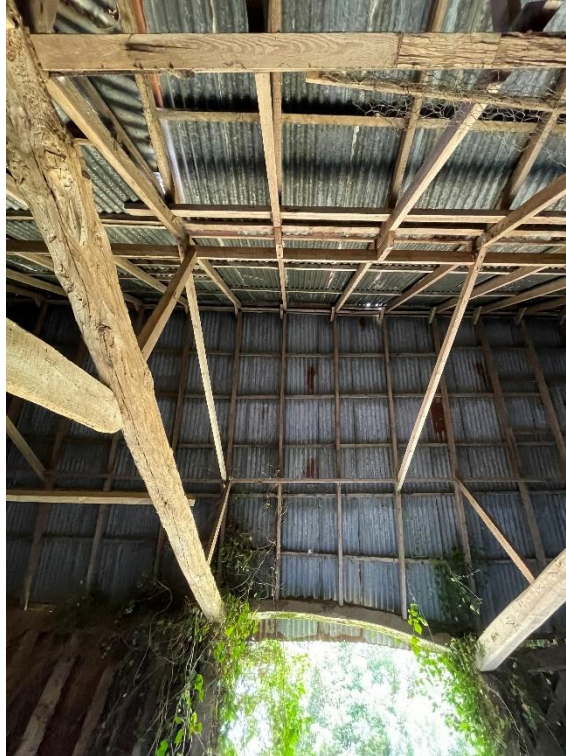
- 3.17 Additional members and ties were introduced to accommodate the movement caused by the racking of the roof with rafters to the main barn being replaced in their entirety to three of the five bays.

Photograph 17
Replacement Rafters Western Bays

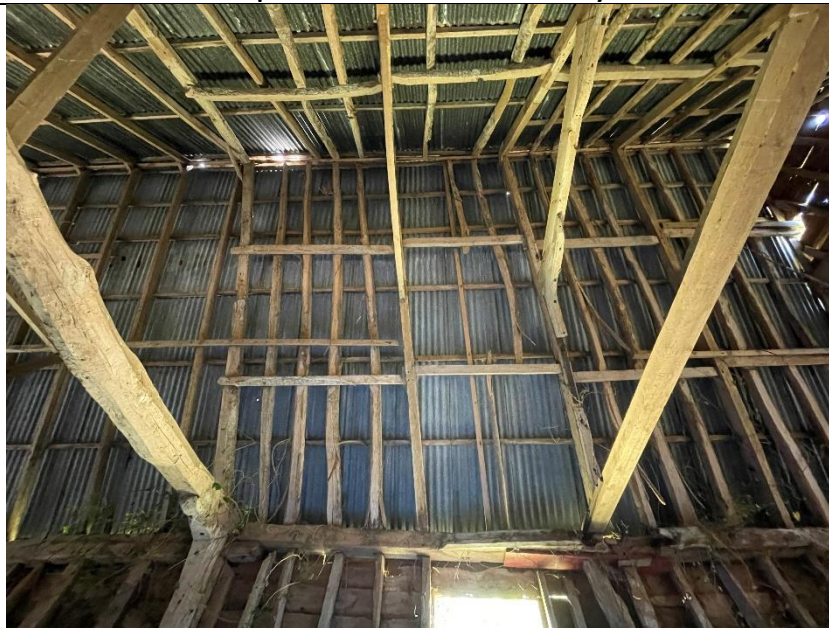
Photograph 18
Eastern Bays Racking to Roof

- 4.3 No calculations have been carried out in relation to the capacity of the existing members, some of which appear slender. It is feasible to conceive that these members can be strengthened using panelvent DWD (breathable sheathing board) this will be satisfactory to support new internal finishes and provide sheathing to resist racking forces on the timber walls. Bracing will be required to the roof structure to resist racking, and this can be achieved with additional timber braces or sheathing.

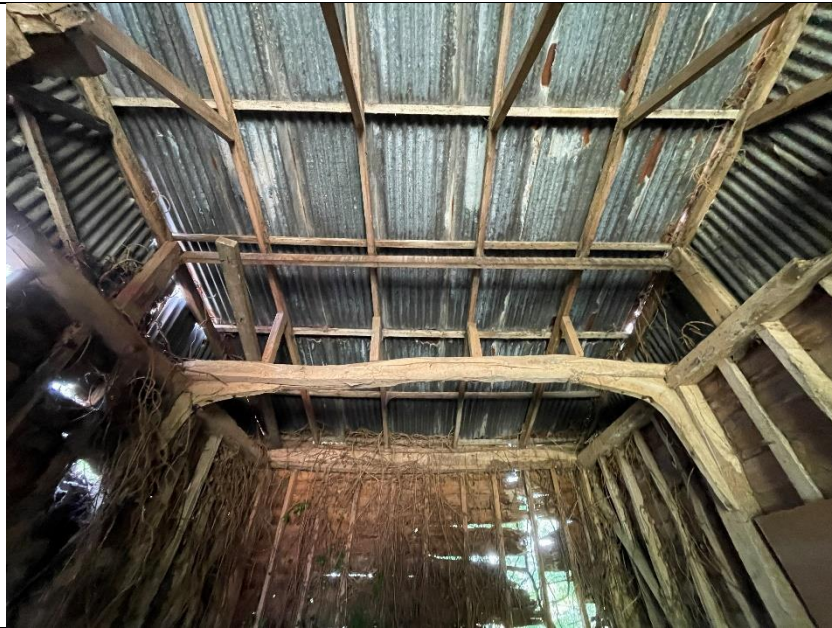
- 3.10 Additional tie beams have been provided across the barn at wall plate level.
- 3.11 The projecting bay on the south elevation the roof has been replaced.

- 3.12 At the junction of the projecting bay to the main barn roof at the valleys, prolonged water ingress has decayed the wall plate on both sides.
- 3.13 The shelter coat finish to the clay lump walls has eroded, with a panel collapsed.

Photograph 19
Projecting Bay Roof

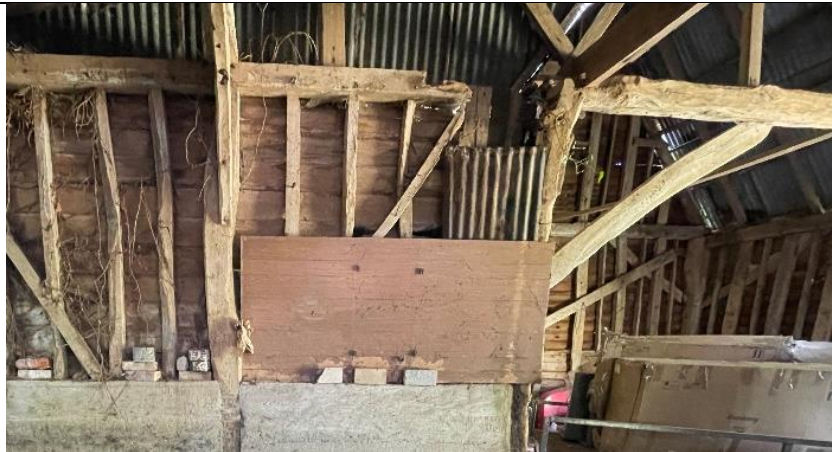
Photograph 20
West Wall of Projecting Bay

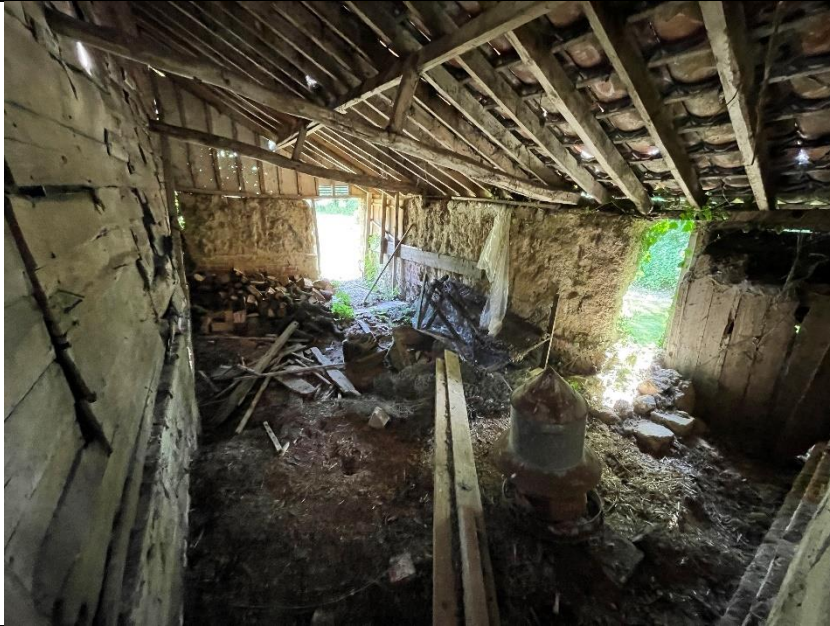
Photograph 21
Lean-To

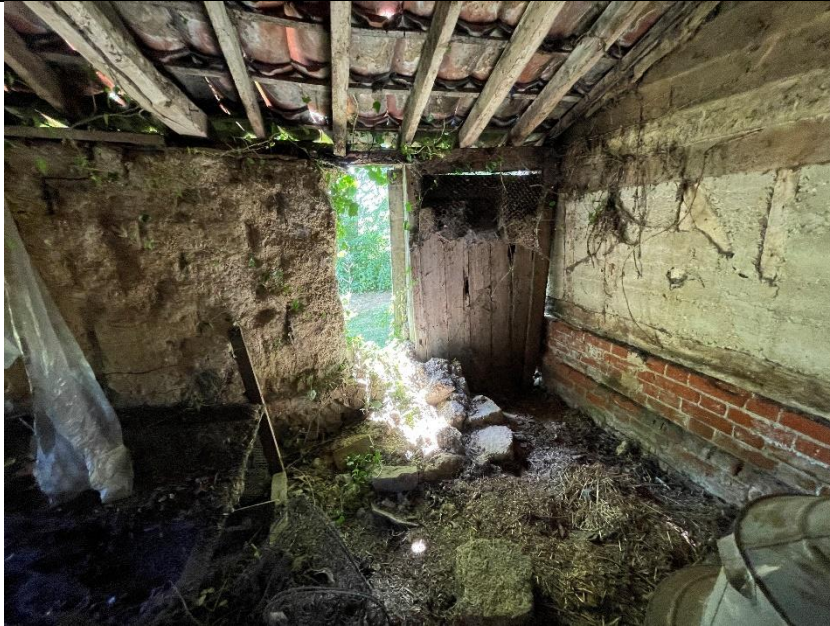
- 3.14 From within the lean-to viewing the east wall of the projecting bay the original brick plinth and timber frame is evident, the concrete repair has been applied to the timber frame above the wall plate in this location.

Photograph 22
Lean-To

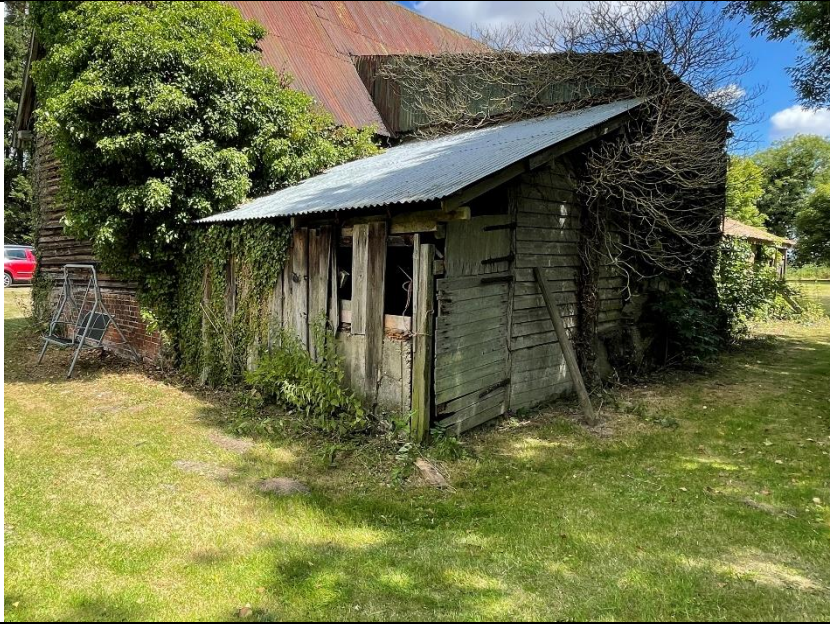
Photograph 23
Store South West Corner

- 3.21 The store on the south west corner, the roof will need to be replaced and re-pitched to provide an effective waterproof detail between the junctions of the intersecting roofs. The brick plinths have been replaced on two sides with concrete and should be rebuilt in masonry.
