Arboricultural Consultancy for Lloyds Bank

| Insured | Dr and Mrs Bennett | Address | Hawthorn House, Main Street, Nocton, LN4 2BH | | |

Scope of Report: To survey the property and determine significant vegetation contributing to subsidence damage, make recommendation for remedial action and assess initial mitigation and recovery prospects. The survey does not make an assessment for decay or hazard evaluation.

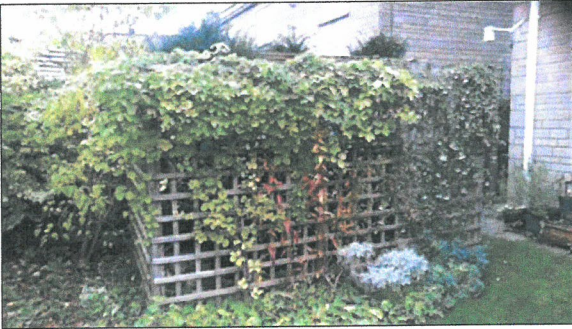
CG1 - Mixed species climbers

| Tree No. | Species | Age Cat | Approx. Height (m) | Distance to Building (m) * | Ownership | Action | Requirement |
|---|---|---|---|---|--|---|--|
| CG1 | Mixed species climbers | 1 | 1.9 | 2.5 | C - Insured | Action to avoid future risk | Maintain at broadly current dimensions by way of regular pruning. |

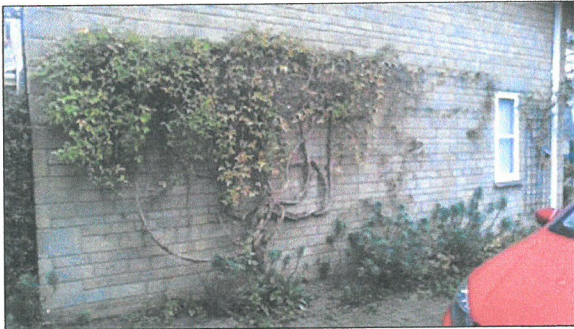
C1 - Honeysuckle

| Tree No. | Species | Age Cat | Approx. Height (m) | Distance to Building (m) * | Ownership | Action | Requirement |
|---|---|---|---|---|--|---|--|
| C1 | Honeysuckle | 1 | 2.5 | 0.2 | C - Insured | Action to avoid future risk | Maintain at broadly current dimensions by way of regular pruning. |

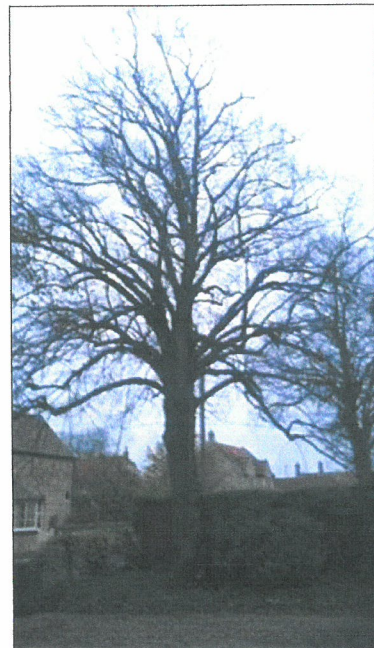
T5 - Lime

| Tree No. | Species | Age Cat | Approx. Height (m) | Distance to Building (m) * | Ownership | Action | Requirement |
|---|---|---|---|---|--|---|--|
| T5 | Lime | 3 | 17 | 9 | C - Insured | Action to avoid future risk | Crown reduce overall canopy by 30% (minimum) to achieve a crown volume reduction in line with BRE IP7/06. Maintain at reduced dimensions by re-pruning back to points of previous reduction on a 3 year (max) cycle. |

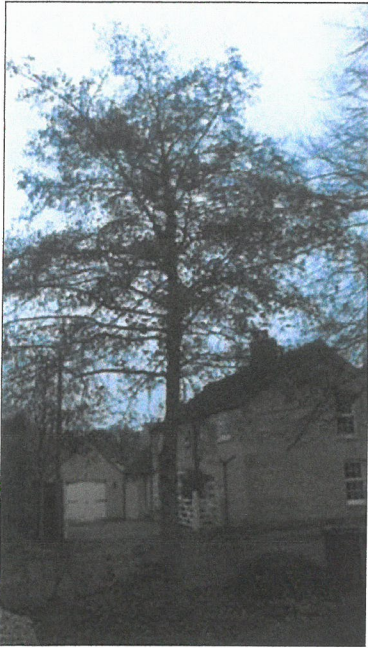
T7 - Alder

| Tree No. | Species | Age Cat | Approx. Height (m) | Distance to Building (m) * | Ownership | Action | Requirement |
|---|---|---|---|---|--|---|--|
| T7 | Alder | 1 | 9.8 | 8.3 | C - Insured | Action to avoid future risk | Maintain at broadly current dimensions by way of regular pruning. |

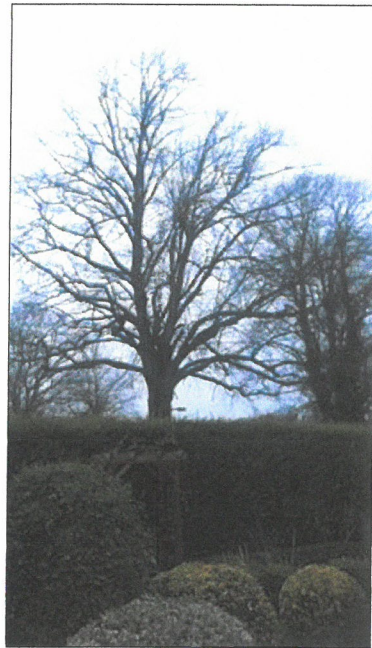
T6 - Lime

| Tree No. | Species | Age Cat | Approx. Height (m) | Distance to Building (m) * | Ownership | Action | Requirement |
|---|---|---|---|---|--|---|--|
| T6 | Lime | 3 | 17 | 12 | A - Third Party | Action to avoid future risk | Crown reduce overall canopy by 30% (minimum) to achieve a crown volume reduction in line with BRE IP7/06. Maintain at reduced dimensions by re-pruning back to points of previous reduction on a 3 year (max) cycle. |

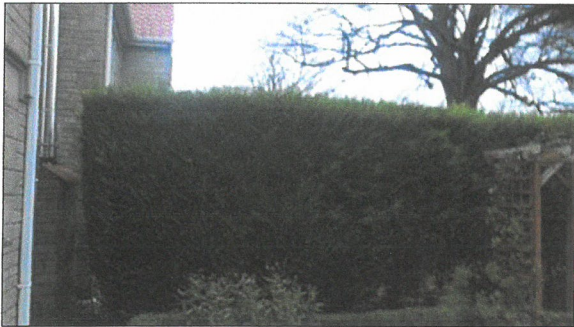
H1 - Cypress

| Tree No. | Species | Age Cat | Approx. Height (m) | Distance to Building (m) * | Ownership | Action | Requirement |
|---|---|---|---|---|--|---|--|
| H1 | Cypress | 1 | 2.5 | 1.6 | E - Boundary Veg (ownership to be confirmed) | Action to avoid future risk | Maintain at broadly current dimensions by way of regular pruning. |

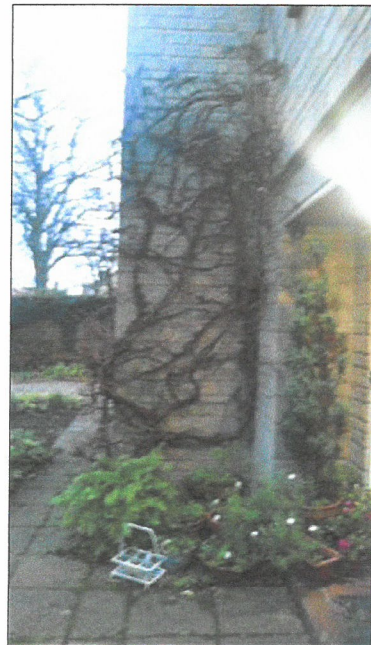
C2 - Hydrangea (Climbing)

| Tree No. | Species | Age Cat | Approx. Height (m) | Distance to Building (m) * | Ownership | Action | Requirement |
|---|---|---|---|---|--|---|--|
| C2 | Hydrangea (Climbing) | 1 | 3.2 | 0.2 | C - Insured | Action to avoid future risk | Maintain at broadly current dimensions by way of regular pruning. |

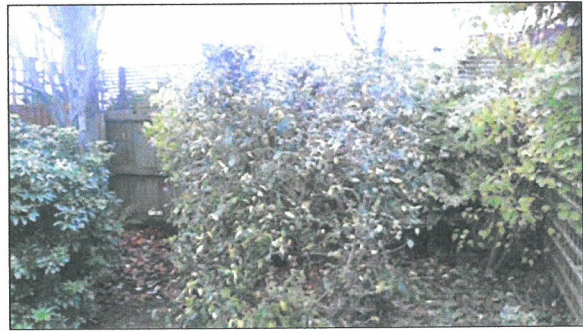
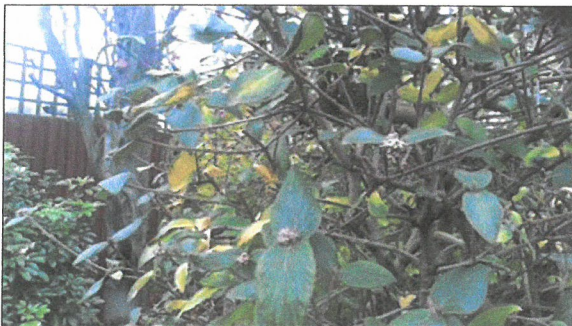
S1 - Shrub

| Tree No. | Species | Age Cat | Approx. Height (m) | Distance to Building (m) * | Ownership | Action | Requirement |
|---|---|---|---|---|--|---|--|
| S1 | Shrub | 1 | 2 | 4.45 | C - Insured | Action to avoid future risk | Maintain at broadly current dimensions by way of regular pruning. |

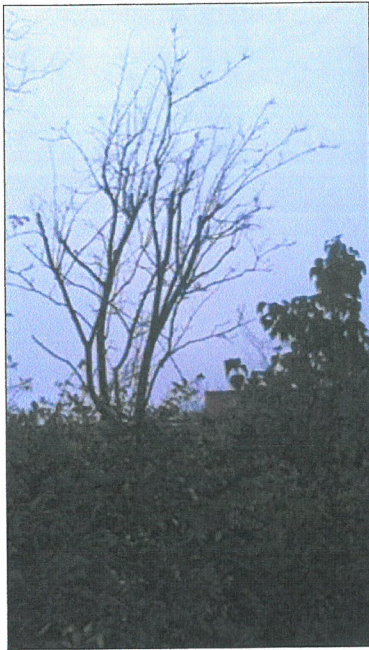
T1 - Rowan

| Tree No. | Species | Age Cat | Approx. Height (m) | Distance to Building (m) * | Ownership | Action | Requirement |
|---|---|---|---|---|--|---|--|
| T1 | Rowan | 1 | 5.8 | 6.1 | C - Insured | Action to avoid future risk | Maintain at broadly current dimensions by way of regular pruning. |

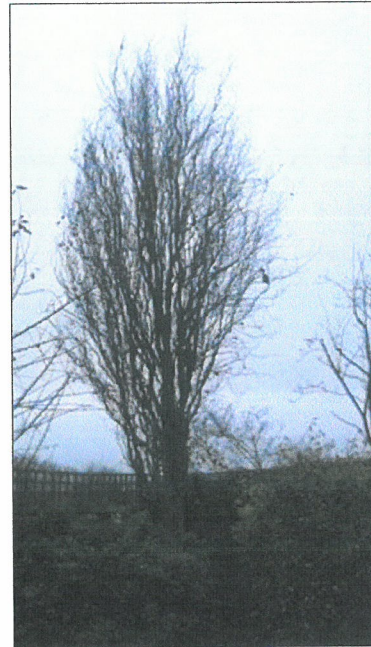
T2 - Beech

With due regards to species profile, size and proximity, the Beech (T2) is considered the dominant feature proximate to the focal area(s) of movement and accordingly, where vegetation is confirmed as being causal, we have identified it as the primary cause of the current subsidence damage.

| Tree No. | Species | Age Cat | Approx. Height (m) | Distance to Building (m) * | Ownership | Action | Requirement |
|---|---|---|---|---|---|---|---|
| T2 | Beech | 1 | 11.2 | 8.2 | C - Insured | Remove | Remove close to ground level and treat stump to inhibit regrowth. |

Consequently, we have advocated the complete removal of T2 as it will offer the most certain arboricultural solution likely to restore long-term stability.

This beech has been removed, with NKDC approval.

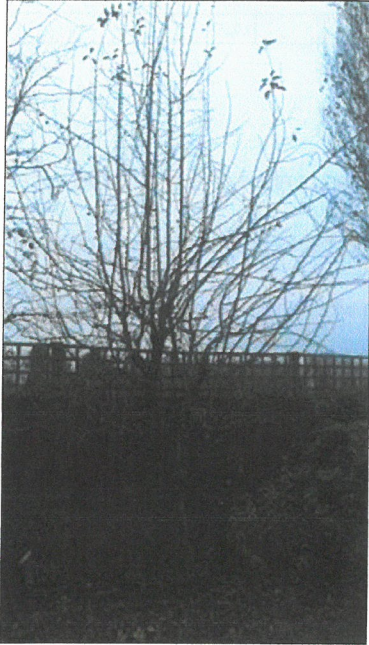
T3 - Apple (Crab)

| Tree No. | Species | Age Cat | Approx. Height (m) | Distance to Building (m) * | Ownership | Action | Requirement |
|---|---|---|---|---|--|---|--|
| T3 | Apple (Crab) | 1 | 2 | 7.1 | C - Insured | Action to avoid future risk | Maintain at broadly current dimensions by way of regular pruning. |

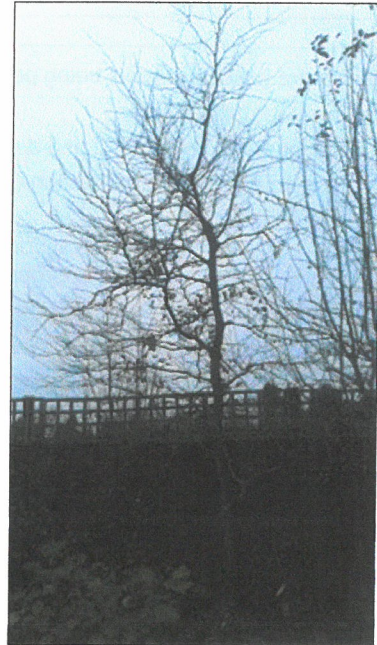
T4 - False Acacia

| Tree No. | Species | Age Cat | Approx. Height (m) | Distance to Building (m) * | Ownership | Action | Requirement |
|---|---|---|---|---|--|---|--|
| T4 | False Acacia | 1 | 7.5 | 7.6 | C - Insured | Action to avoid future risk | Do not allow to exceed current dimensions by way of regular pruning. |

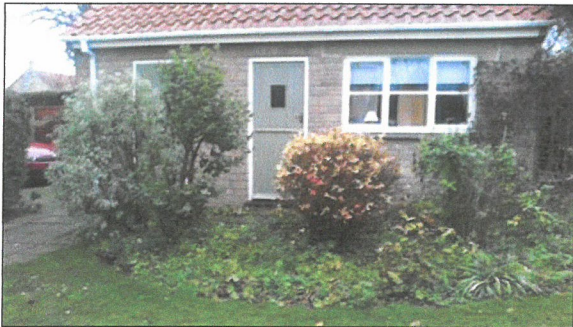
SG1 - Mixed species shrubs

| Tree No. | Species | Age Cat | Approx. Height (m) | Distance to Building (m) * | Ownership | Action | Requirement |
|---|---|---|---|---|--|---|--|
| SG1 | Mixed species shrubs: including pittosporum, viburnum, spirea, hypericum. | 1 | 2 | 1.9 | C - Insured | Action to avoid future risk | Maintain at broadly current dimensions by way of regular pruning. |

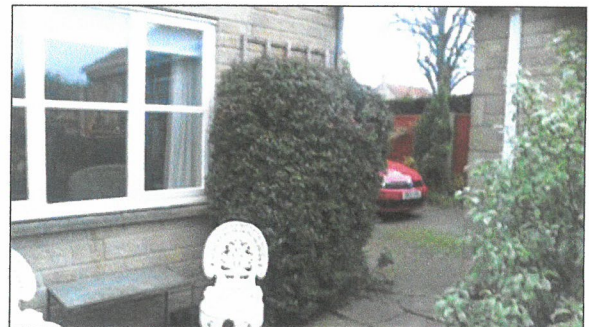
S2 - Pyracantha

| Tree No. | Species | Age Cat | Approx. Height (m) | Distance to Building (m) * | Ownership | Action | Requirement |
|---|---|---|---|---|--|---|--|
| S2 | Pyracantha | 1 | 2 | 0.1 | C - Insured | Action to avoid future risk | Maintain at broadly current dimensions by way of regular pruning. |
