# Arboricultural Impact Assessment

Edelweiss Church Close Abbotts Ann SP11 7BH

Survey Date: 22<sup>nd</sup> March 2021 Report Date: 15<sup>th</sup> April 2021

Project no: 1658

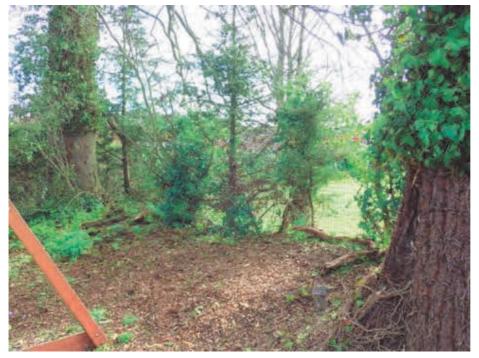
- 5.1.3 A hedge of Leyland cypress, sycamore and yew (G6) runs along a section of the southern boundary. The hedge is patchy and providing a low level of screening from the adjacent public right of way.

Low quality hedge, G6, along south side of site. Self sown sycamore, Leyland cypress and yew. The section of yew is providing a dense screen to the adjacent PROW, and has the potential to provide nesting sites. The other species will not thrive in shade conditions below mature tree canopies.

- 6.6 Provided the recommendations in this report are followed, the arboricultural impact of this development on existing trees will be minimal. The proposed replacement of sections of the existing boundary hedge will improve site screening and will provide a more sustainable hedge.

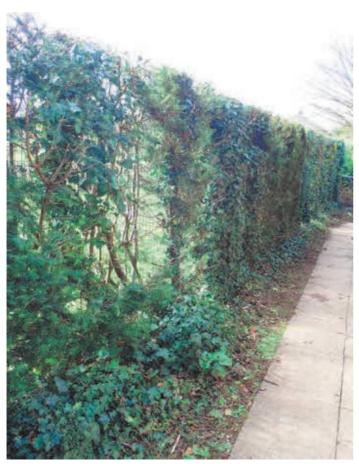
Thin section of G6 formed from tightly clipped Leyland cypress and sycamore stems.

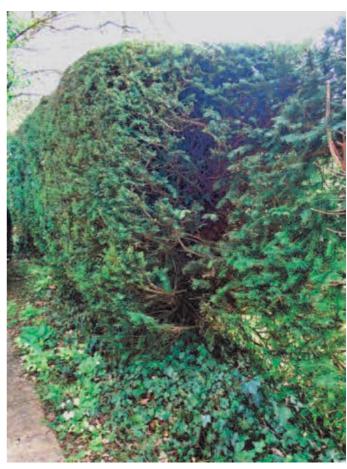
Good quality section of G6 formed from yew.
