JP Chick & Partners Ltd  
Consulting Civil & Structural Engineers

**Stable Building  
The Old Rectory  
Drinkstone  
Suffolk**

**STRUCTURAL INSPECTION REPORT**

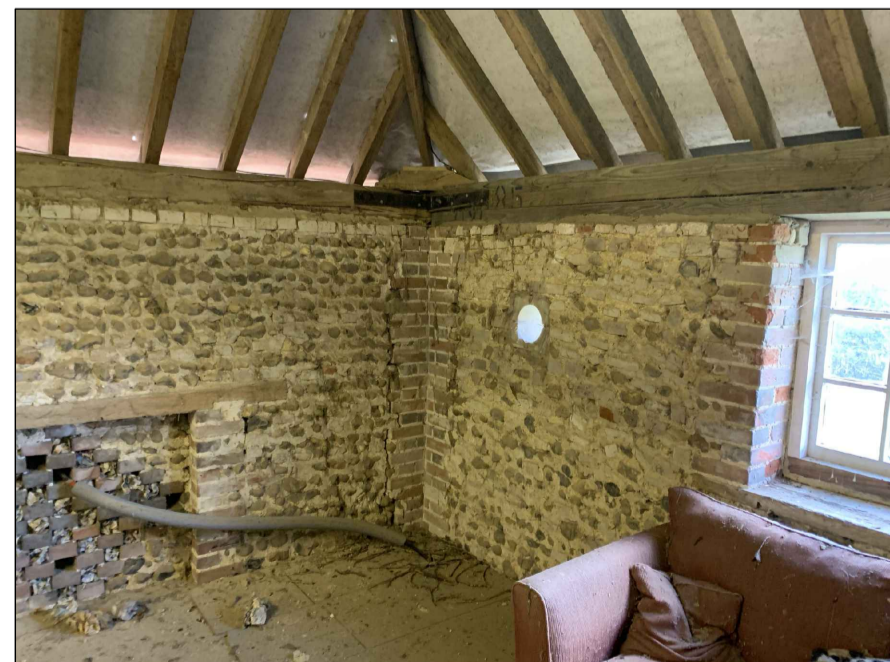
CRACKING LOCATION 3

4.1.4 Cracking has also occurred to the flint wall at first floor to the northeast corner which has similar characteristics to the cracking located at the entrance of the stable building. The cracking originates from wall plate level past the mezzanine floor. Due to storage being located within the stable at ground floor we were unable to determine whether this crack continues to the plinth wall. The cracking is 20mm to 30mm wide.

- 6.2 The cracked flint walls are to be repaired with Helifix Helibar, or similar, which is to tie the new face back to the existing core. The installation method is to be in accordance with manufacturers specification. Given the specialist nature of the works, a suitably experienced and competent contractor is to be used.

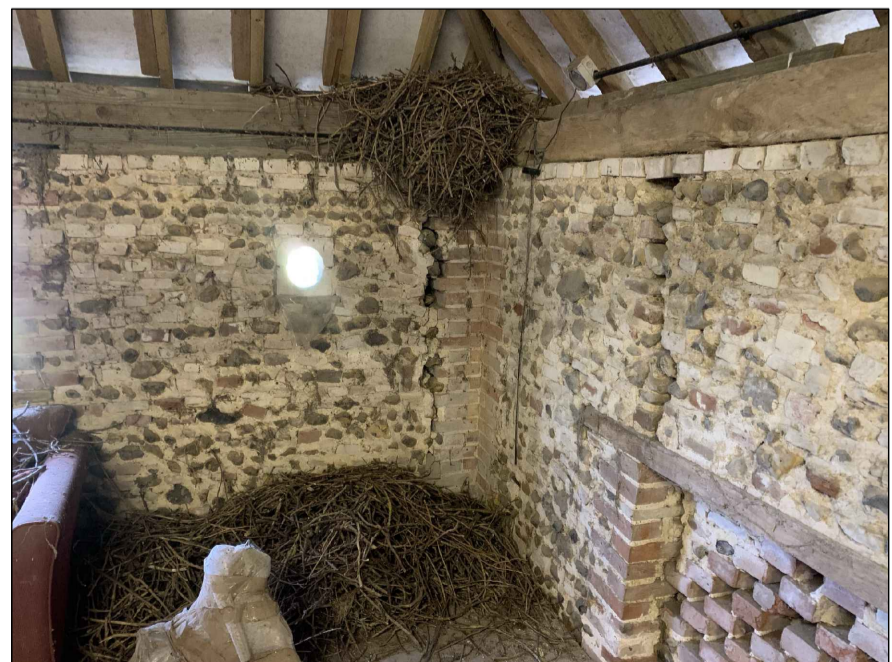
CRACKING LOCATION 4

4.1.6 The north-west corner of the stable building has also suffered from cracking. The cracking to this corner of the building, similar to the other, is vertical in nature but does not originate from the wall

plate. This cracking is approximately 5mm to 10mm wide. The northwest corner of the barn, at wall plate level, has had a steel corner strap installed.

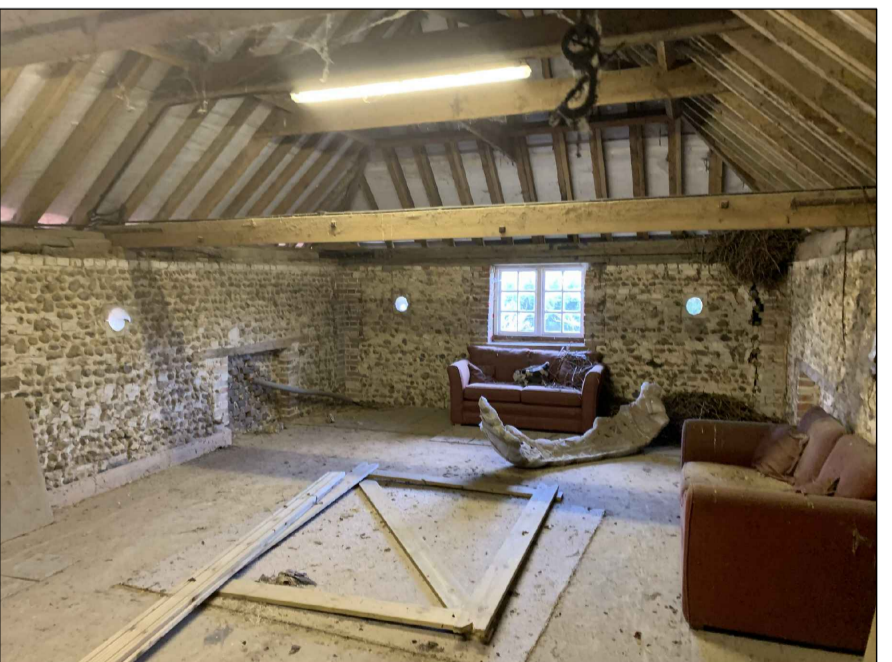
ROOF STRUCTURE

- 4.1.7 The roof structure is a hand cut hipped roof. The rafters to the roof are in good condition with no signs of deflection, degradation, or infestation. The rafters bear onto the wall plate which is also in a good condition and free of any significant defects. Purlins are located at mid-level throughout the roof structure and is supported by collars. The purlins are undersized which has resulted in lateral forces causing roof spread. The east and west wall plates are tied together with timber ties.

- 6.3 The current roof structure to the stable building is in a reasonable condition however it has suffered from roof spread. The rafters and ridge do not show significant signs of deflection or deterioration. We consider that the rafters will be suitable for incorporation into a future development subject to final design review and calculation check for loadings. These rafters may require strengthening if they are deemed to be undersized. Remedial works will be required to prevent further roof spread which will include upgrading / augmenting the existing purlins as well as the works stated in section 6.1 of this report.

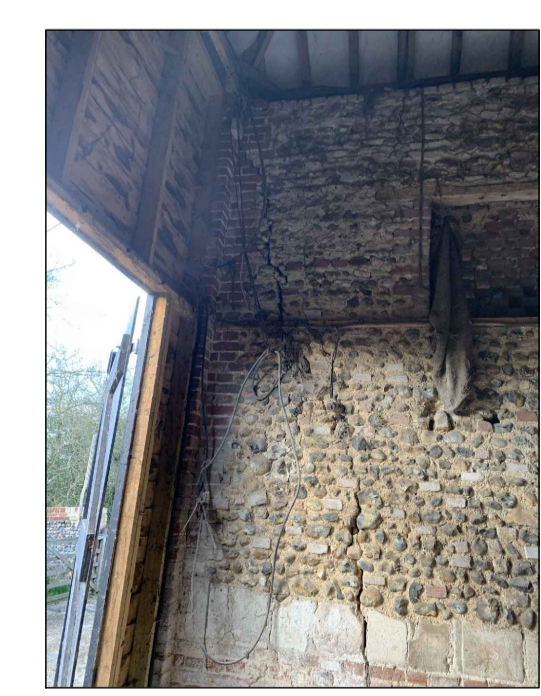
CRACKING LOCATION 1

4.1.2 The flint walls to the entrance of the stable building have suffered from cracking. The cracking is vertical in nature and originates from the bottom of the plinth wall to the wall plate. The crack to the flint walls was approximately 30mm to 40mm. It is noted that the external flint walls to this area do not show any signs of cracking or movement and are in good condition.

- 6.1 Based upon our inspection we consider the cracking that has occurred to the flint walls has been caused by roof spread. The roof spread has primarily affected the corners of the building as this is where the hips are located. The cracking appears to have been limited in the northwest corner through the installation of steel corner strap which is fixed to the two wall plates. It is recommended that where the roof spread has occurred to the entrance that a feature truss is installed to prop the roof apex and tie the hip roof together. Where the cracking has occurred to the northeast and northwest, we recommend dragon ties or similar are installed to prevent further roof spread.
