Phase I Geo-Environmental Site Assessment

Rookery Farm, Rookery Farm Lane, Basingstoke, RG26 5HW

March 2023

Omnia ref: A11764/1.1

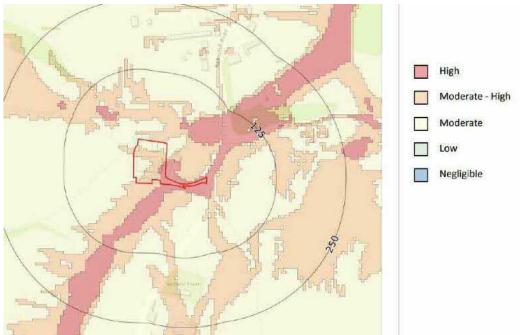
Figure 4-1 Groundwater Flooding Risk – (GS-9380197. Ordnance Survey Licence 100035207)

The Groundsure report indicates that the risk of groundwater flooding on site is designated as high within the southeast, moderate to high within the centre of site, and moderate in the north and west of site. This pattern of groundwater flooding risk appears to correlate with local topography with topographic contours suggesting the presence of a northeast to southwest and a west-northwest to east-southeast aligned dry valleys with the area of highest risk associated with the confluence of these two features. The groundwater flooding risk for the site is depicted in Figure 4-1 below.

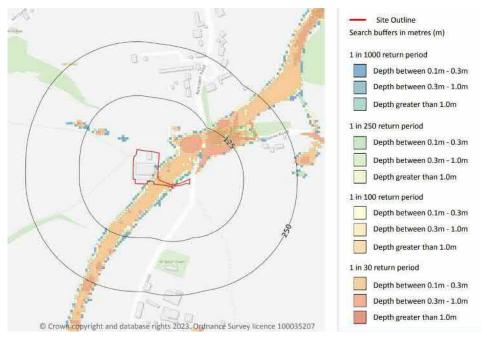
Figure 4-2 Surface Water Flooding Risk-(GS-9380197. Ordnance Survey Licence 100035207)

The majority of the site is not at risk from surface water flooding. However, the south-eastern extent is considered to be at risk. The ratings range from a 1 in 1000 years return period with a 0.1 –0.3m flood event, to a 1 in 30 year risk on site of 0.30 - 1.0m. This is shown in Figure 4-2 overleaf.

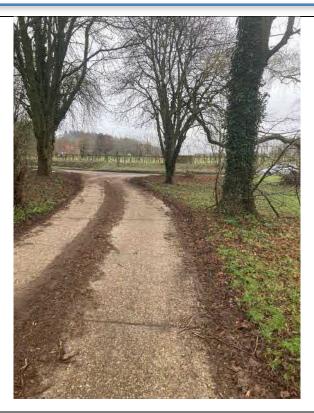
At the time of site walkover, the access route comprised a private concrete road off Rookery Farm Lane to the east (Photographs 1-3). This was noted from superficial visual inspection to be in good condition. The road was also an access point for a residential property adjacent to the east of the site. The Rookery Farm entrance was marked by a metal gate with pedestrian access either side of the gate (Photograph 4). The access route led onto a yard area, which contained 5 main barns and a stable block (Photograph 5, Figure 3.0 within Appendix III).

Photograph 1: Access road.

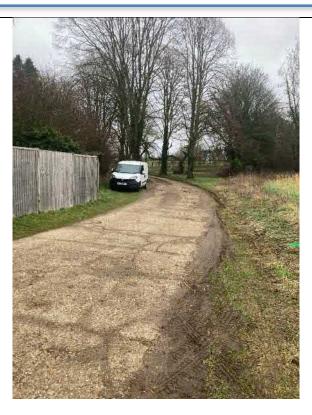
Photograph 3 –Concrete access road

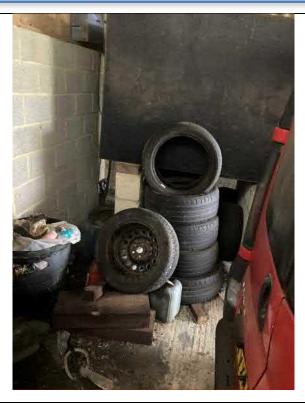
Photograph 15 –Behind the vehicles in the garage area of Barn 5 including Tank 1

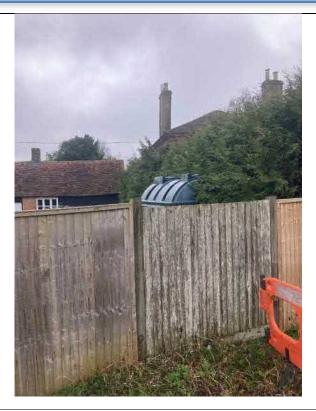
Tank 2 was situated adjacent to the eastern site boundary, within the garden of the neighbouring residential property. The tank was green plastic, and the capacity was noted to be 500L. It was suspected that the tank was a kerosene oil tank used by the residential property, and appeared to be in use. It was unclear if the tank was bunded however it was raised.

Photograph 28 –Tank 2 situated off-site to the east

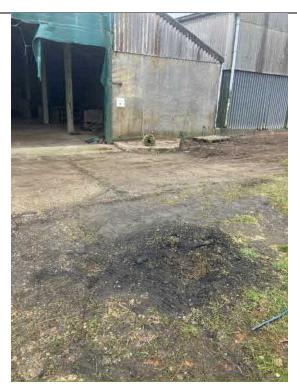
To the south of the stable block was a burnt area approximately 1.5m x 1.5m showing scorch marks on the surface (Photograph 29). To the east of the stable block was an area of grass, which contained discarded straw on it and wooden fencing around it. To the west of the stable block was an area of mostly discarded materials including empty containers, disused animal feeders, empty plastic wrappings and an old trailer with general household waste within it (Photographs 30-31).

Photograph 29 –Burnt area south of the stables

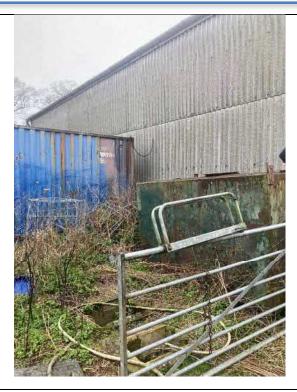
Tank 3 was identified west of the stable block and had a capacity of 500L and was constructed of green metal in a rusted condition and was not bunded. The tank was empty, however after visual inspection was suspected to have previously contained diesel.

Photograph 30 –Discarded materials to the west of the stables including Tank 3 and the shipping container

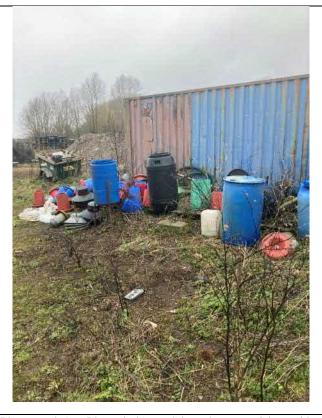
Photograph 31 –Discarded materials to the west of the stables

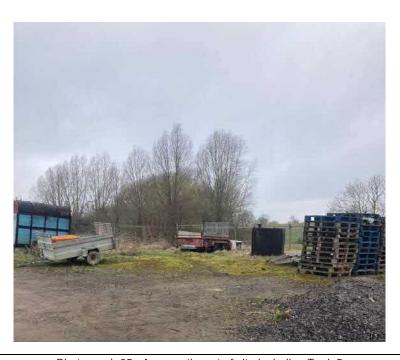
Tank 5 was located approximately 10m west of the site, and was noted to be empty. The contents of this tank were unknown and there was no labelling. It was constructed of black metal that has small amounts of rusting and was not raised or bunded but placed straight on top of the ground.

Photograph 35 –Area northwest of site including Tank 5
