Tree Survey BS5837:2012

Client: Marc Dewing

Site: 52 Woodlands Way, Mildenhall, Bury St Edmunds, IP28 7JF

Scope: Arboricultural Survey to BS5837:2012
with Arboricultural Impact Assessment,
Arboricultural Method Statement &
Tree Protection Plan.

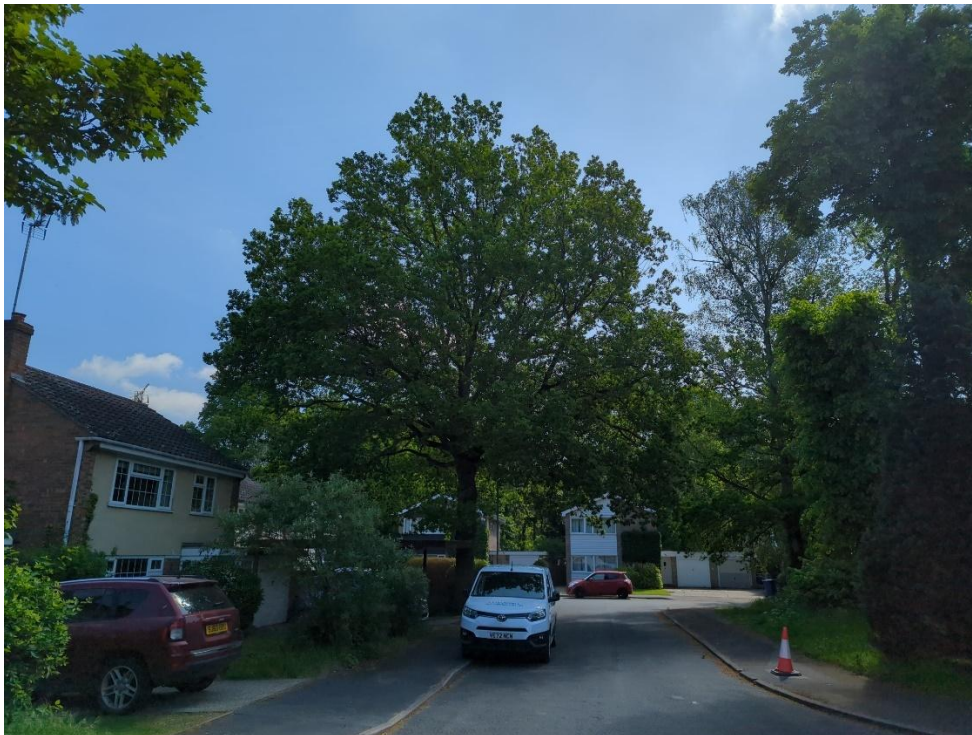
Photo 1 overview of tree from the north.

Recommended works for T1- Crown lift to 5 metres for vehicle access.

Crown reduction by 2m from the top and between 1-2m on the sides to match the shape, ensuring a minimum 1.5m gap to any proposed new structure.

Remove dead wood (major greater than 25mm).

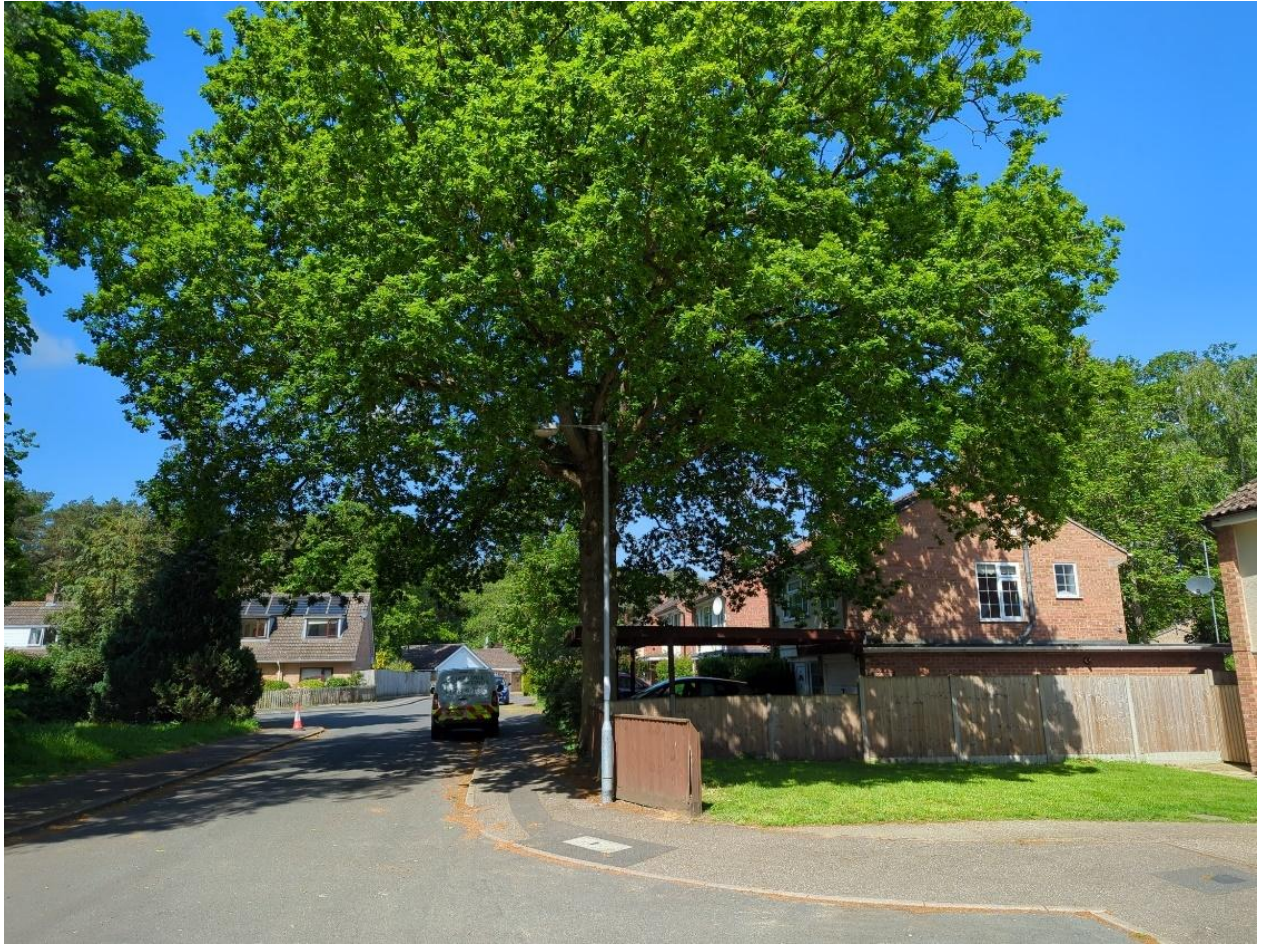
Photo 2 Overview of tree from the South.

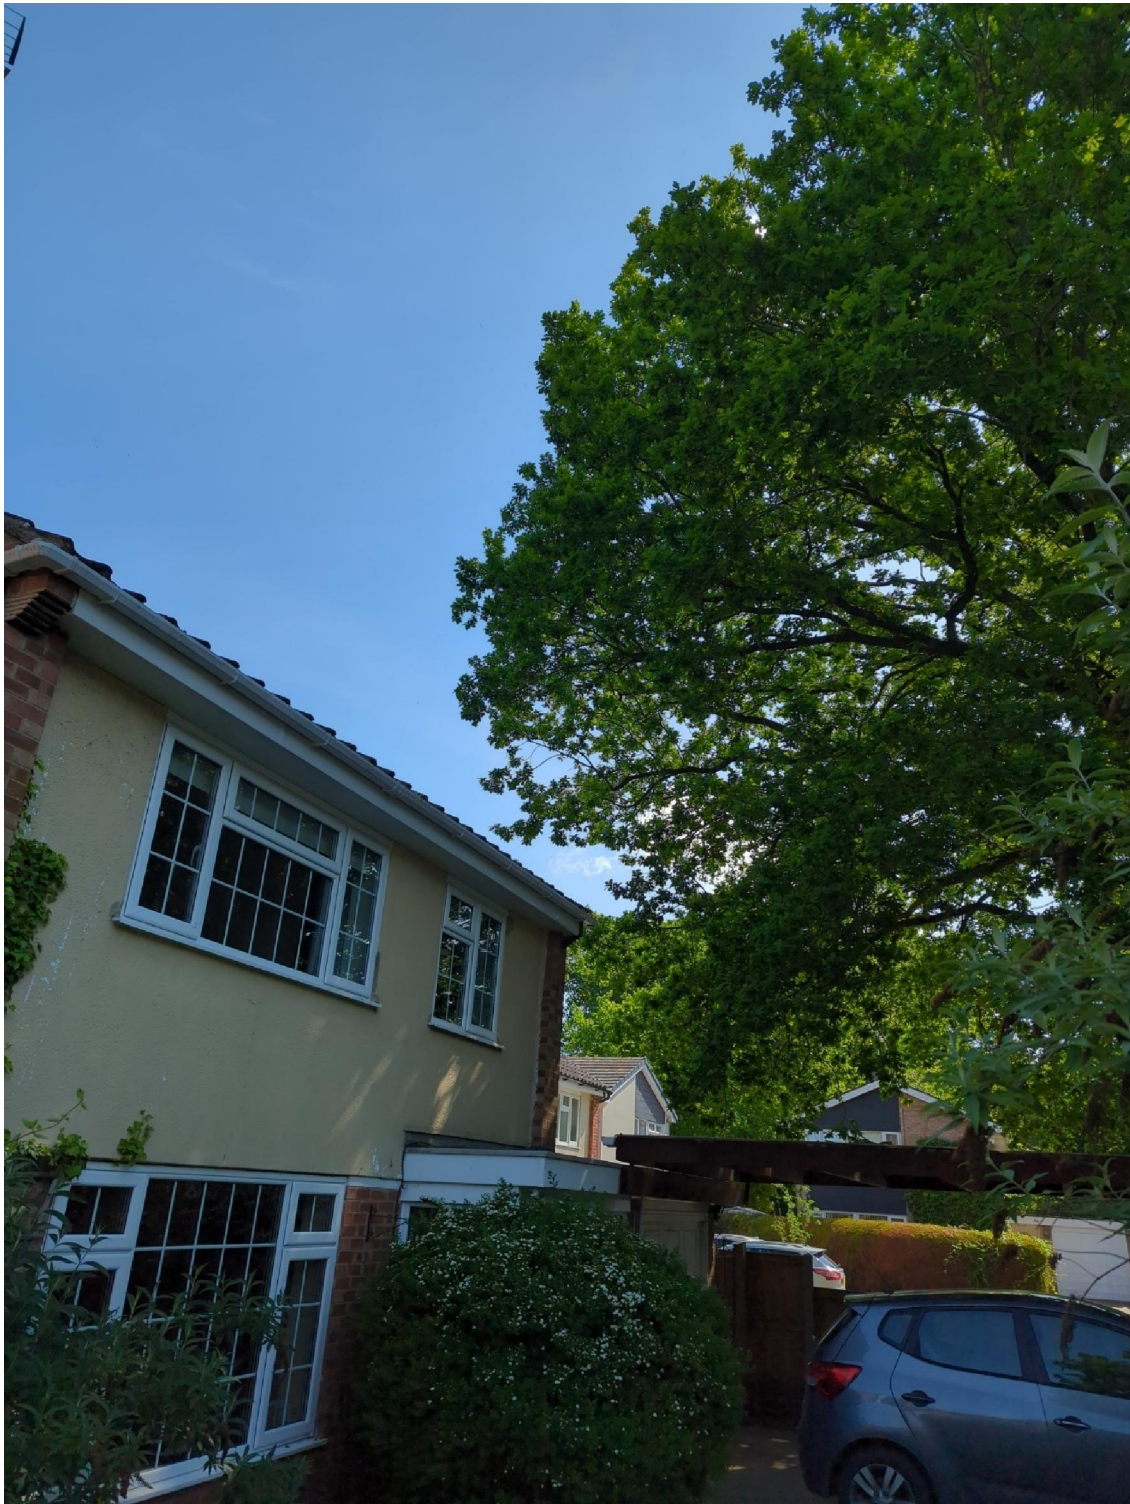
T1 will require a crown reduction to allow the proposed structure to be built and I would recommend to crown reduce the rest of the tree along with a crown lift as the canopy is now exceptionally large and is beginning to hang low over the road which may lead to vehicle strikes for materials being delivered. Major deadwood has been seen within the crown and should be removed for the safety of the public and anyone who will be working on or visiting the site.

Photo 3 Closer view of tree and building.

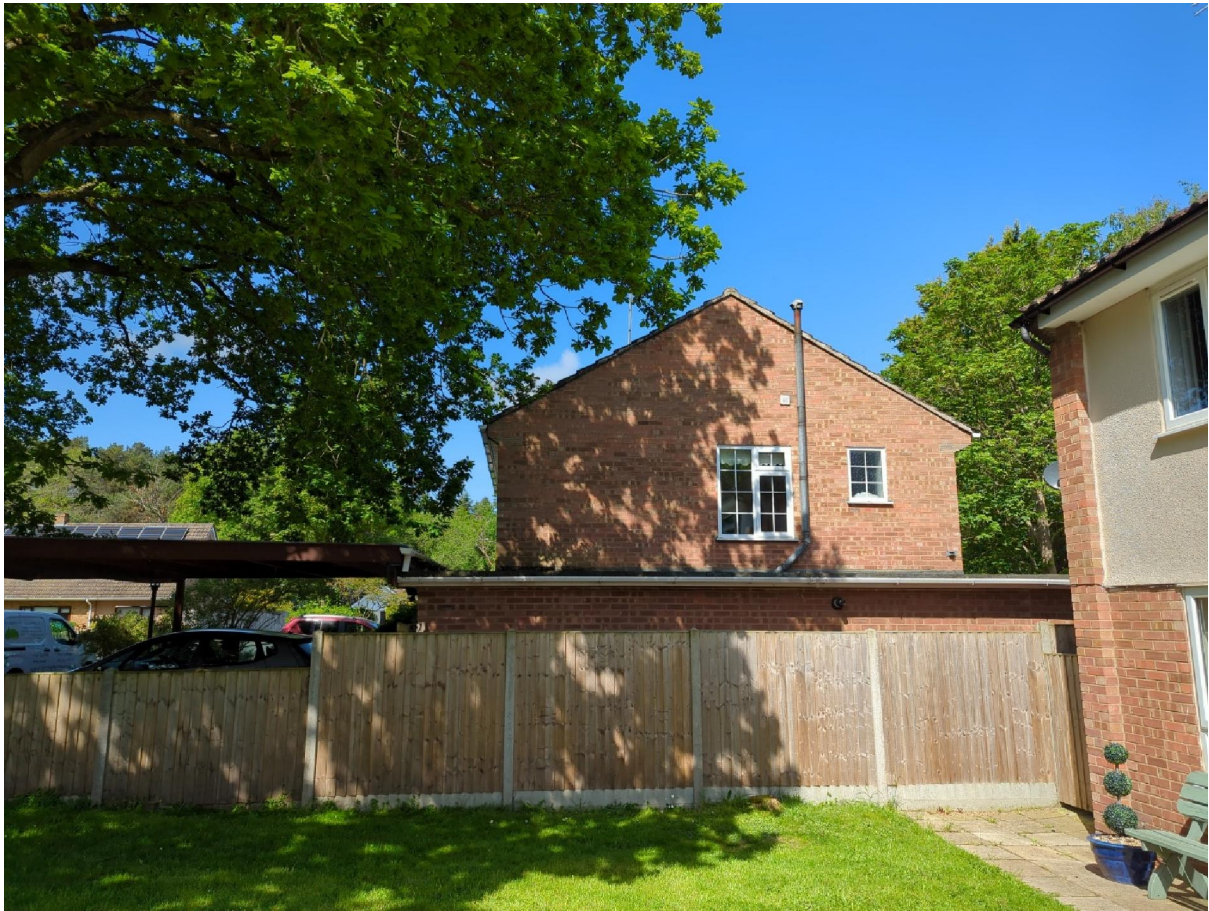
Photo 4 view from the South over area of proposed new structure.

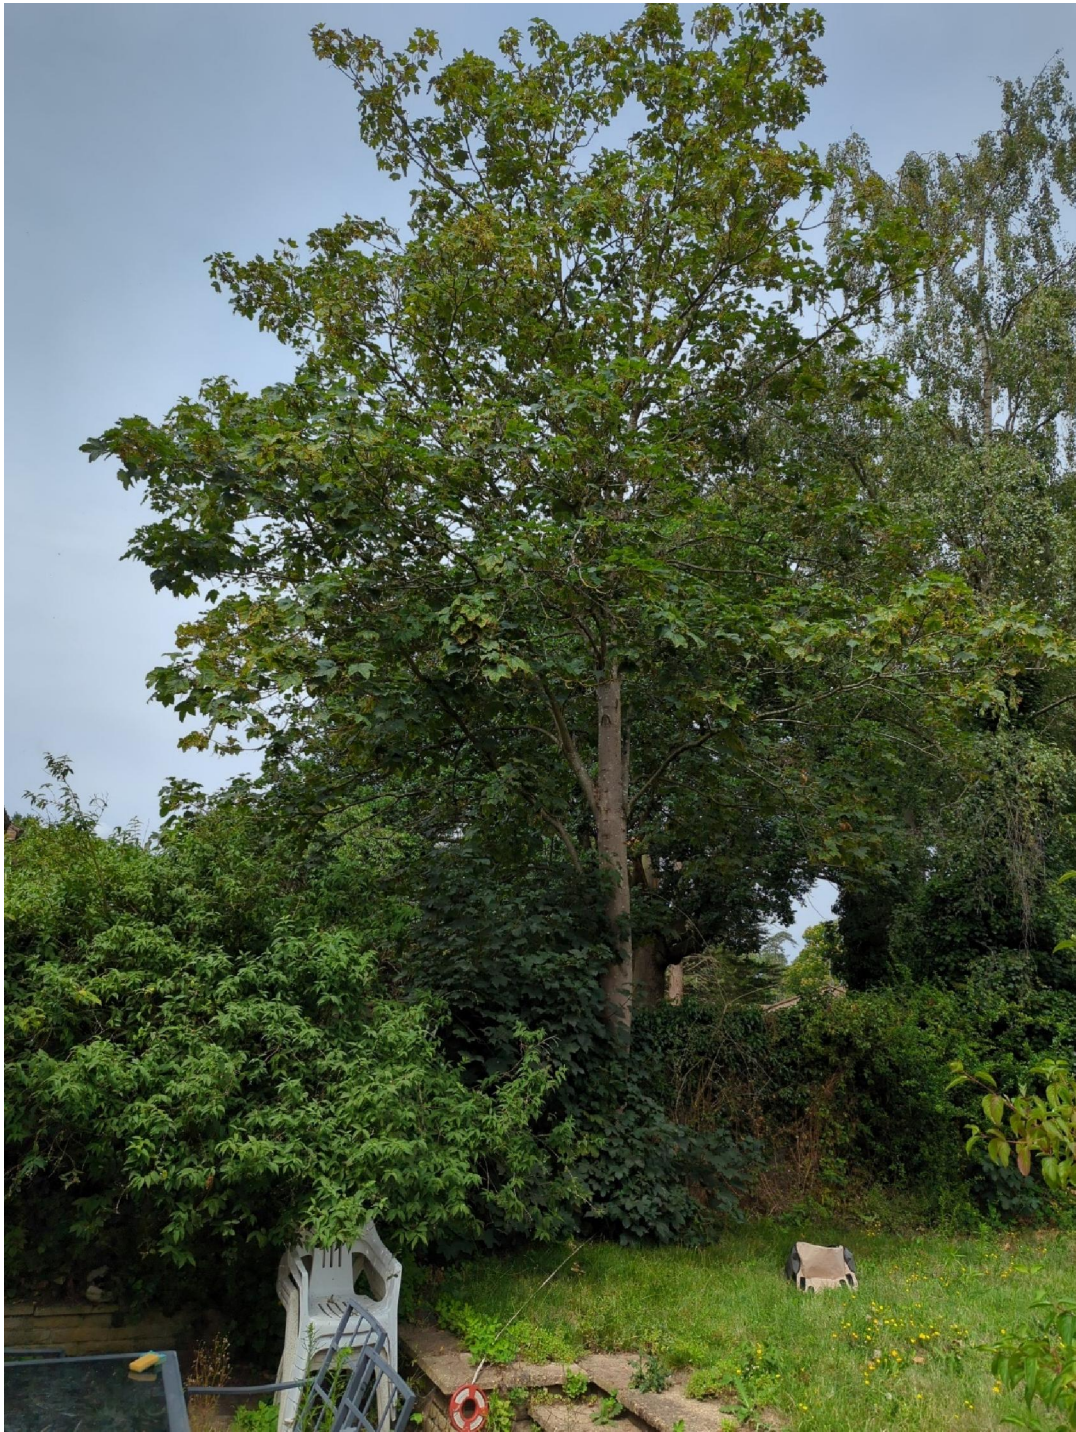
Photo 5 T2 at rear of the building on the northern boundary line.

T002	Sycamore (<i>Acer pseudoplatanus</i>)	11	300	3	3	3	3	4		<p>Root plate not showing signs of disturbance. Stem has historical pruning wounds with good occlusion. Crown breaks at approx. 3m above ground level and has good form and vitality. Tree is located on the boundary line.</p>	<p>Pre construction: No action required.</p> <p>During construction: Protect trees with protective barriers - as shown on plans.</p> <p>Post construction: No action required.</p>	20+ Years	B1	Radius: 3.6m. Area: 41 sq m.

T2 will not require any works to facilitate the development.

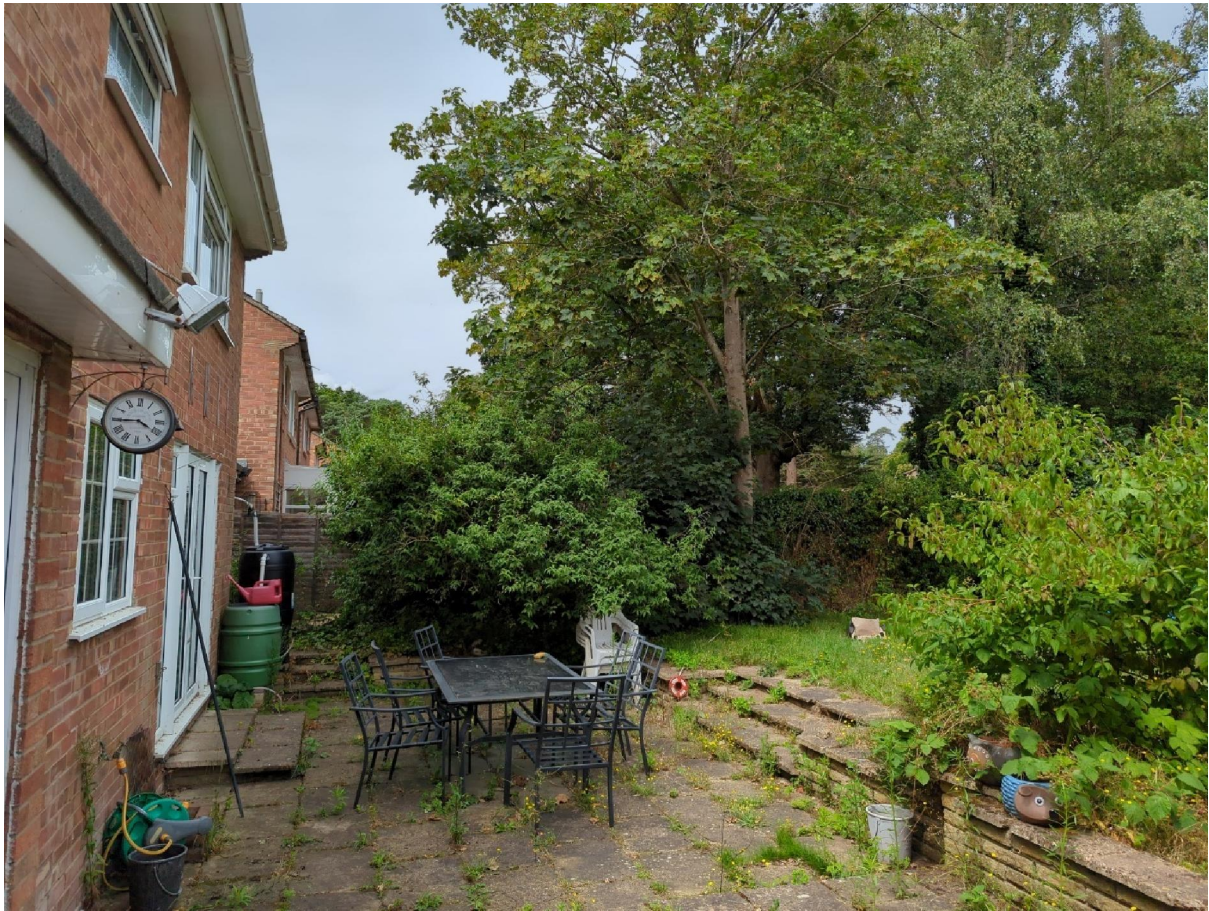
Photo 6 T2 rear of the building showing overall context.
