SITE PHOTOGRAPHS AND BUILDING PHOTOGRAPHS POST LBC APPROVAL – 1  
MAIN STREET, LOW VALLEYFIELD ‘WESTEND COTTAGE’.

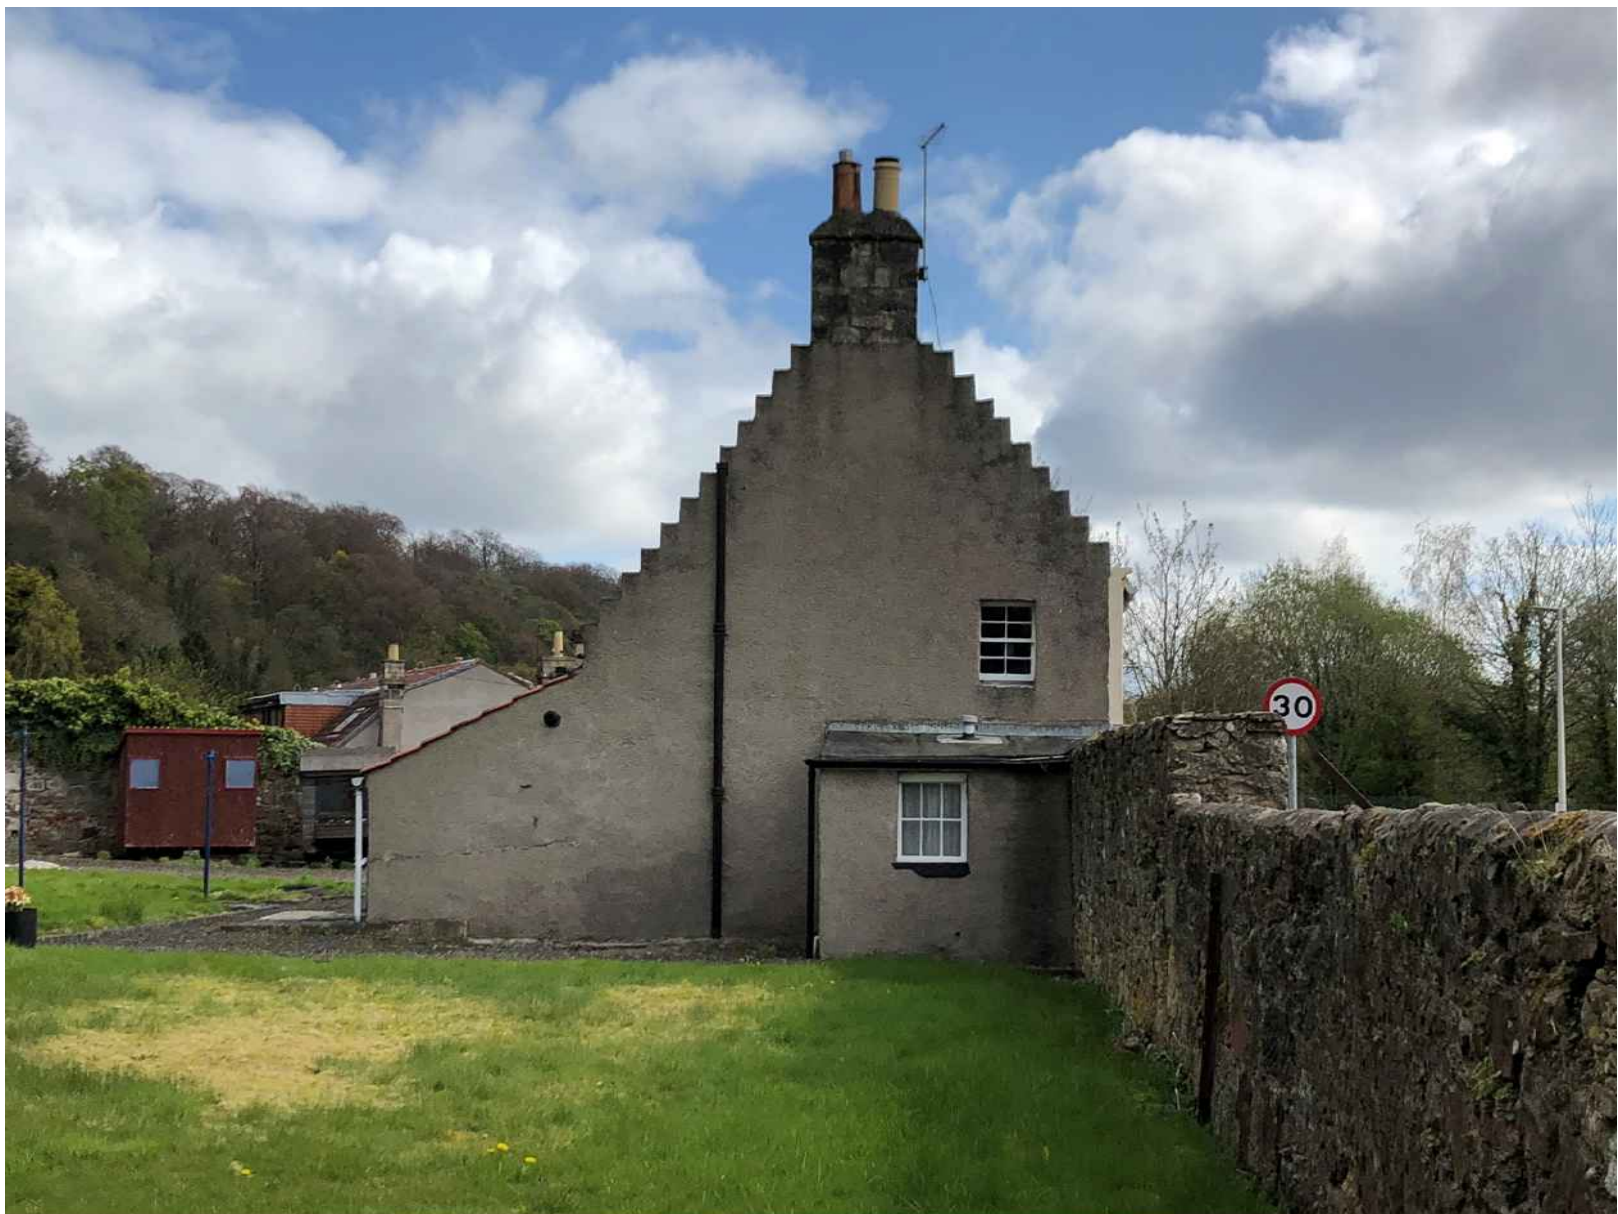
*Figure 10: View of the west elevation of Westend Cottage showing the change in height of the southern boundary wall and the poor and leaking single storey bathroom extension built without LBC and against the boundary wall*

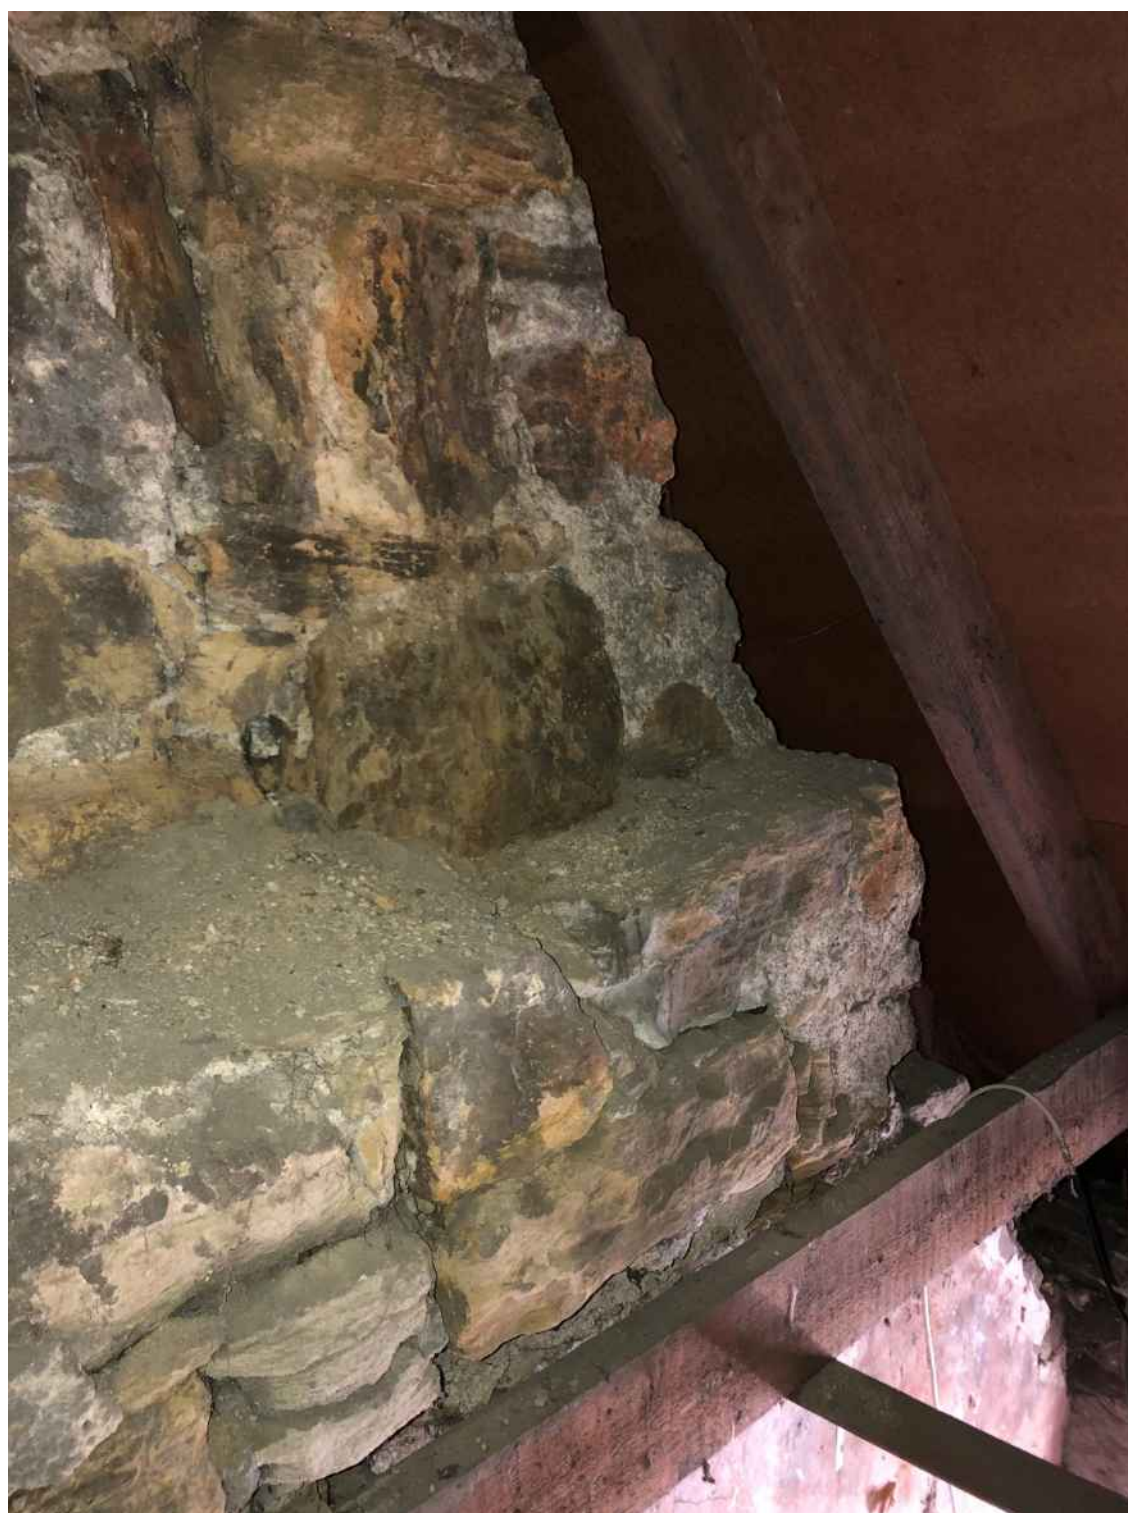
*Figure 14: View of northwest gable wall behind 1980's timber trusses that shows the removal of stone in the rake of the gable to ensure the new roof fitted. This has had a negative impact on the listed building*

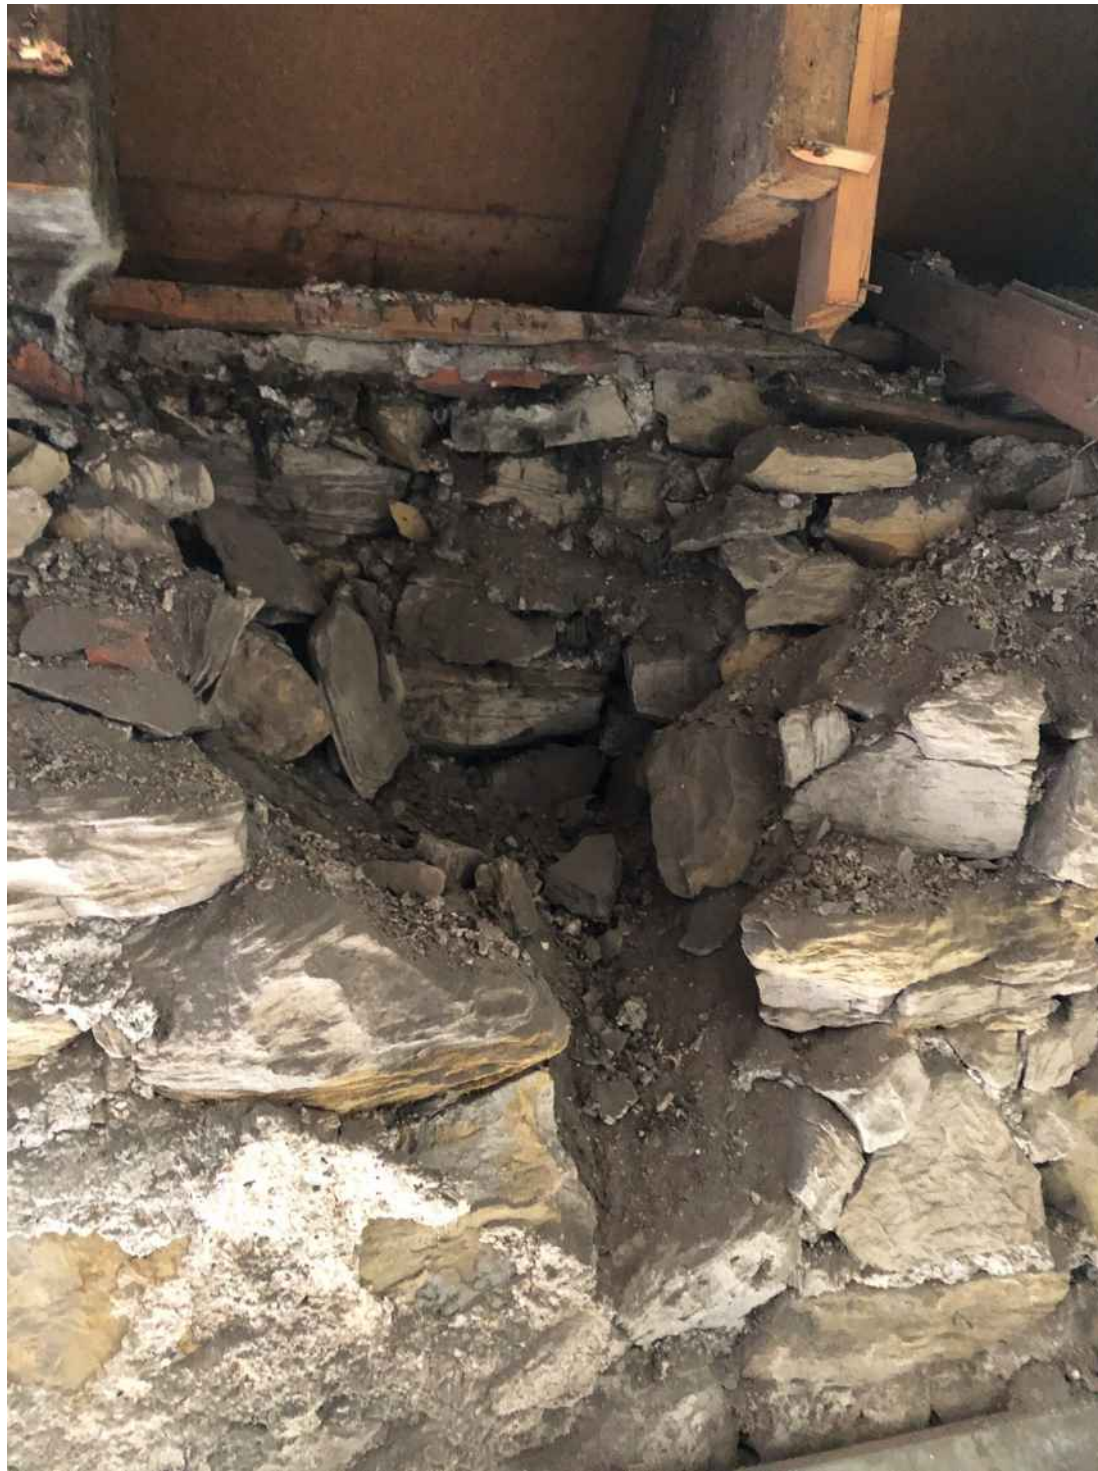
*Figure 15: Loss of sandstone at the top of the southern wall head inflicted when the roof was installed in the 1980's and was covered by the subframe and t&g from the 1980's. Wall head to be repaired with local sandstone and lime mortar, NHL2.5*

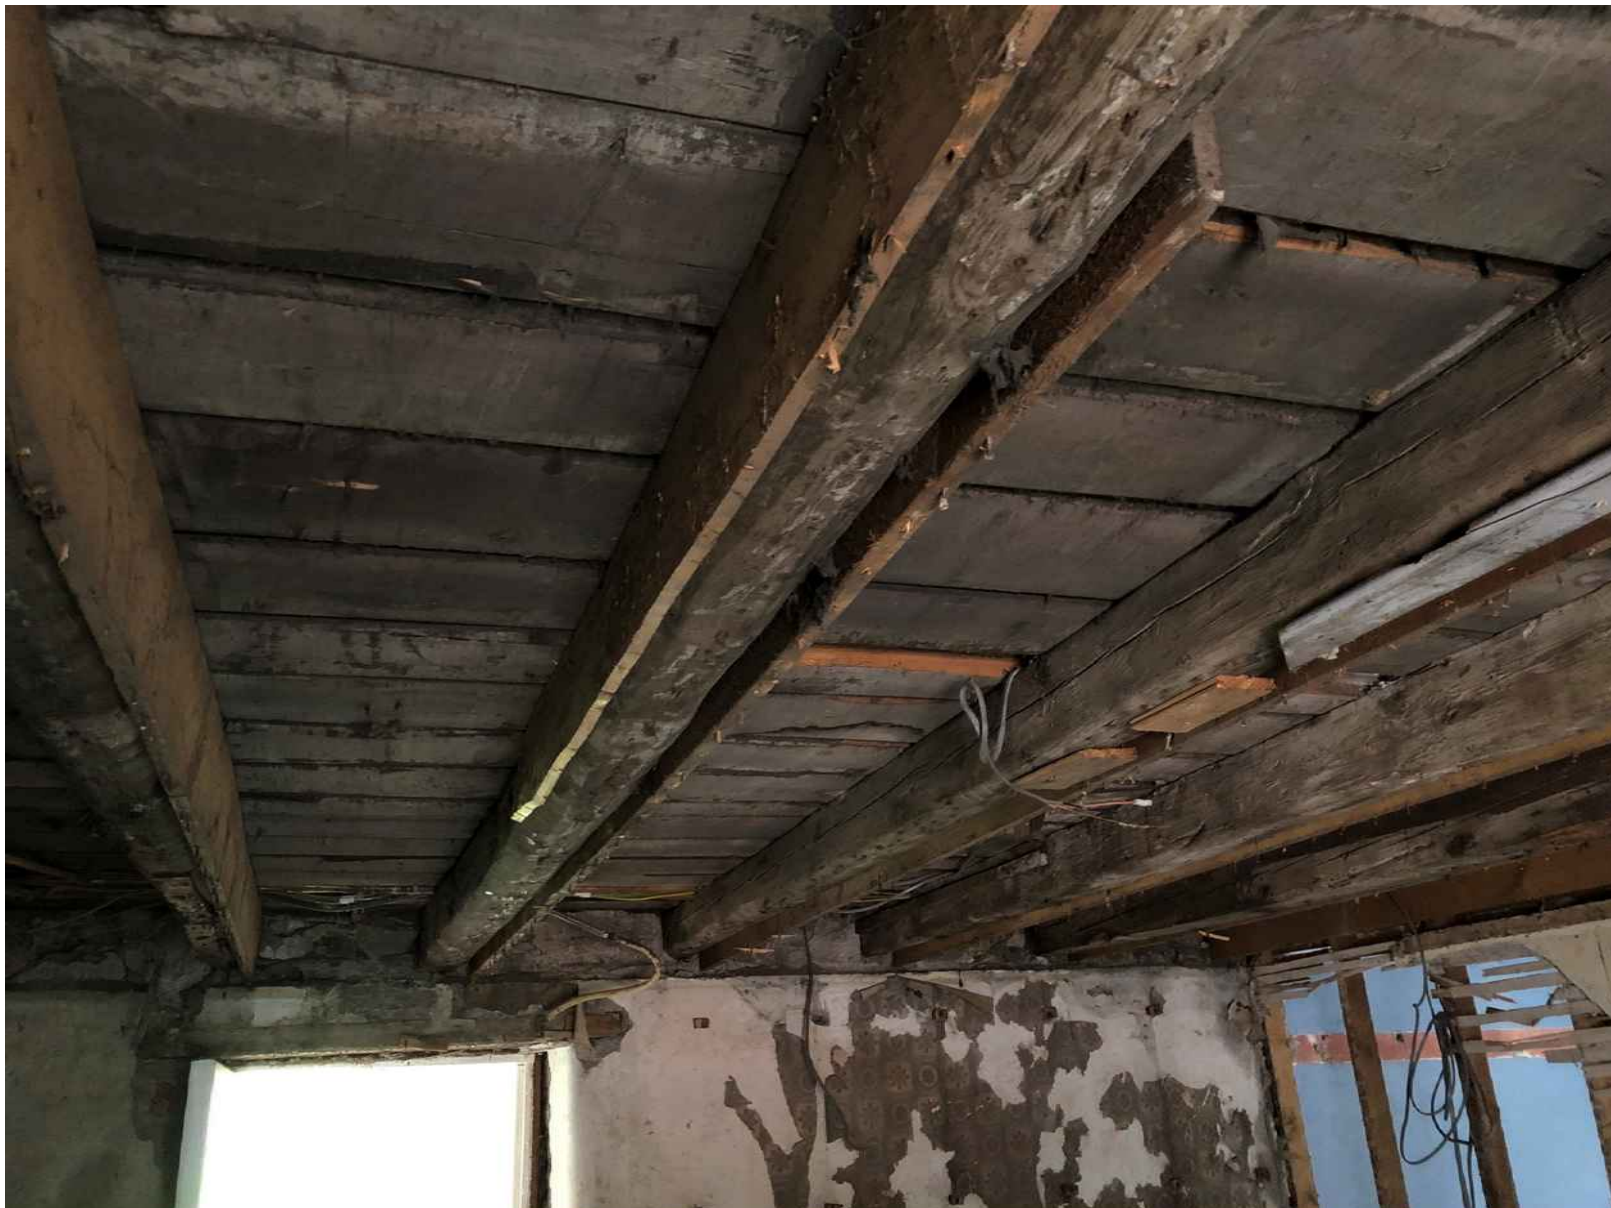
*Figure 16: Image showing the poor condition of floor beams which have been sistered by contemporary timber to ensure stability. Timbers have dry rot throughout and are not original to the building based on the size of joist pockets in the opposing wall*

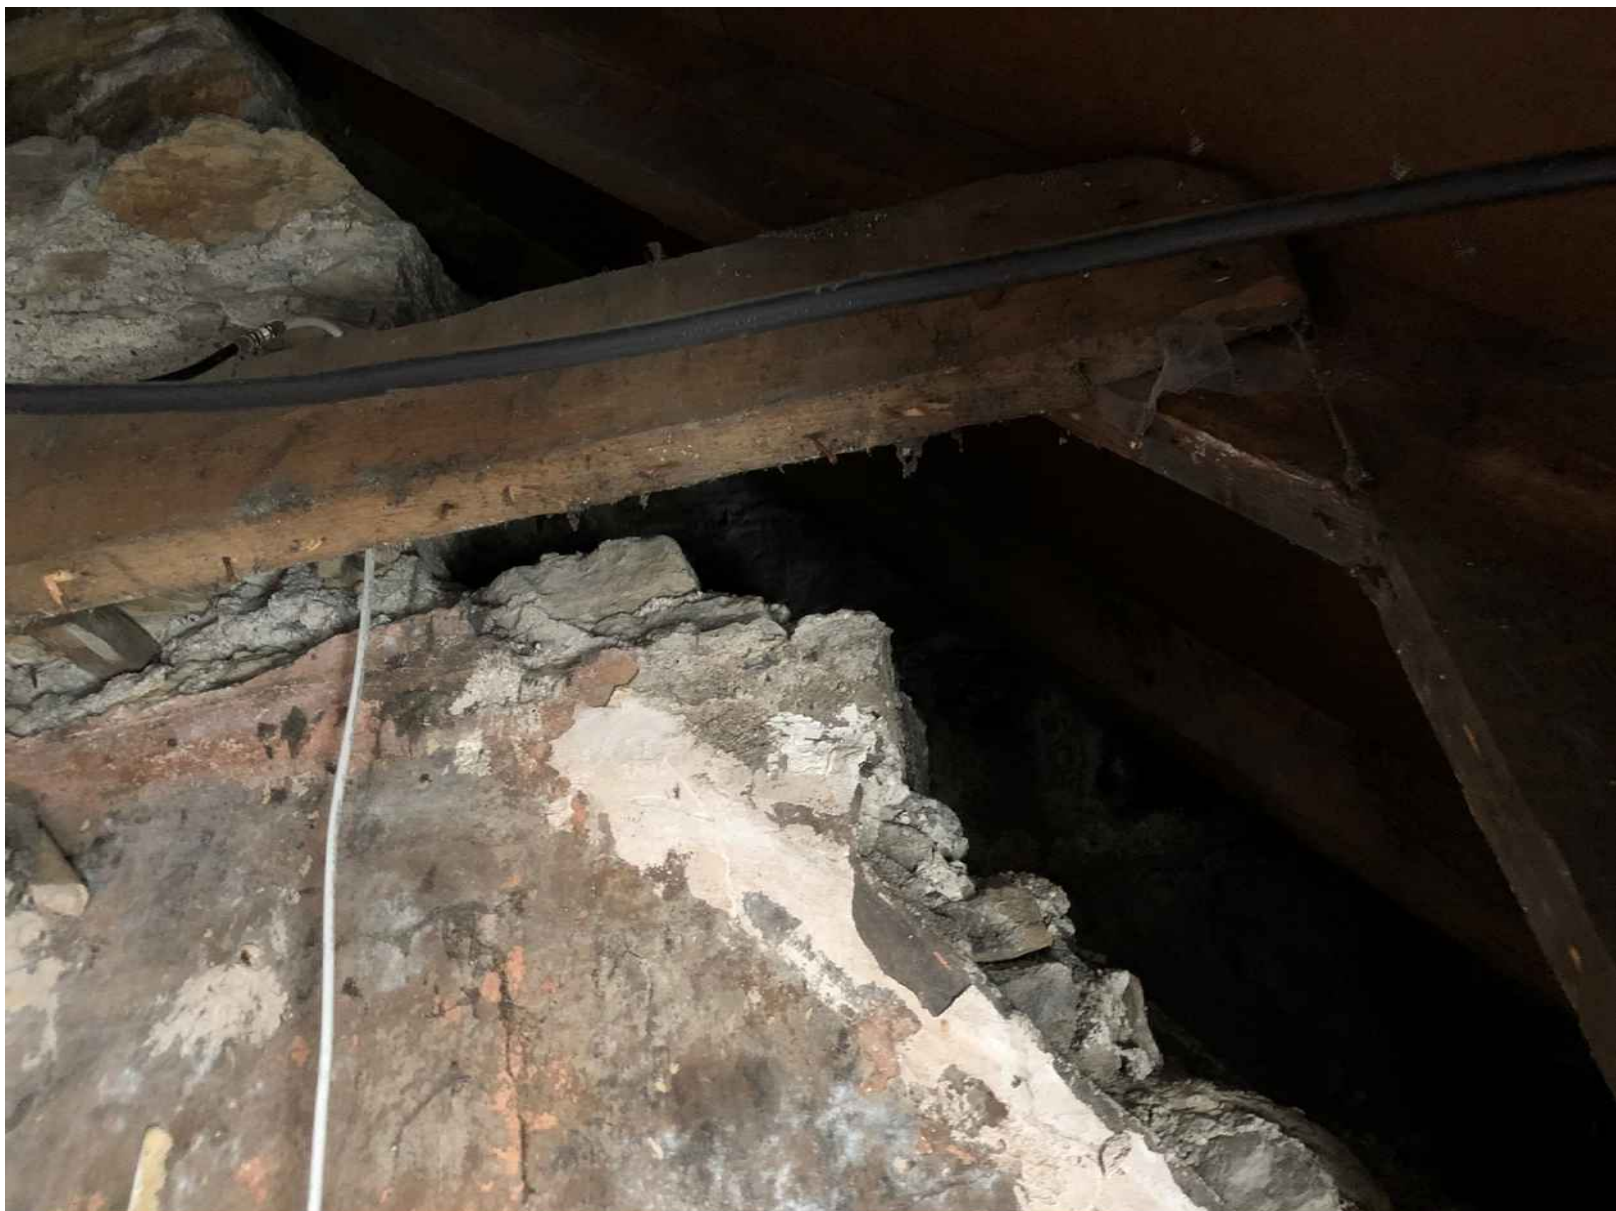
*Figure 18: View of northwest gable wall behind 1980's timber trusses that shows the removal of stone in the rake of the gable to ensure the new roof fitted. This has had a negative impact on the listed building*

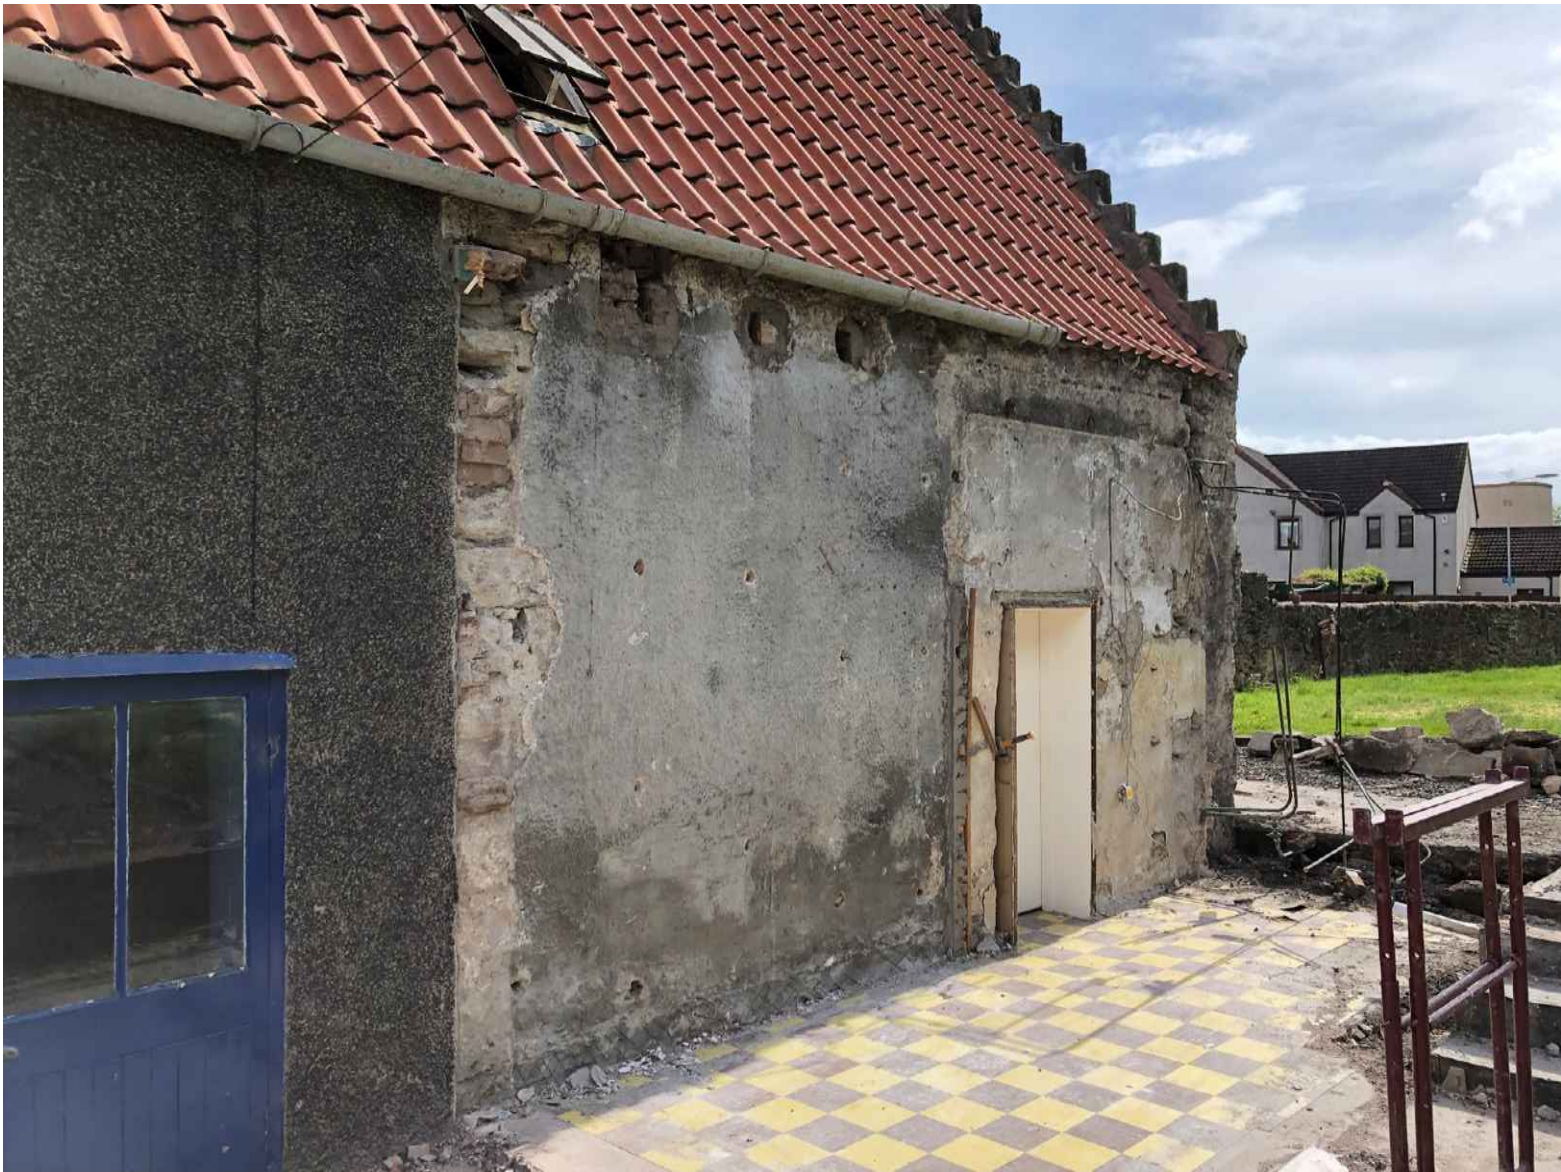
*Figure 19:Rear wall of the original cottage once late Victorian kitchen has been removed. The image shows there was no keying in of the kitchen to the original structure*

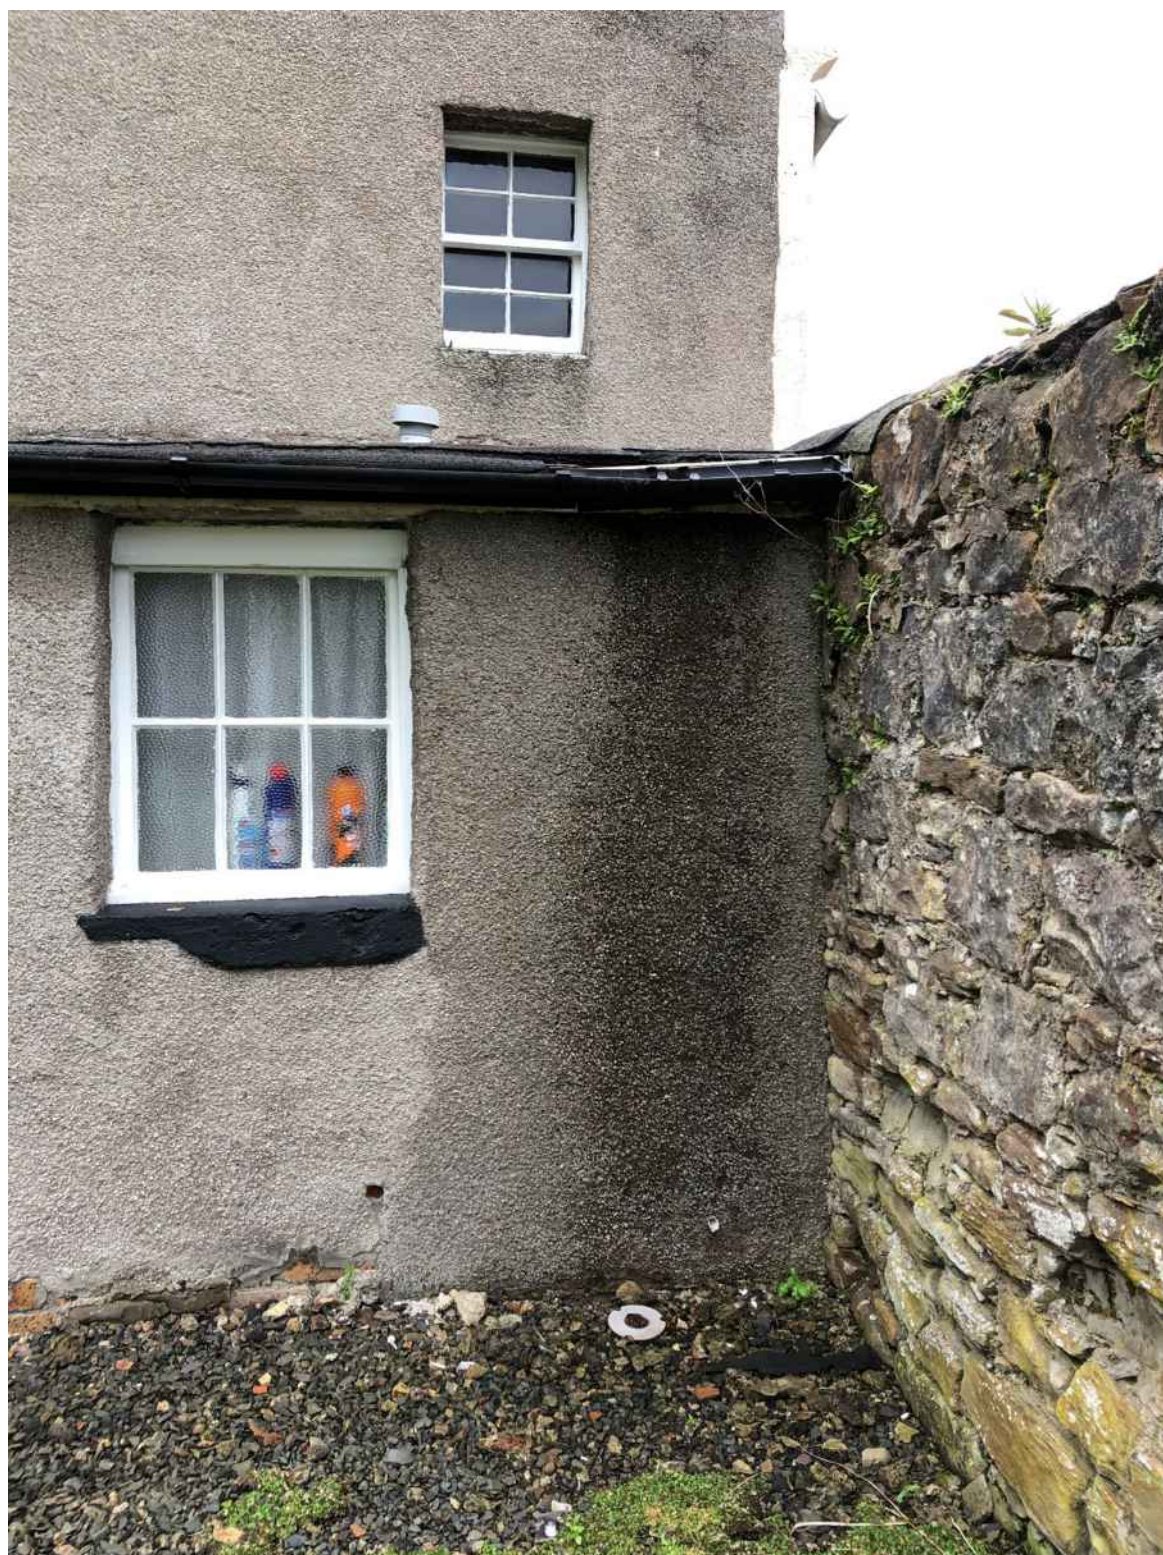
*Figure 20: View of bathroom on west gable that has poor detailing and water ingress. The image also shows the west gable of the cottage with water damage from the installation of the cement harling*

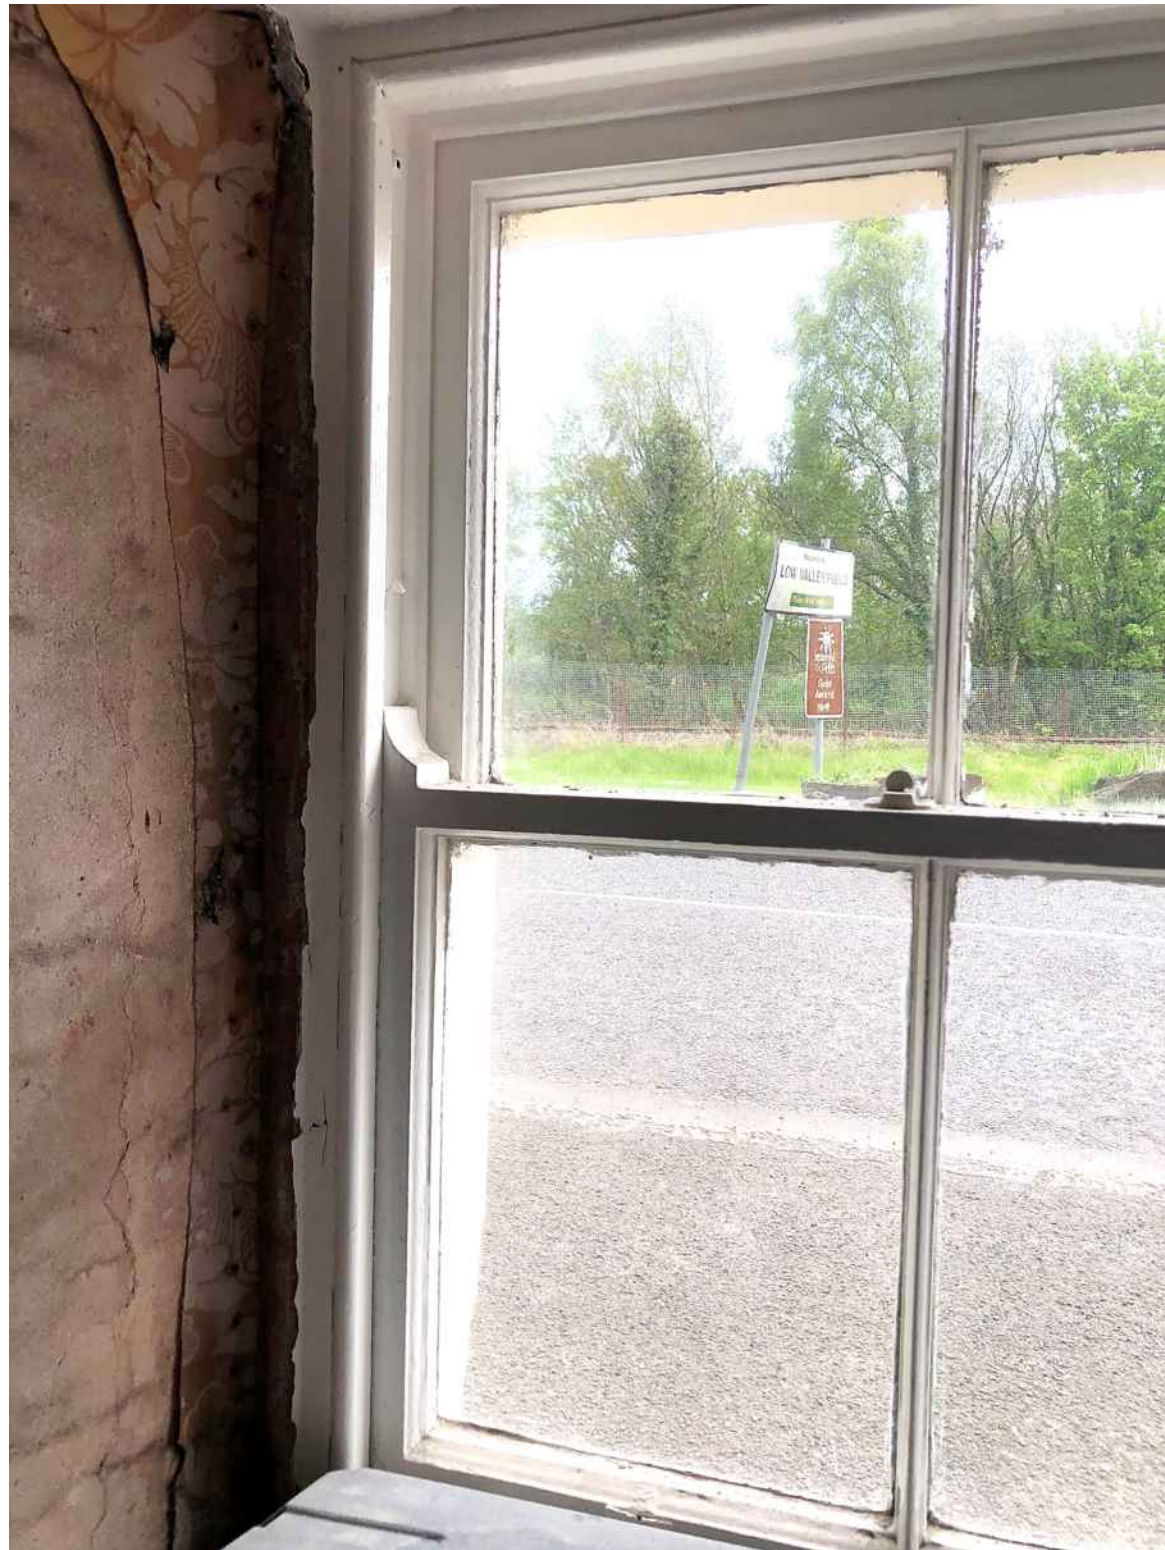
Figure 21: Image of window with stripped out box for sash and case so that the window fitted the opening. These windows were installed in the mid 20th century and are non-operational. Removal of the render as shown later dates window installation

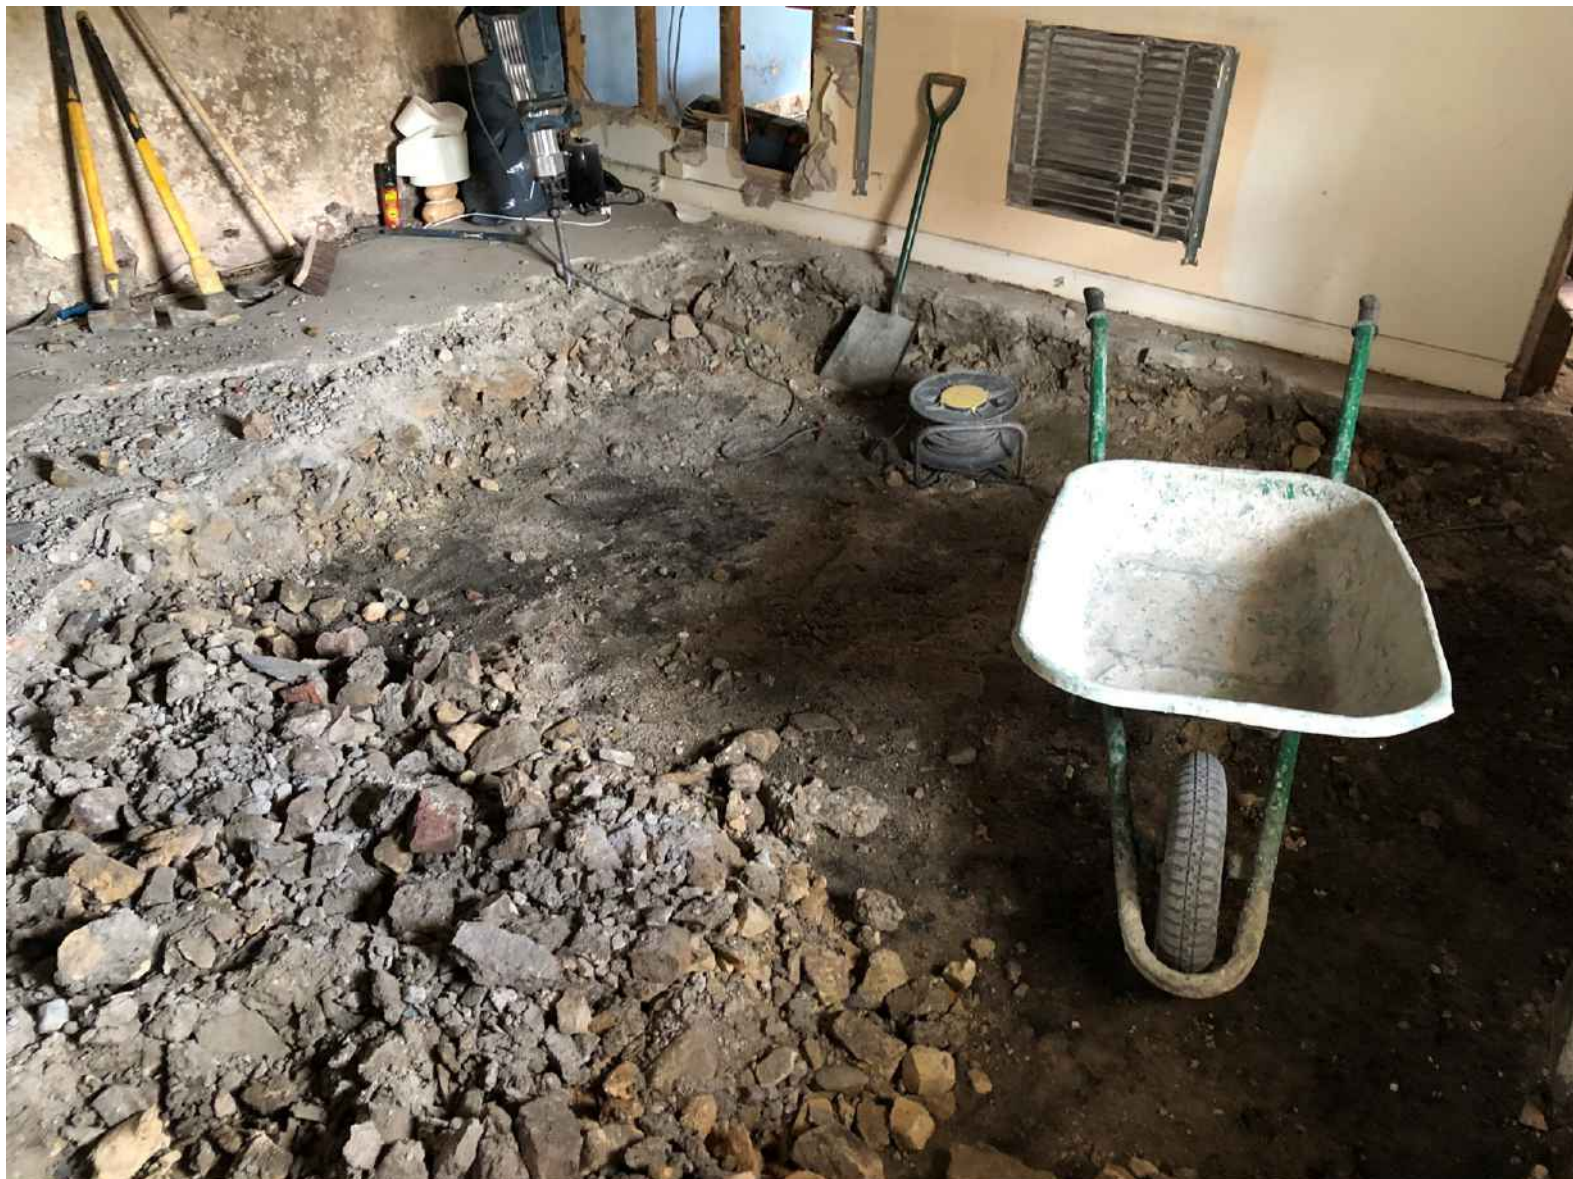
Figure 22: Excavation for the removal of the cement floor revealing the original grade surface with areas of fire charred remains. None of the original stone floor remained.

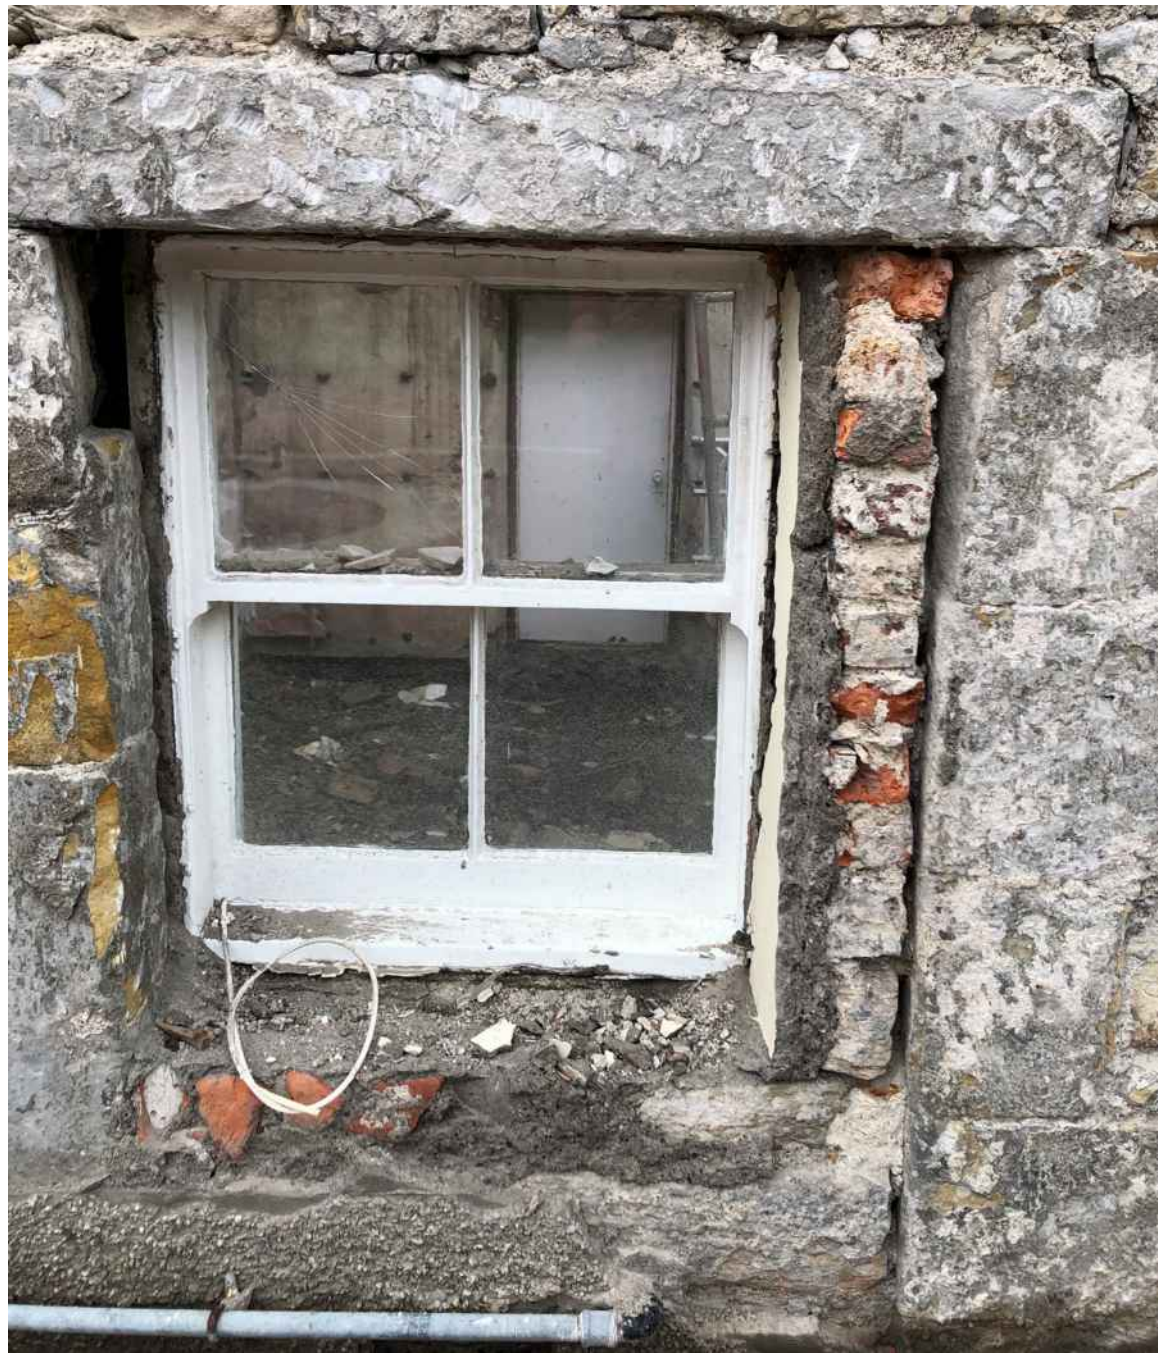
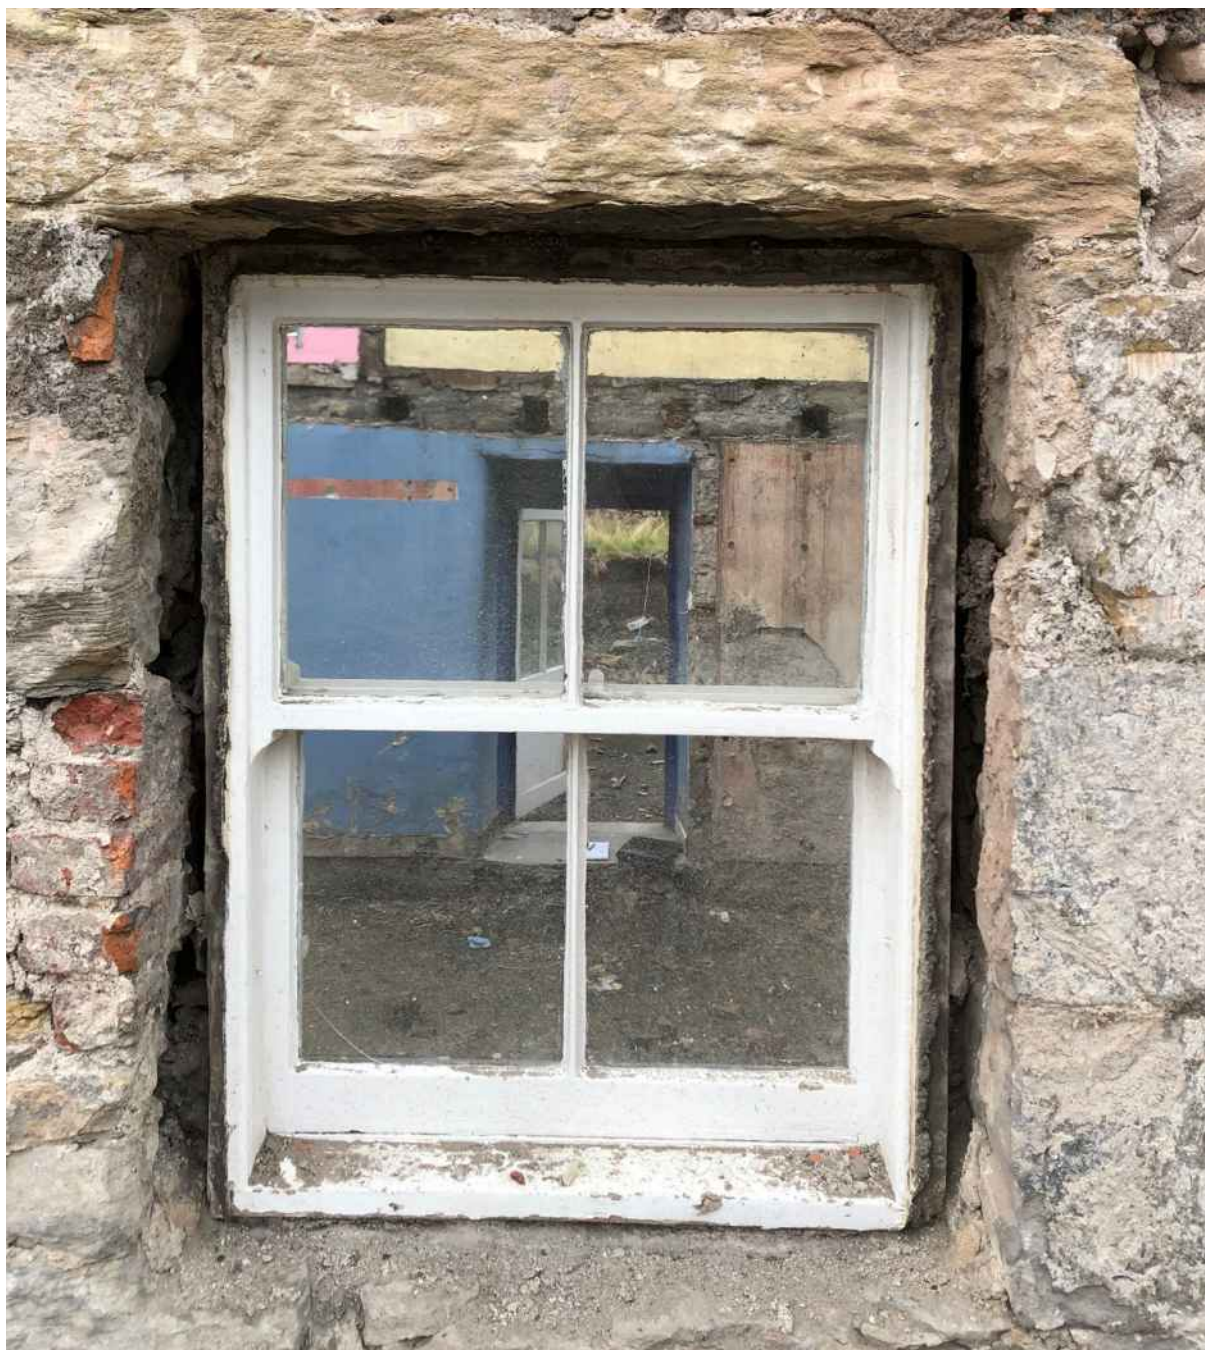
*Figure 23 above and 24 below: Image of window with stripped out box for sash and case so that the window fitted the opening. These windows were installed in the mid-20th century and are non-operational. Removal of the render as shown dates window installation to that of the time of render. The windows no longer fit the cottage with the cement removed and the windows returned to their original sizes.*

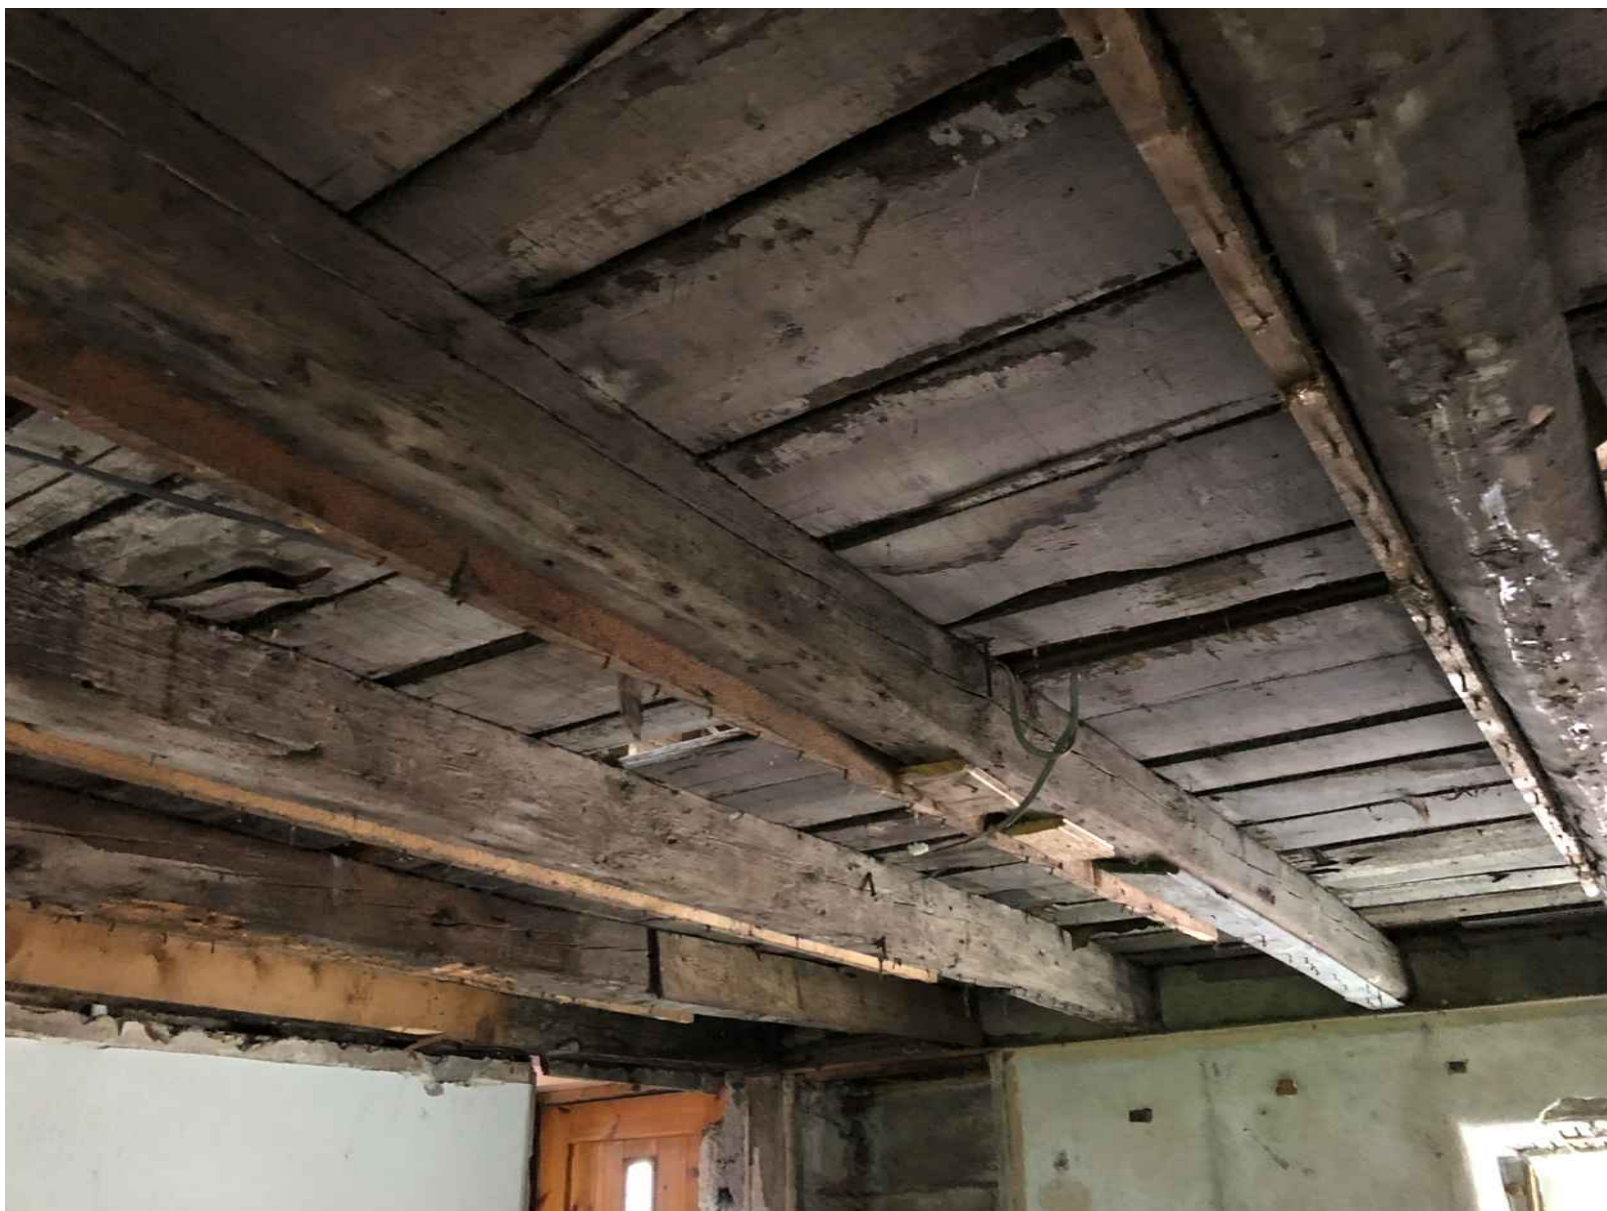
*Figure 24: Image showing the poor condition of floor beams which have been sistered by contemporary timber to ensure stability. Timbers have dry rot throughout and are not original to the building based on the size of joist pockets in the opposing wall*
