SITE PHOTOGRAPHS AND BUILDING PHOTOGRAPHS POST LBC APPROVAL – 1  
MAIN STREET, LOW VALLEYFIELD ‘WESTEND COTTAGE’.

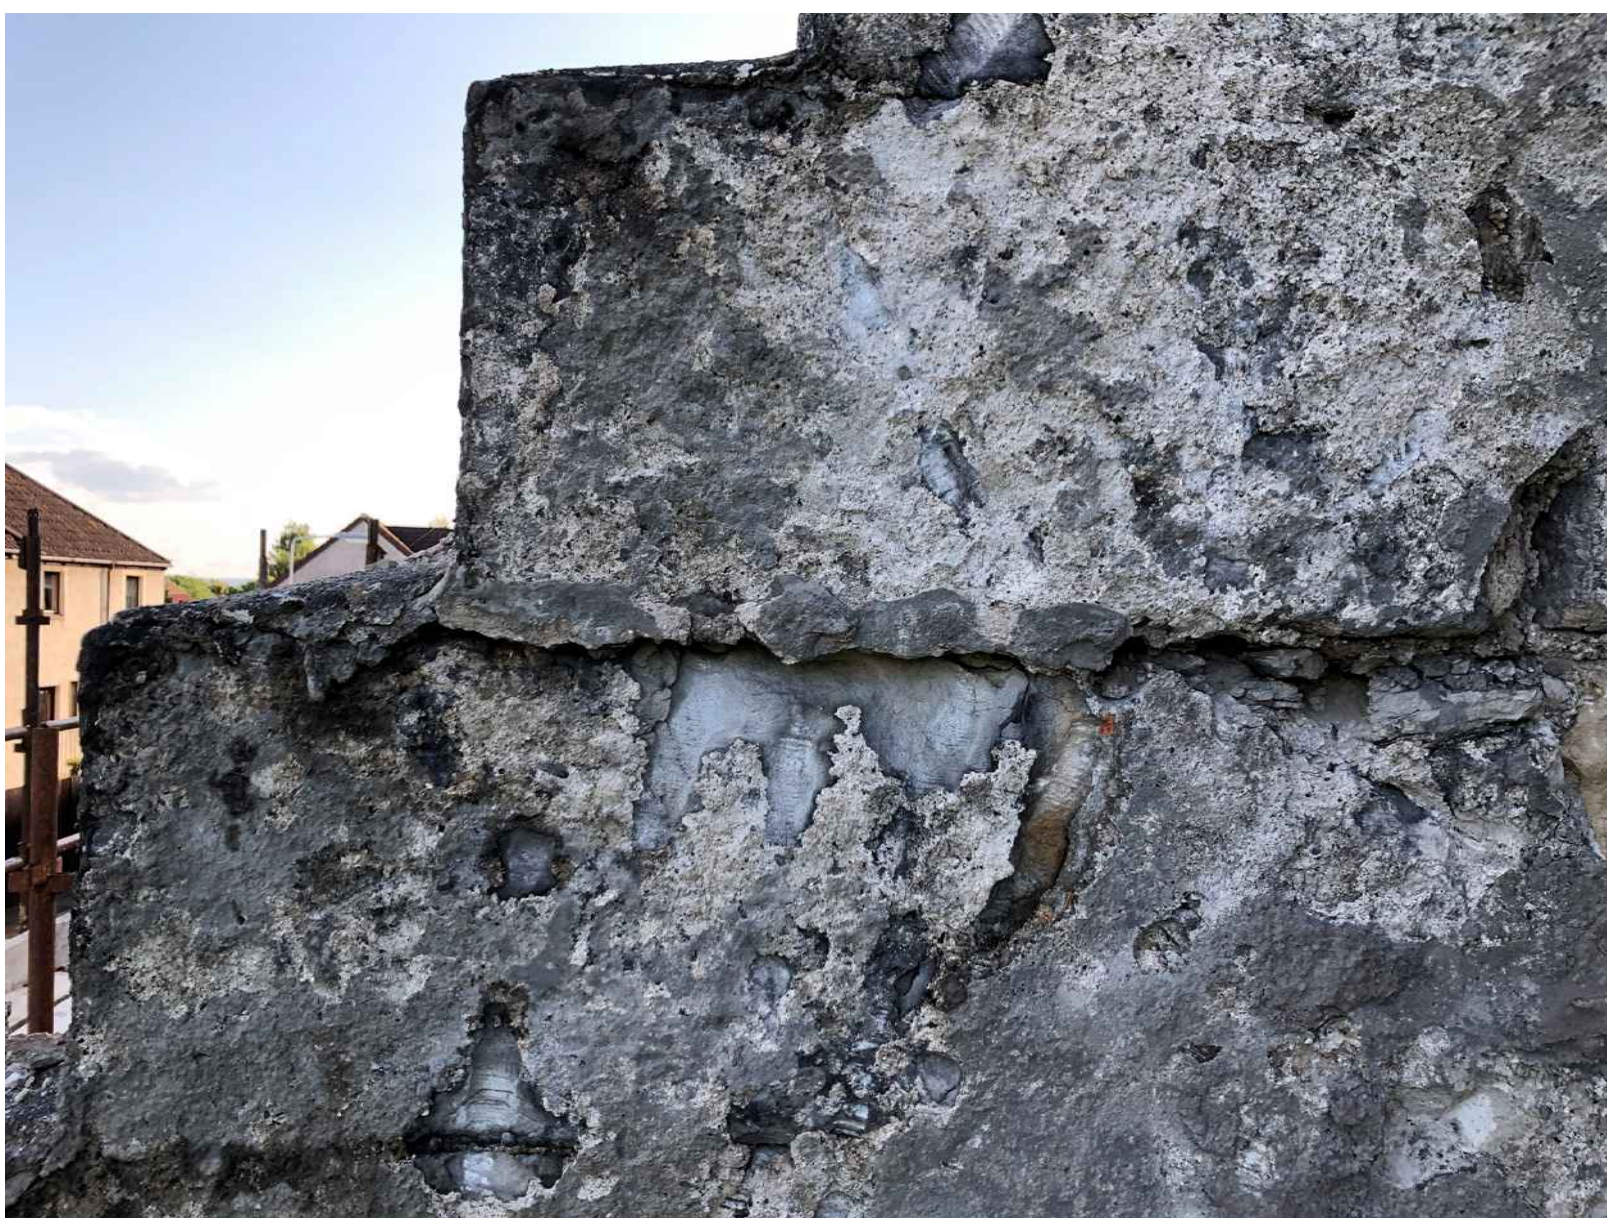
*Figure 25: Crowstepped gables stone blocks hewn as individual elements of 500mm x 280mm each. Exterior Ashlar finish patina has been removed through poor workmanship when the roof and harling were installed*

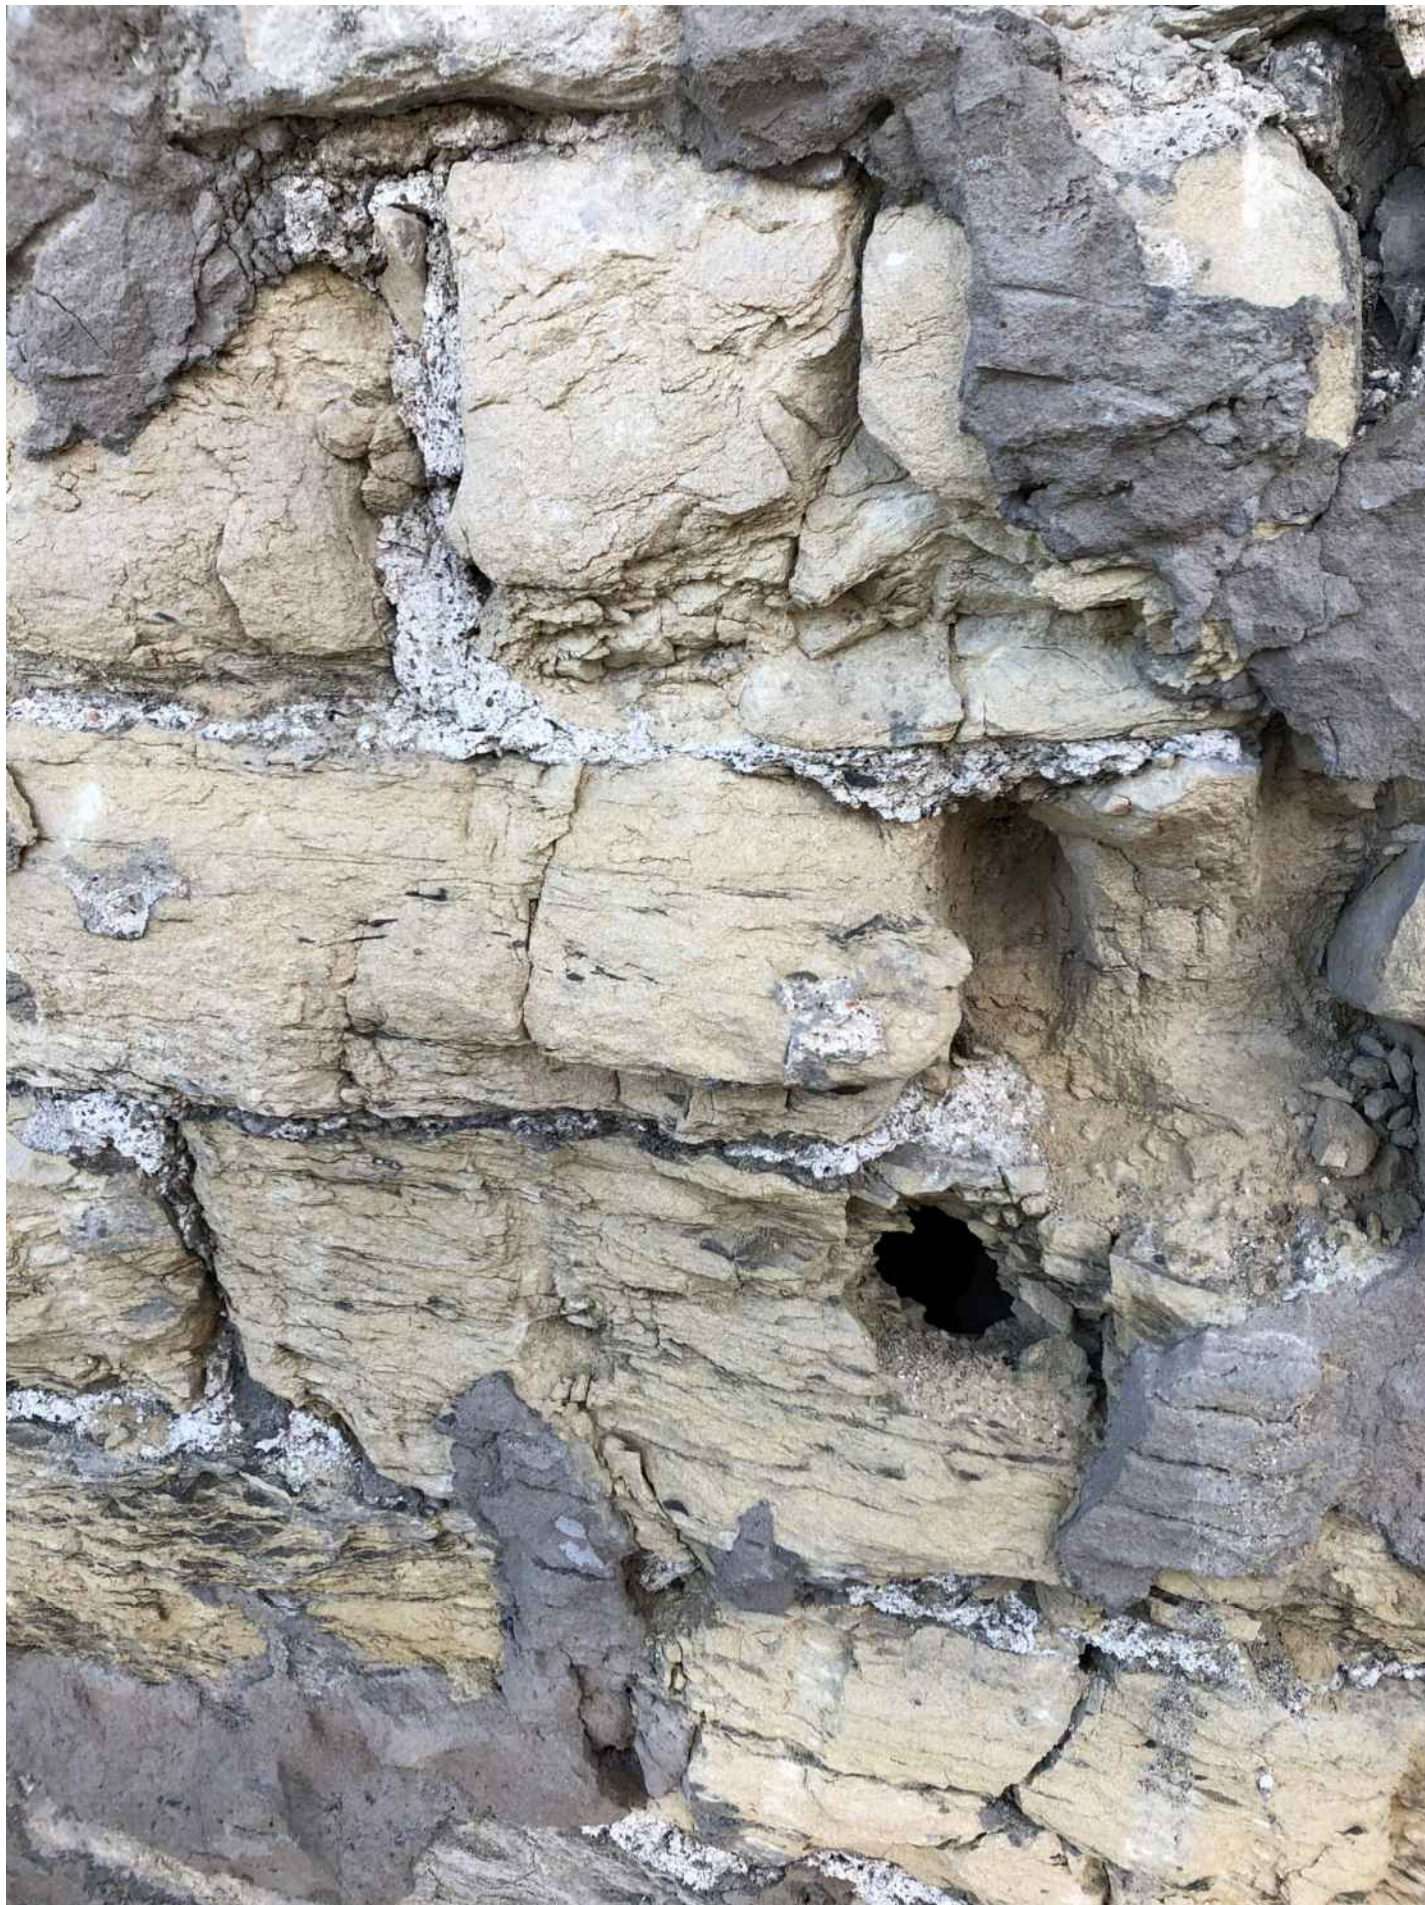
*Figure 26: Image of exterior wall with cement harling removed showing that the poor condition of the sandstone and lime mortar means the wall was exposed to the elements for long periods of time before being covered by cement also pictured here.*

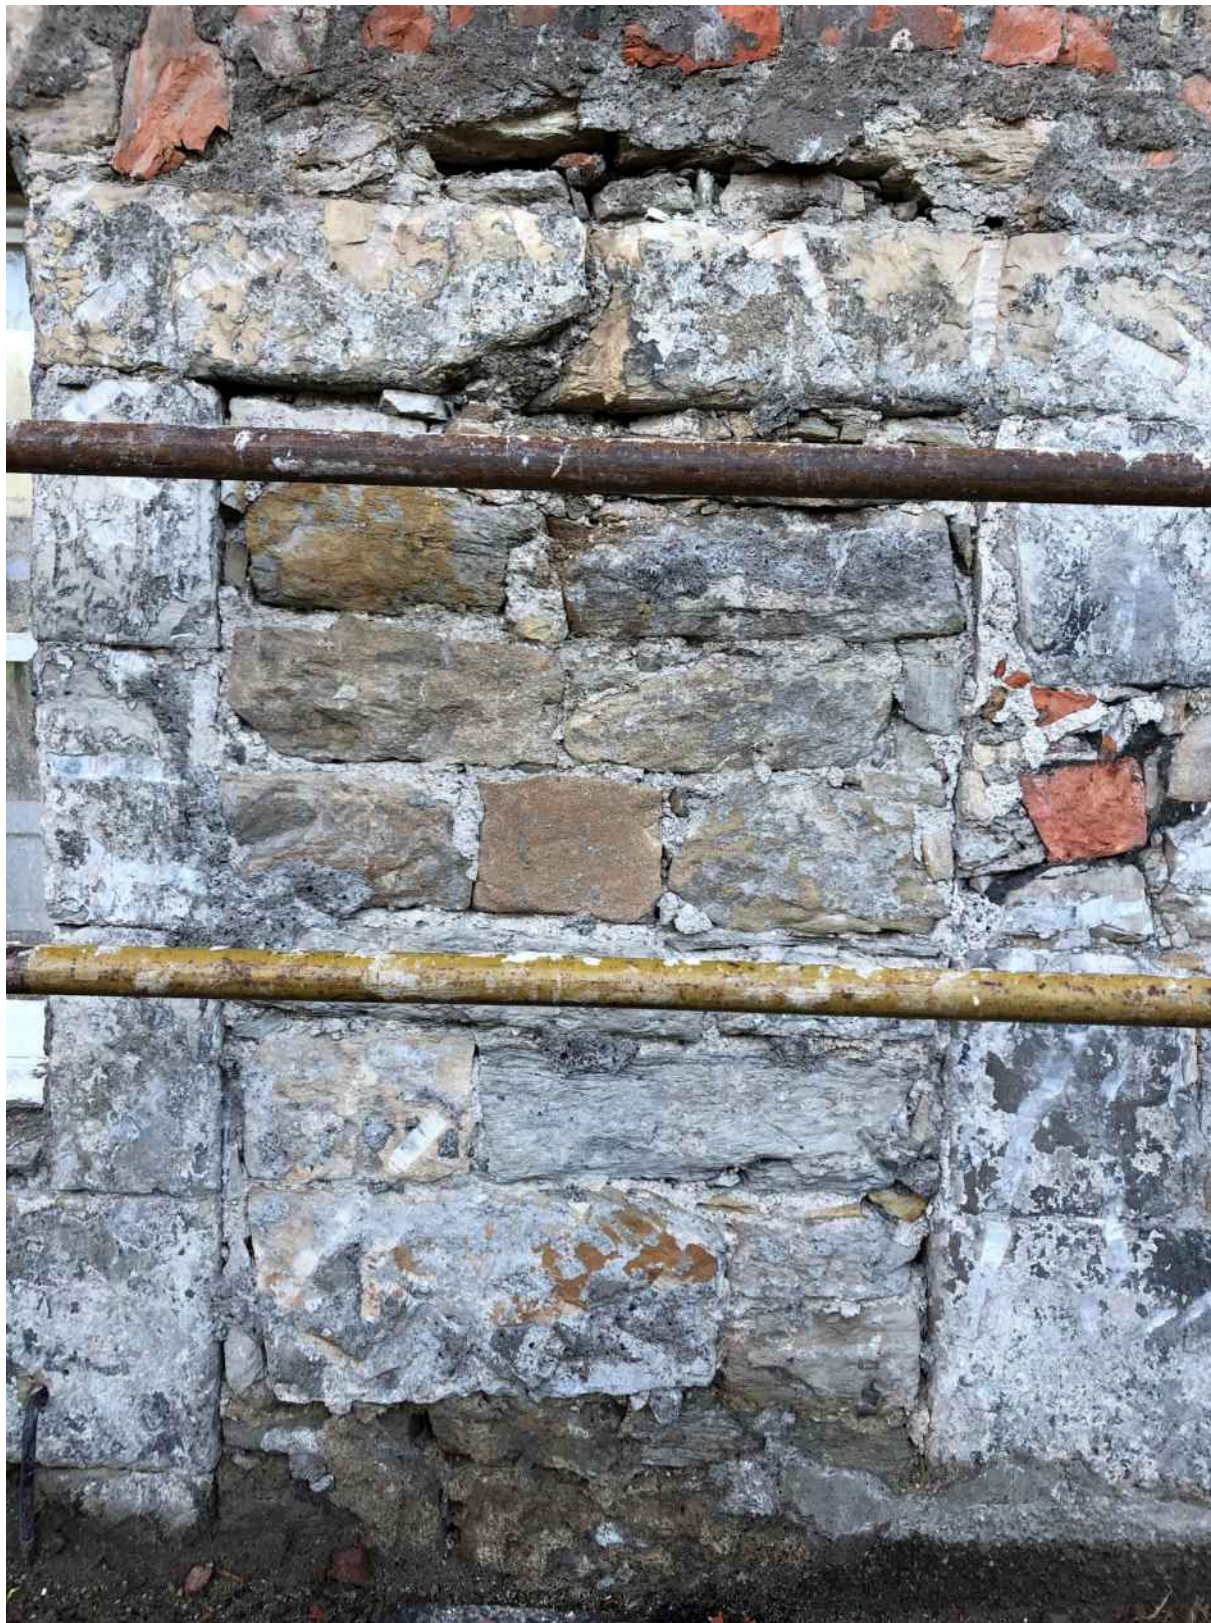
*Figure 27: Original door to the east of the south facade with quoin opening and cement and pan tile filling above the lintel*

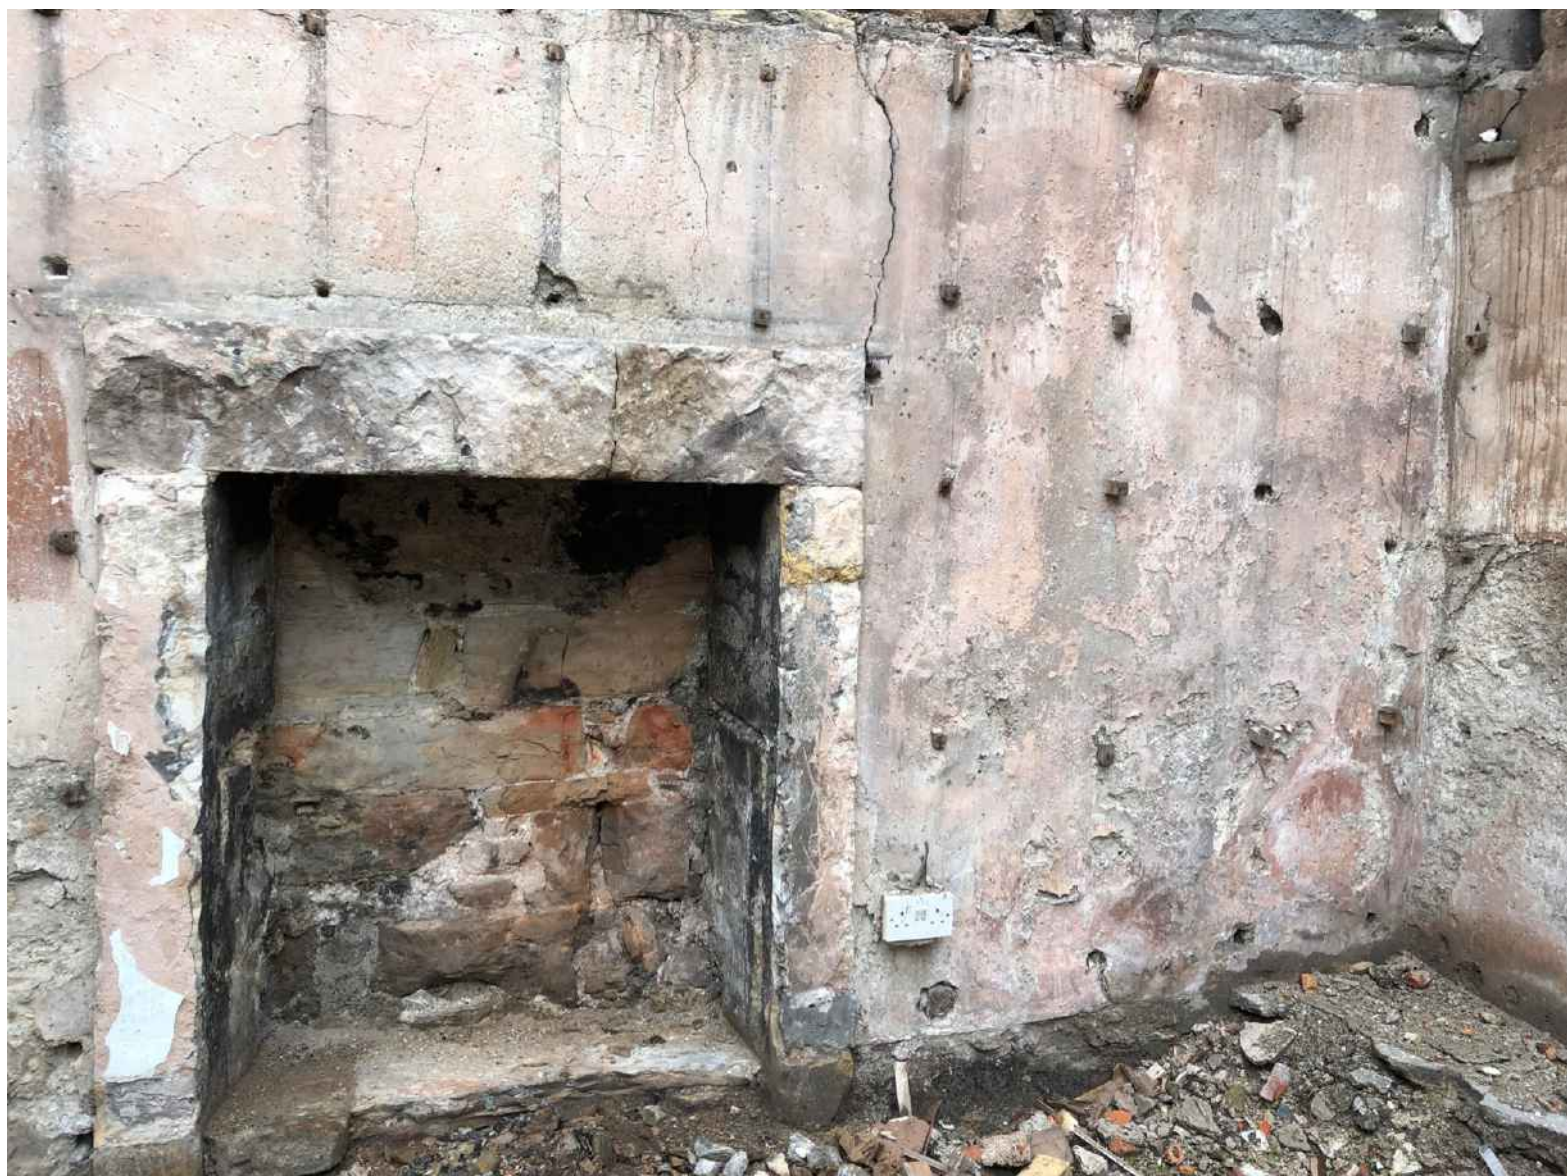
*Figure 28: Image of uncovered original stone fireplace frame and lintel with stone grate and fire chamber on the east wall to be retained*

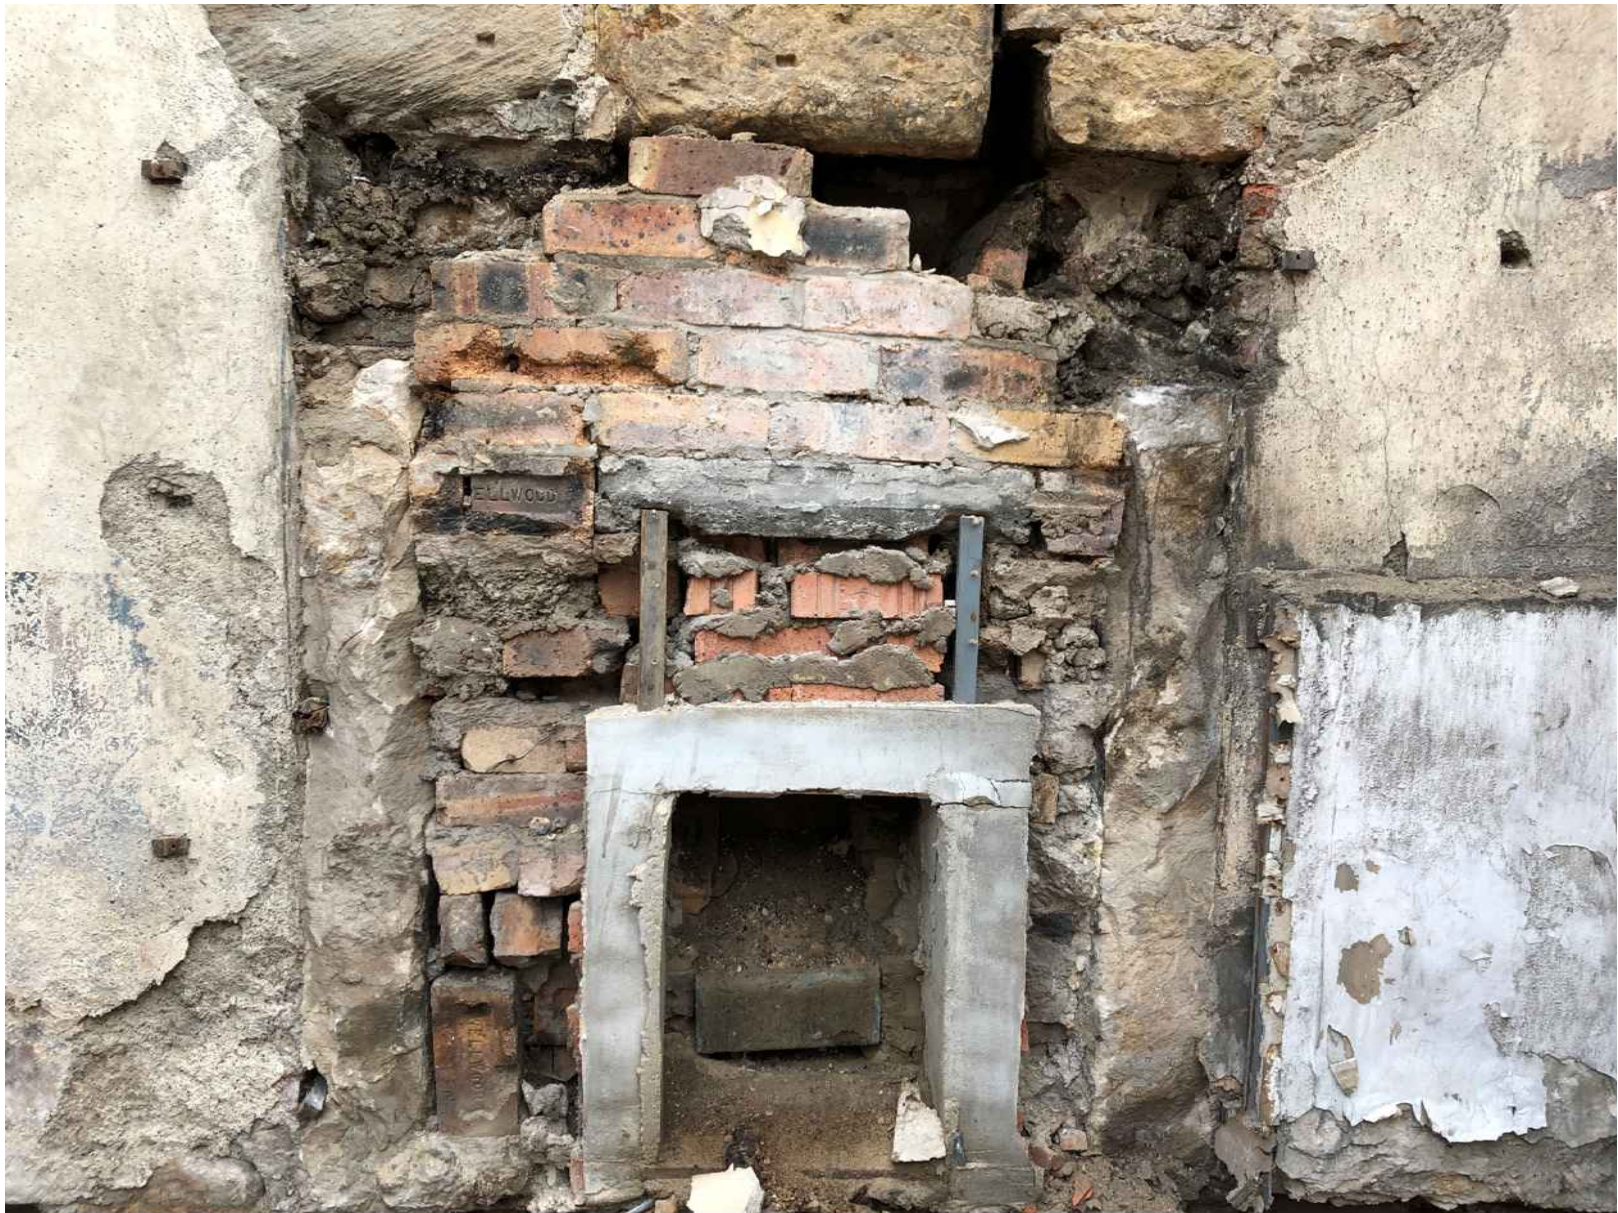
*Figure 29: Image of uncovered original stone fireplace frame with missing lintel and the impact of the imposition of the Victorian fire chamber. This will be opened with a new stone lintel installed.*
