CJ TPO App- 'Turweston Manor, Main Street, Turweston, Brackley, Northamptonshire, NN13 5JX'

I am submitting this application to work on a tree which is subject to a CA and TPO on behalf of our client. The Tree Survey was carried out by one of our fully qualified and experienced Surveyors.

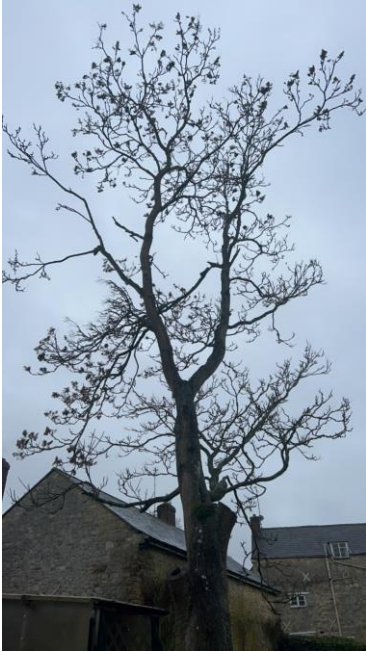
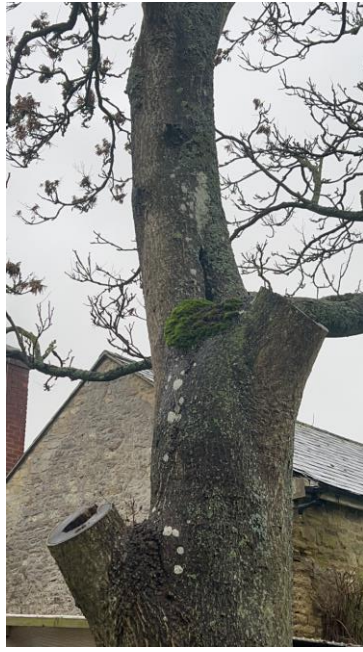
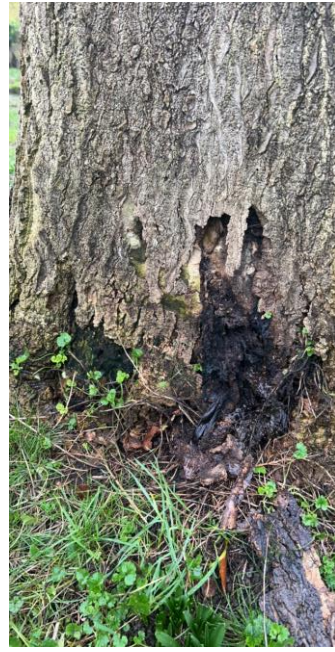
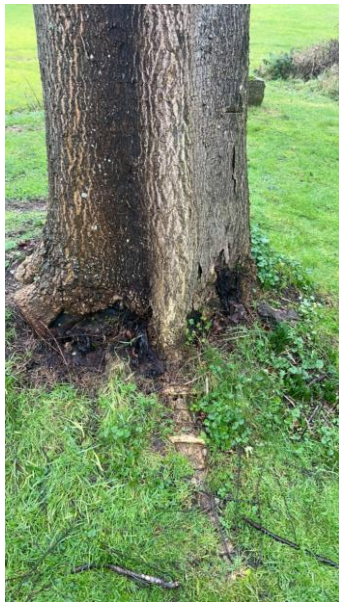
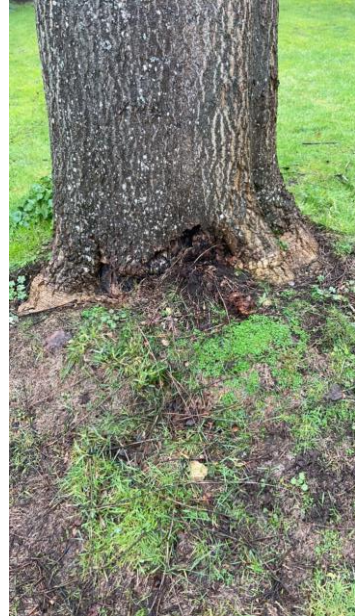
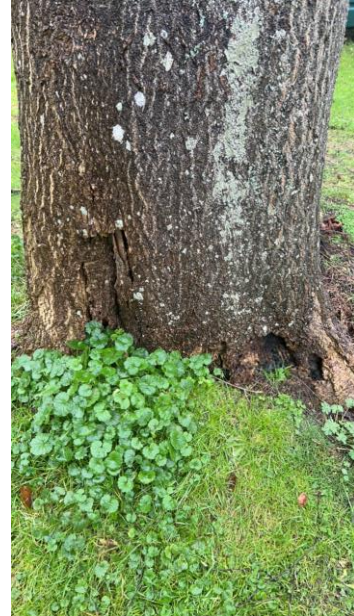
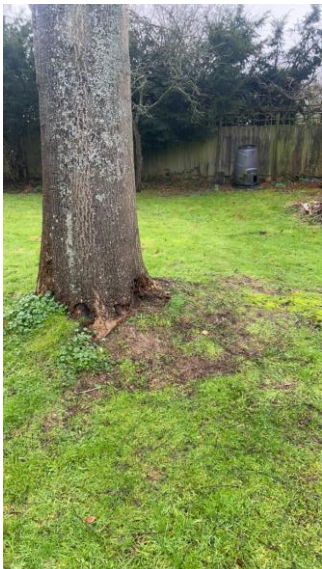
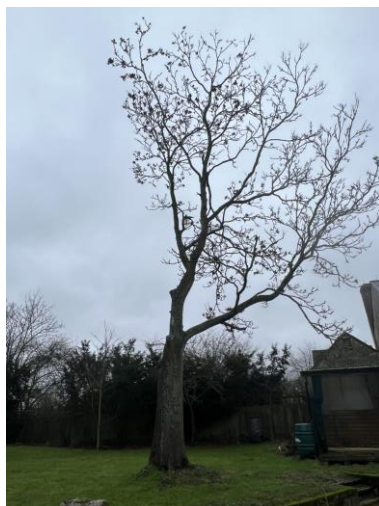
Tree Tag: 5105

Tag Number	Group of Trees	Number in Group	Species	Age Class	Defect Crown	Comments
5105	No		Other broadleaves	Semi-mature		ToH. Decay around base and on buttresses/ribs. Black substance around decayed base, poss Kretz. Cavity on removed limb at 2m and hammer suggests hollowing/decay below this point to the base. Hanger in main crown and minor deadwood throughout. Previous limbs decayed and removed means tree is left with 50% crown all weighted on one side. Crack on main stem at 3m on West side, unknown decay. Soil appears raised around base. Monolith at 3-5m removing all branches.
