ARBORICULTURAL SURVEY

TO BS5837:2012

DEVELOPMENT OF NEW DWELLING

LAND ADJACENT TO 14 WILLOW CORNER

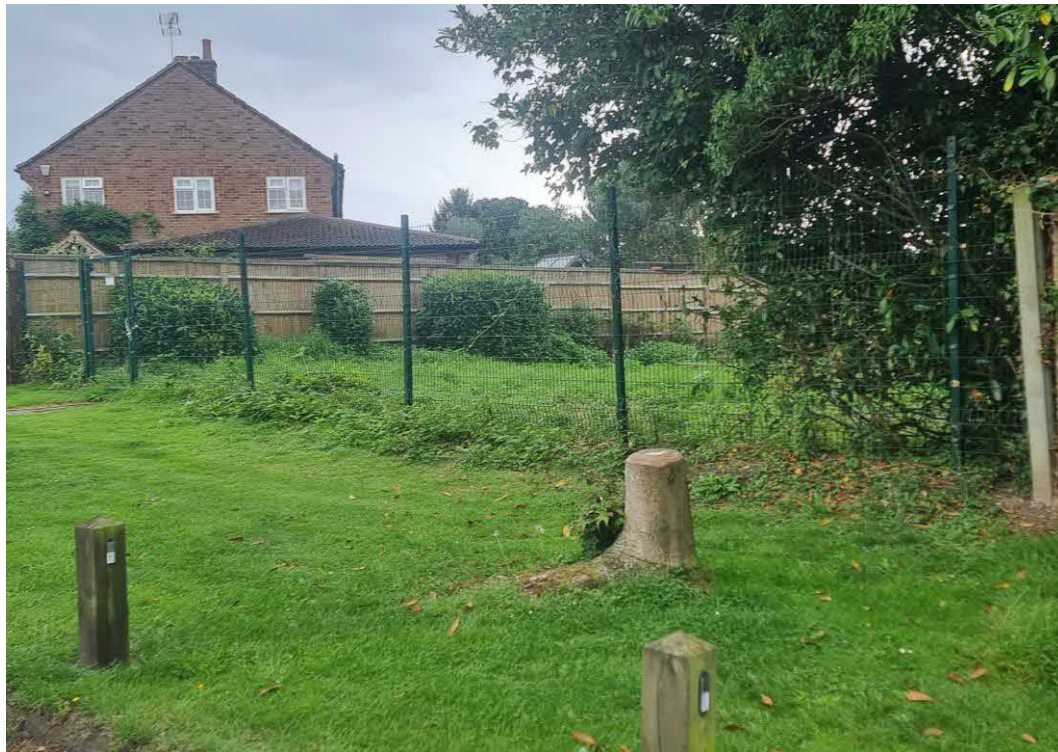
Tree T7, a Norway maple has been felled by the Hertfordshire County Council in 2023

Tree stump of T7 following being felled in 2023.
