Refurbishment and Demolition **Asbestos Survey**

The Rest & Welcome Pub
The Street
Haultwick
SG11 1JF

Ref: ACE2120

Date: 3rd January 2018

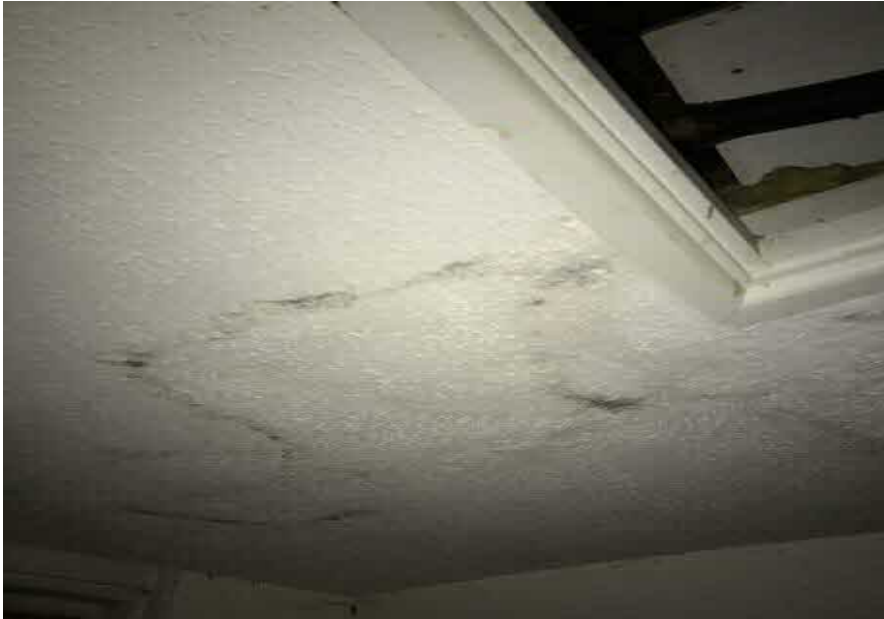
Sample reference 01 – Textured coating

The bulk sample of textured coating taken from the ceiling in the main room located on the 1st floor of the property has proven positive to contain **Chrysotile (white asbestos)**.

Sample 01 – Textured coating – ***Chrysotile (white asbestos).***

Recommendation: The material should be removed before refurbishment if being disturbed.

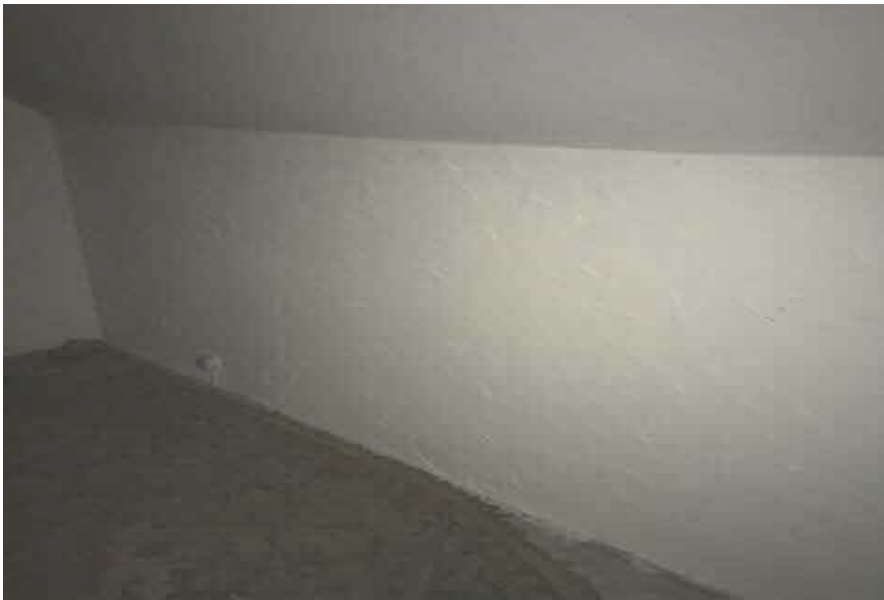
Sample reference 02 – Textured coating

The bulk sample of textured coating taken from the walls in the main room located on the 1st floor of the property has proven positive to contain **Chrysotile (white asbestos)**.

Sample 02 – Textured coating – ***Chrysotile (white asbestos).***

Recommendation: The material should be removed before refurbishment if being disturbed.

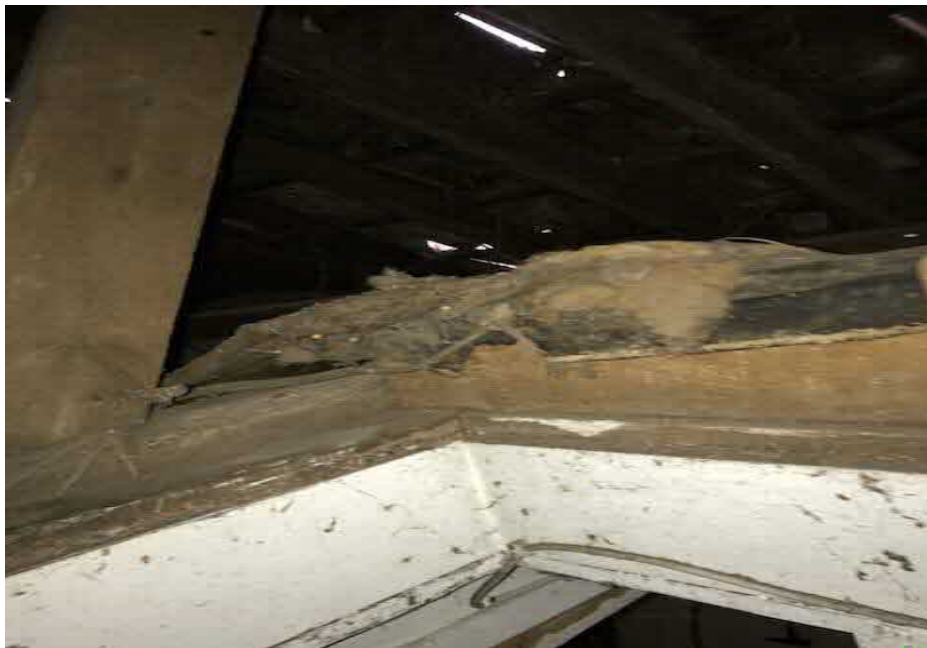
Sample reference 03 – Thermal insulation

The bulk sample of thermal insulation taken from the loft has proven negative to contain asbestos, **no asbestos detected**; therefore no further action is required for this material.

Sample 03 – Thermal insulation – ***No asbestos detected.***

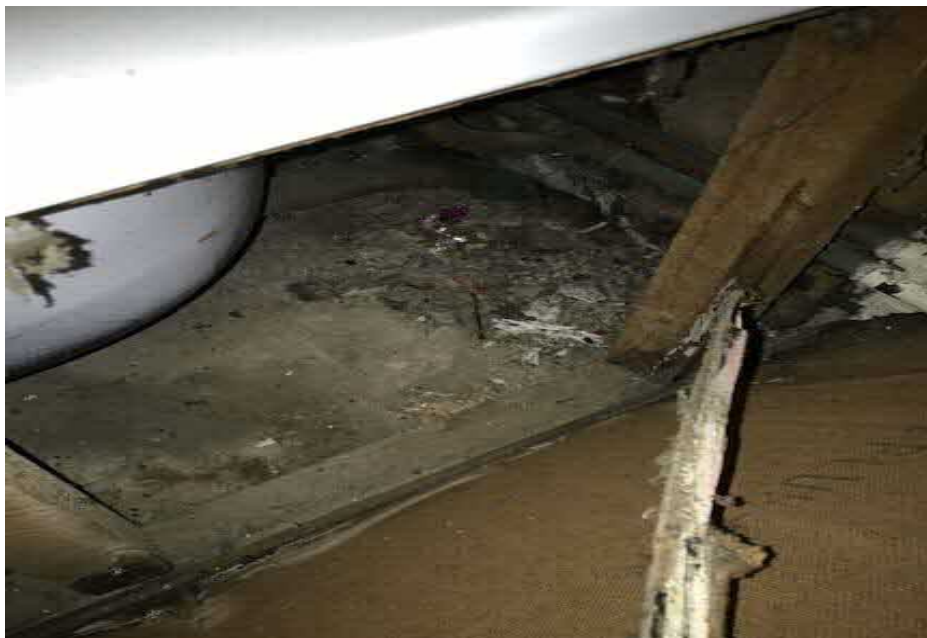
Sample reference 04 – Debris

The bulk sample of debris taken from under the bath located on the ground floor of the property has proven negative to contain asbestos, **no asbestos detected**; therefore no further action is required for this material.

Sample 04 – Debris – ***No asbestos detected.***

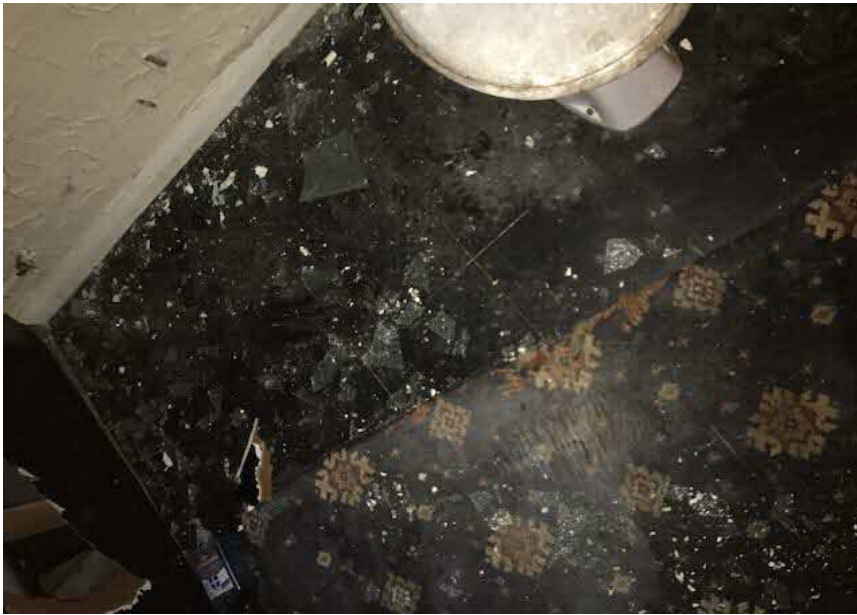
Sample reference 05 – Floor tiles

The bulk sample of floor tiles taken from the bathroom located on the ground floor of the property has proven negative to contain asbestos, **no asbestos detected**; therefore no further action is required for this material.

Sample 05 – Floor tiles – ***No asbestos detected.***

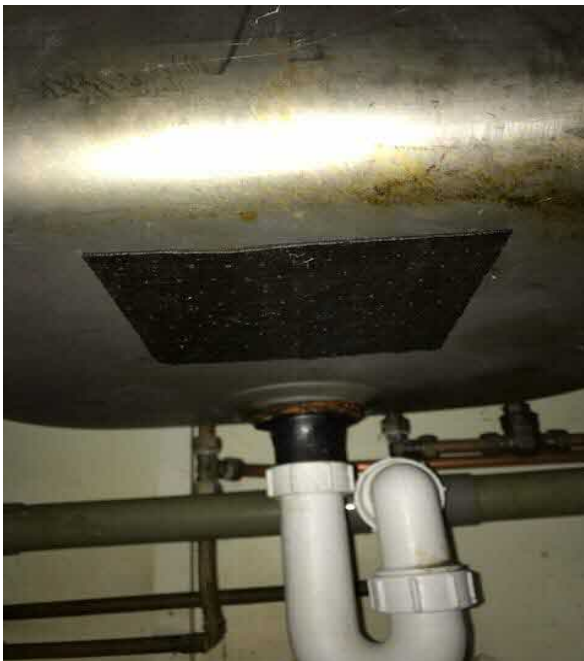
Sample reference 06 – Acoustic sink pad

The bulk sample of acoustic sink pad taken from under the sink of the kitchen located on the ground floor of the property has proven negative to contain asbestos, ***no asbestos detected***; therefore no further action is required for this material.

Sample 06 – Acoustic sink pad – ***No asbestos detected.***

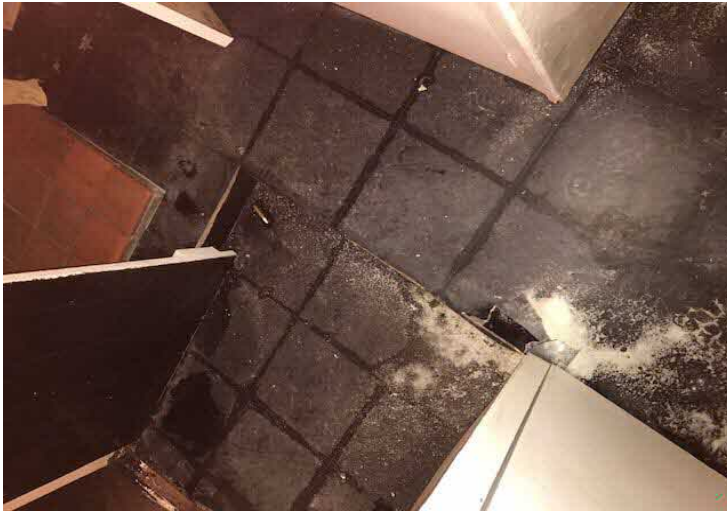
Sample reference 07 – Floor tiles

The bulk sample of floor tiles taken from the lobby located on the ground floor of the property has proven negative to contain asbestos, ***no asbestos detected***; therefore no further action is required for this material.

Sample 07 – Floor tiles – **No asbestos detected.**

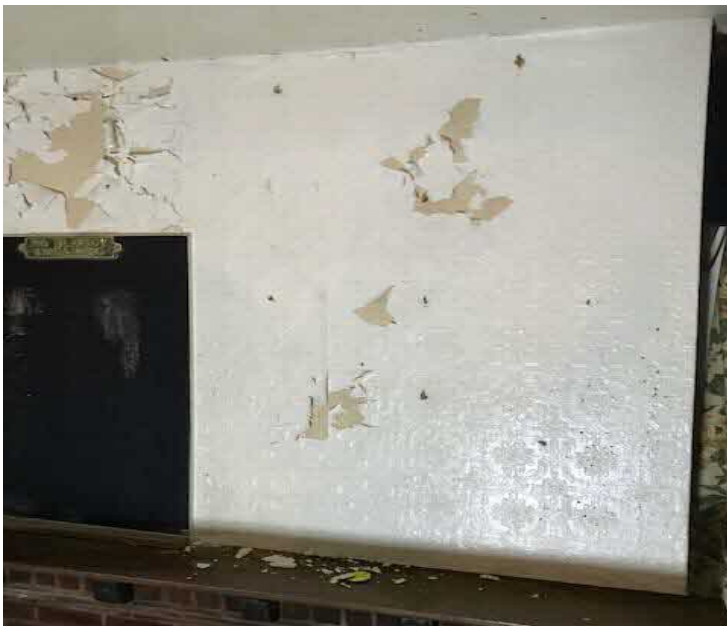
Sample reference 08 – Flaking paint

The bulk sample of flaking paint taken from the walls of the front bar located on the ground floor of the property has proven negative to contain asbestos, ***no asbestos detected***; therefore no further action is required for this material.

Sample 08 – Flaking paint - **No asbestos detected.**
