First floor Repairs 1

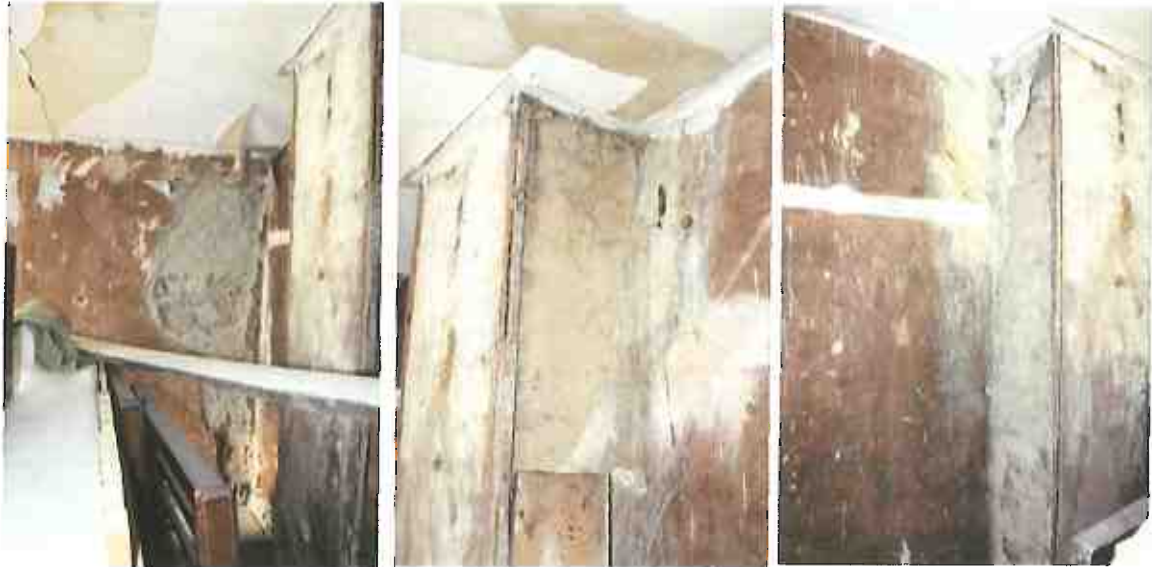
The walls were covered in soft-board so underneath were some areas that need addressing. In the corner of the room and either side of a disused chimney stack the lime plaster had fallen off.

This will be plastered with lime hemp plaster.

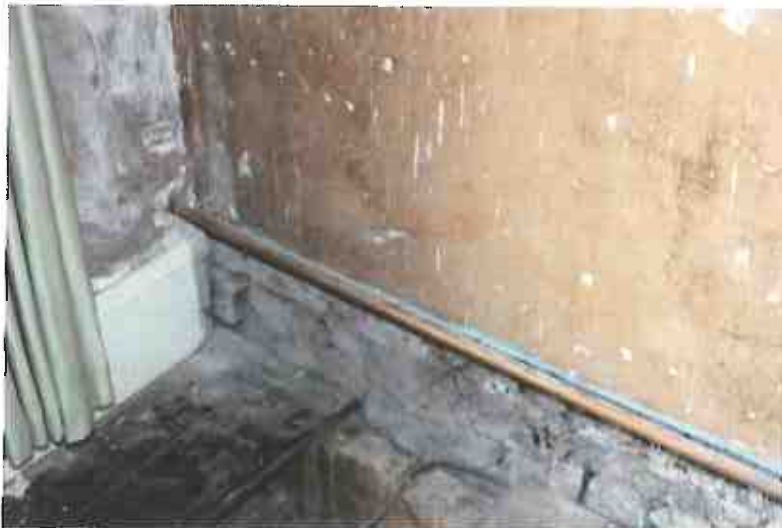
At the end of the room there is a copper pipe that comes up from the toilet below, into the room in one corner above the skirting board and across to the other corner, through the wall and externally across to the waste pipe. This pipe carries the saniflow sewage waste. The plumber will be removing this very

inappropriate layout but the exact route to be used is not fully defined but it will be done according to the pertaining rules and be discreetly hidden.

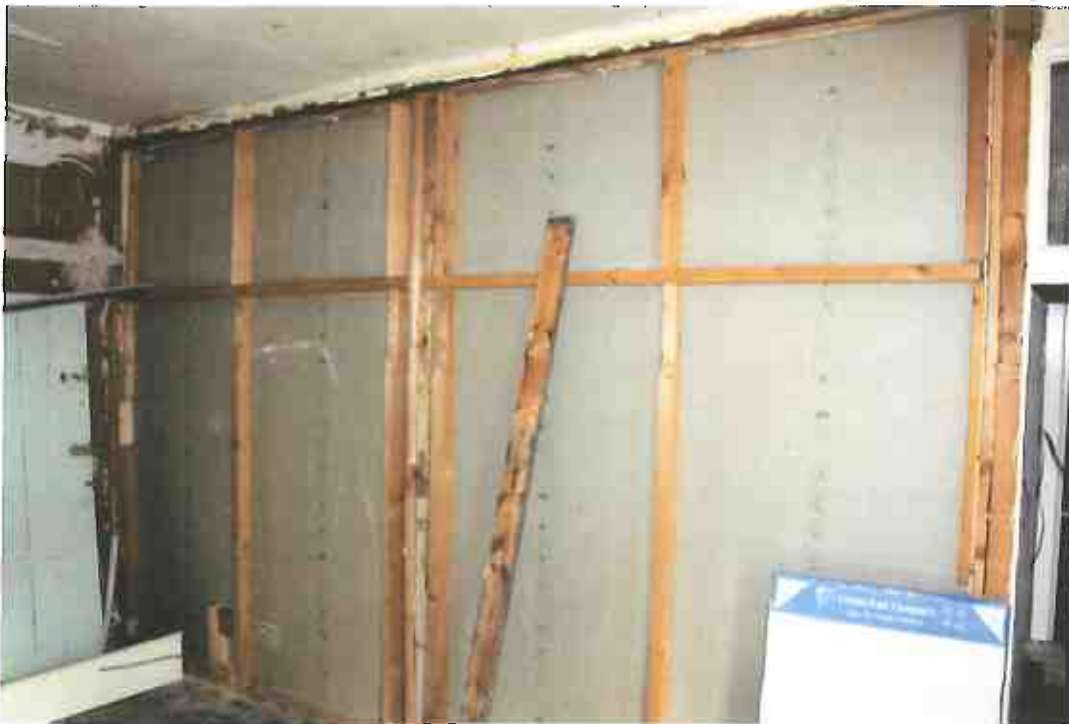
The opposite wall (which was originally covered in soft-board) is of a modern timber frame that has been erected to divide this large open area into 3 bedrooms. The other faces of the partitioning is clad with modern plasterboard so we would propose cladding this section with plasterboard.

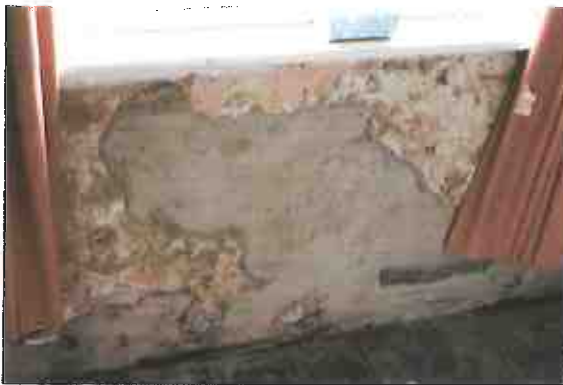
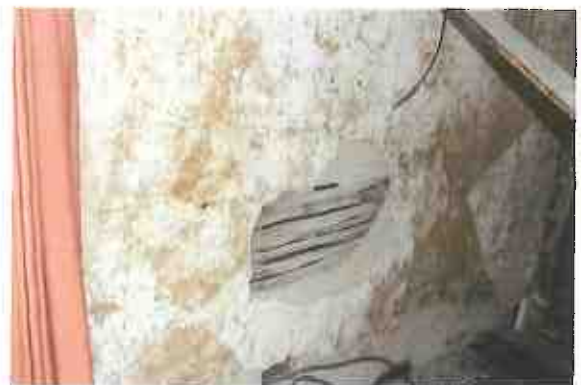
The front wall

In this room the original lime plaster was very soft and falling off. To minimise the loss of the original plaster I injected some areas with glue to reattach it to the laths and strengthen the plaster. However there are a number of large patches that require plastering which will be done with lime hemp and a small amount of laths will be replaced. All of the walls in the room will need to be painted with a vapour open mineral primer then skimmed with a lime top coat to firm the plaster up and provide a good surface for painting with a breathable paint.

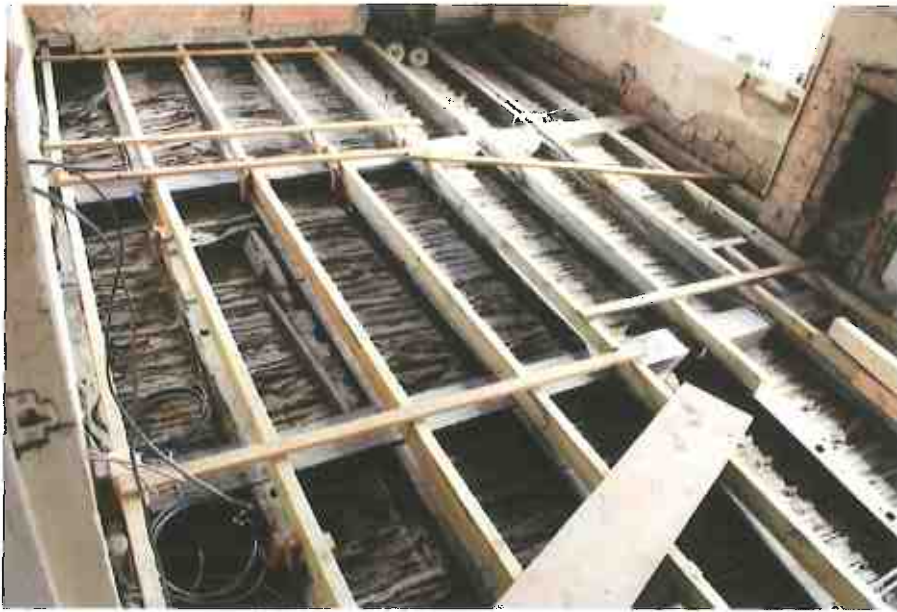
This room has the only oak floor which has been carefully lifted, numbered, and temporarily removed. The floor slopes from the front end corner, across to the doorway, requiring up to 175 mm of “packing” to level the surface. The wooden packing illustrated below is resting on the original oak beams but not fixed, so the cables and pipework can be located between the original beams and the oak floor which will be re-laid after the wiring and plumbing is finished.

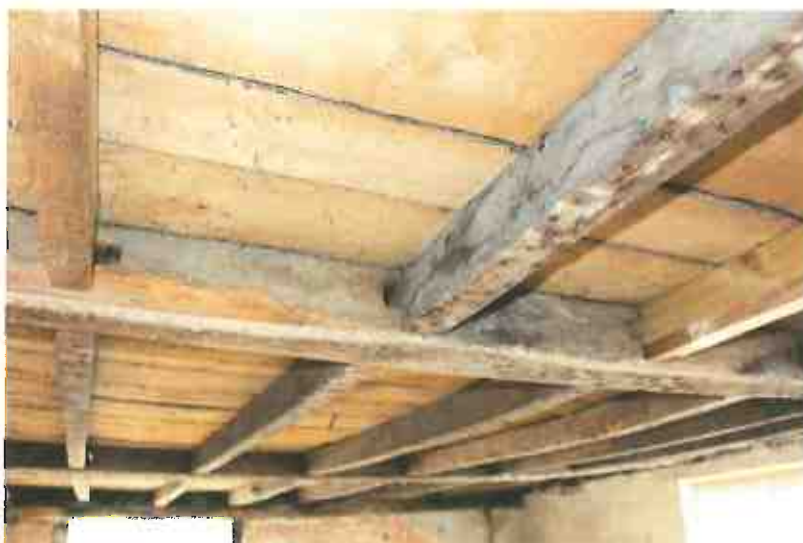
The ceiling was covered in sagging soft-board which has been removed. A couple of spars had to be replaced due to excessive woodworm and in one case due to a large rat hole gnawed through the middle.

For simplicity we would prefer to replace this ceiling with modern plaster board as has been done in the dividing walls between bedrooms 1,2,and 5.

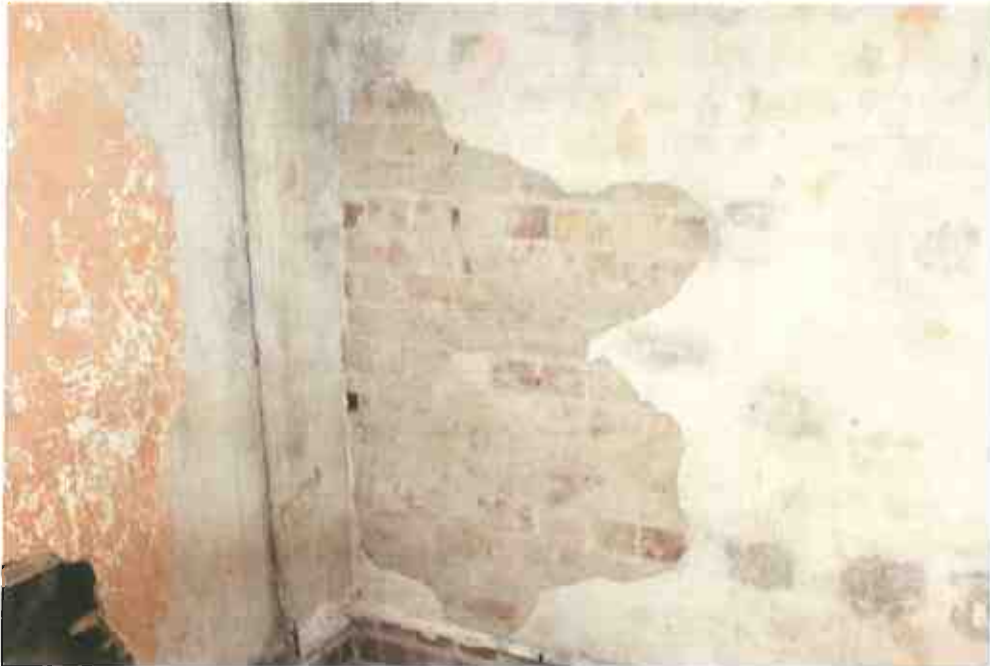
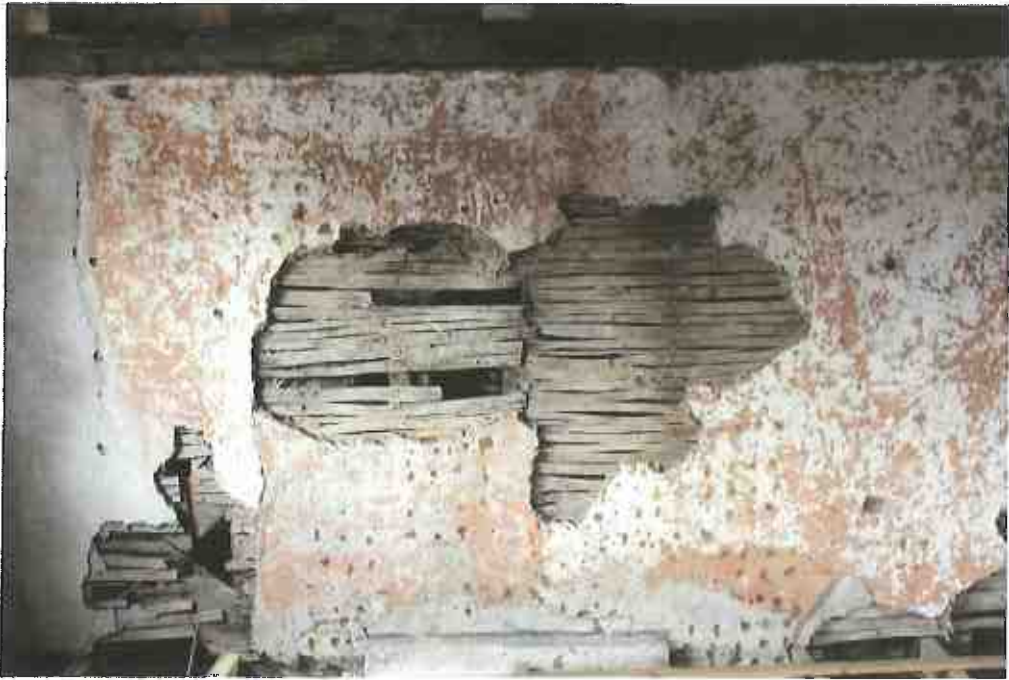
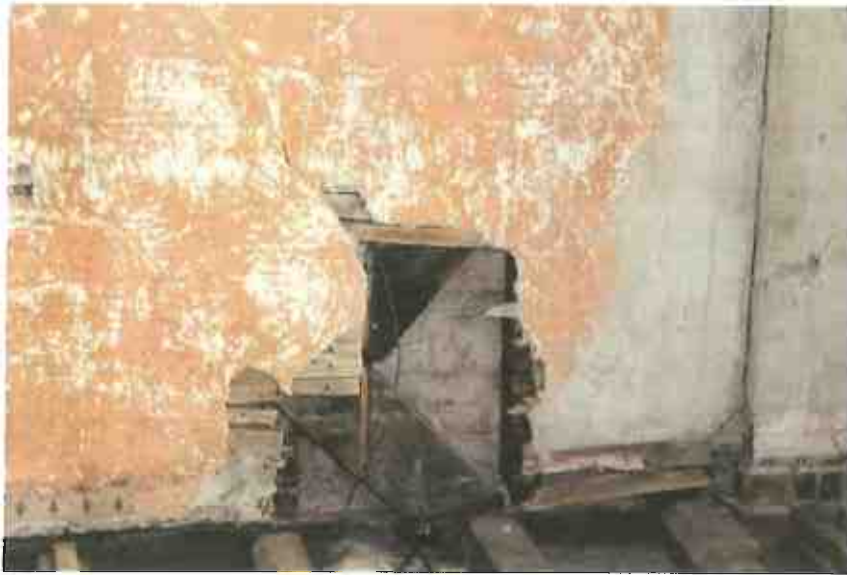
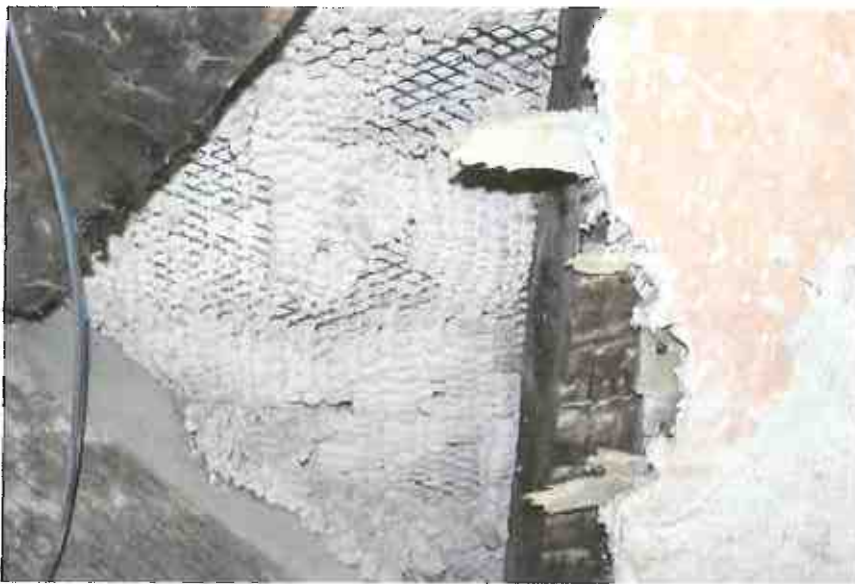
There are some sections of the wall where the lime plaster has come away from the brick wall and lath walls.

On this picture you can see the way the sprayed cement rough render coating was applied over a steel mesh across the entire front of the house

These areas will be plastered with lime hemp, after missing laths are replaced.

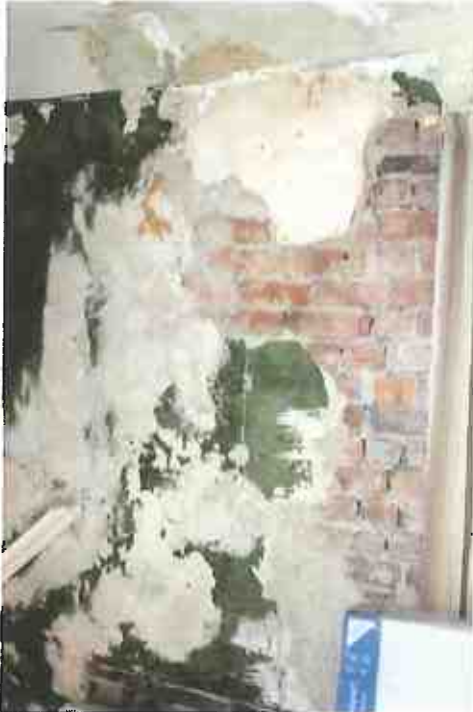
Top of the stairs

On the outside brick wall some modern plaster was used to patch up the original lime plaster. This new plaster had subsequently failed and was coming off the wall, so it was removed.

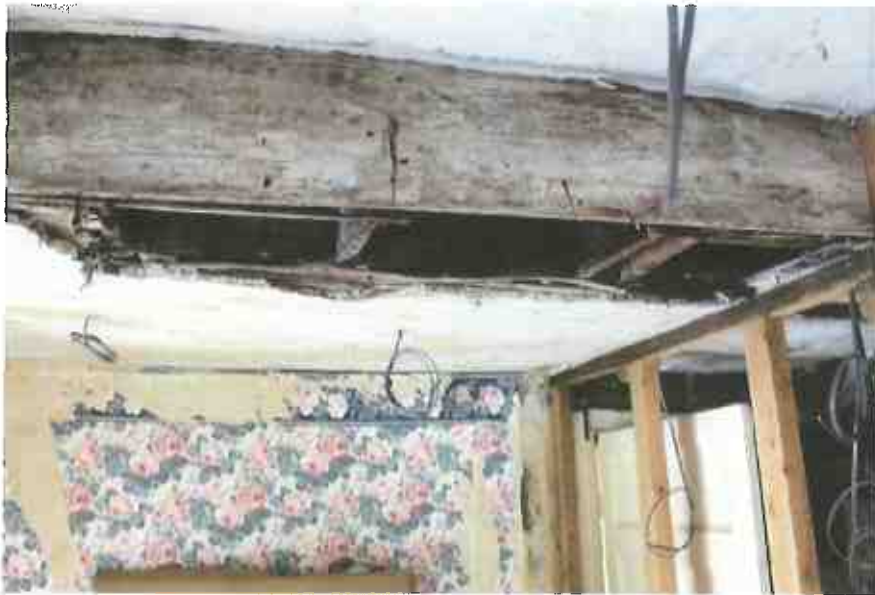
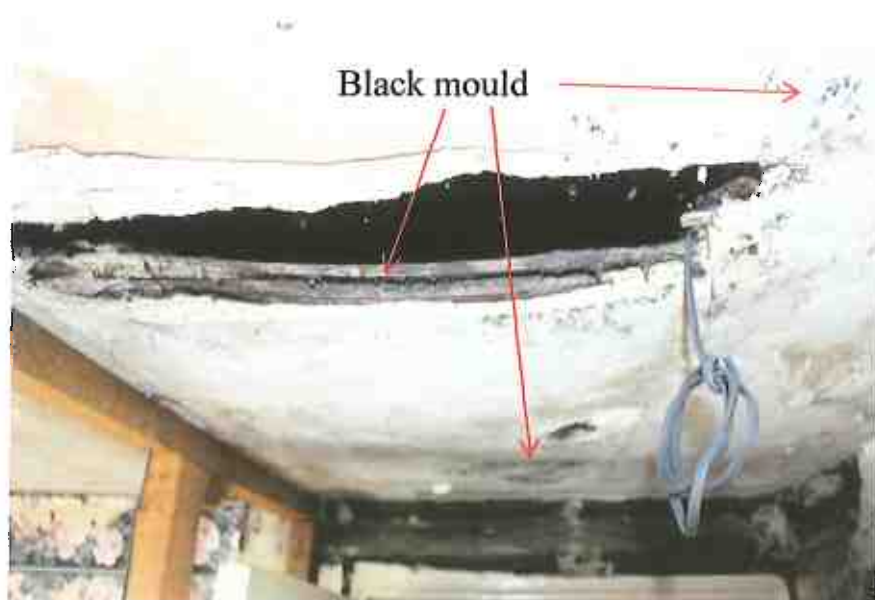
There is a section of the bathroom and hall ceiling which has been water damaged due to a slipped slate tile on the roof. The laths have rotted and have black mould on them. This section of ceiling will have to be removed back to sound laths and plaster then new lathes replaced and plastered with lime hemp.

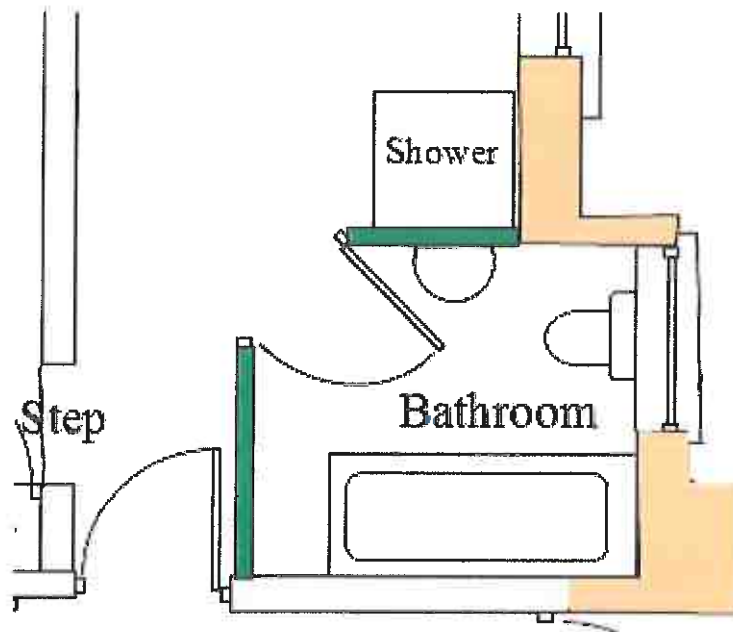
A small change is proposed to the bathroom, with the original layout below. The walls were modern timber frame with soft-board covering. The toilet was backing onto the window with no privacy unless the curtains were closed. An external shower (made out of a converted metal hearing aid testing booth) was added later for the elderly residents.
