Ground floor repairs

Ground floor Repairs 1

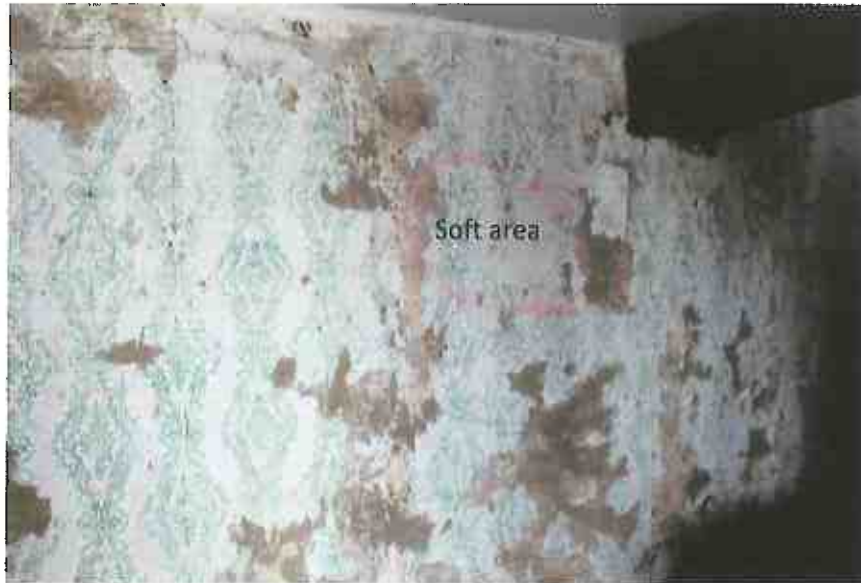
- 1) The wall in front right reception room is very soft in some sections on the wall that is adjacent to the small cellar. The lime plaster is spongy with the laths moving (in patches) so some repair to strengthen these areas will need to be done. Perhaps injecting a glue to reinforce and stabilise these areas.

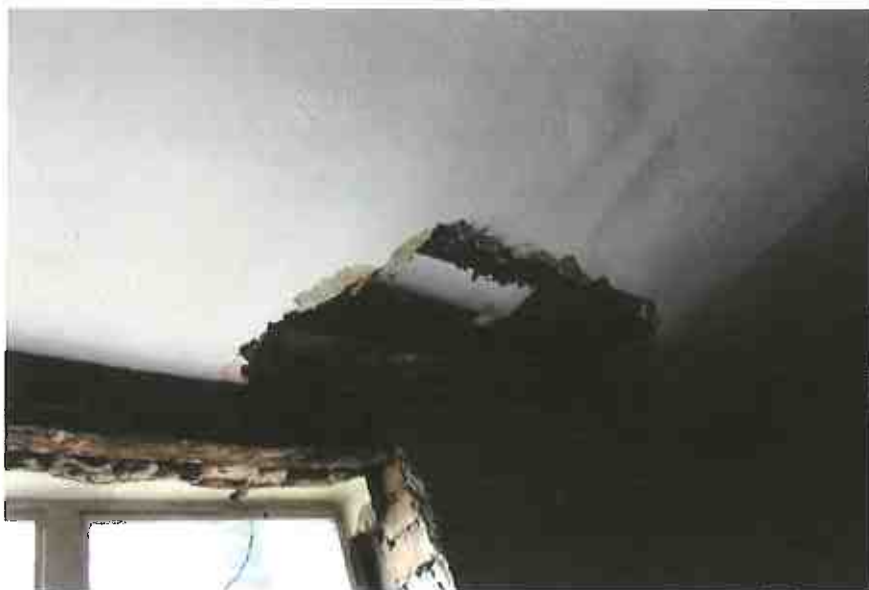
- 2) The kitchen ceiling has an area which is below the bathroom where the laths were rotten and not supporting the lime plaster, which looks like historical water damage.

This area will have new laths nailed up and the patch lime plastered

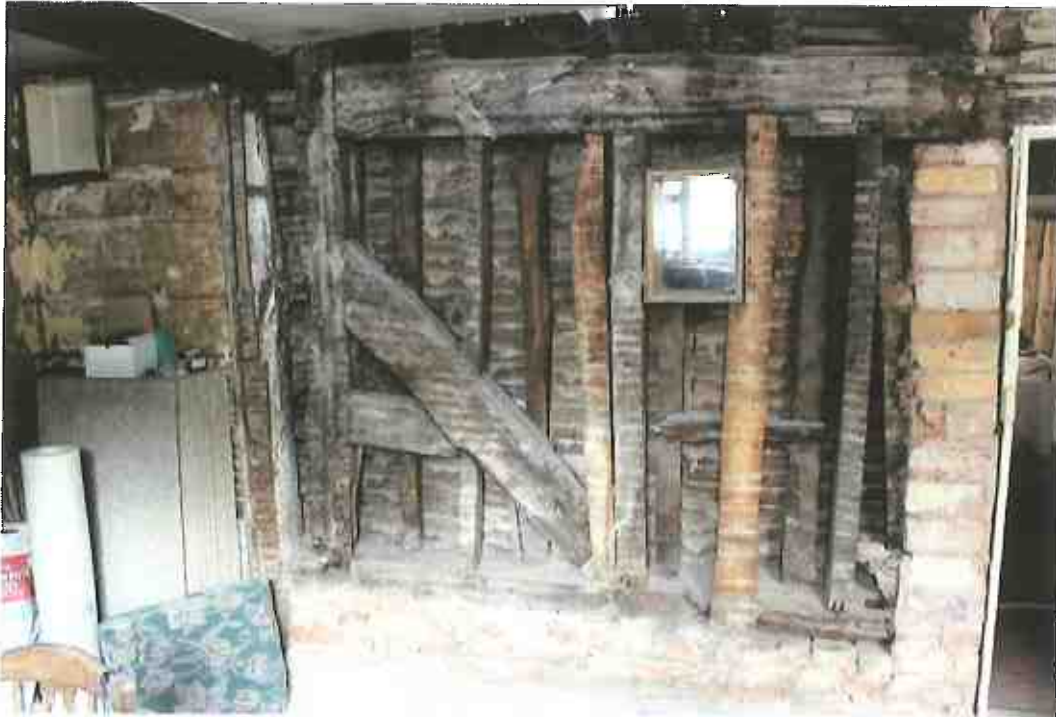
- 3) In this area the lime plaster over laths was extremely poor and crumbling so under advice from a specialist lime plastering tradesman, the lime plaster and laths were removed exposing the wall structure as below.

Under advice the proposed repair is to use woodfibre board screwed to the structural wood frame to provide a flat surface, then plaster with lime hemp with a layer of plastic render mesh embedded in the plaster to help with the shrinkage.

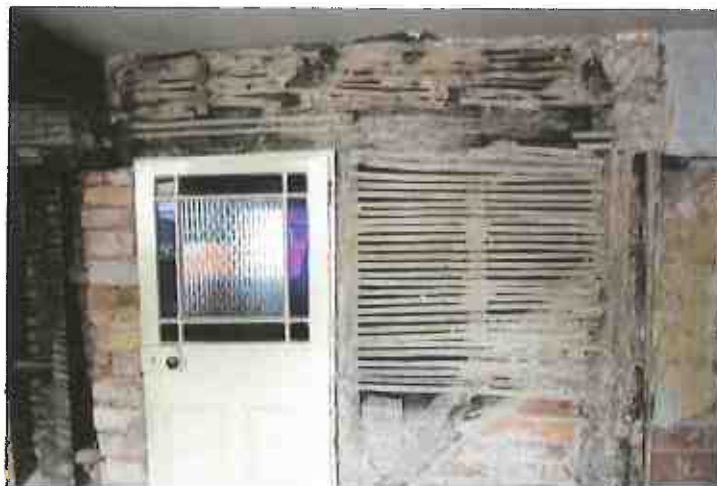
- 4) Further along this wall there is a section where the laths are ok but the lime plaster was crumbling, so this area will just be plastered with new lime hemp plaster.

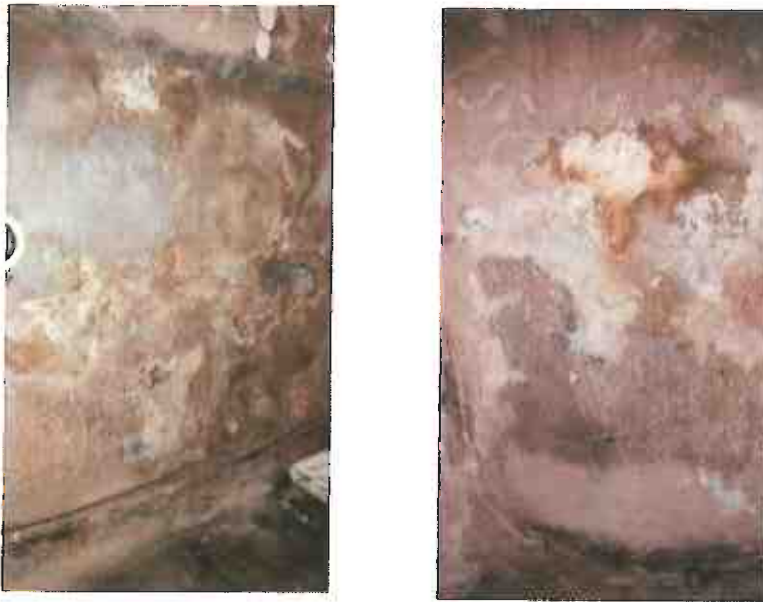
Kitchen external wall

- 5) The outside wall of the kitchen was renewed at some time with modern render and plaster applied, which had succumbed to damp penetrating through the wall. The ground level at the back of the house is too high, allowing water to soak through the wall, from the “drain system”. This was water running into a leaky brick built gulley to an open drain. This exposed open gulley was used for roof drainage, bathroom sink, shower, bath, and downstairs sink. So this drain system will need to be addressed, and the outside ground level by the wall lowered.

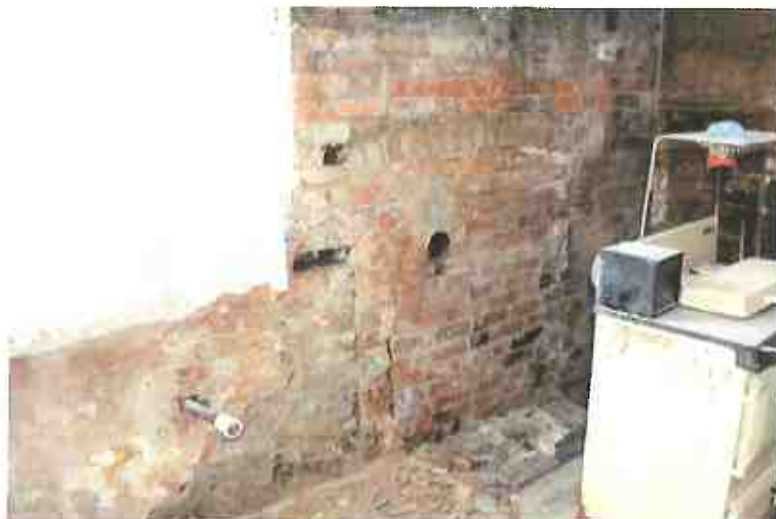
This cement render and modern plaster was completely removed (again on expert advice) and taken back to bare brick

This wall will be rendered with lime hemp plaster , medium 2x9mm, fine 2x6mm then the finish coats, which will be done in all areas requiring repair.

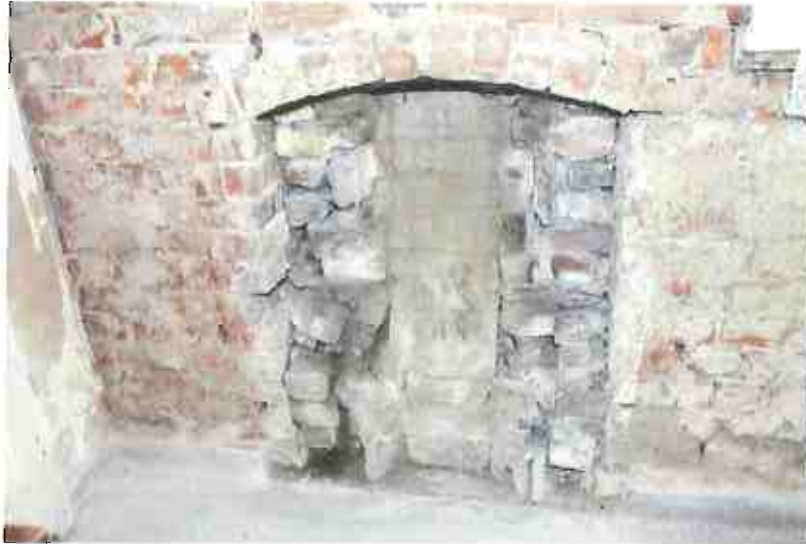
In the position (5) there are the remains of a fire place that we would like to brick up (using lime mortar) then lime hemp plaster over.

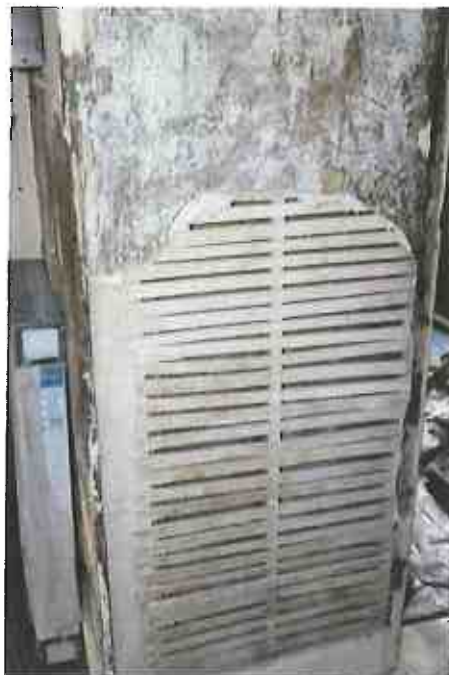
- 6) In the hallway there is a section of lime plastered wall where the laths were only nailed either end (700mm stretch) and the plaster had been stressed so was falling off. This plaster has been removed , the laths nailed to the middle strut (stainless steel nails used) ready for plastering with lime hemp plaster.

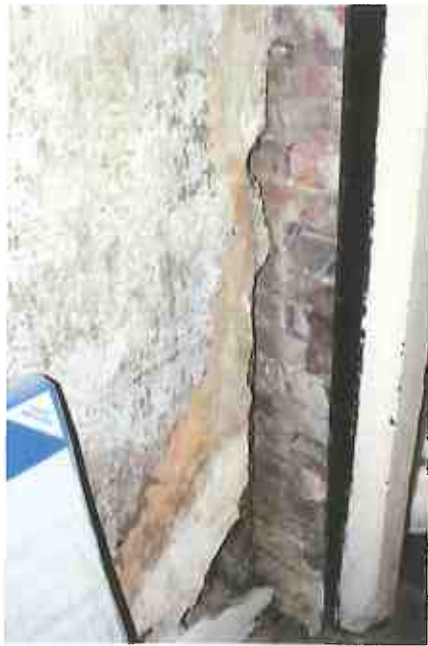
- 7) Further along the rear hallway there is damage to the wood and plaster.
See below :

This will be patched up with some laths and lime hemp plaster, with the bottom skirting board rotted section removed and a replica insert installed. This wood rot was caused by years of the hot water pipework leaking.

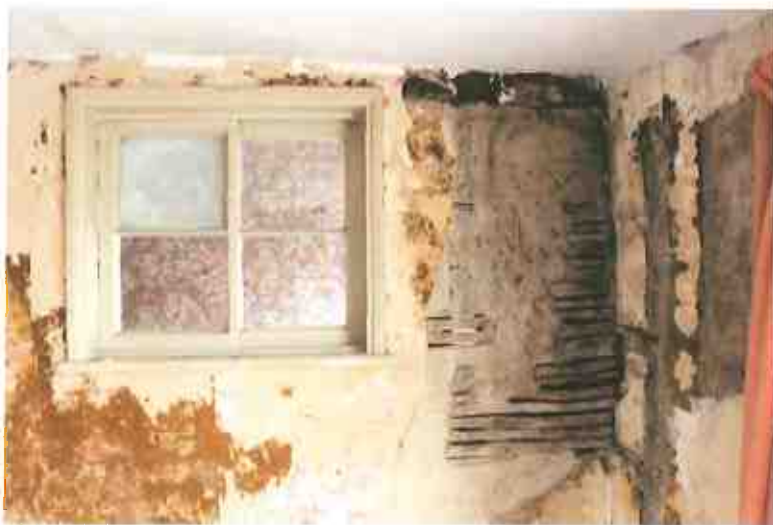
- 8) In the middle reception room a patch of plaster fell off the laths when removing the wallpaper.

This area of wall will be repaired with lime hemp plaster.

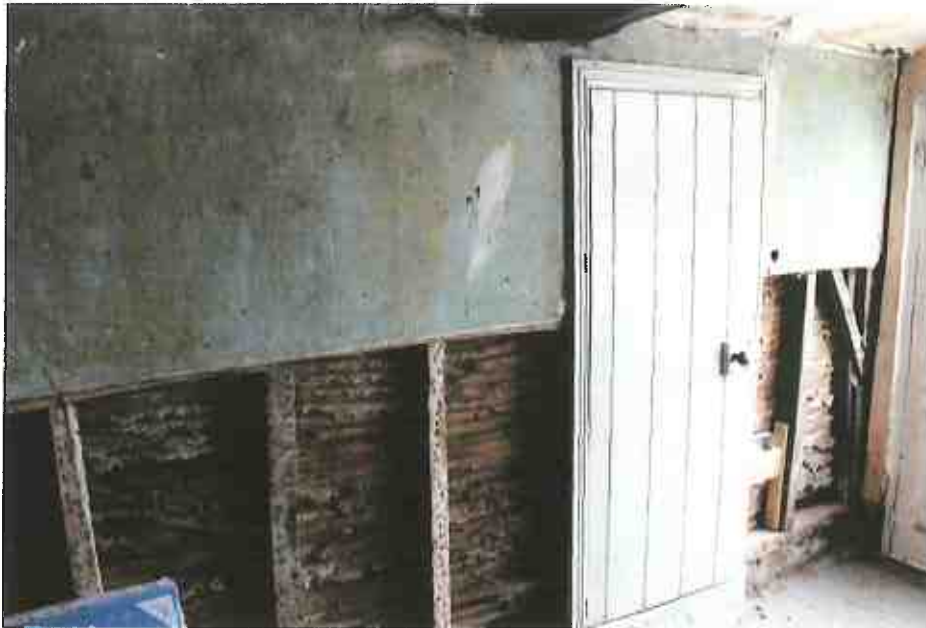
- 9) The far left reception room has no plaster on the lower half of the wall. This was found after the flammable soft-board covering this wall was removed.

Again following expert advice we will apply woodfibre board screwed to the structural wood frame to provide a flat surface, then plaster with lime hemp with a layer of plastic render mesh embedded in the plaster to help with the shrinkage.

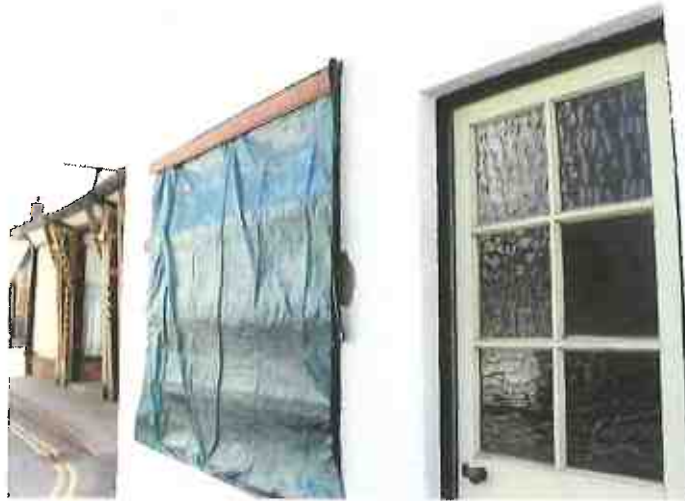
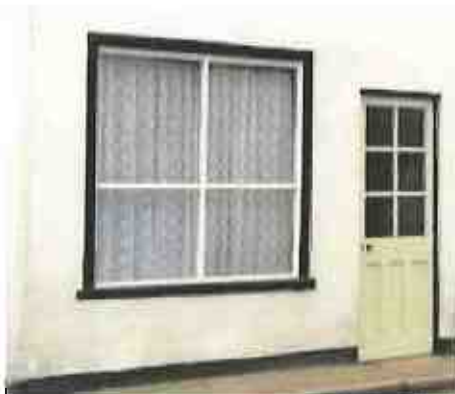
Damaged window boarded up

In April 2022 there was an accident, a tractor towing a plough parked in front of the house. When the driver returned he reversed and did not make allowance for the plough which rotated and ripped into the house damaging a small section of the rendered front wall and ripping out the large window and frame smashing the wood and all of the glass, fortunately no one was injured.

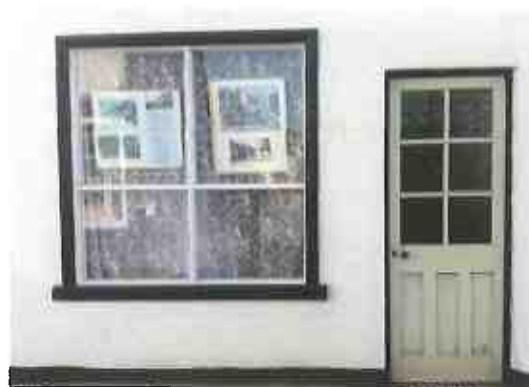
Original window before damage

This original window was renewed, probably when the corner of the house was damaged (so mid 20th century). This window was constructed by an amateur using various pieces of soft wood nailed together. The window panes were installed using very small beading on the inside .

The glass varying from 4mm to 7mm in thickness. The central horizontal bar was attached to the outside with another piece nailed inside which simulated a proper framework, but the right hand side was one single piece from top to bottom.

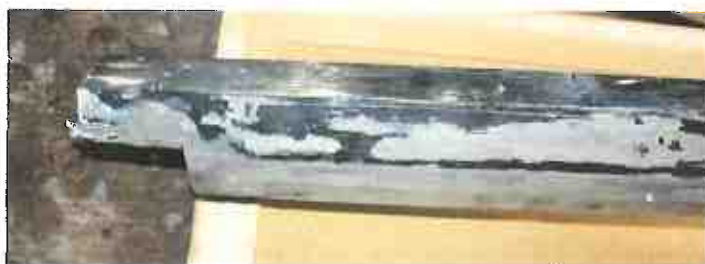
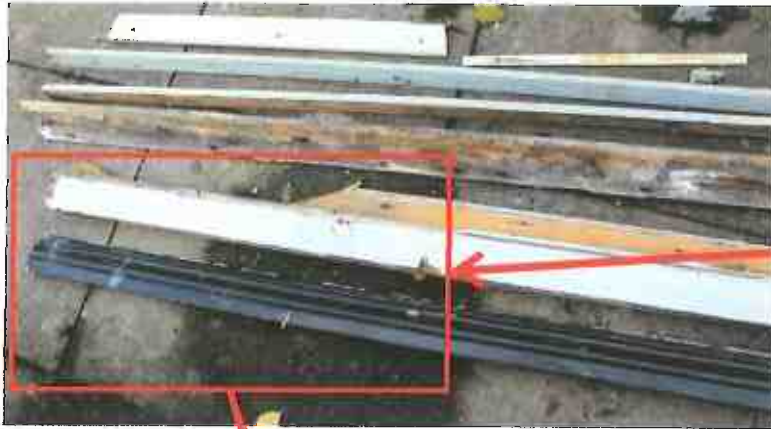
Some of the wood from the original frame

The frame around the outside looked good on the black painted side but was rotting in places on the back

The wood on the sill was alright but had been replaced from the original so was considered of no historical significance.

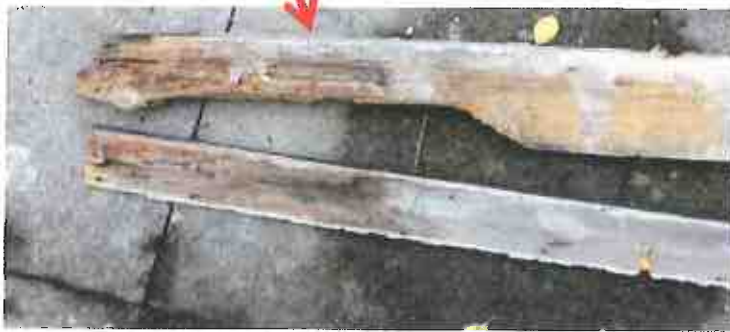
The white section is the vertical right hand side of the original window frame, with the notch being where the metal of the plough ripped through the window

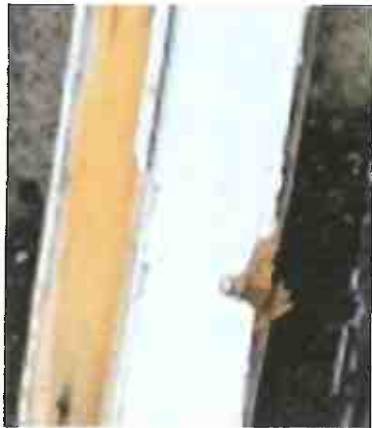
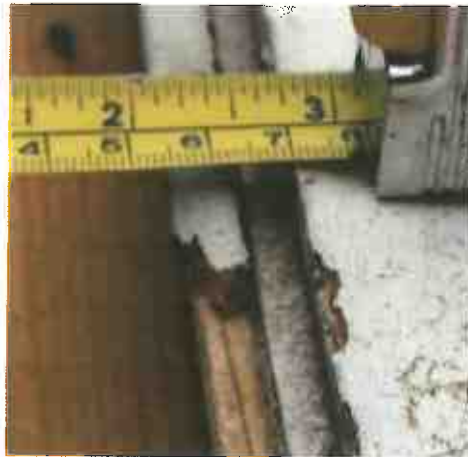
These pictures illustrate the condition of the frame on the underside, illustrating the rot in places

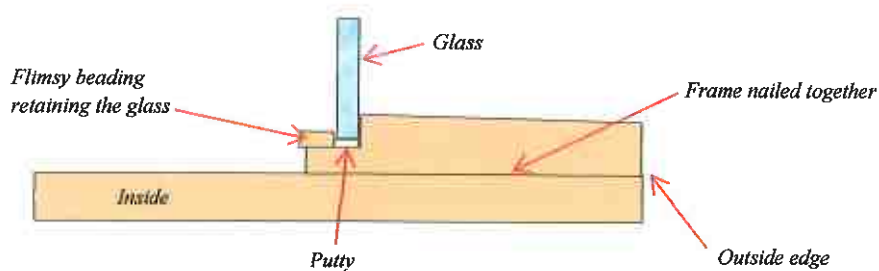
The picture above and illustration below is of the right hand vertical frame showing the very thin fragile beading which was used to retain the window pane.
