Building Fabric Inspection Report

Inspection date 22.2.22

Report Date 24.03.22

19 High Street, Hawick

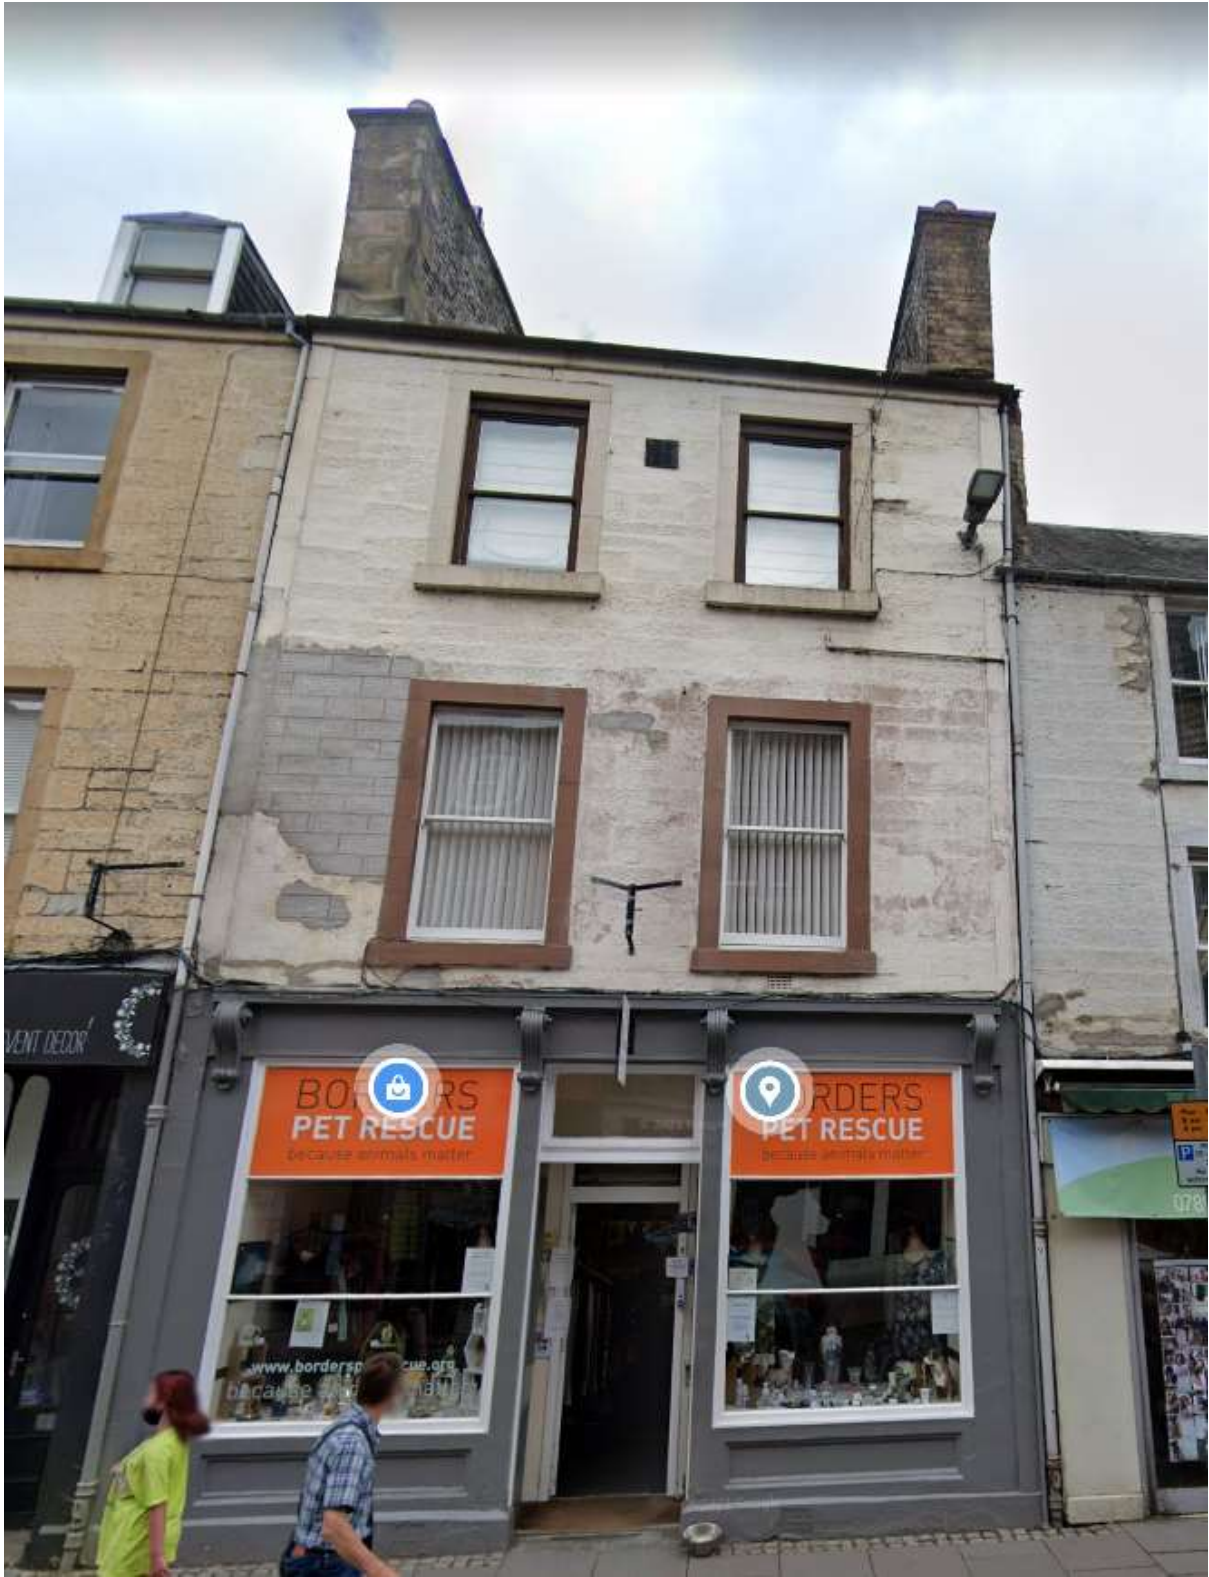
Main Front Elevation to High Street

2. Chimneys are largely sound but require some repairs to copes and re-pointing, Vent cowls should be fitted to the Pots.
3. Elevations The front elevation has received many cement patches over the years we would recommend a general overhaul removal of loose paint and render. A detail inspection of the finishes from scaffolding local repairs should be carried as necessary and recoating/decoration with a breathable paint to tidy. We would not recommend removal of cement elements at this stage as this would cause more damage than good. Rear elevations although not closely inspected should receive inspection from a scaffold. However, from the ground look sound bar the left-hand verge area mentioned.

4. Shop front cornice has no cover flashing and is bare ply and water ingress might be occurring. Further investigation is required, and a new ply base/lead cover flashing fitted over shop front.

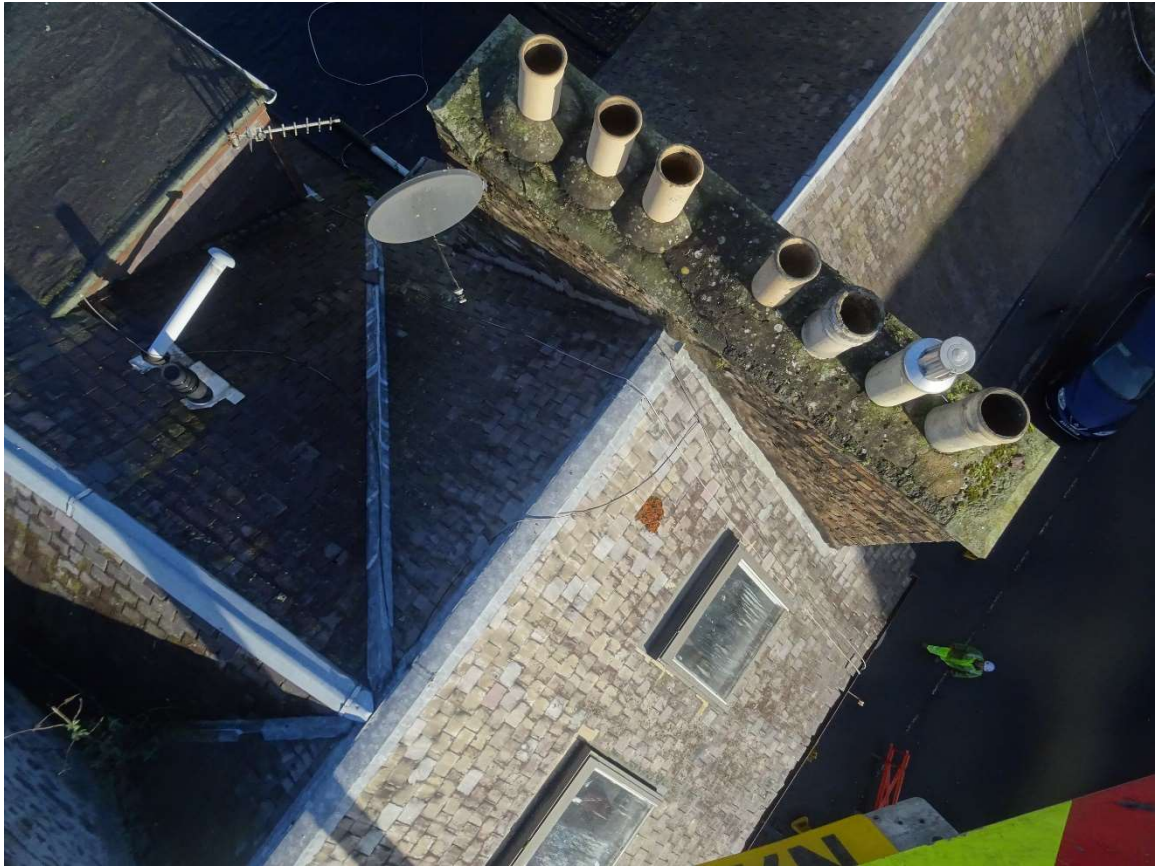
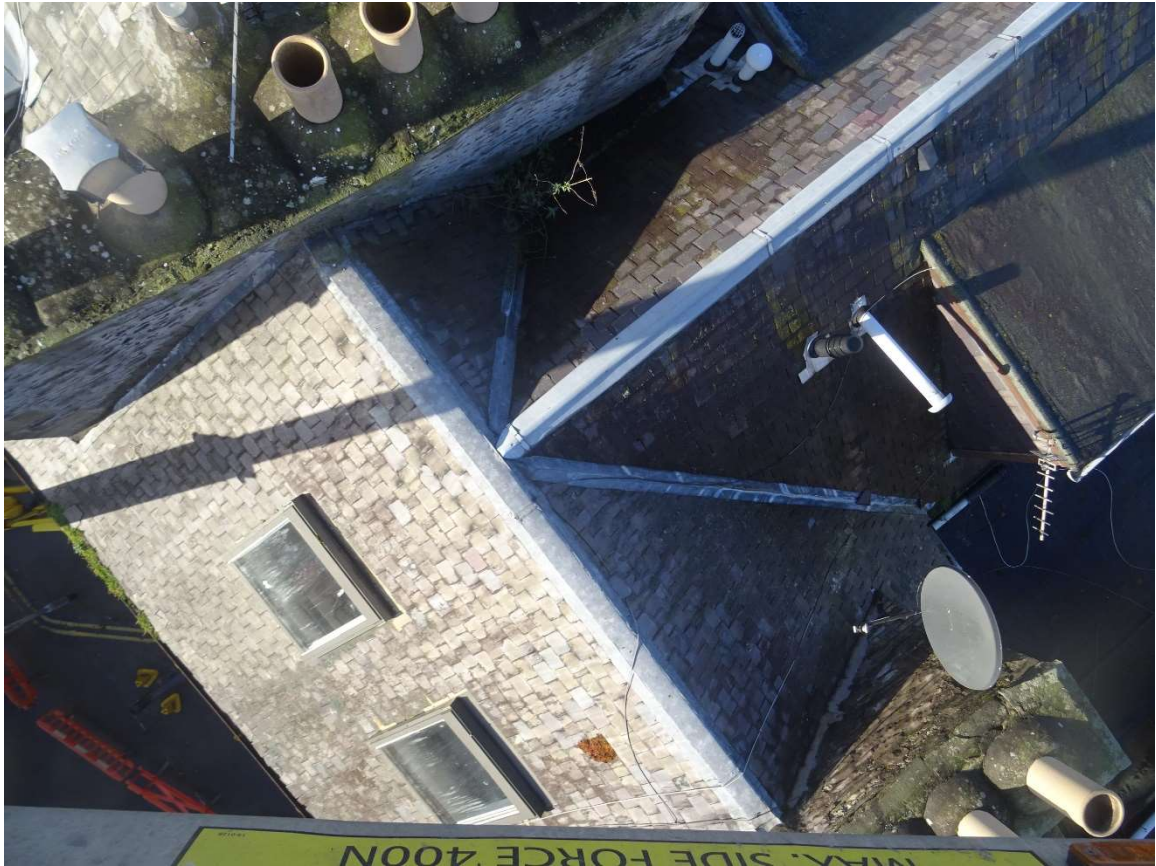
Looking Down on the main roof

Cat
<p>1.0 Main roof - Front roof pitch to Street (Southeast) Existing slate roof incorporating two Velux windows added as later addition This is assumed to be the original slate roof. Many slates have slipped, and the sarking is visible (32,7) a patch has been attempted with spray foam (77,106) the roof nails appear to be corroded. The roof is in need of a full refurbishment.</p> <p>There does not appear to be any felt underlay to the roof.</p> <p><u>Flashings</u> Flashing to chimneys to the r/h chimney lead cover have been fitted over the slates and is untidy and this has a cement skew/cover over which is cracked and it potentially loose (77,41,95) . The abutment flashing at the chimney base has visible mechanical fixings and no cover flashings (9)</p> <p>The l/h chimney a cement skew is in place over a lead cover flashing (11,17,12) The lead is badly buckled due to length and cement skew has cracks in numerous places.</p> <p>Ridge flashing - There is a lead ridge flashing that has been nailed directly to the substrate rusted nail heads are visible(108,29)</p>

<u>Recommendation</u>	3/F

<p>Full re- slate re-using existing slate making up with matching approved second hand or new slate to current standards on breathable felt layer (Tyvek supro or equal)</p> <p>It would be advisable to renew velux soaker flashings as part of the works as these will need to be removed and re-instated for the works.</p> <p>All perimeter flashings to chimney and ridge should be renewed along with roof. Lead soaker flashings and cover flashing to new raggle to chimneys,</p> <p>New lead ridge held with clips</p> <p>Further inspection of roof substrate for rot and other degradation allowances should be made for timber/sarking replacement</p> <p>All new leadworks should be accordance with Lead Sheet Training Academy (LSTA) Guidelines</p>	
<p>2.0 Main Rear Slate roof (North West)</p> <p>The slate of this roof is similar to front roof with the rear abutment there is evidence of slipped slates and repairs(42)</p> <p>Flashings Chimney abutments comments as per item 1 front roof</p> <p>Lead Valley flashings to adjacent roof (42 36) It was not possible to closely examine this there does not appear to be any laps to allow movement.</p>

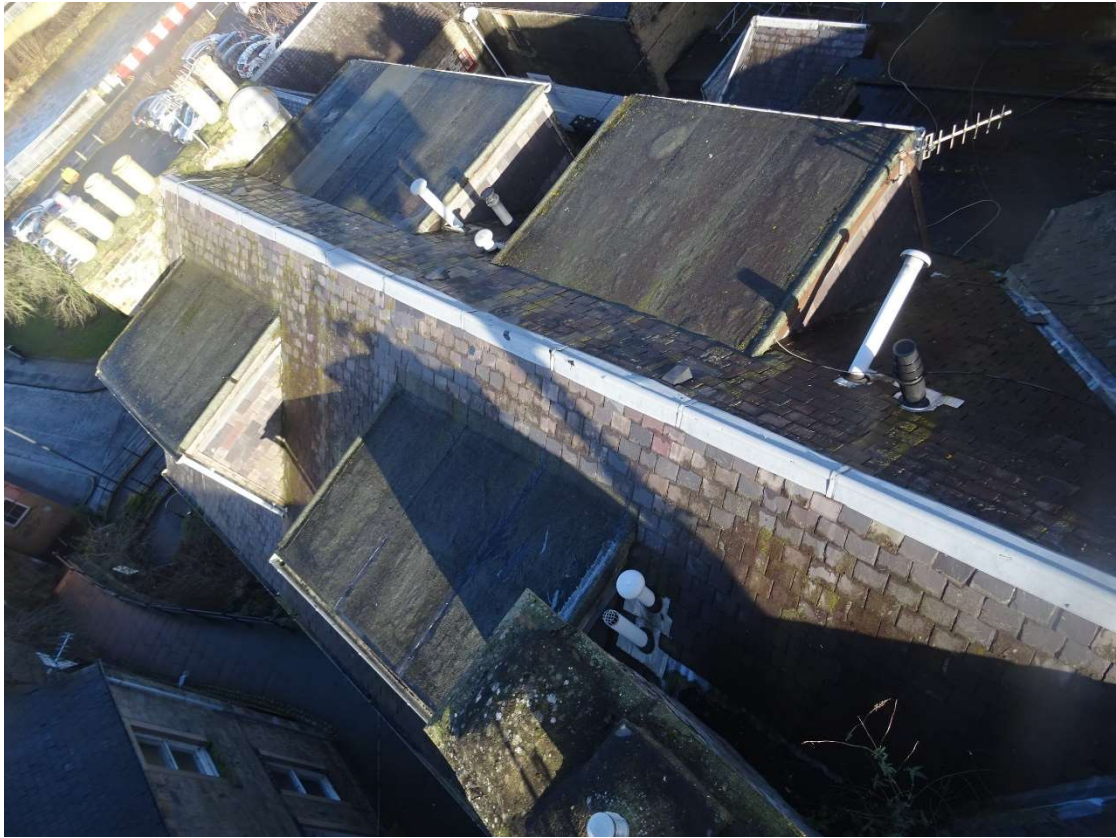
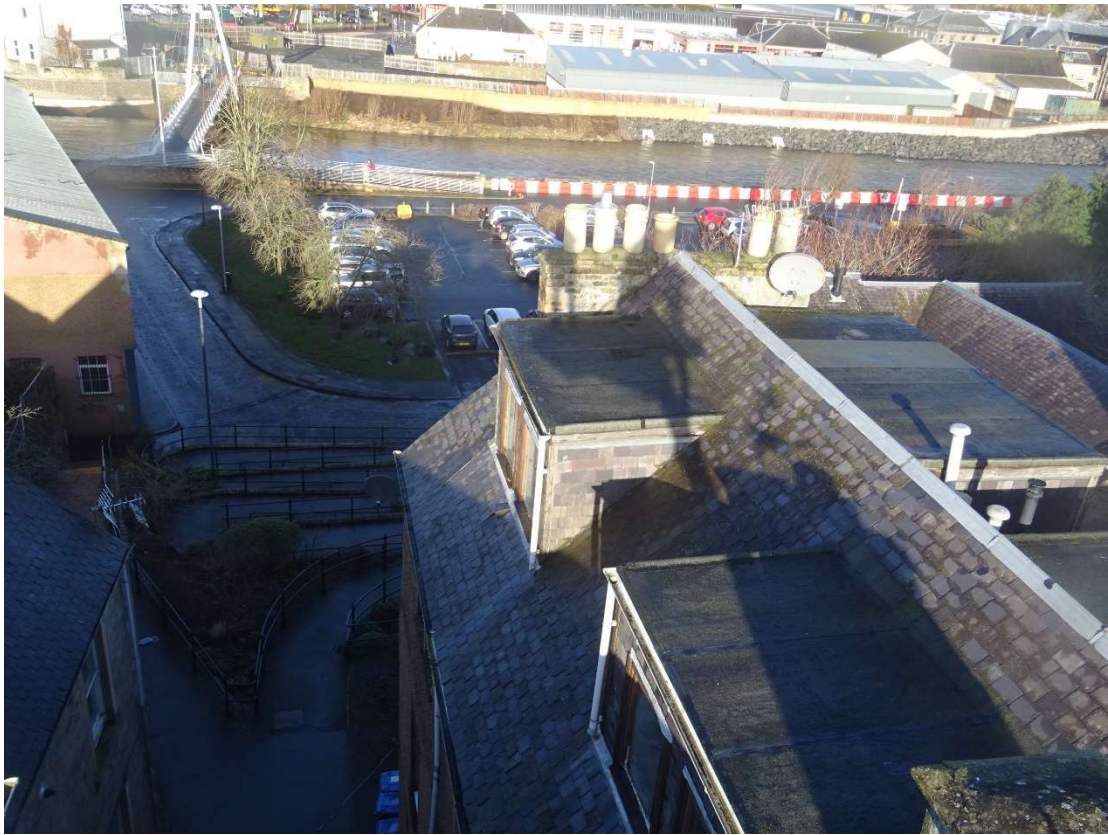
Rear roof and Dormers

The is a lower slate roof that abuts the main roof at the back and a chimney at the Northwest rear gable. This roof incorporates 4 felt covered dormers (97) and also falls to lead gutter valley behind the South west front Chimney which discharges to the main rear roof .

This is more recent roof. There is some evidence of loose slates (19,40) .

The dormer roofs are flat felt roof with abut the main roof and discharge to gutters at their front. There is no evidence of ventilation of the flat roof and the roofs have been heavily patched and show signs of repairs and bubbling and have reached the end of their lives and should be replaced. If these roofs are uninsulated this may have caused a condensation/rot problems in the structure

Existing slate roof to be closely examined overhauled as required. It would be prudent to allow for a full re-slate, but this might not be necessary

Full re-roof with approved slates on breathable roof membrane – This is recommended as installing slate vents and removing slate for abutments for the new dormer roof and general repair will not leave much of the roof left. Full roof refurbishment will negate the need for the vents and provide assurity for the future and overall given the extent of the other works to this roof would make sense.

<p>Slate Abutment to the Northwest Chimney Lead soakers should be installed and cover flashing ragged into chimney</p> <p>The Dormers roofs should be re-roofed options are</p> <p><u>Rear Dormers Option 1 (not recommended)</u> Replace with felt roof as minimum some insulation should be added to alleviate any condensation risk. This option is unlikely to attract CARS grant funding</p> <p><u>Rear Dormers Option 2</u> New single ply roof Sarna fill (better quality) This will last longer than felt again we would recommend insulation is incorporated. This option is unlikely to attract CARS grant funding and would possibly require listed building consent</p> <p><u>Rear Dormers Option 3</u> New standing seam ventilated zinc roof New VM zinc roof on new ply timber deck with ventilation and insulation below. Details will require cross ventilation to roof to be maintained under the new deck.</p>	
<p>4.0 Rear Dormers</p> <p>The 4 dormers are in the rear roof with flat felt roofs falling to gutters to the front they have slated Haffits and fronts and timber facing to the roof edges and slate corners (37,63,72,82,91,92)</p> <p>Dormer Roofs see 3.0</p> <p>Dormer Haffits and fronts (43,50,62,63) It was not possible to see all the slate haffits but those visible (the southeast side of the dormers) did not show any slipped slates and the haffits are serviceable. However, the timber facings to the roof and corners have not been painted and are bleached by the sun although as close inspection was not possible. They may be sound.</p>
