# Structural Inspection Report

## Barns at Corner Farm, Hoxne Barn A

1.01. Superstructures were instructed by J W Havers & Son to undertake a structural inspection at the Corner Farm site with specific regard to the structural stability and integrity of the barns for conversion into residential use via a permitted development route. This report specifically refers to Barn A.

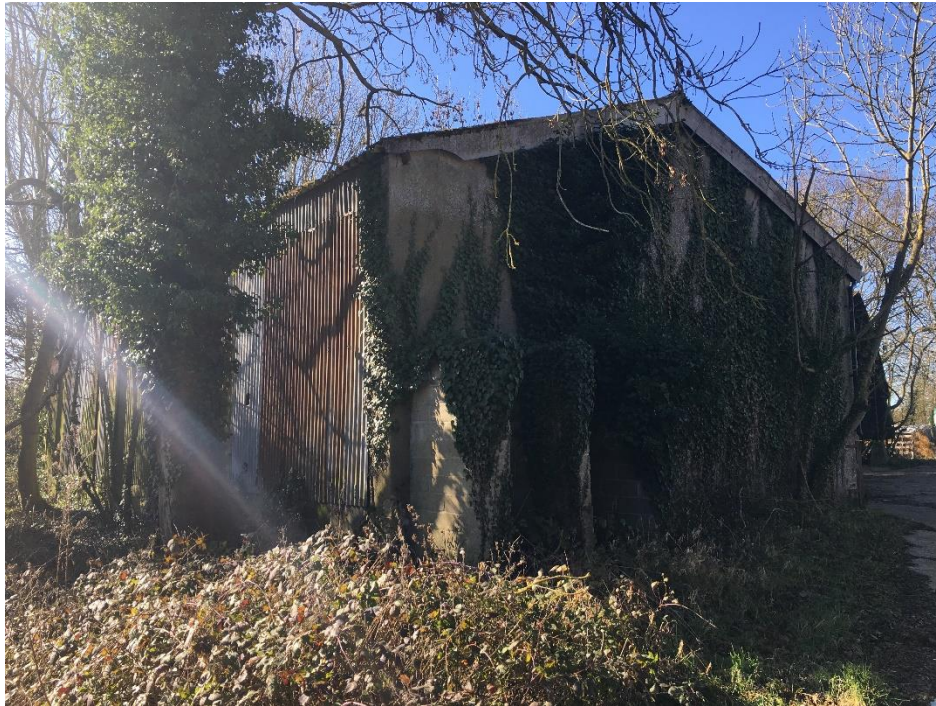
2.05. The barn is positioned on relatively flat site. To the South and East of the barn there are a number of mature trees. The nearest tree to the barn is a substantial mature Ash tree within 1m of the North East corner.

**A1.1** North Gable with mature tree to East side

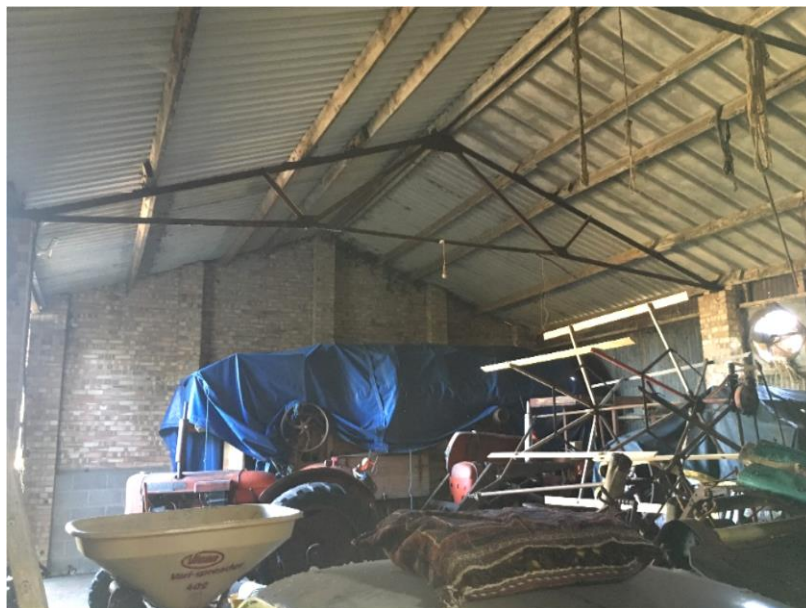
**A1.2** Internal view showing roof and north gable

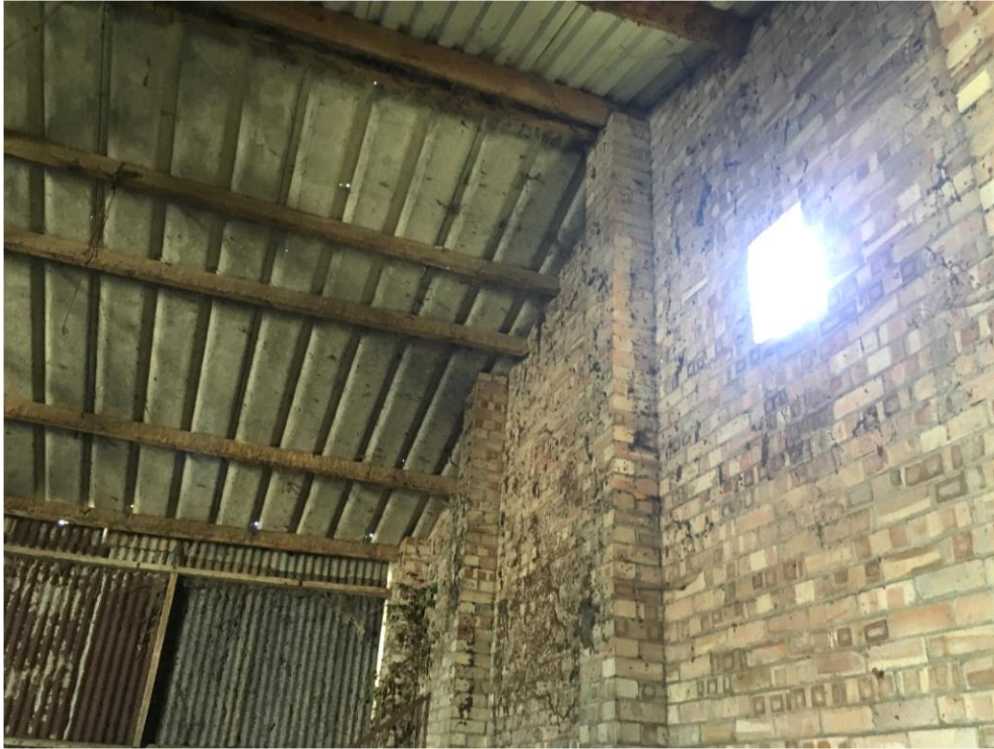
**A1.3.** Internal view of roof and South gable

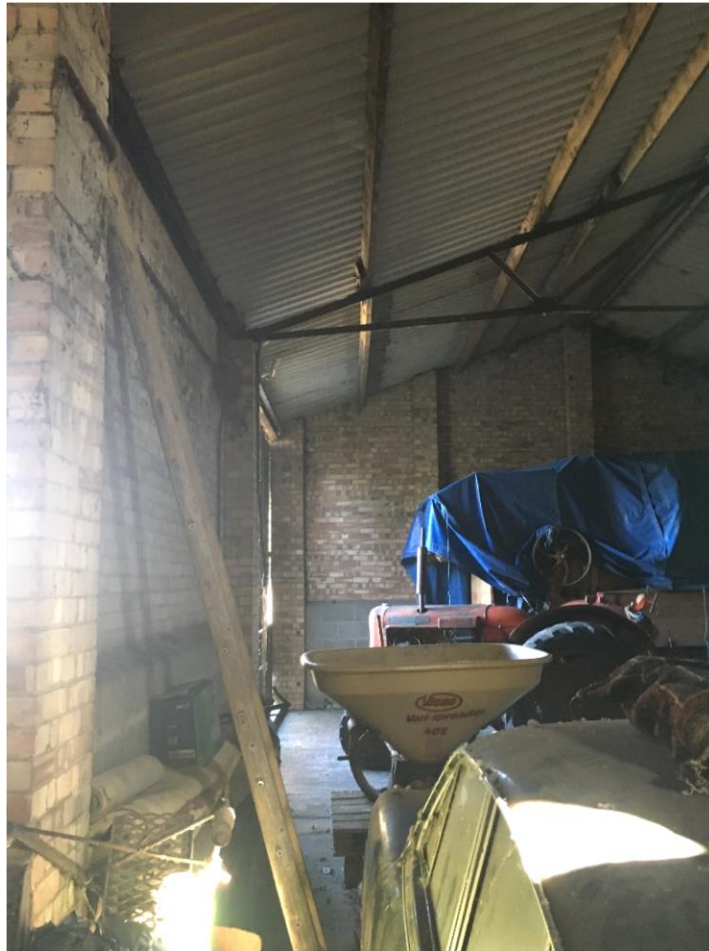
**A1.4** Internal photo west wall and part roof
