Specific Defect Report

Relating to: 23 Old End
Padbury
Buckingham
MK18 2BB

Report date: 6 February 2020

Job reference: DJA/SR/20347

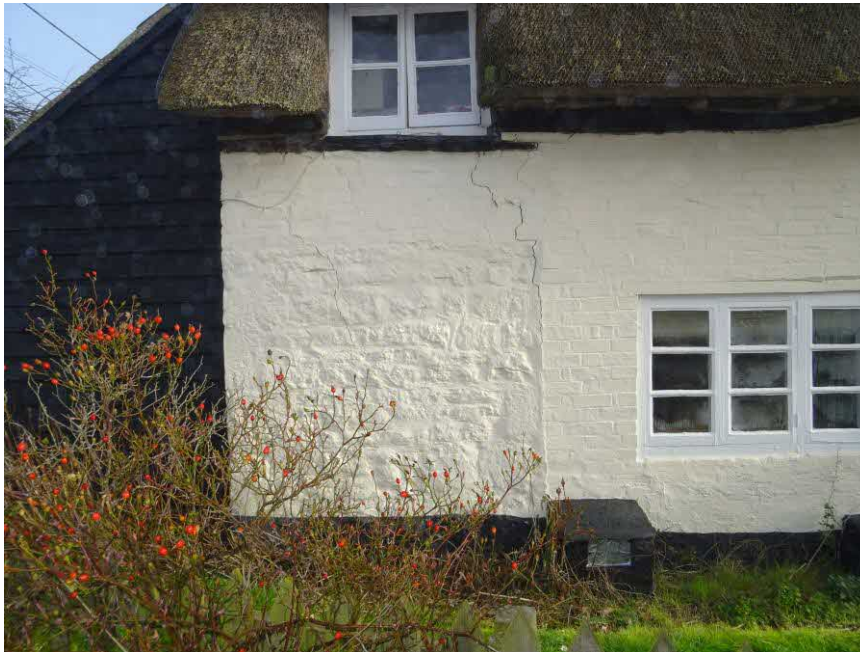
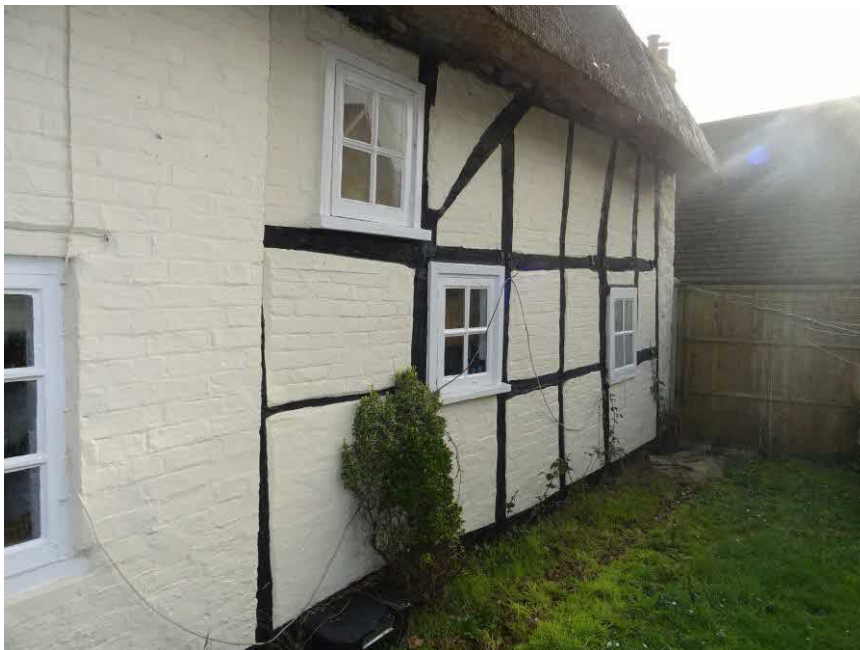
On the right-hand corner there is a vertical joint where we consider there may be rendered rubble stonework joining the brickwork with no tying.

It appears that a sinking of the corner has occurred as there is a significant tapering crack extending from approximately 5mm to 15mm externally where it reaches the eaves level almost to the cill level of the first-floor window.

The movement on the right-hand corner, whilst it may well have been exacerbated by roof spread, has not been totally caused by roof spread as it is a sinking movement of the rear right-hand corner which has pulled away from the joint with the brickwork due to insufficient tying.

Currently the damage to the rear right-hand corner falls into Category 5 “very severe” and as such we consider that the corner is becoming dangerous and if further movement occurs there is a possibility that the corner stonework could fail, which may cause a structural imbalance within the roof structure on that corner causing serious problems.

In the first instance we consider further investigations are required and to this extent trial holes should be excavated around the rear right-hand corner so as to determine if any foundations are present and if there are, on what they are founded, and the properties of the soil in that vicinity.

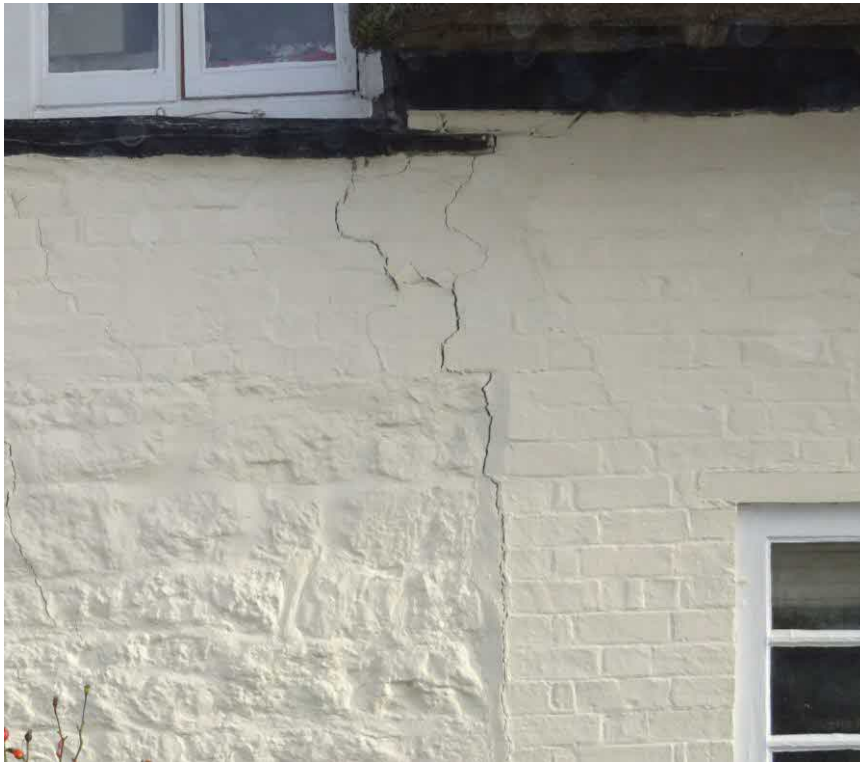
The window at first floor level was also skewed and couldn't be used.

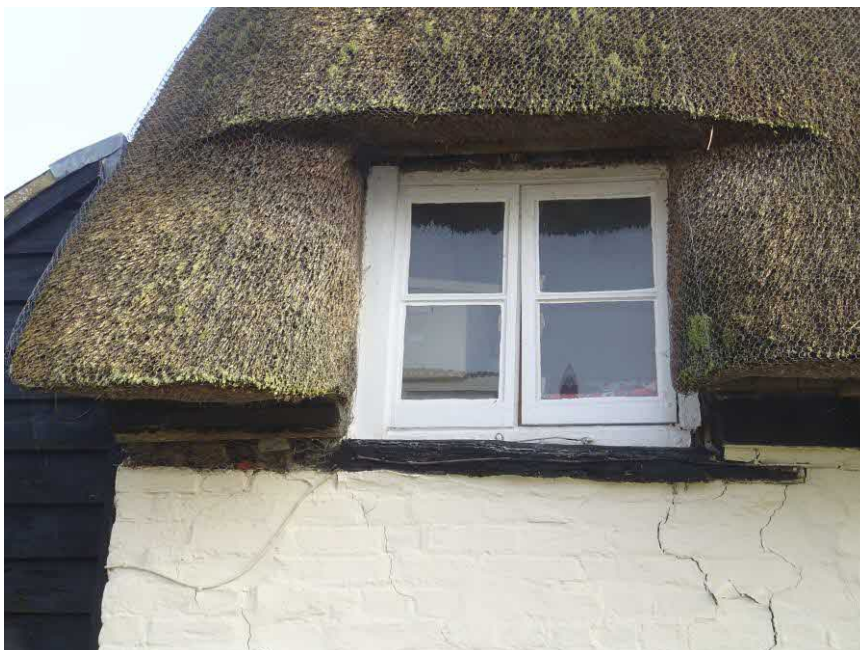
The thatch to the rear roof surface appears in relatively reasonable condition being comparatively thin indicating that the original thatch was removed when the roof was re-thatched in approximately 2005.

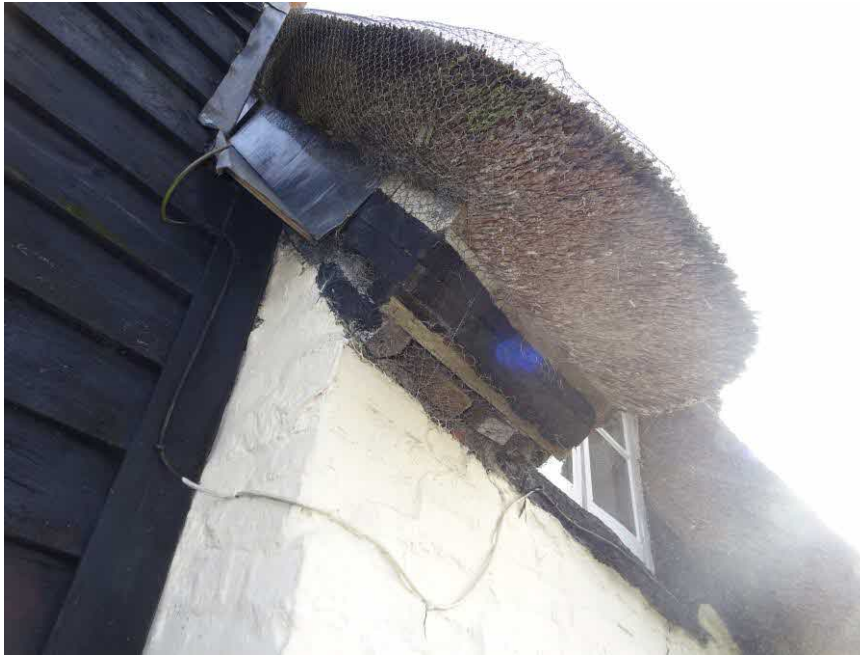
However, the front roof surface appears to have had several over thatches which will have increased the weight to the roof which it was not designed to take.

It is quite often normal for a thin secondary over thatch however in this particular property it appears it may well have had four over thatches which all appear quite substantial.

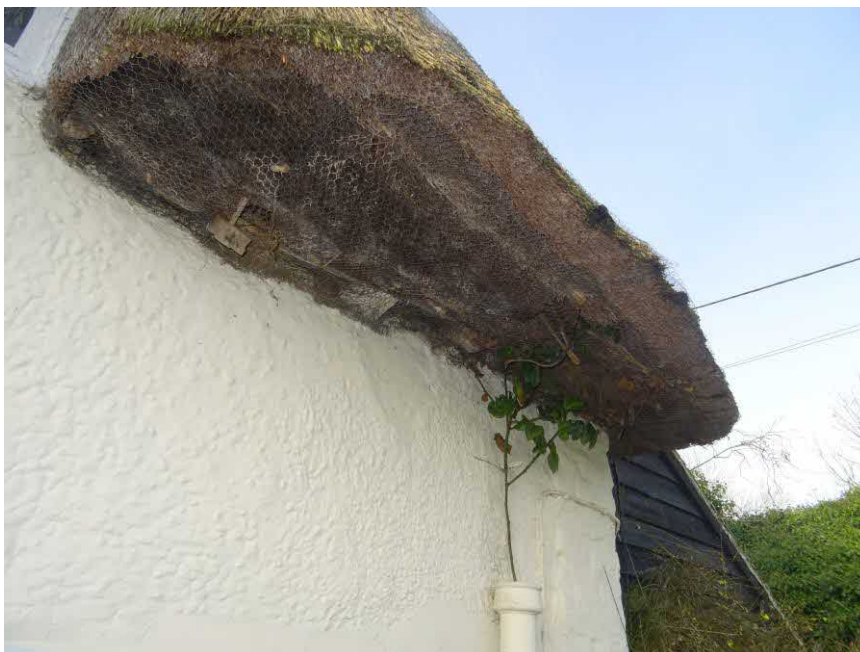
The right-hand rear corner appears to have sunk away from the rest of the elevation.

There is no storm water downpipe in this vicinity although where a timber overlap planking lean-to joins the main construction there is a water butt present.

At this stage there is only the possibility that the water butt overflows and a quantity of water goes into the ground in this area which causes a softening of the ground, reducing the bearing capacity, allowing the corner to sink away from the main body of the property due to not being tied in.

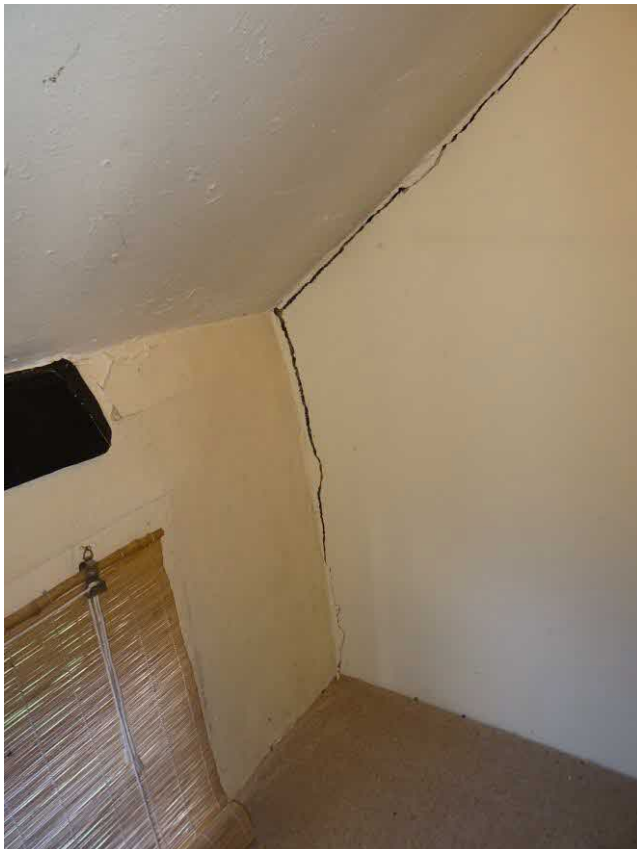
At first floor level however as previously stated the bedrooms were located within the roof structure and there was a noticeable curl at the top of the rear wall outwards where cracking in the order of 10 mm wide had occurred at intersecting walls indicating roof spread.

We therefore consider that roof spread is occurring which may well have been exacerbated by the over thatches of the roof to the front roof surface.

Also, we consider that the roof hatch should be constructed in the roof surface large enough for a head and shoulders inspection because the roof timbers are more than likely riddled with worm and unsafe to support the weight for an internal survey. From this we would be able to determine whether any roof timbers were broken or damaged which we understand some were at the time of the last thatching in 2005.

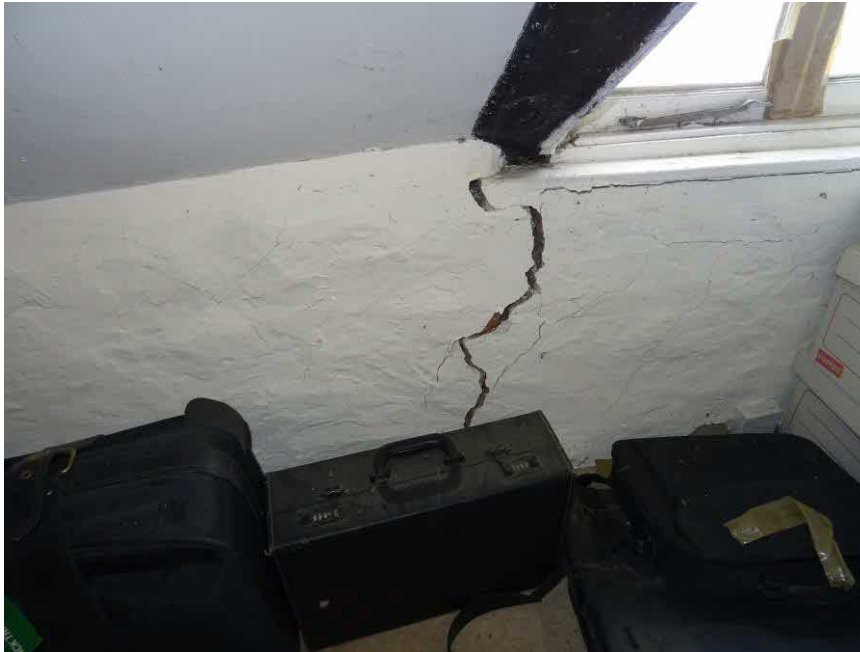
In the rear right-hand bedroom separation cracking was next to the right-hand window which is on the line of the cracking externally, and internally the crack was in the order of 30mm wide being extremely significant and having been in place for some period of time.

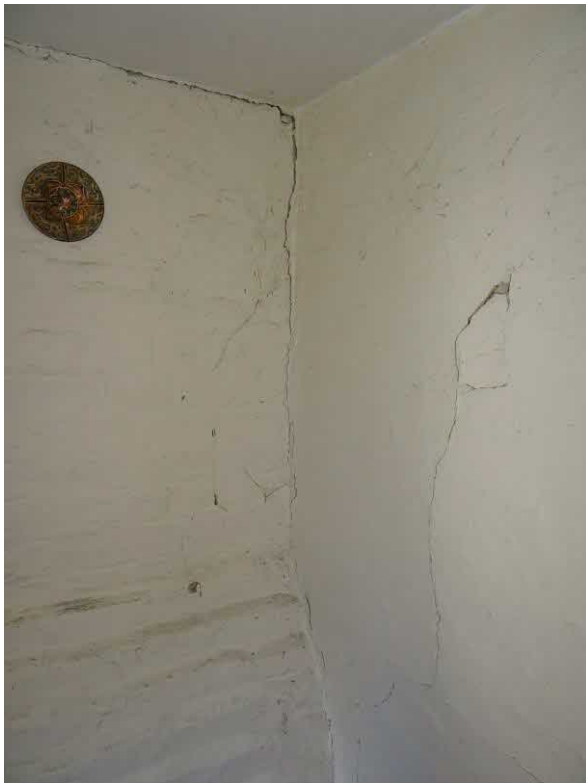
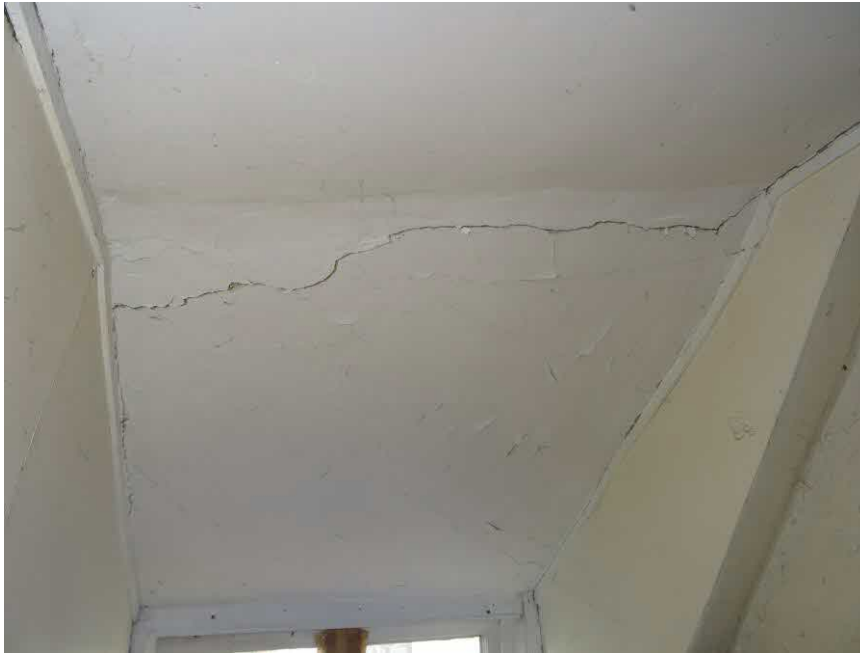
Various other cracks were present around the right-hand gable wall and chimneybreast both to the rear right-hand bedroom and front right-hand bedroom.
