Investigation

Report

23 Old End,
Padbury,
Buckinghamshire
MK18 2BB

Report date: 30th October 2019

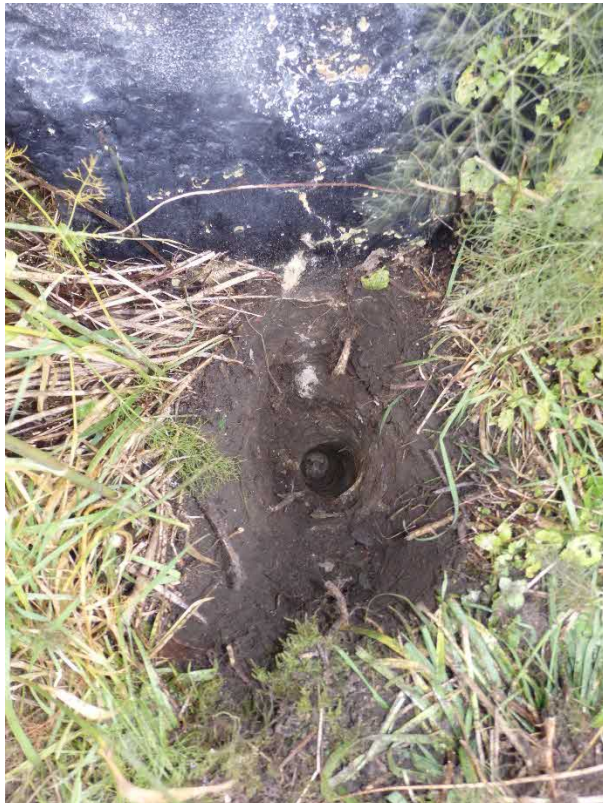
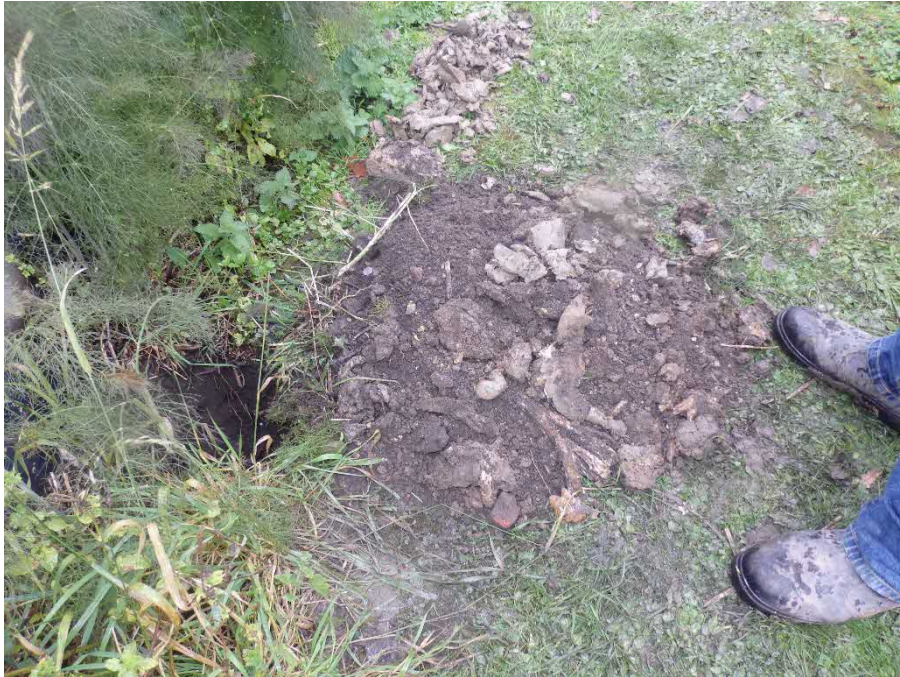
Trial hole 1 was excavated on the rear right hand corner which appears to be the original stonework to the gabled wall.

The foundation was again stone, but founded at 300mm below ground level onto an organic type fill material.

The trial was extended and at 800mm the ground changed to a grey mottled clay again.

The trial hole was extended with a 50mm hand auger upto 2.0m below ground level with ground being a constant grey mottled clay.

A Mackintosh Probe (a cone penetrometer) gave a result of 10 blows for a 75mm penetration of the ground beneath the foundation which is a soft soil of low bearing capacity.

At 2.0m the Mackintosh Probe (a cone penetrometer) gave a result of 42 blows for a 75mm penetration of the ground beneath the foundation which is a firm clay of medium bearing capacity.

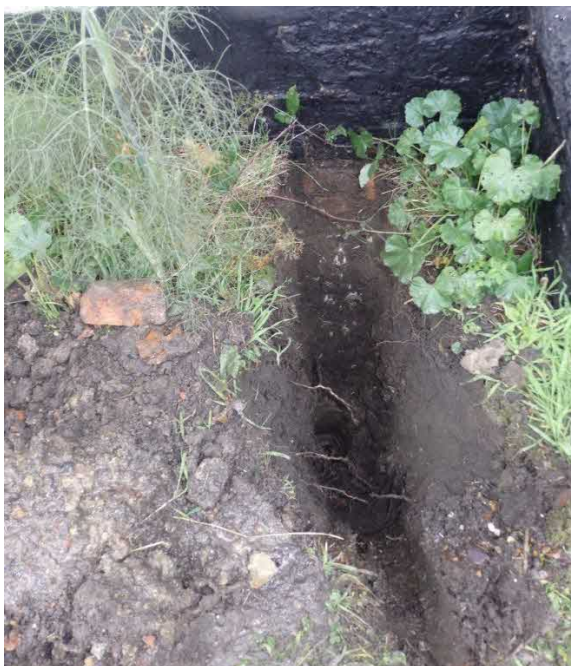
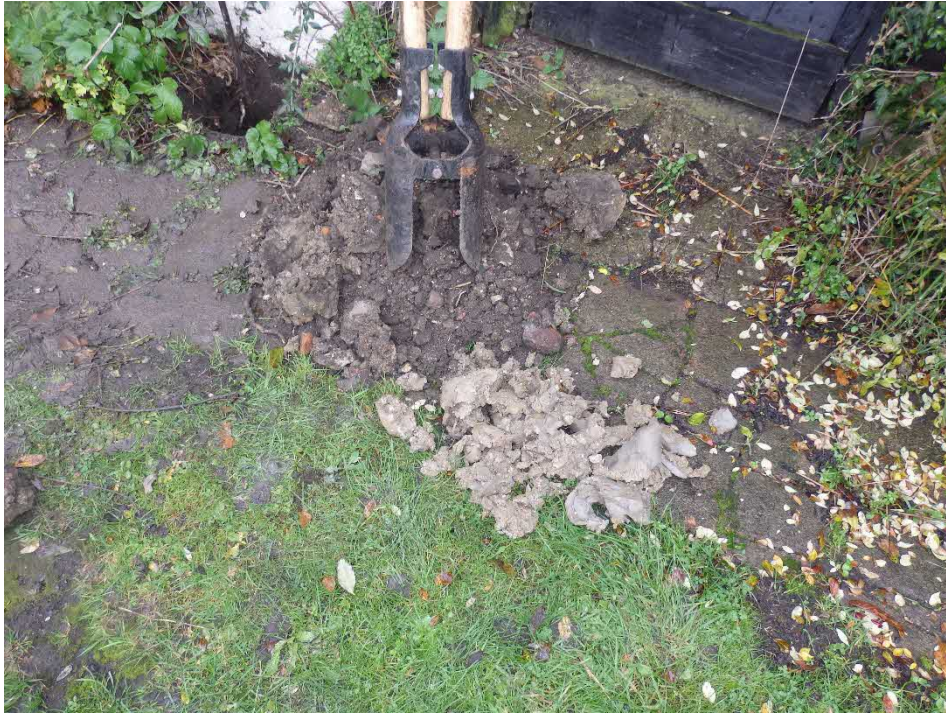
Trial hole 2 adjacent the rear brick section of the property was stone, founded at 800mm below ground level having an over sail corbel of 150mm.

The brick corbel started 300mm below ground level.

The soil excavated through was an organic fill material with a grey mottled clay at 800mm below ground level which was the founding level.

The trial hole was extended with a 50mm hand auger upto 2.3m below ground level with ground being a constant grey mottled clay.

A Mackintosh Probe (a cone penetrometer) gave a result of 15 blows for a 75mm penetration of the ground beneath the foundation which is a soft soil of low bearing capacity.

At 2.0m the Mackintosh Probe (a cone penetrometer) gave a result of 42 blows for a 75mm penetration of the ground beneath the foundation which is a firm clay of medium bearing capacity.

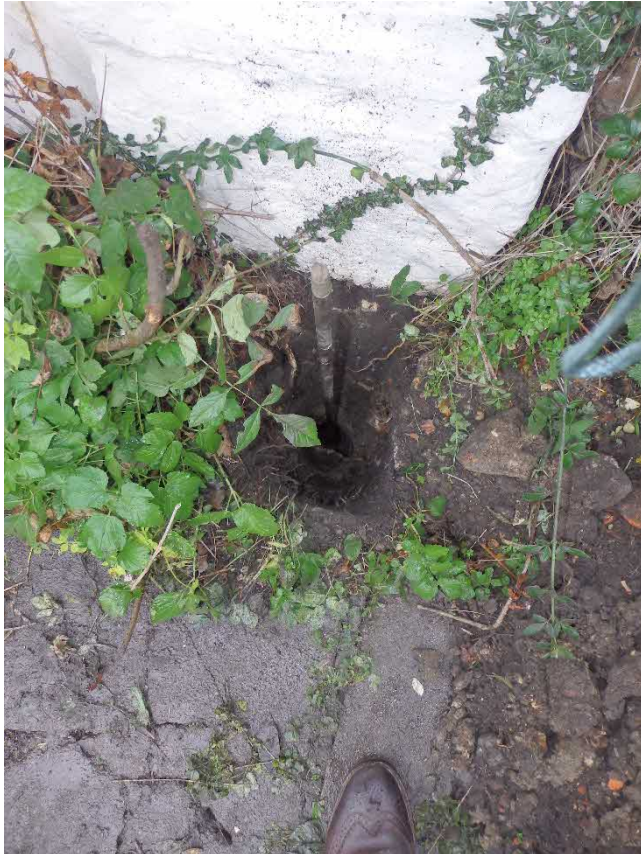
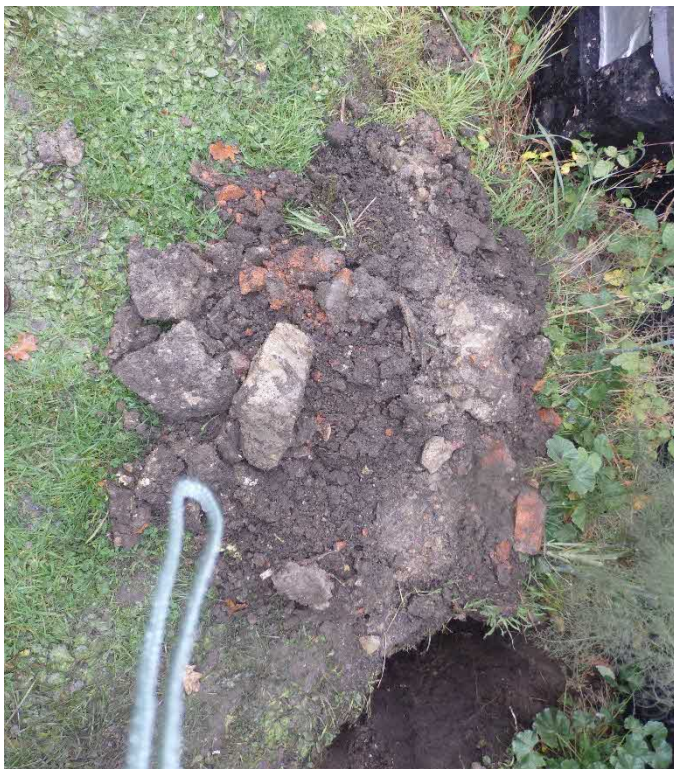
Trial hole 3 was excavated on the front right hand corner which appears to be the original stonework to the gabled wall and similar to trial hole 2.

The foundation was again stone but founded at 300mm below ground level onto an organic type fill material containing fragments of brick.

The trial was extended and at 800mm the ground changed to a grey mottled clay again.

The trial hole was extended with a 50mm hand auger upto 2.0m below ground level with ground being a constant grey mottled clay.

A Mackintosh Probe (a cone penetrometer) gave a result of 9 blows for a 75mm penetration of the ground beneath the foundation which is a soft soil of low bearing capacity.

At 2.0m the Mackintosh Probe (a cone penetrometer) gave a result of 38 blows for a 75mm penetration of the ground beneath the foundation which is a firm clay of medium bearing capacity.

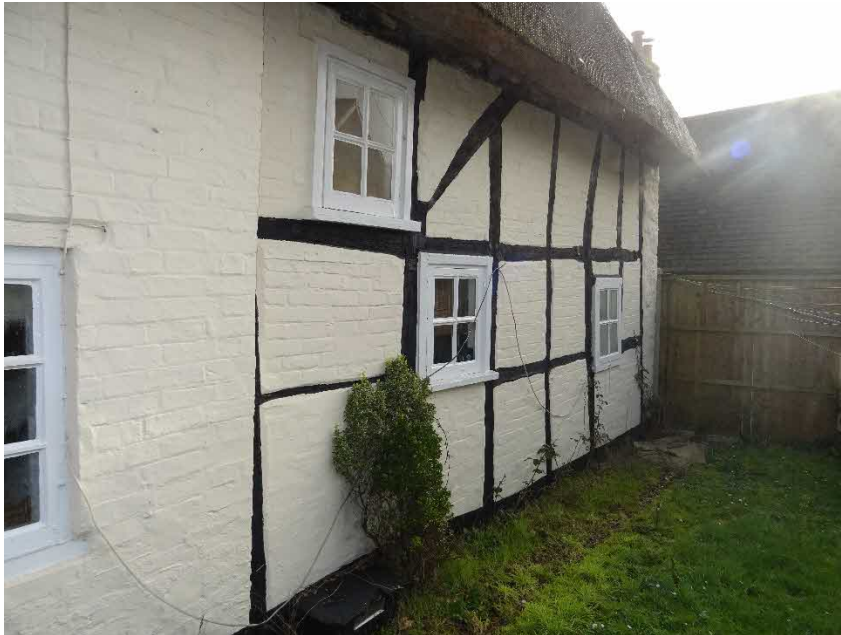
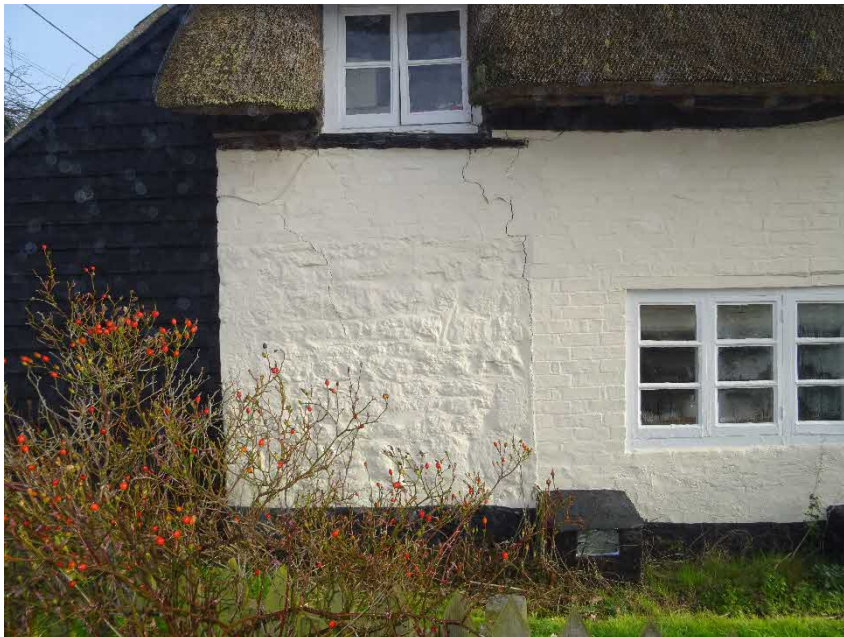
The property may have originally been 2 cottages as the construction at the rear is different with a half-timbered section to the left-hand side and plain brickwork to the right.

This is even more complicated where it appears that the gabled wall to the right hand side and small return to the rear is original and the brick section to the left of the rear return may have been rebuilt at some time and not tied to the stone so as the gabled wall sank the separation cracking has appeared.

The stone section including the gabled wall has negligible foundations and founded on an organic material whereas the brick section has a more reasonable foundation onto what appears to be a natural clay.

Over a period of time consolidation has occurred to the right hand gabled wall as the organic material beneath the foundation continues to degrade, consequently this has caused a slight sinking resulting in differential movement and the cracking between the brick and stone areas which do not appear to be tied together.

Stabilisation in the form of shallow underpinning will need to be to the stone gabled wall section down to 1300mm below ground level with transition zones at either end of the underpinning section, due to the weight of the stone gable.

Super structure repairs will then be required, and as the property is listed we would suggest 'Helifix' restraint bars are installed across the cracked areas both internally and externally, however advice from a specialist installer should be taken due to connecting stone to brickwork as to the best 'helifix' technique.
