Pratts Green Farmhouse, Kirtling

As instructed, we met at the property with Alan Smith of Snell David Architects on 9 November 2021. The purpose of our visit was to visually inspect the structure of the property and in particular the cracking adjacent to the area of earlier underpinning.

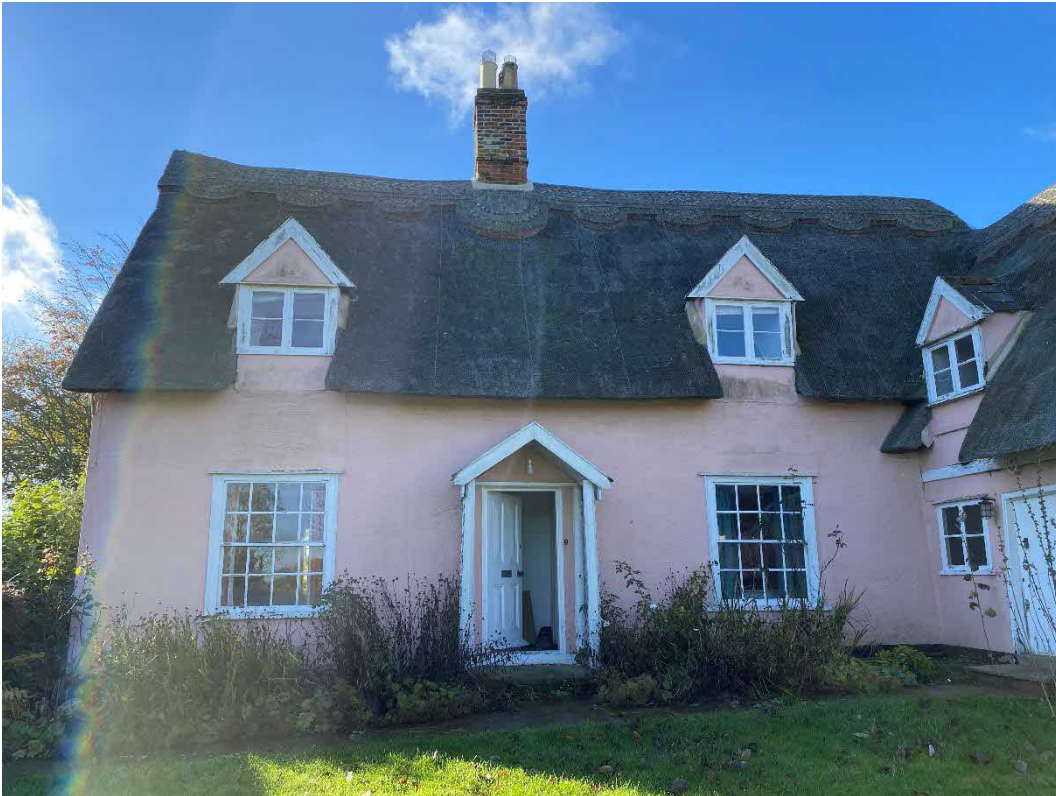
Photograph 1

External examination to the front wall of the original cottage revealed no significant structural cracking to the painted render above a low brick plinth. The roof line was reasonable plane with a level ridge. The chimney was relatively plumb (refer to Photograph 1).

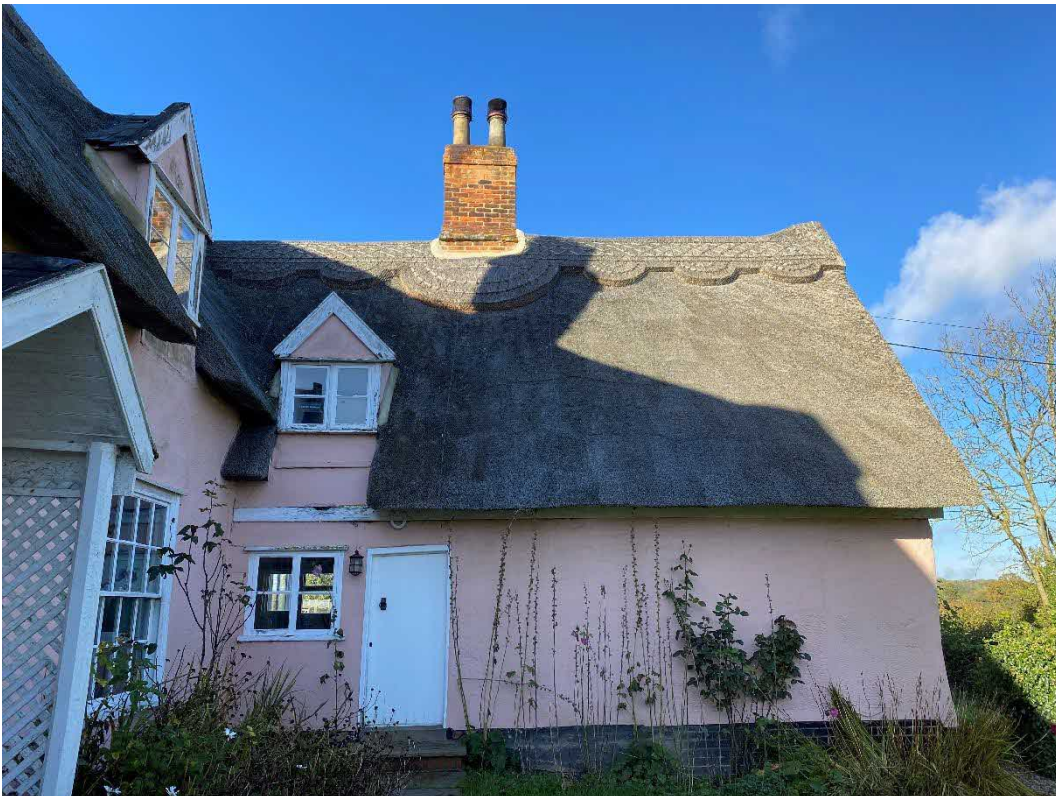
Photograph 2

Inspection to the front elevation of the north wing of the property showed the wall to bow outwards slightly along its length. At this location there was a fine vertical crack to the render. At the base of this wall was a relatively modern brickwork plinth (refer to Photograph 2).

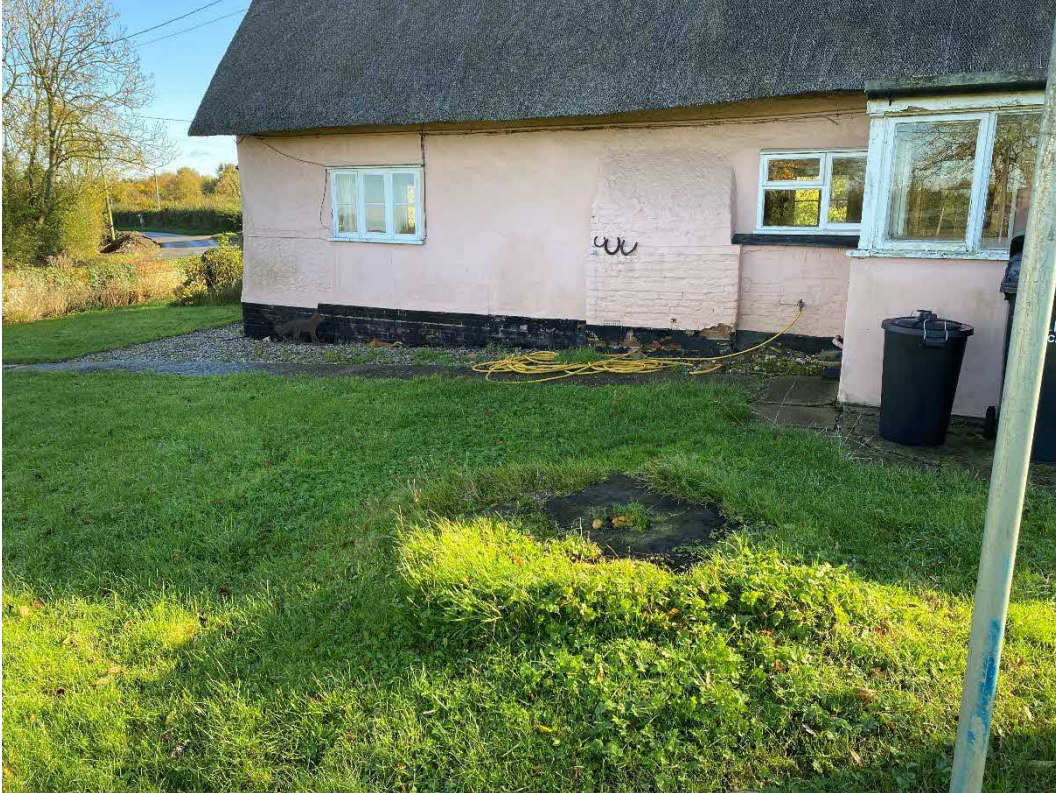
Photograph 3

Inspection to the west facing wall again showed no significant structural cracking to the render. A fine vertical crack to the render was noted centrally below the sitting room window. There was an area of brickwork exposed externally which would appear to have been part of an earlier chimney breast/oven. The plinth to this length of wall was painted red brickwork (refer to Photograph 3). It was noted that a very large tree appears to have been cut down from the garden. The stump is still evident.

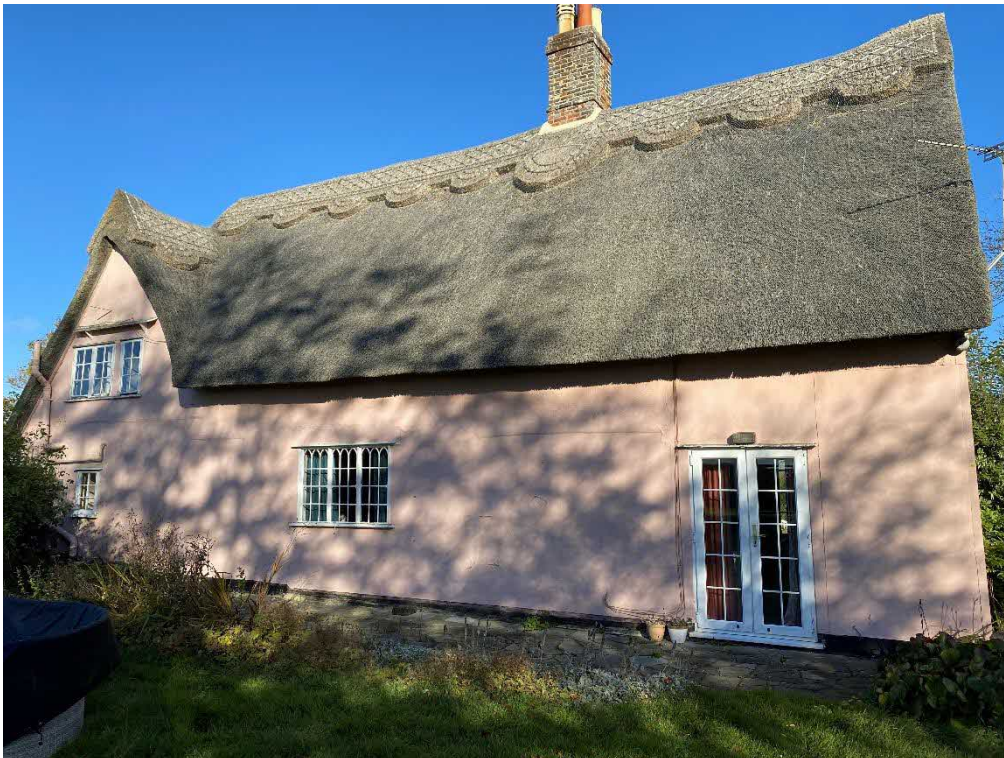
Photograph 4

External inspection to the rear south facing wall revealed distortions to the render but no significant recent structural cracking was noted (refer to Photograph 4).

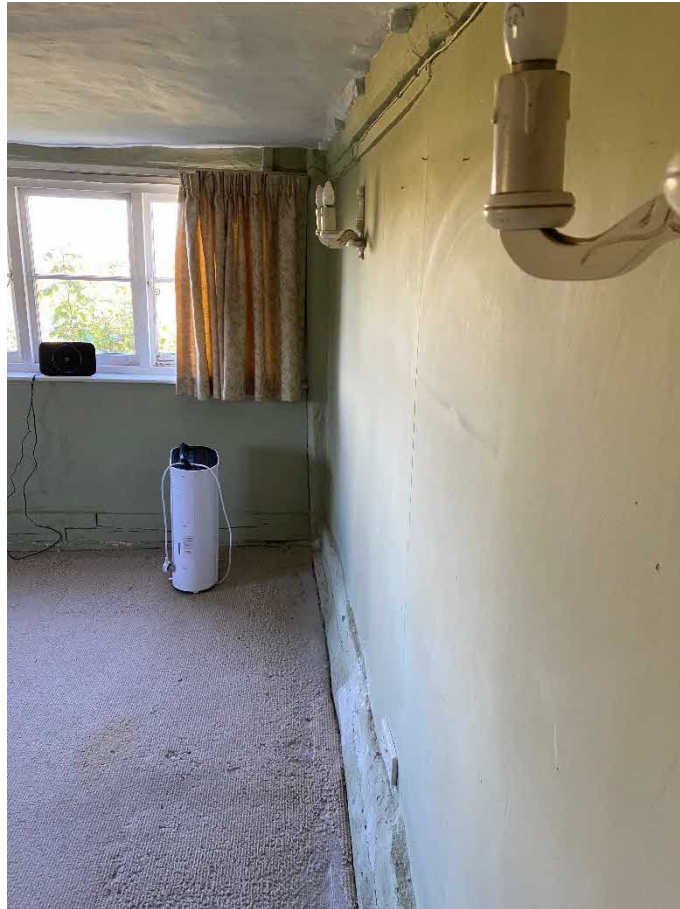
Photograph 5

Internal inspection to the ground floor of the property showed no significant structural cracking or distortion to the ground floor. The bow noted externally to the front wall of the sitting room was also evident internally (refer to Photograph 5). The timber soleplate to this length of wall appeared to be original. However, the soleplate to the north wall appeared to have been replaced (refer to Photograph 6).

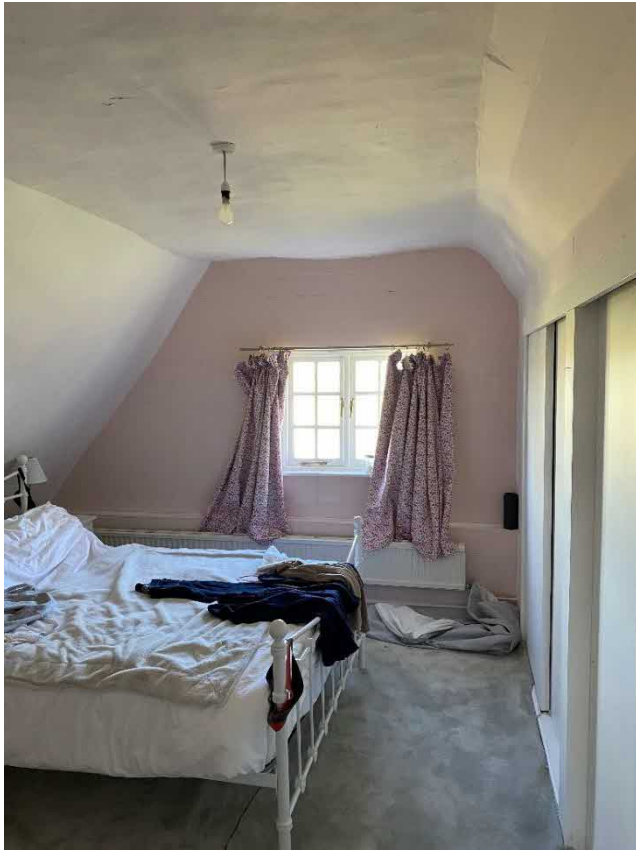
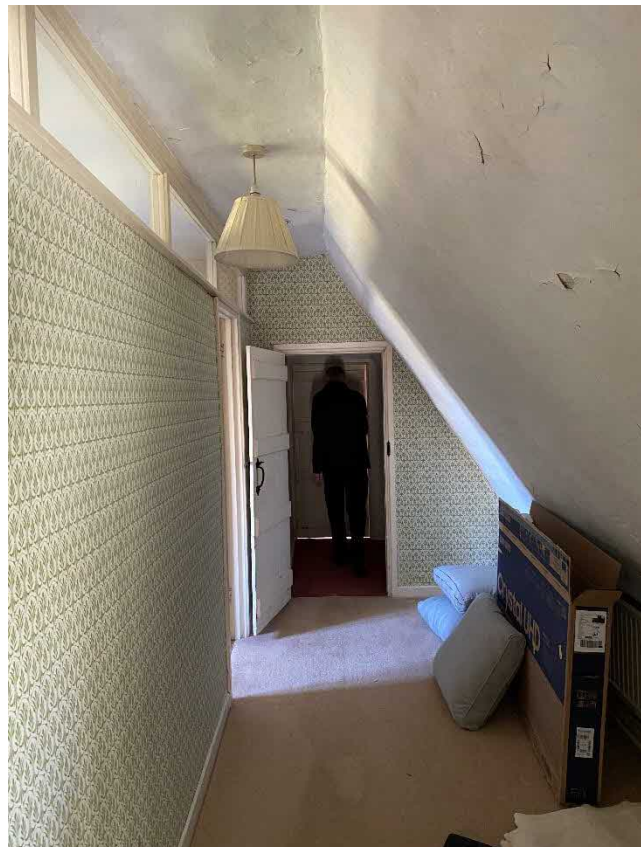
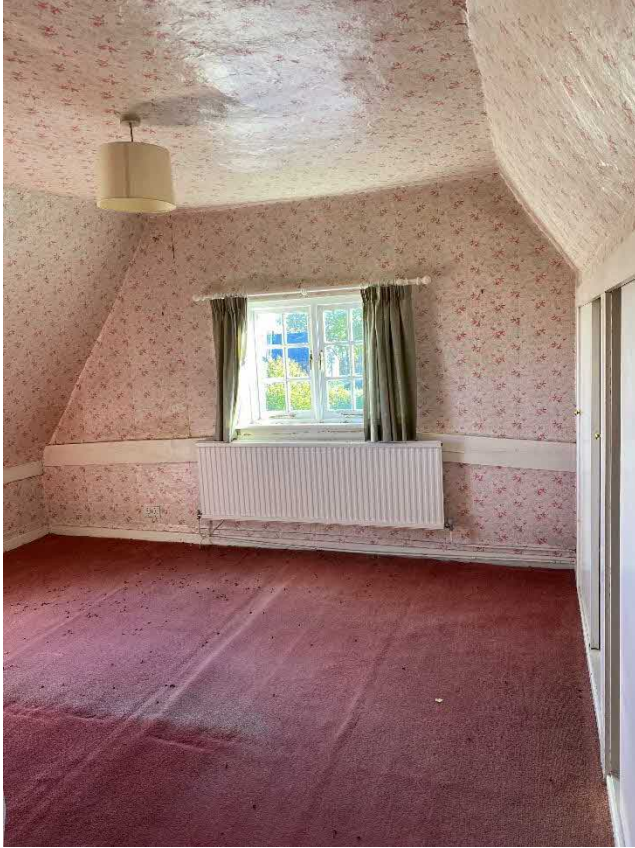
The property has a raised collar 'A-frame' roof structure with the wall plate being above the first floor level (refer to Photographs 7, 8 and 9). Again, with this form and age of construction it is common for the roof to 'sit down' and to push out the tops of the side walls. This movement has occurred to this property resulting in cracking along the ceiling/wall junctions. Attempts have been made to resist this outward movement by tying the raised wall plate to the first floor structure with a curved steel tie beside the stairs (refer to Photograph 10) and a steel tie to the corners (refer to Photograph 11).

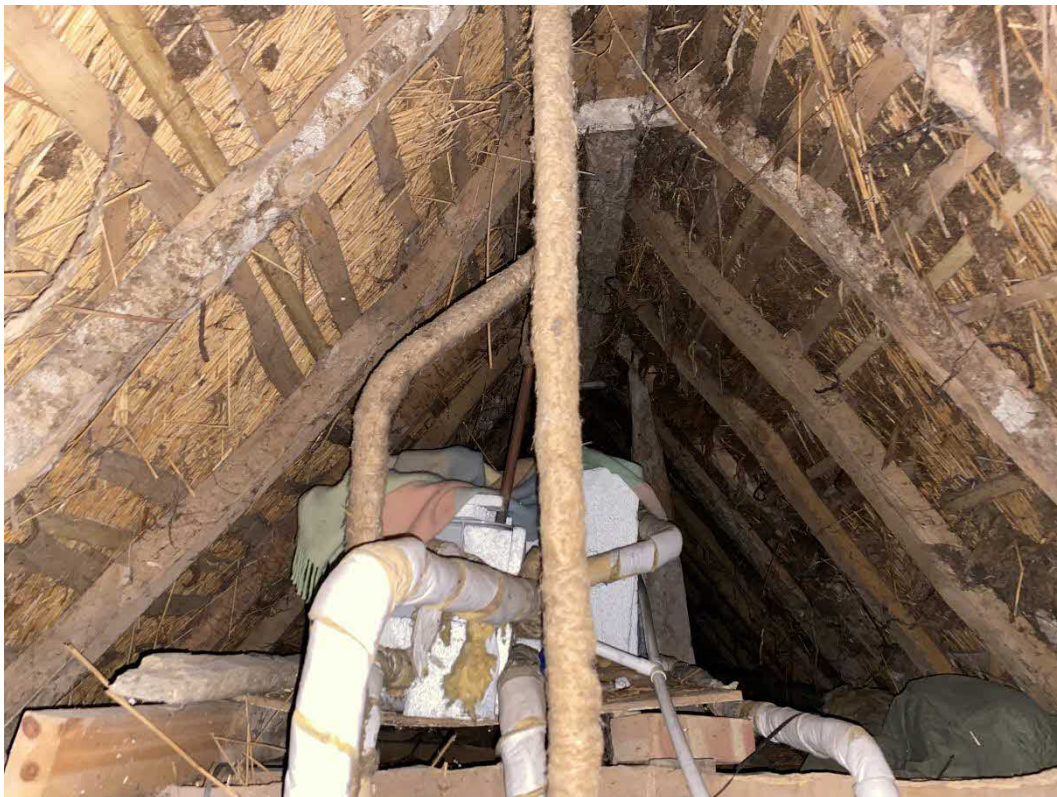
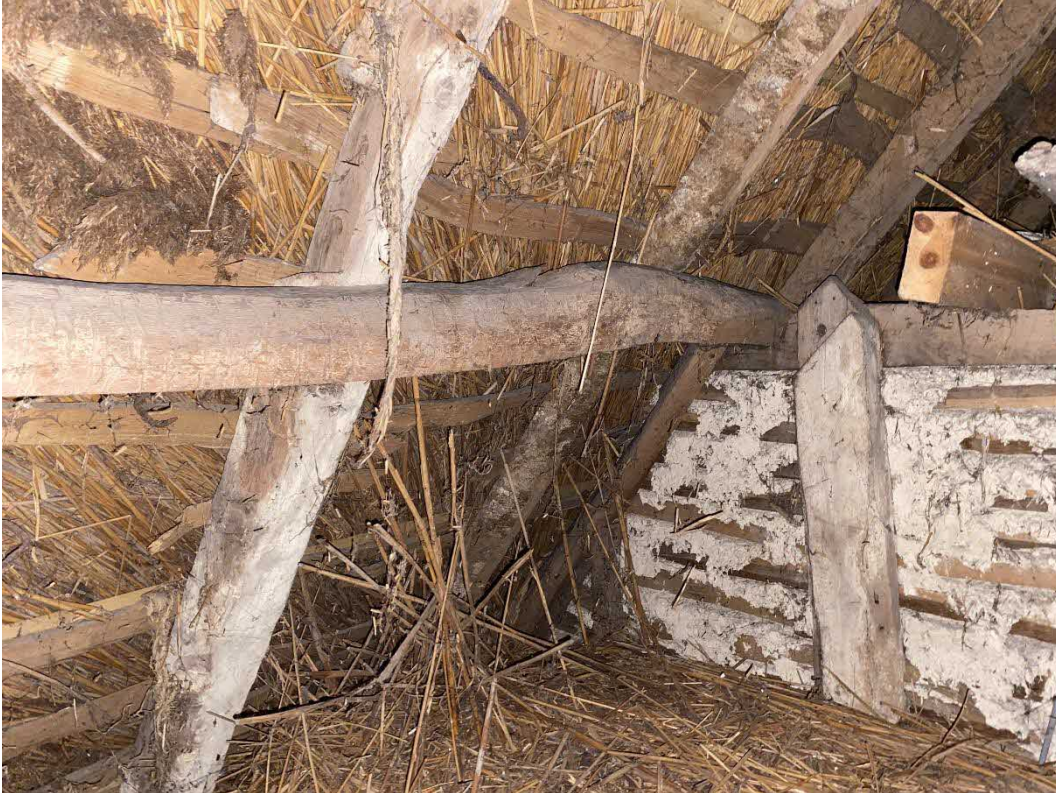
An inspection within the roof space was difficult due to the fragile nature of the ceiling joists and lack of access to the roof above the original wing of the cottage. It is apparent that the roof structure is relatively weak, but again typical for this type and age of construction (refer to Photographs 12, 13 and 14). There appears to have been insect damage to the original roof and additional rafters have been added (refer to Photograph 15). From our inspection it is apparent that further opening up to gain access to the roof structure will be required and it is anticipated that it will be necessary to undertake roof strengthening works.
