DESIGN, ACCESS AND HERITAGE STATEMENT

ADDRESS: Yew Cottage, Station Road, Eynsford, Kent DA4 0ER

PROPOSED WORKS: Replacement of 2 dormer windows, repair works to dormer, plus repair and refurbishment works to smaller side window and rear ground floor window.

Condition Report & Specification of Works

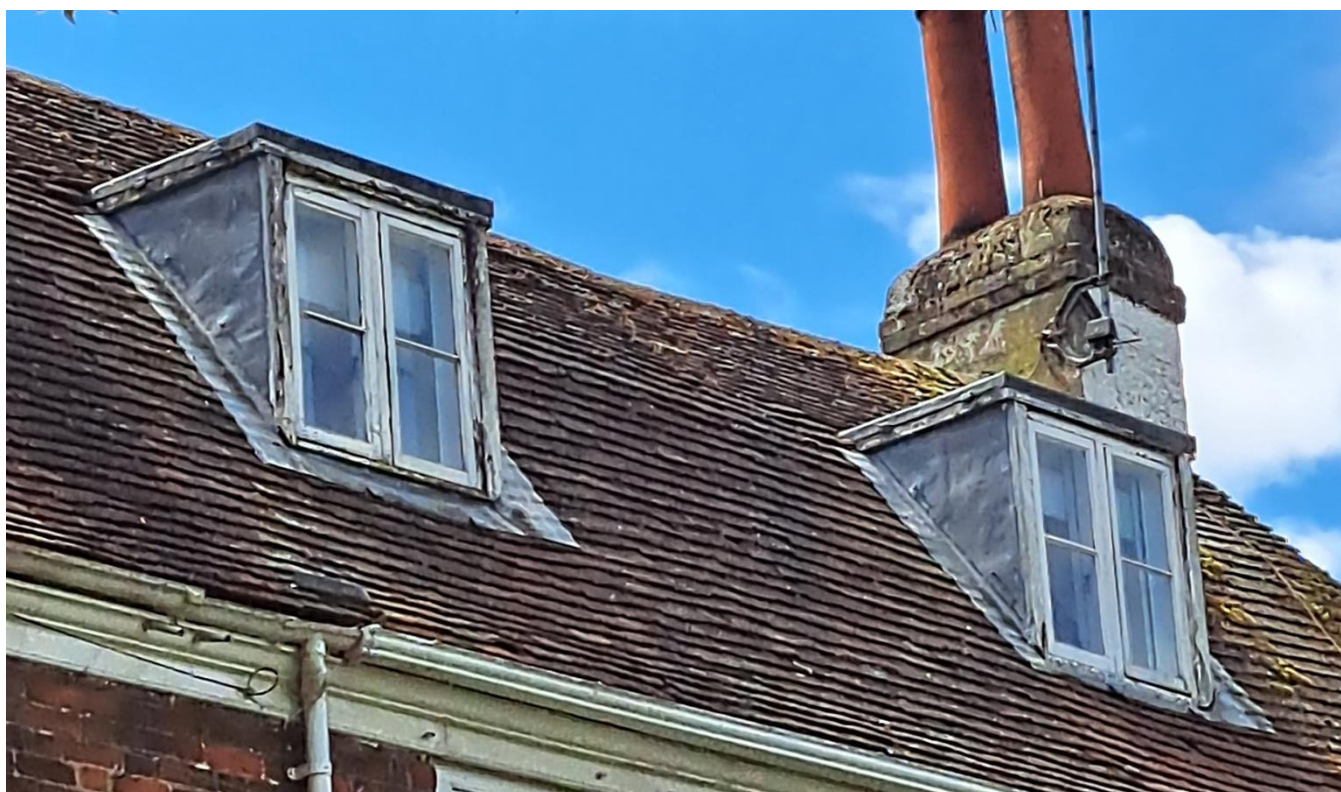
View of second floor dormers from front of house. Dormer to left hand side is hereon referred to as LHD1 and dormer to right hand side RHD2.

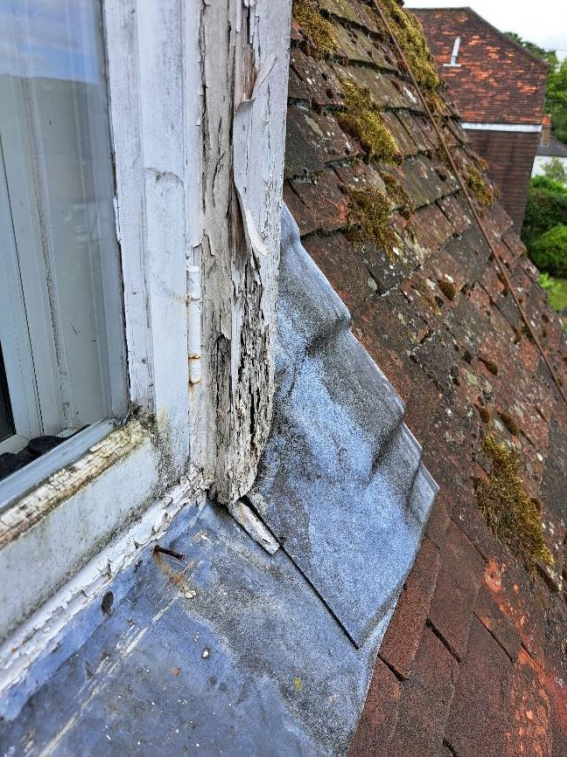
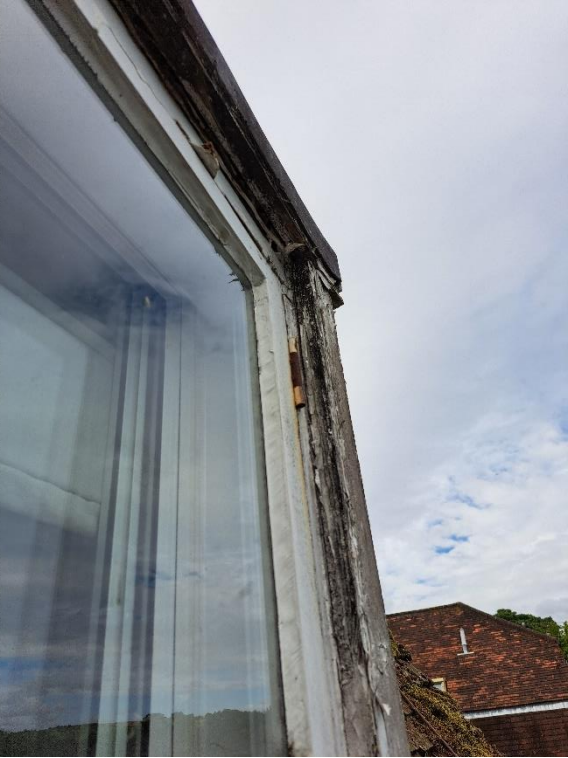
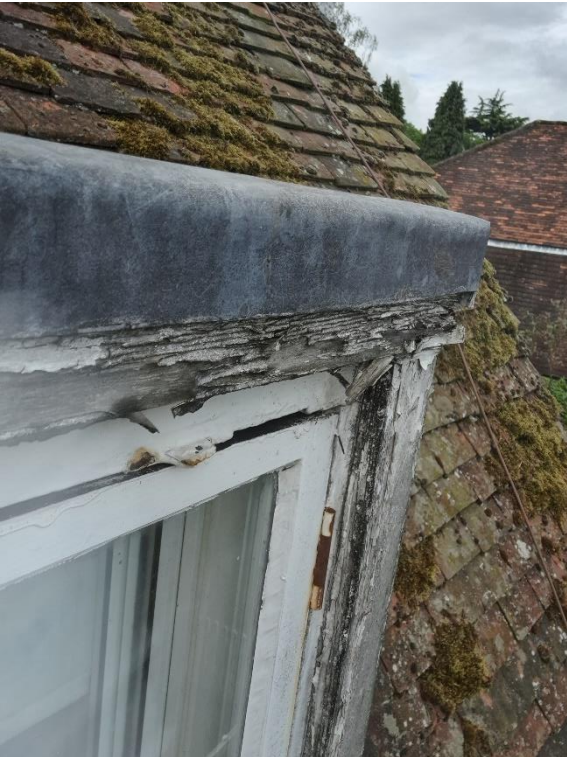
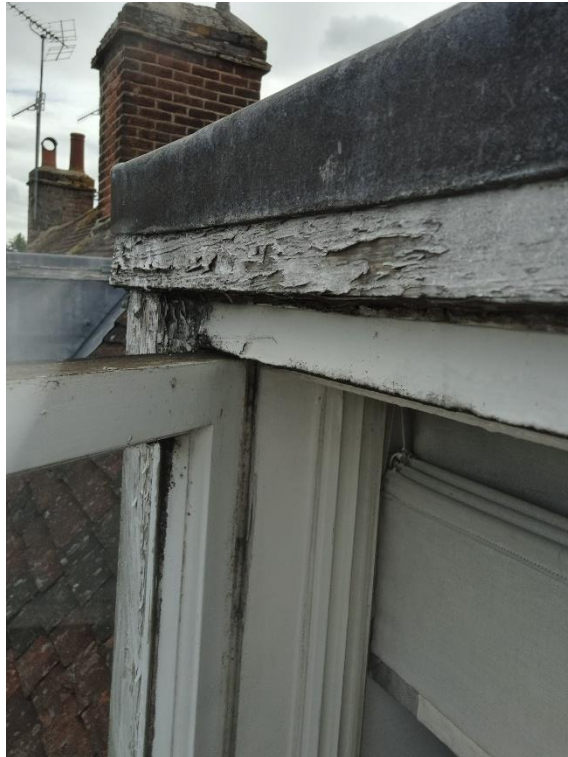
Photographs of LHD1

As indicated in the photos above, sections of the dormer timber framework are beyond reasonable repair. The degraded timbers are on an exposed elevation and there is evidence of water absorption indicating wood decay, particularly in the head of the frame and the side cover boards. The exterior paint has failed, with paint flaking off and there are large depressions and splits visible in the timber.

The lead apron is in reasonable condition, but nails are rusting (possibly incorrect specification installed during the 1960s refurbishment).

Replacement of head of frame and side cover boards which are beyond pair. Profile and paint colour to match existing.

Repairs to be carried out in-situ. Careful removal of lead cheeks, soakers and lead roof to assess condition of dormer structure. Specialist contractor to carefully cut out any rotten sections of timber and replace with sound, treated timber. Inserts should be made from good-quality wood similar in species and moisture content to the parent timber. They should be fitted with the grain orientated to match the existing. Use of timber with defects such as shakes, resin pockets, knots or sapwood should be avoided.

Remove existing dormer casement windows and replace with hardwood primed windowsets, with Fineo vacuum glass. Frame to match existing profile and paintwork colour. Fineo vacuum glazing has an ultra-thin profile avoiding the requirement for a deeper window frame and is suitable for use on listed buildings.

Condition of lead apron to be checked when scaffolding in position and nails to be replaced with correct specification (stainless steel, never galvanized or aluminium fixings).

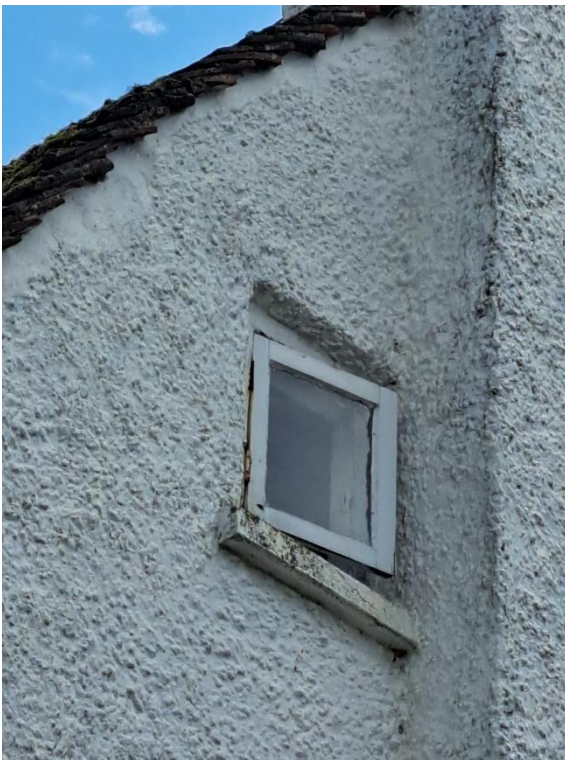
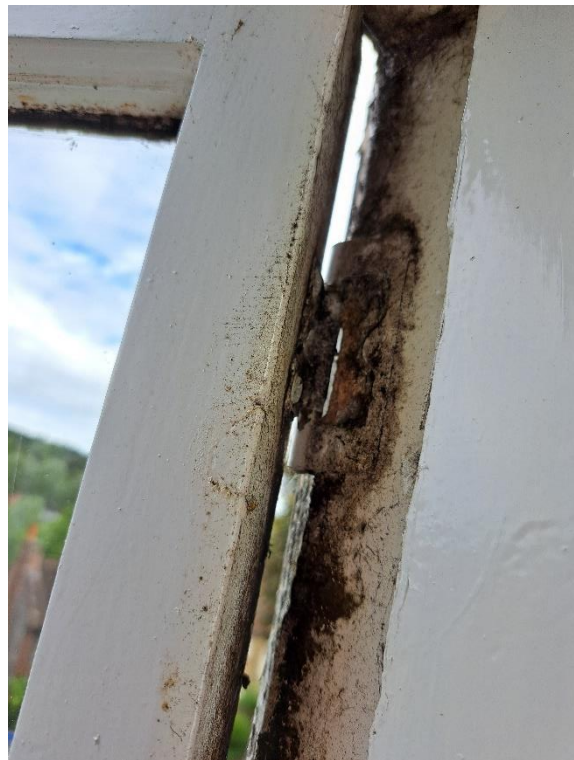
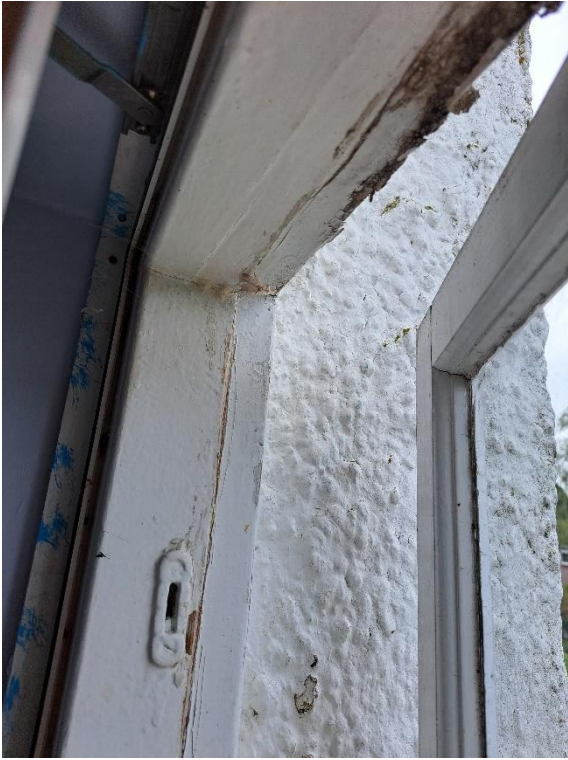
Photographs of SW1

Sections of the window frame are beyond reasonable repair including the side jamb and head jamb. There is evidence of water absorption indicating wood decay and the interior paint has failed, with paint flaking off and depressions and splits visible in the timber.

Remove existing window and replace with hardwood primed windowset, with Fineo vacuum glass. Frame to match existing; dimensions and paintwork colour. Fineo vacuum glazing has an ultra-thin profile avoiding the requirement for a deeper window frame and is suitable for use on listed buildings.

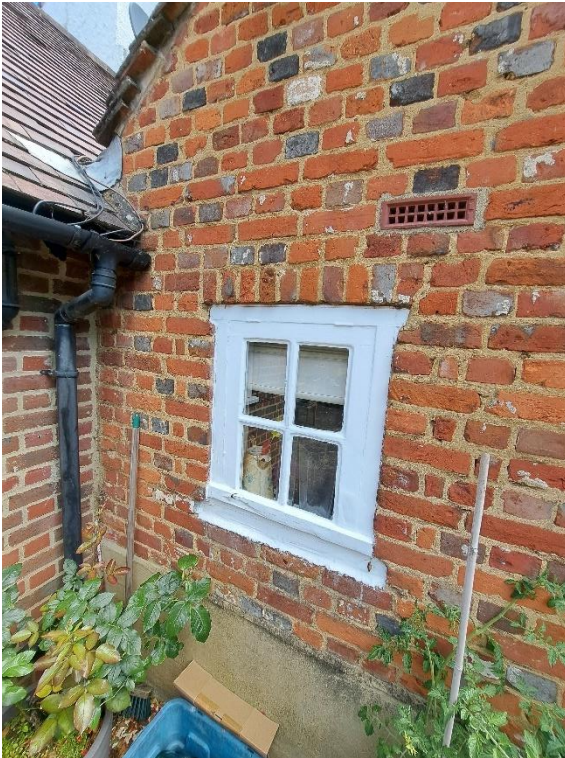
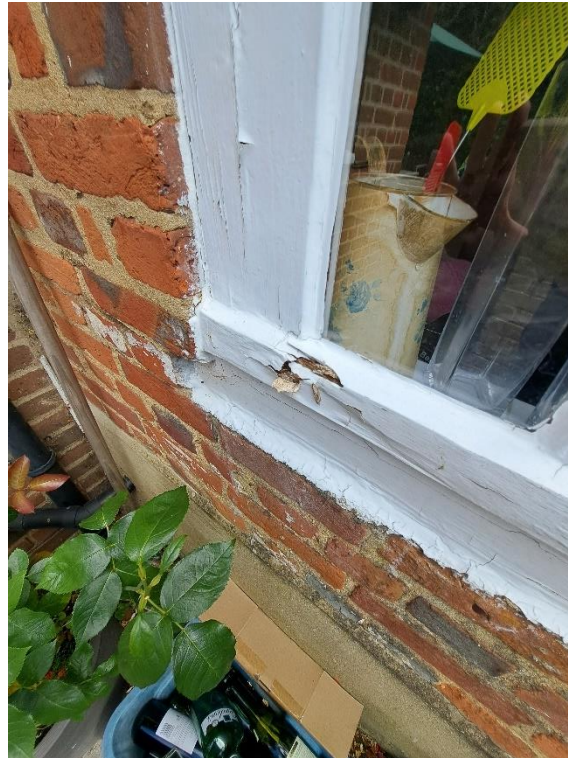
Photographs of RW1

Essential repairs required to rotting window sill, which appears to be caused by fungi/bacteria. If left untreated this could cause further damage to the sill and eventually to the window frame itself. The frame is soft and fibrous in the rotten section. Window condition will decline if repairs are not carried out.

Repairs to be carried out in-situ. Carefully cut out rotten sections of timber and replace with sound, treated timber. Inserts should be made from good-quality wood similar in species and moisture content to the parent timber. They should be fitted with the grain orientated to match the existing. Use of timber with defects such as shakes, resin pockets, knots or sapwood should be avoided.

Paintwork to the main frame has been over-coated many times with some overspill on to glazed sections. The saddle bar and stanchion bar should be lightly sanded to remove loose or blistering paint, and then cleaned with sugar soap to improve the key. Paint colour to match existing. Old putty to be removed with putty lamp and replaced if required by specialist contractor.

Precautions should be taken with regard to the possible presence of existing lead paint; therefore assume it is present and take precautions accordingly.
