Redlands
St. Marys Road
WORCESTER PARK
KT4 7JL

INSURANCE CLAIM

CONCERNING SUSPECTED SUBSIDENCE

ENGINEERING APPRAISAL REPORT

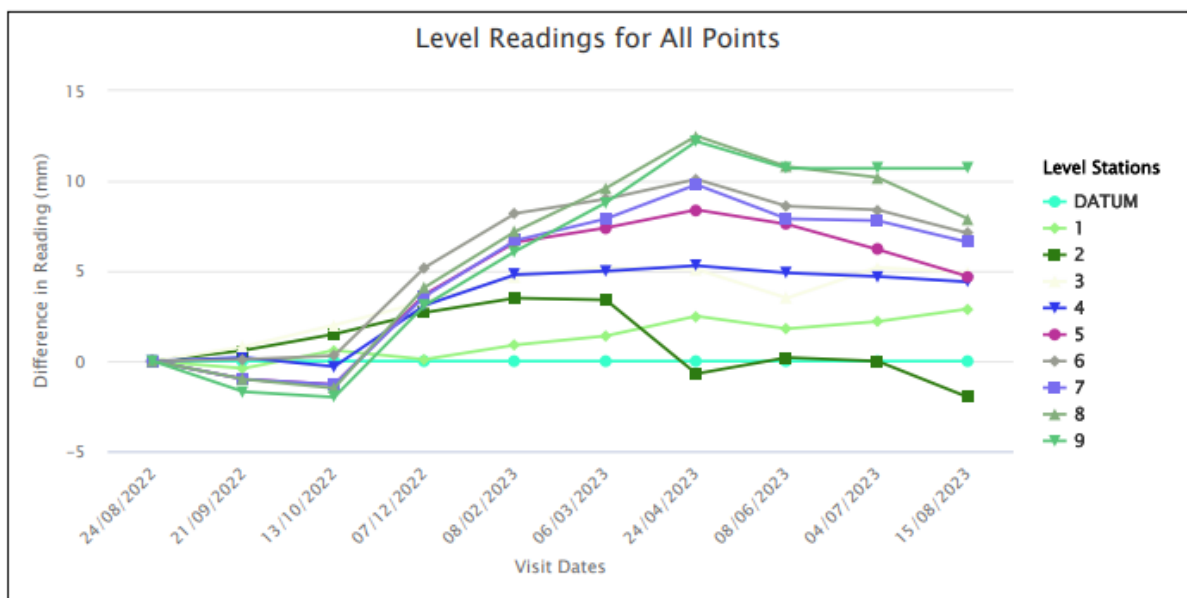
Monitoring has been ongoing since August 2022, it is noted that slight downward movement has been recorded to October and then a swift recovery through out the following months until the latest reading has been recorded. The latest readings show that downwards movement has started into summer 2023 as per the below diagram. This is following the removal of the none TPO vegetation to the rear of the property.
