ARBORICULTURAL ASSESSMENT REPORT

Redlands, St. Marys Road, Worcester Park, KT4 7JL

**PRI Ref:** 251663

**Survey Date:** 03/02/2023

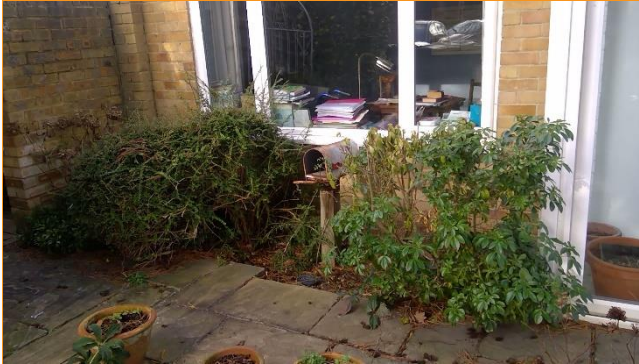
SG1 - Mixed species shrubs

Tree No:	Species	Works Required
SG1	Mixed species shrubs	Fell and treat stump with eco plugs (broadleaved).
SG2	Mixed species shrubs	Fell and treat stump with eco plugs (broadleaved).
T9	Giant Sequoia	Fell and treat stump with eco plugs (broadleaved).

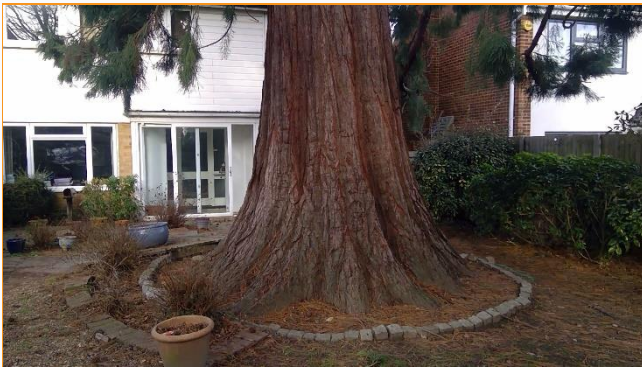
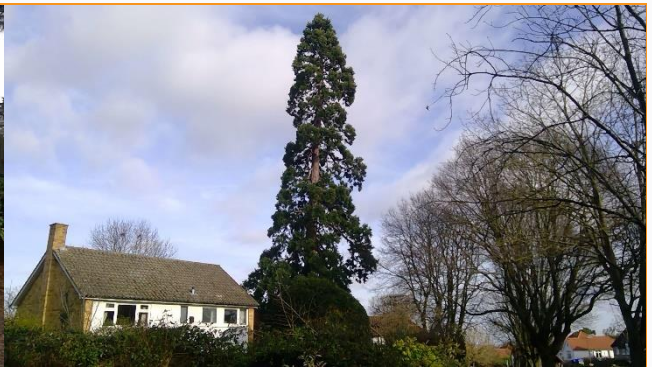
T9 - Giant Sequoia

Epsom and Ewell Council website has confirmed that the implicated vegetation T9 is subject to a Tree Preservation Order.

Tree No	Common Name	Age Class	Condition	Height (m)	Crown Spread (m)	Stem diam. (mm)	Dist to bldg. (m)	Roots Implicated	Pruning history	Recommendation	Tree work constraints	Notes	Owner address	Owner
T9	Giant Sequoia	Mature	Fair	36*	11.0	2000*	6.2	Y	Subject to past management. No significant recent management.	Fell and treat stump with eco plugs (broadleaved).			Redlands St. Marys Road Worcester Park KT4 7JL	PH
T10	Ash	Mature	Fair	11.5*	12	480*	7.01432282143192	N	Subject to past management. No significant recent management.	No work required.			Redlands St. Marys Road Worcester Park KT4 7JL	PH
T11	Cherry	Mature	Fair	6	6.5	200*	6.8	N	Subject to past management. No significant recent management.	No work required.			Greenwood St. Marys Road Worcester Park KT4 7JL	P3P
T12	Apple	Mature	Fair	5.8*	6	380*	7.6	N	Subject to past management. No significant recent management.	No work required.			Redlands St. Marys Road Worcester Park KT4 7JL	PH
