Our Ref: B25239-JNP-XX-XX-RP-S-0001 Chkd: VW

Re: Bell Farm Avenue

The purpose of this report is to inspect and report on the existing structural arrangement, size of members and any visual defects. It also includes the findings from the CCTV survey and the Damp and Timber survey which can be found in the appendices.

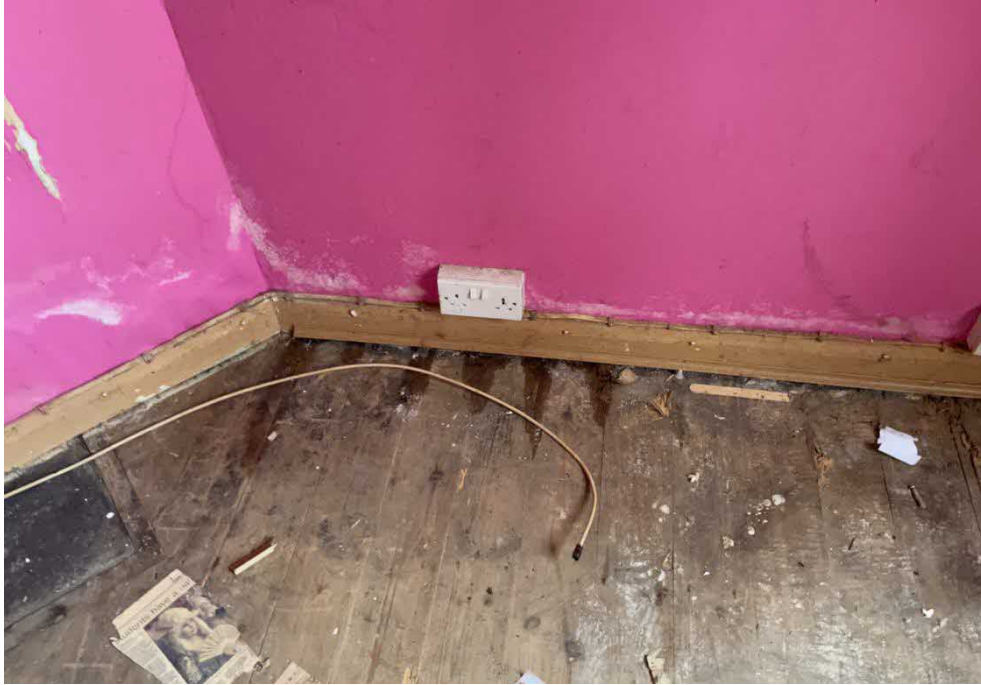
Property No. 25 was noted to have had issues with water ingress to the ground floor bedroom at some point. This appears to have caused the floor to swell. Refer to damp and timber survey for details for other properties.

Photograph 13. Ground Floor Bedroom Showing Water Ingress

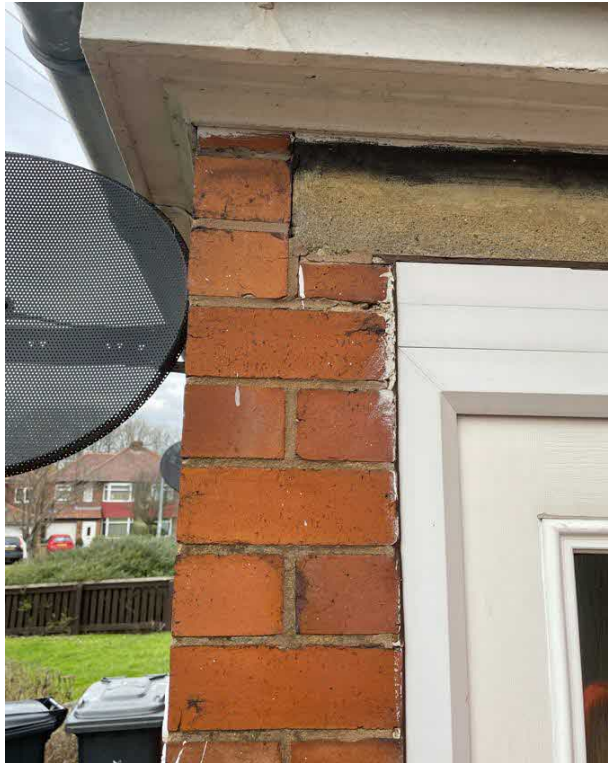
It was noted that the external wall of the porch to the front door was leaning out at the top slightly.

Photograph 15. External Wall to Porch Leaning Out

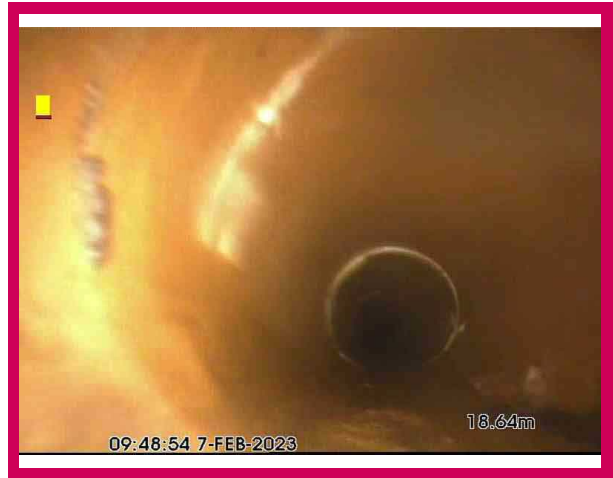
2, 00:00:58, 13.54 m
Crack, circumferential at joint from 12 o'clock to 12 o'clock

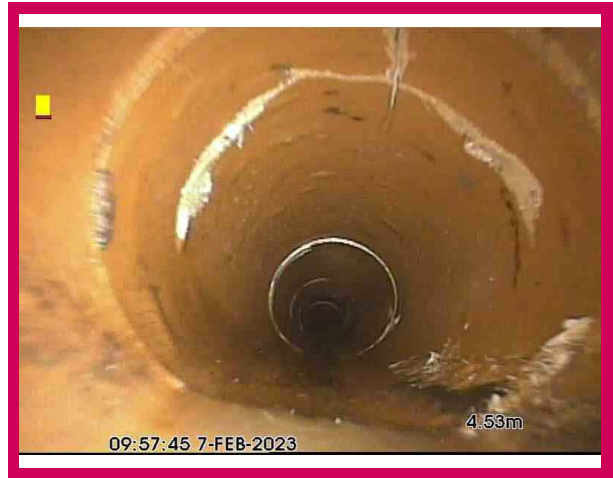
2, 00:00:19, 4.53 m
Fracture, circumferential at joint from 12 o'clock to 12 o'clock

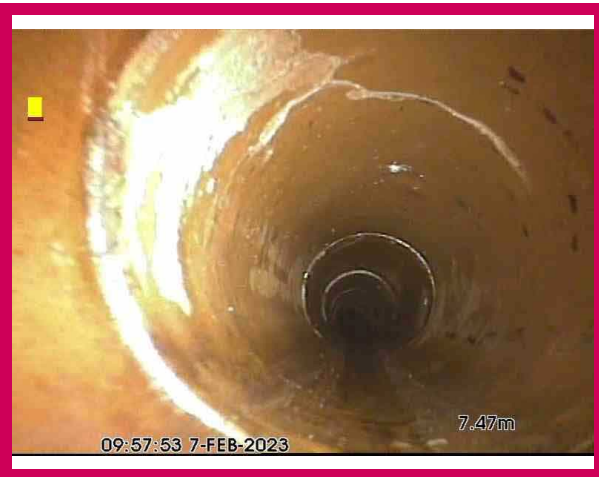
3, 00:00:27, 7.45 m
Crack, circumferential at joint from 12 o'clock to 12 o'clock

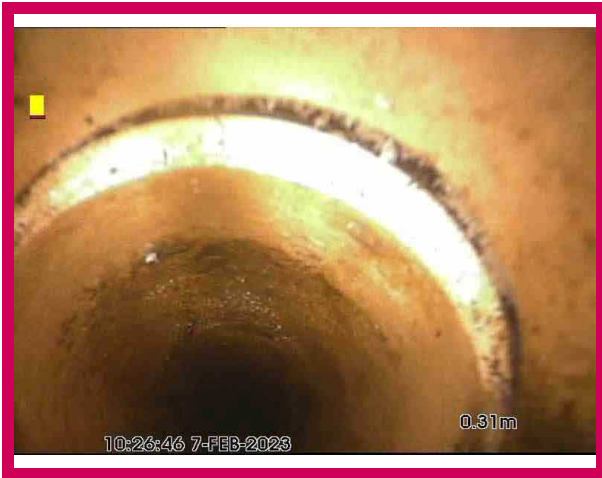
1, 00:00:13, 0.40 m
Joint displaced, medium

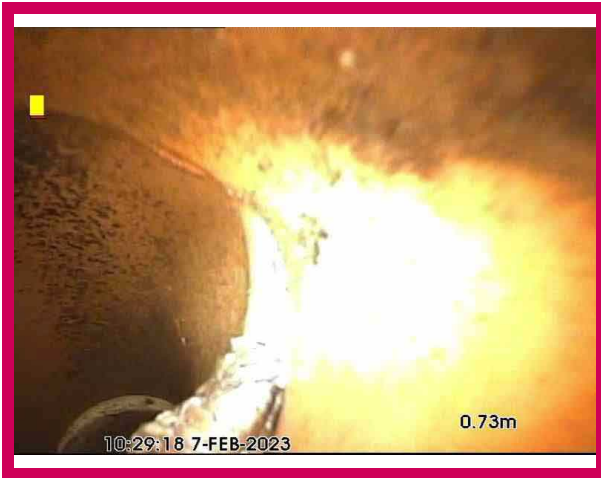
1, 00:00:10, 0.73 m
Joint displaced, medium

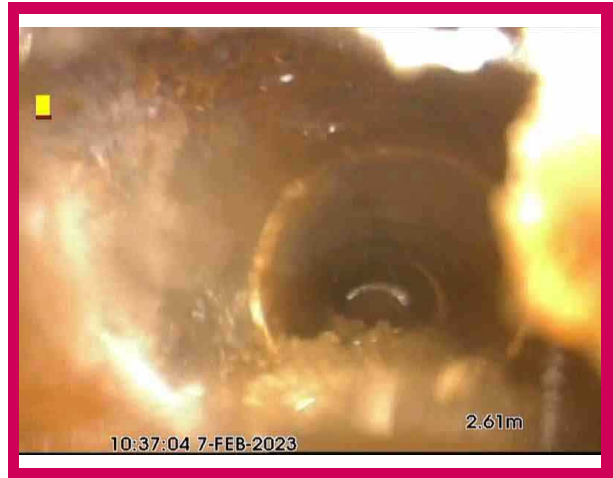
2, 00:00:15, 2.61 m
Attached deposits, fouling from 4 o'clock to 7 o'clock, 20% cross-sectional area loss

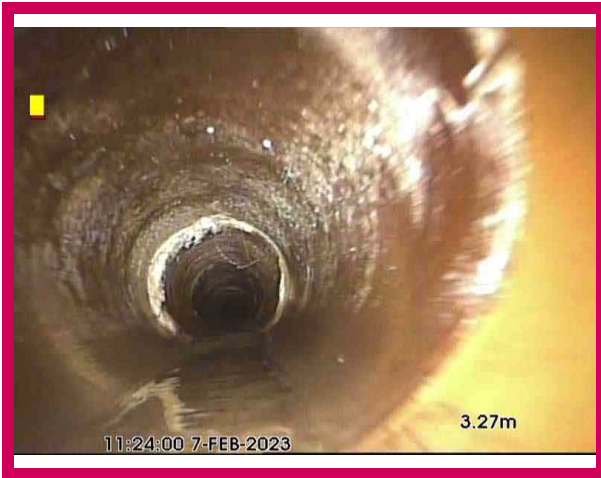
1, 00:00:15, 3.37 m
Crack, circumferential at joint from 12 o'clock to 12 o'clock

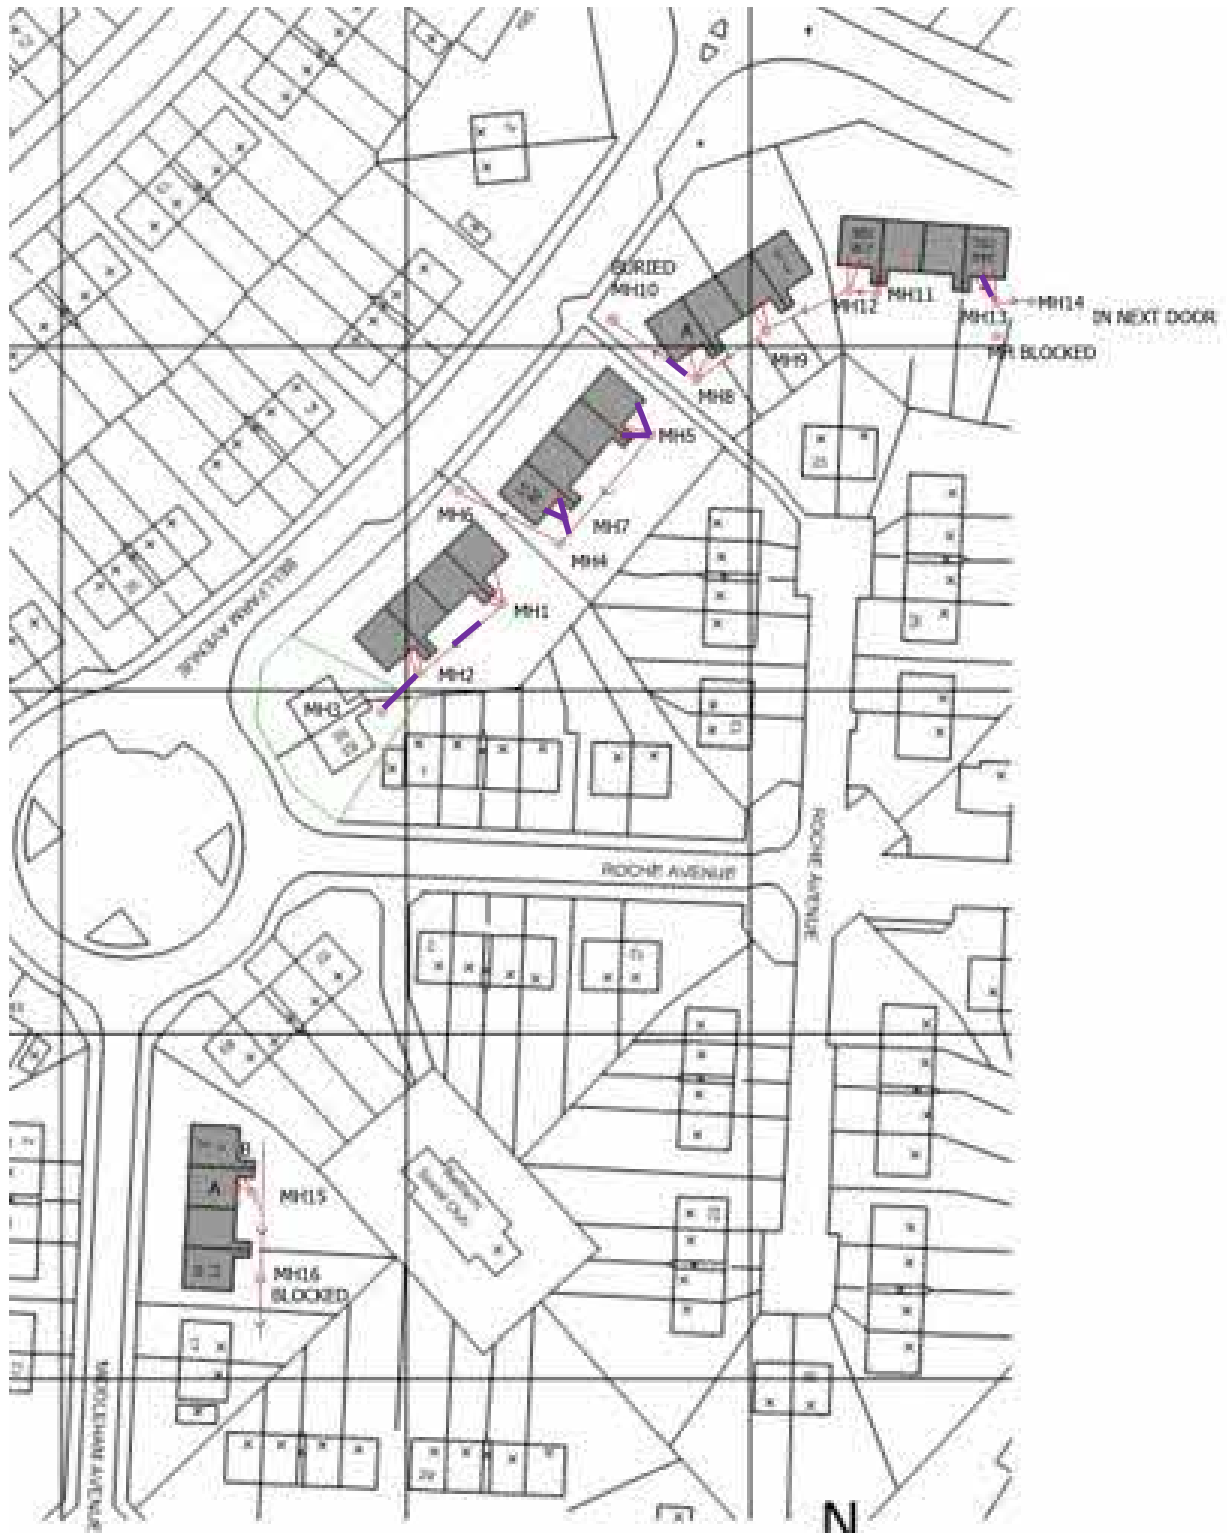
Foul drainage exits the buildings to the rear of the properties and is then directed through the front garden areas to an assumed connection with the adopted sewer. Junction connections along some of the drain lengths suggest that RWP's from the rear elevations also connect onto the system. The general condition of the drains varies with stretches of pipework being blocked or having need for repair. The main areas flagged for repair are highlighted on a sketch in Appendix A.

— Length of drain identified as needing repair
