## **BUILDING CONDITION SURVEY**

**In respect of**  
**Lords Farm Barn**

**Queen Street**  
**Eynsham, Oxfordshire**

**For and on behalf of**  
**OXFORD PRESERVATION TRUST**

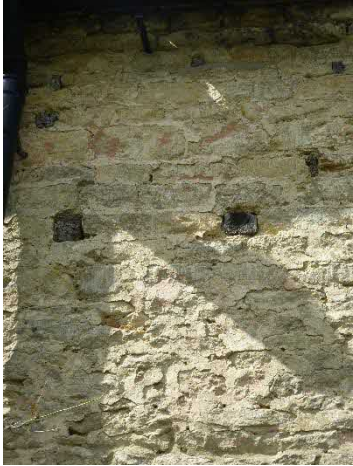
Item	Element	Description	Condition	Repair
20.	High Level Adjacent No 2. 422

Better dressed stone blocks at upper level with rubble below.	Area shows signs of past limewashing with a red tint to the finish indicating that the walls were probably limewashed at some stage. Buttered over pointing to create a smoother finish wall for lime washing.	Some minor repointing but care to preserve areas of nice old lime pointing and lime wash.  Replicating this limewashing if desired where there is cement pointing will be difficult as it doesn't adhere very well to cement work.

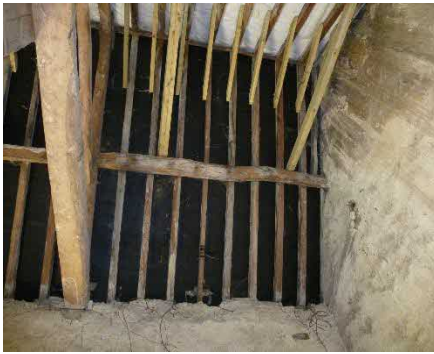
As other	Collar and principal rafters seem sound. Owl box present.	
41.	South Bay Purlins 403 – See Also 402

Both purlins are older roughly trimmed halved or whole beams but have smaller span than centre section.	Suffering from more extensive surface common furniture beetle decay. Even though there is a long ladder available, it didn't enable an inspection at close quarters.  Likely they are still serviceable. The west will have been assessed at recovering and has been left as found.  East may have some surface decay.	A proper assessment of East purlin can be made at recovering. Localised treatment likely for CFB.
42.	Rafters West Side 402	Sawn softwood as others. Recent roofing membrane over as others.	Seem generally serviceable. 2 new collars installed.	None anticipated.

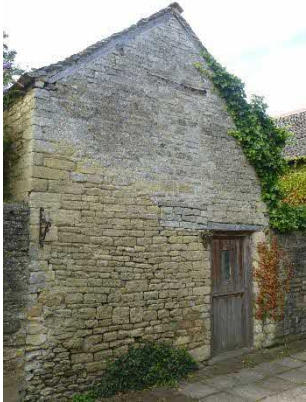
Item	Element	Description	Condition	Repair
78.	<p>North Gable Wall 353</p>

<p>(accessed from adjoining property)</p>	<p>Solid stone wall mainly dressed blocks brought to courses.</p>	<p>Extensive weathering of pointing at ground floor level. Less so to first floor and apex area.</p> <p>Most stonework sound.</p> <p>Extensive ivy growth creeping over the west corner which should be removed.</p> <p>A few inbuilt pieces of timber to a lower section of walling. No undue bulging to this whole gable wall.</p>	<p>Extensive deep re-pointing.</p> <p>Remove creeper.</p>
