Arboricultural Appraisal Report

Subsidence Damage Investigation at:

1 Hardwick Road
Toft
Cambridge
CB23 2RQ

CLIENT:	Crawford & Company
CLIENT REF:	SU2300135
MWA REF:	SUB230228-12462
MWA CONSULTANT:	Richard Percival (TechArborA)
REPORT DATE:	21/04/2023

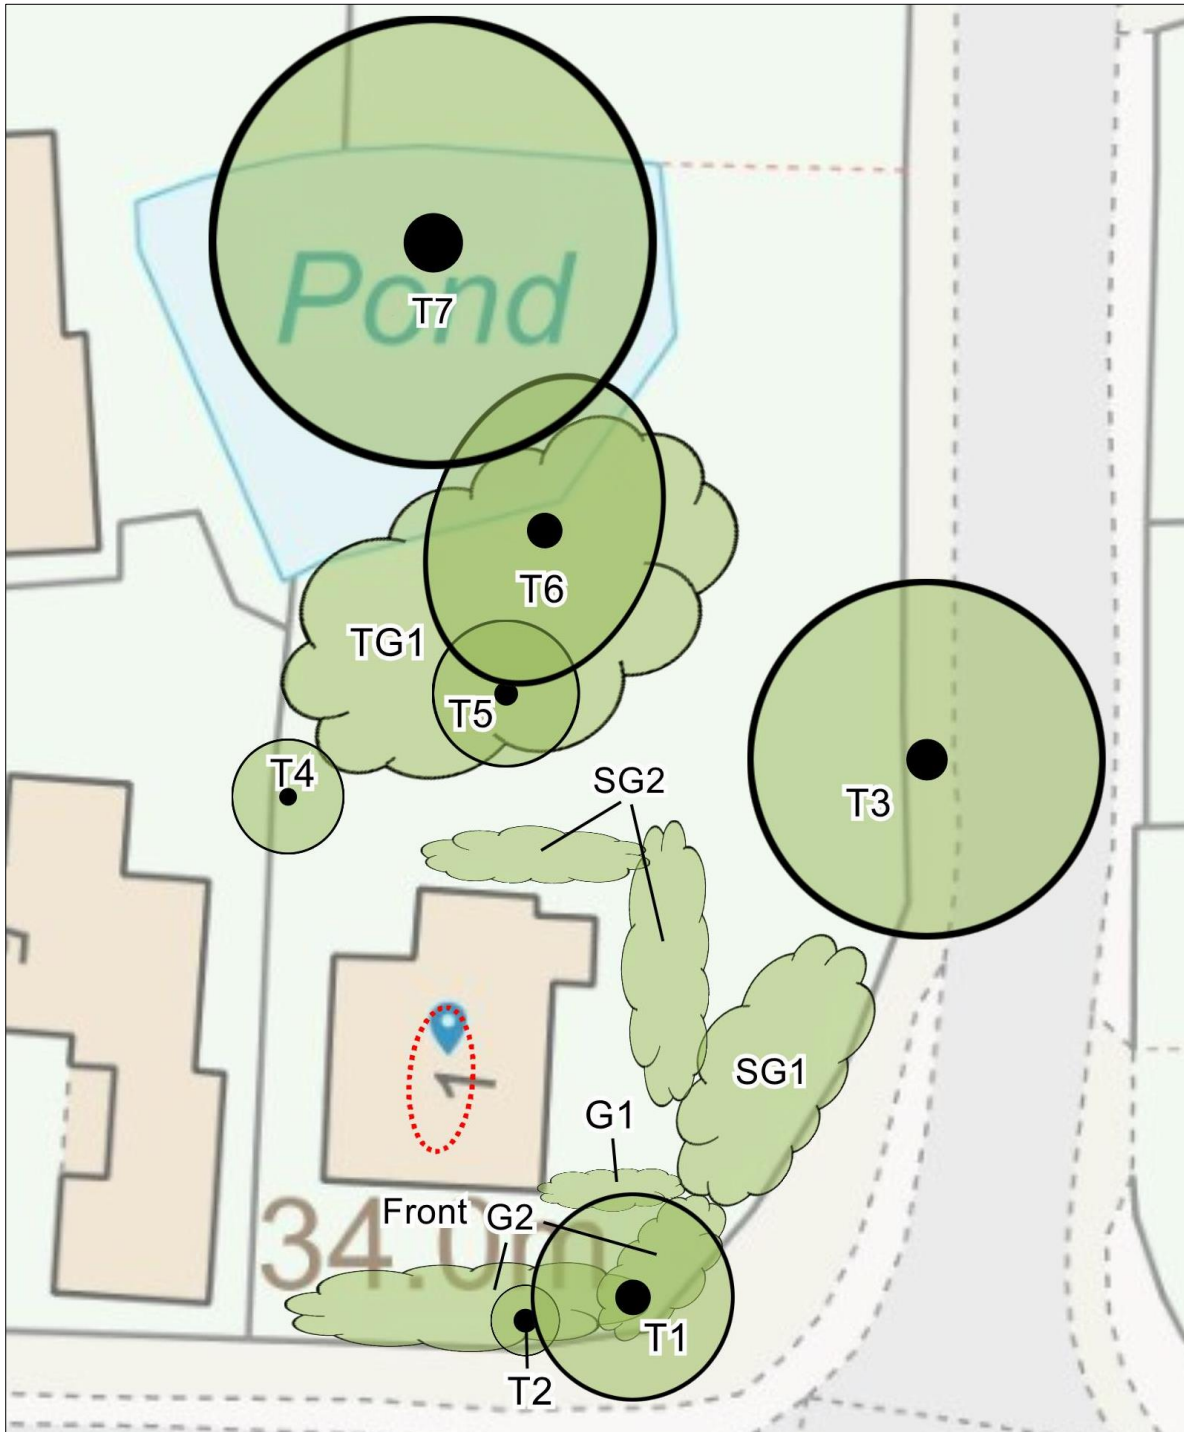
Site Plan

Approximate areas of damage
