**BUILDING AT NORTH HELE FARM,**  
**CLAYHANGER,**  
**TIVERTON,**  
**EX16 7NZ**

**REPORT ON THE STRUCTURAL CONDITION  
OF THE EXISTING BUILDING**

19<sup>th</sup> June 2019

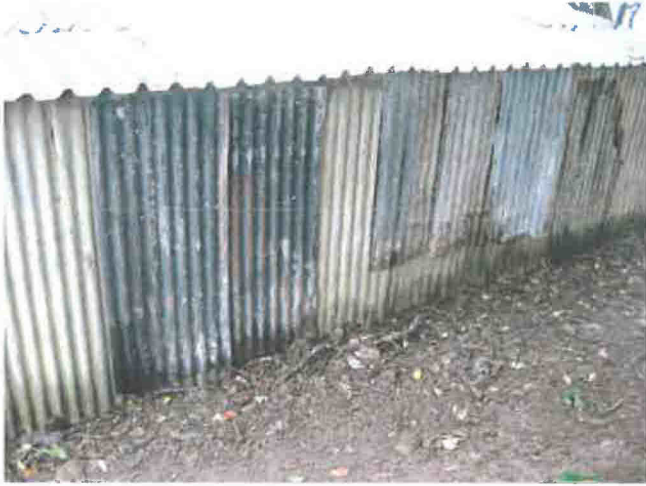
Photo 1 – North View

The north wall to the lean-to section is comprised of timber frame studding with vertical galvanised corrugated iron sheeting externally and 3/4mm thick calcium silicate boarding internally to approximately half of the length. There is no gutter to this wall on the outside.

The walls to the lean-to section would benefit from rebuilding to current standards.

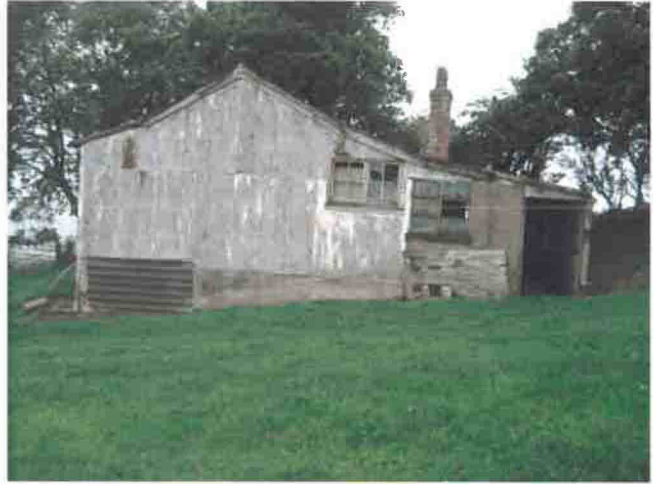
Photo 2- East View

The northern section of the east wall is built in 100mm thick dense concrete block work and rendered externally. There is a small steel window to the bathroom area which is in poor condition. The remainder of the wall is timber frame construction similar to the southern wall. There is a small timber window to the main room and this window is also in poor condition. The eaves are sealed by timber boarding which is in slightly better condition than the western elevation.

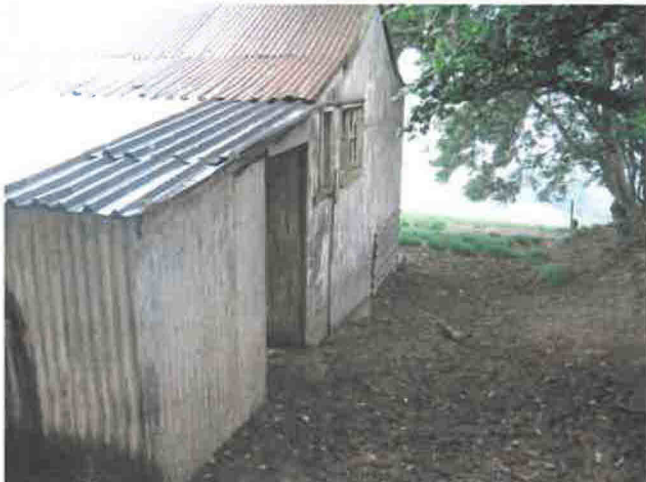
Photo 3 – West View

The northern section is a timber stud wall with galvanised corrugated iron sheeting. The southern section is the gable wall to the main room and comprises rebated timber boarding onto 75mm by 50mm timber studs at 600mm centres. The timber boarding has then been over-clad in galvanised steel sheeting. The steel sheeting is starting to rust, but where visible the original timber boarding appears to be in satisfactory condition. Internally small additional studs have been added to the main structure studs and thin hardboard used as an inner lining. The hardboard has been damaged in many areas with holes formed to show the external timber boarding. There is no insulation between the boarding and the hardboard inner liner. There are two timber windows to this elevation but these are in poor condition. The eaves are sealed against the roof sheeting by timber boards but these are in poor condition.

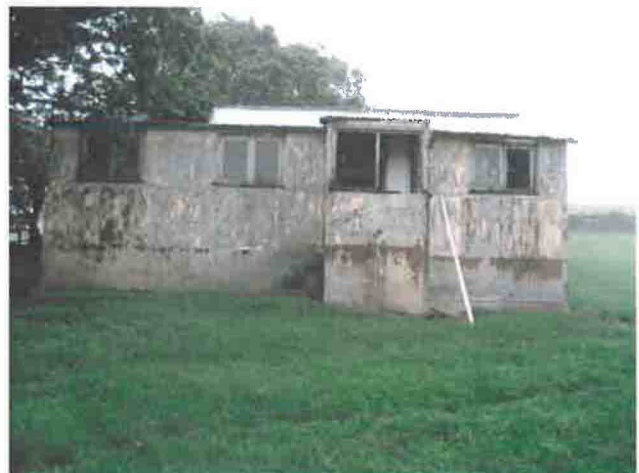
Photo 4 – South View

The south wall is similar to the west wall but the external steel sheeting is showing more signs of rust. There is a small raised entrance porch but the floor has disintegrated. The timber windows to the porch and the three other windows along this elevation are all in poor condition. The lower walls to the porch are in stone and it is assumed that the other external walls to the main building area also have a stone base up to floor level. There is no guttering to this elevation.

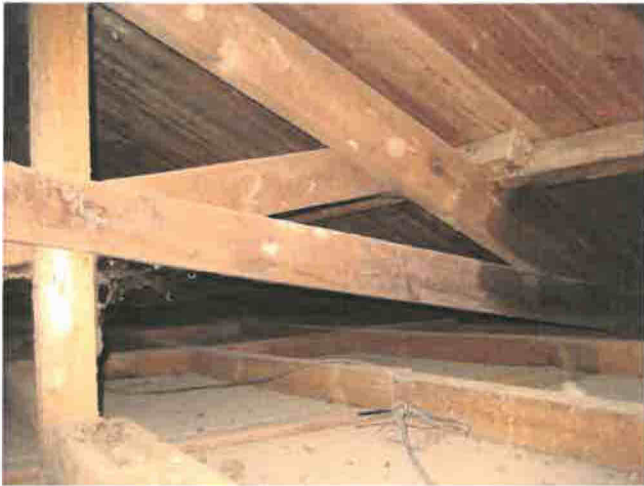
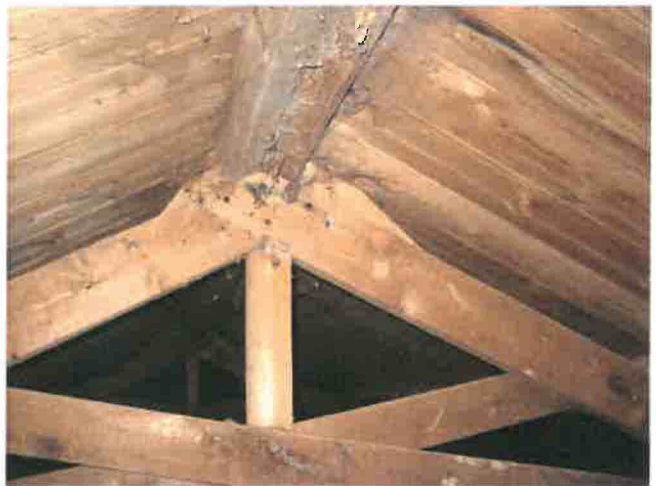
The roof to the lean-to section is a mixture of corrugated iron sheeting and profiled steel sheeting. It is supported on a central made-up timber purlin. The roof to the main room area is corrugated iron sheeting and this is now rusty. The ridge is sealed by a shaped steel section. The main roof appears to be water tight. The sheeting is supported by timber sarking and then 75mm by 47mm timber purlins which span between the gable walls and the two timber trusses. The timber trusses have 150mm by 50mm principal rafters and 175mm by 50mm lower ties. Some notches have been cut in the lower ties but these are unlikely to affect their performance.

The roof will require insulating and an inner surface formed. The existing steel sheeting would ideally be replaced.

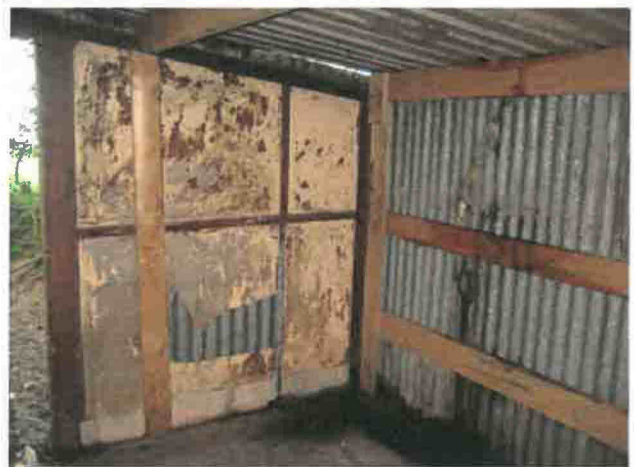
Photo 8 – North West Room Area

There is a stand alone partition wall in the lean-to area which is timber frame with a single layer of 3/4mm calcium silicate board

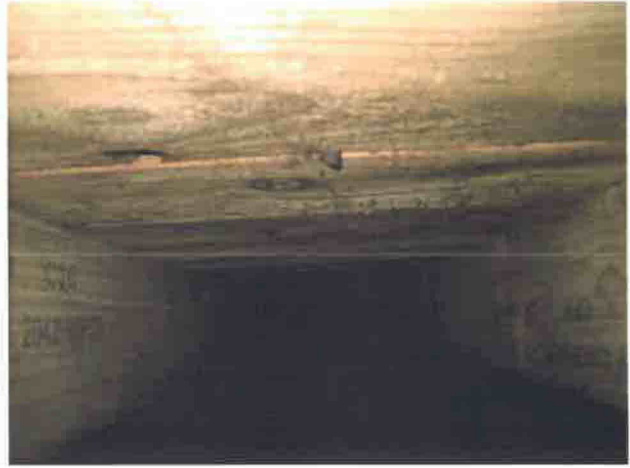
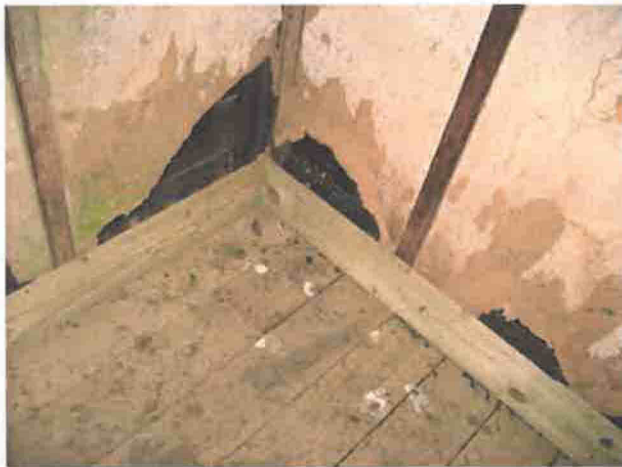
The northern lean-to areas have a concrete floor at the adjacent ground level, although this concrete appears to be in satisfactory condition. The floor of the main room area is a suspended timber floor and appears to be relatively new. The 47mm by 125mm timber floor joists can be seen at the porch area and they still display their stamp markings. The floor boards themselves may have been reclaimed but are in good condition. From photographs it appears that there is a concrete over-site below the suspended timber floor.

The main room area would also need insulating and this could be done between the existing floor joists or by insulating above the existing floor and then providing a new floor surface.
