# NOTES FOR CLEARANCE OF CONDITIONS

Location: Stonewall, East Street, Hunton, Kent ME15 0RB

Description: Listed Building Consent for Internal and External Repairs and Alterations

Reference: Maidstone Borough Council Application No.: 22/505899/LBC

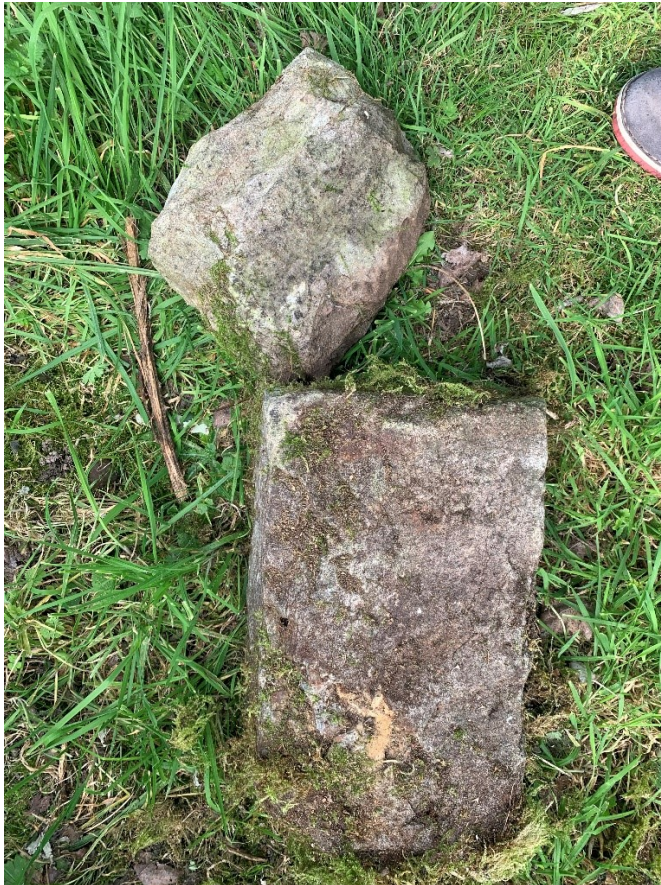
Fig.1 (Left) Sample of Kentish Ragstone on site to be used for repairs and plinth to new gable wall. This will be cleaned off and selected ready cut stones will be used.

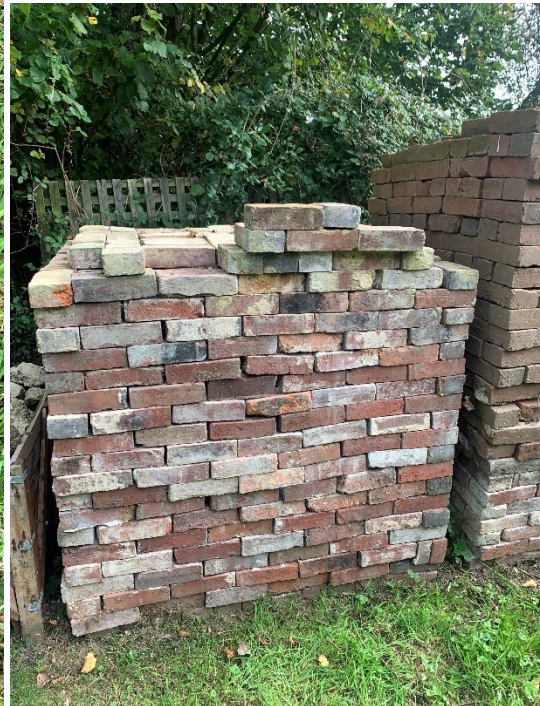
Fig.2 (Right) Local bricks on site to be used for repairs as required.

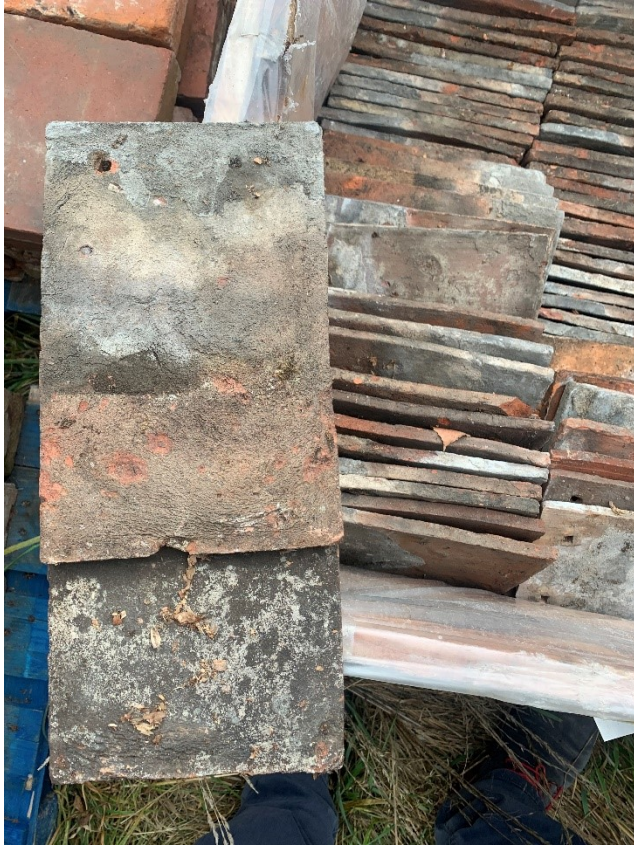
Fig.3 (Above) Kent peg tiles on site to be used for roof repairs and repair of vertical tile hanging.

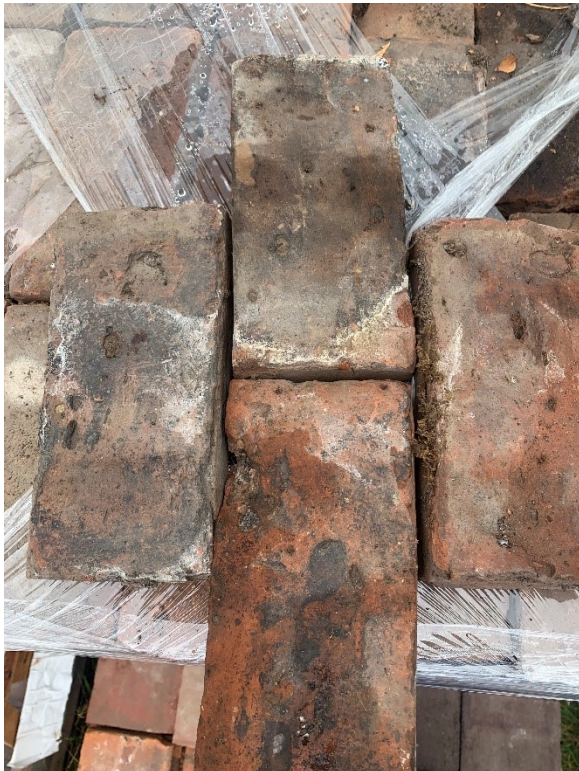
Fig.4 (Below) Paving Bricks to be used for the Study, Passage and Stair Passage floors, where the existing floors are not finished. These are believed to have been salvaged from elsewhere in the house when the floors were raised by the previous owners.

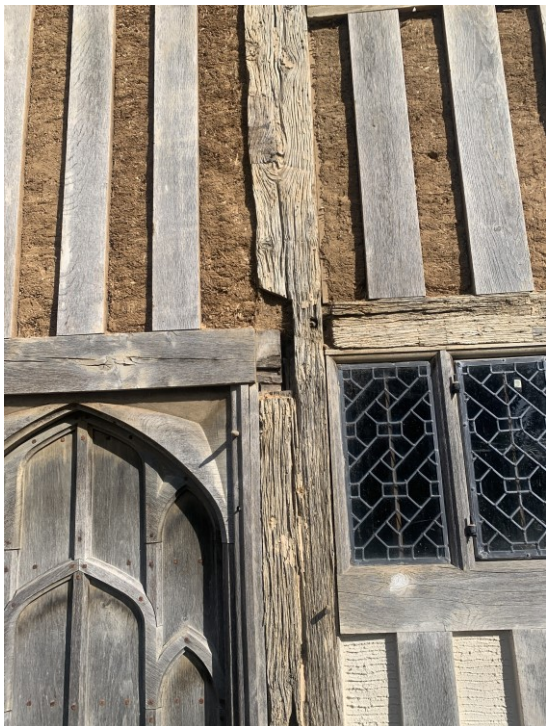
Oak Frame Repair FR1: South Elevation

Post between D5 & W14 at junction with lintel over D5, and east end of lintol over W14.

The intention in these areas is to carefully remove defective timber and cement, and after assessing the extent of damage, to scarf in new sections of green oak. Oak pegs will be used to secure joints.

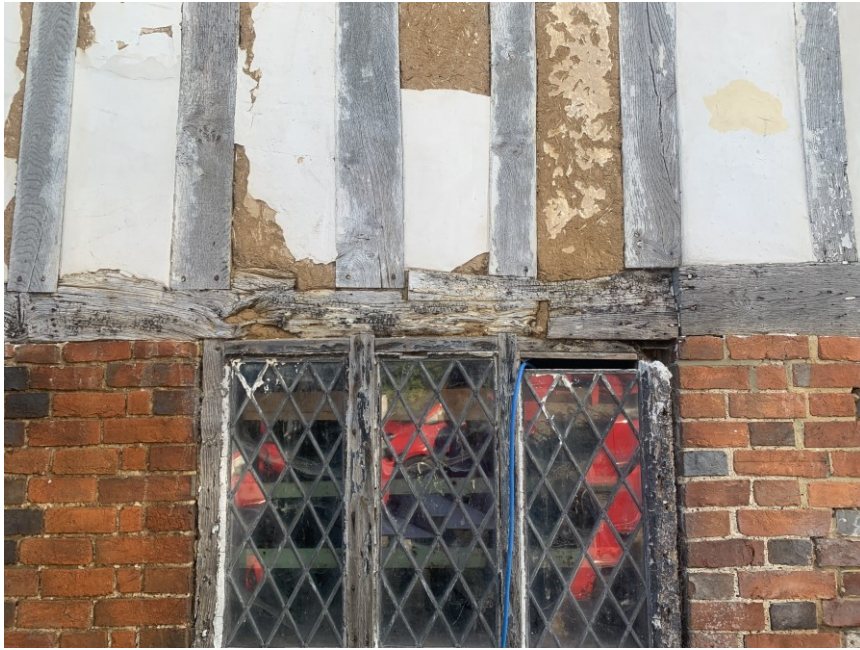
**Oak Frame Repair FR2: West Elevation**

Plate above W6 severe decay, part, poorly repaired with cement mortar, part repaired with sections of timber nailed to the joist ends behind.

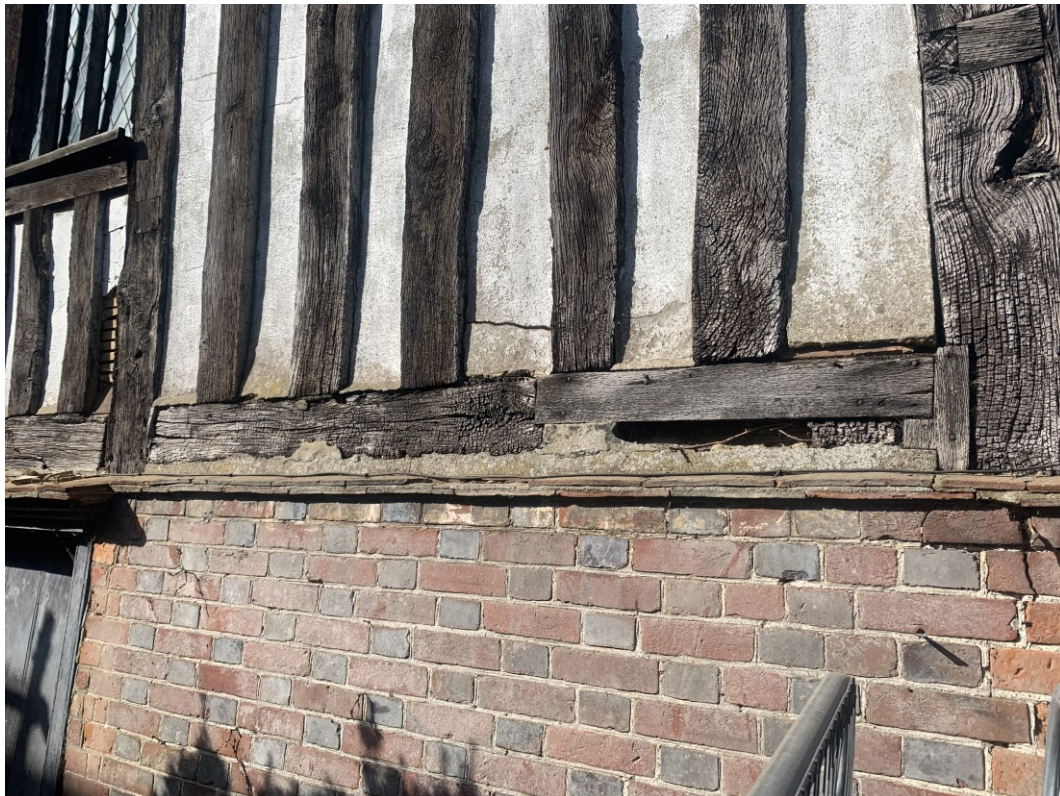
**Oak Frame Repair FR3: Courtyard, East Elevation**

Plate above brickwork to north of door D2, poorly repaired with cement mortar, part repaired with a plank nailed to the joist ends behind.

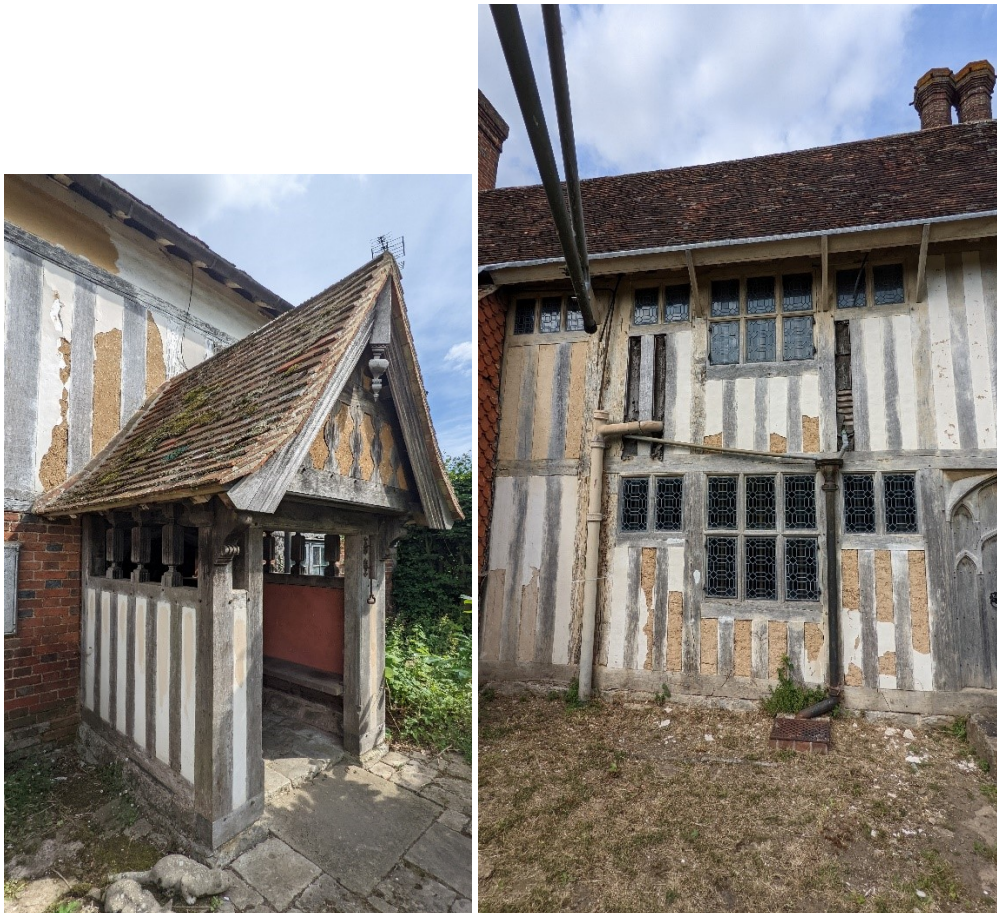
The chosen method was to apply a rough daub up to 75mm deep made of lime mortar with a straw binding. A thin finishing coat of approximately 2mm was applied over this. This top coat has failed extensively, in some areas it has fallen off completely. This has exposed the daub beneath which has been damaged by rain and frost and is in a poor state (see figs. 1 & 2 below).

Fig. 1 (left) Part of west elevation with modern porch, fig.2 (right) part of the south elevation, showing extensive damage to the late C20 render infill.

It is quite clear that all the late C20 infill (except perhaps for that on the porch bay) is to the same specification and will perish in the same way within a few years.

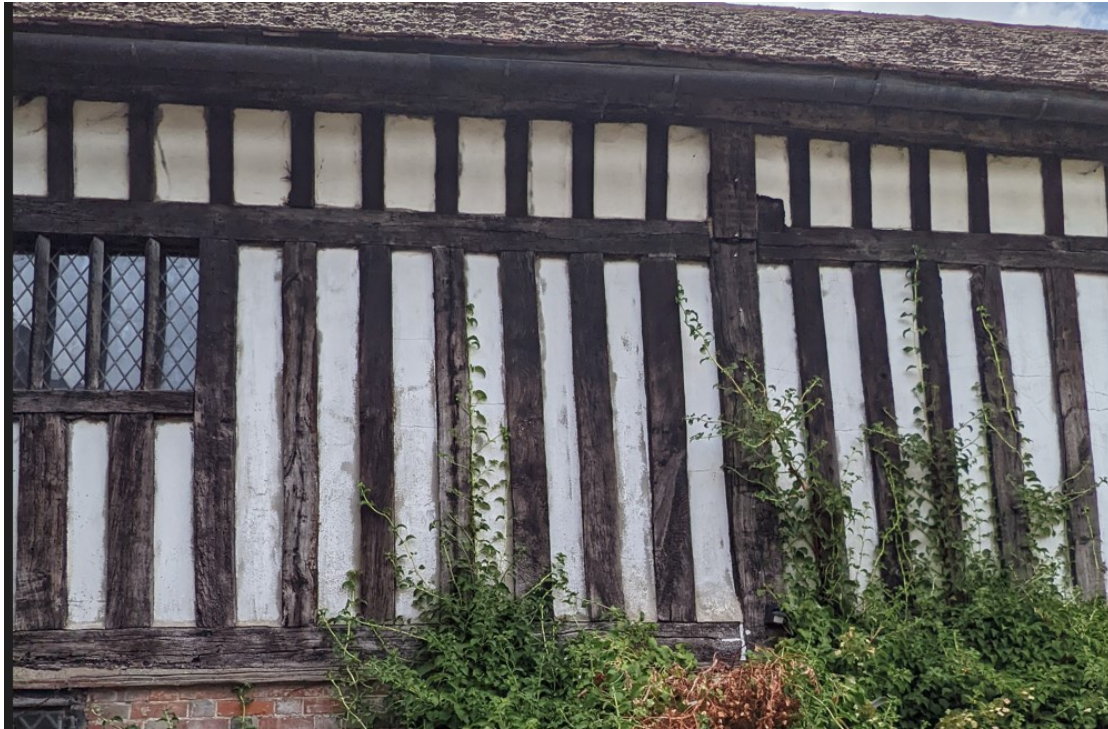
Fig 3. (above) Upper part of the east elevation of the north courtyard. The late C20 restoration was not completed and it is clear that this section was left until last and not repaired. The infill is clearly cement Based and will need to be removed and replaced with lime render.

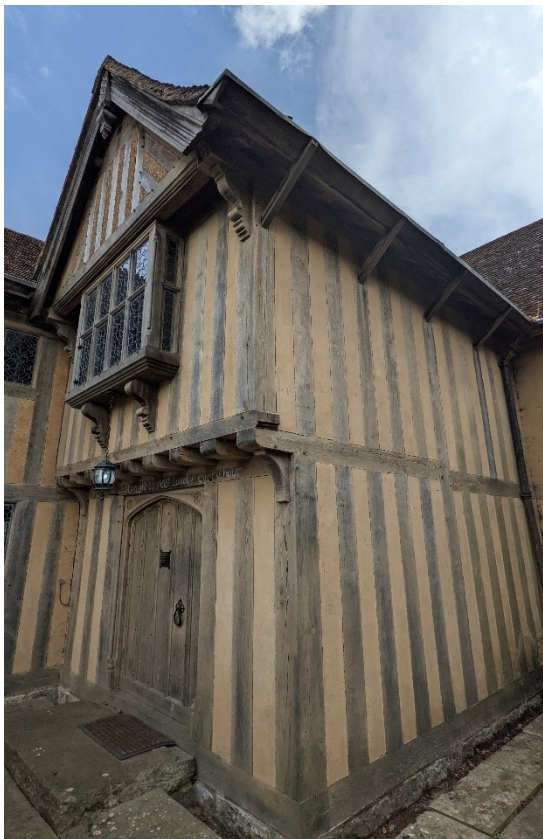
Fig. 4 (left) The render to the porch extension (dating from the 1980s) appears to be in better condition than that used elsewhere. However, this may just be because it was the last part of the house to be rendered.

The gable section was never given a finishing coat and has the same straw-based substrate found everywhere. We are therefore applying for consent to remove the render here and replace it with the specified lime mix.

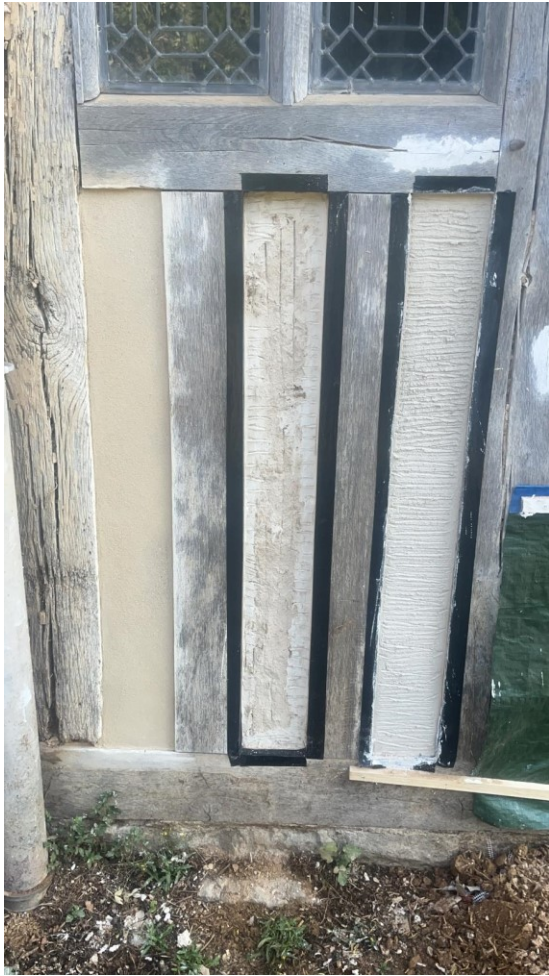
Fig. 5 (left): Sample panels showing stages of three-coat work with finished (unpigmented) panel on the left hand side.

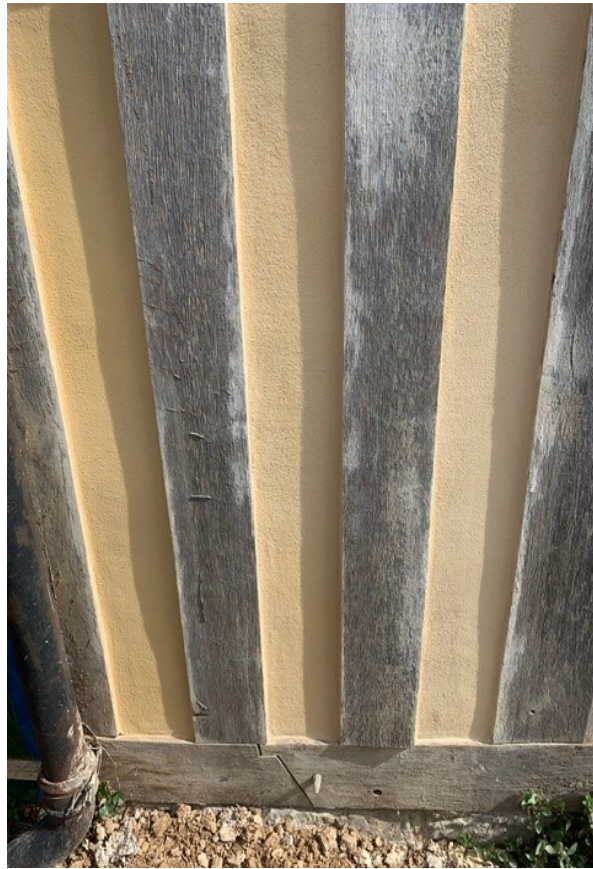
Fig. 6 (right) Sample showing possible pigment colour and surface finish. The bases of these panels are recessed but it was decided that while the tops and sides will be set 5mm behind the face of the studs, the base will be flared out slightly to help repel rainwater.

Note that this render is pigmented to achieve the desired colour. Following discussions it was decided not to tint the render and use a traditional limewash, possibly with some pigments.
