Tree report

October 2023

| Project | Low Gables copper beech tree |
| Location | 1 Low Gables, South Park, Hexham, NE46 1AH |

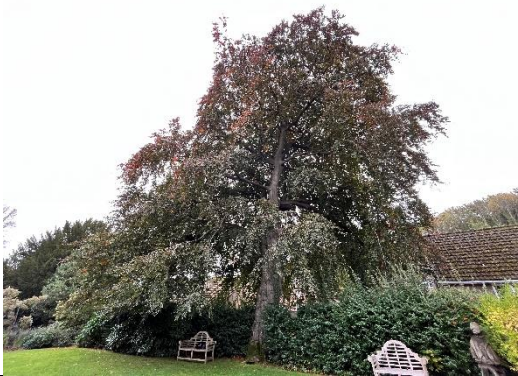
| <p>1. View of the western elevation of the tree (looking east).</p> | <p>2. Torsional loading and reaction wood on the main stem.</p> |

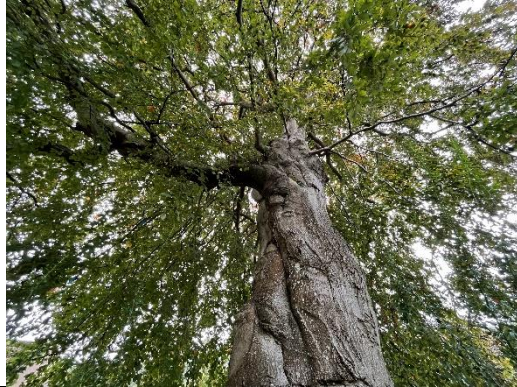
- 3.7 There are longitudinal reaction-wood torsional ribs present on the main stem up to the first major union. This is the tree adapting to constant wind pressure from prevailing winds as it has grown through its lifecycle. External strengthening of the bole and the main stem in this way could also be an indication of hollowing; a natural process as the tree transitions towards over maturity, although the bole appeared sound when struck with the Thorex mallet. With such old and large trees surrounded by targets; it is always advisable to carry out an advanced assessment of the condition of the bole using non-invasive decay detection equipment such as a PICUS tomograph.

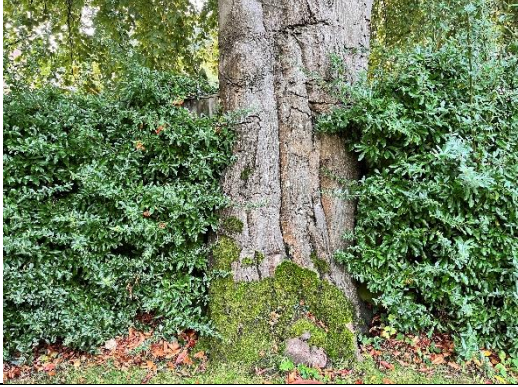
| <p>3. Reaction wood ribs on the bole.</p> | <p>4. Asymmetric crown.</p> |

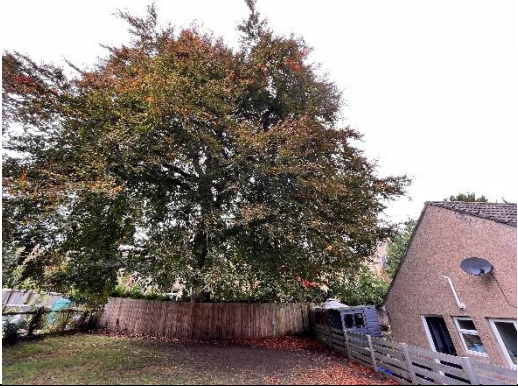
| <p>5. View of the tree from the eastern elevation and proximity to number 43.</p> | <p>6. Proximity to number 45.</p> |

- 3.4 A section of the eastern crown overhanging number 43 will be end-pruned/ reduced to provide at least 3m clearance from the roof.
- 3.5 A section of the eastern crown overhanging number 45 will be end-pruned/reduced to provide at least 3m clearance from the roof.
- 3.6 Each pruning cut will be to an established growing point.

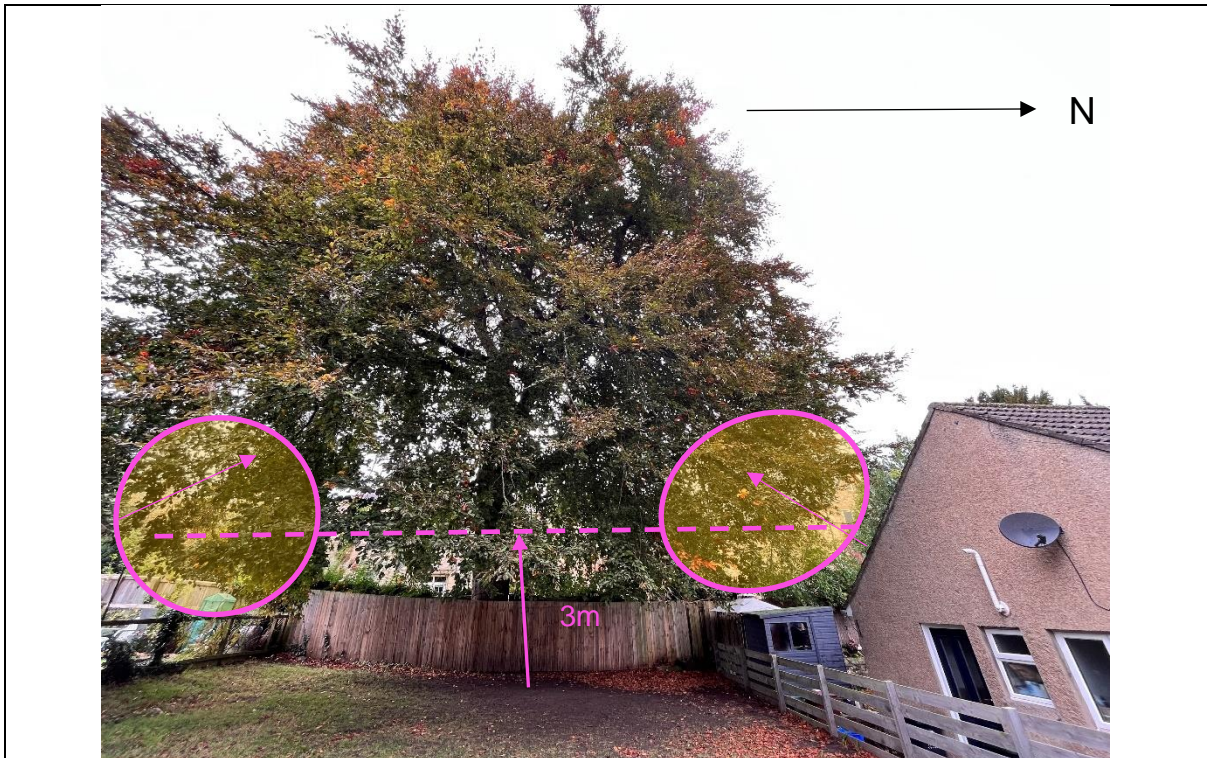
7. Dotted lines and polygons mark the sections of the crown that will be raised and removed away from the roofs of the neighbouring properties.

- 3.8 Any pruning of the tree will be carried out in the late winter to limit the likelihood of pathogen infection and just prior to when the tree will begin to flush.
- 3.1 All pruning works must be carried out according to British Standard BS 3998:2010 'Tree works recommendations' by an experienced and knowledgeable arboriculturist familiar with modern pruning practices.
- 3.2 The pruning works will be carried out under the direction and supervision of the project arboricultural consultant.
- 3.3 The crown will be raised up to 3m above ground level on the eastern elevation.

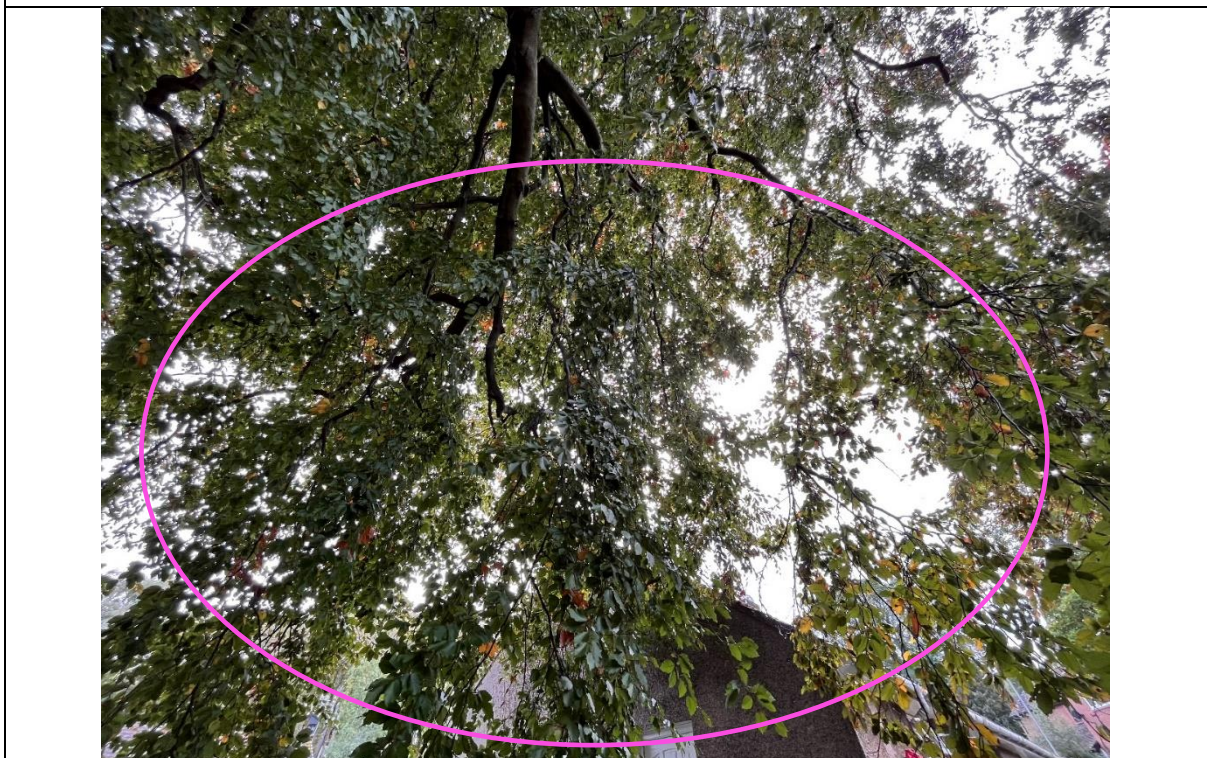
8. Section of the crown to be pruned back 3m from number 45.

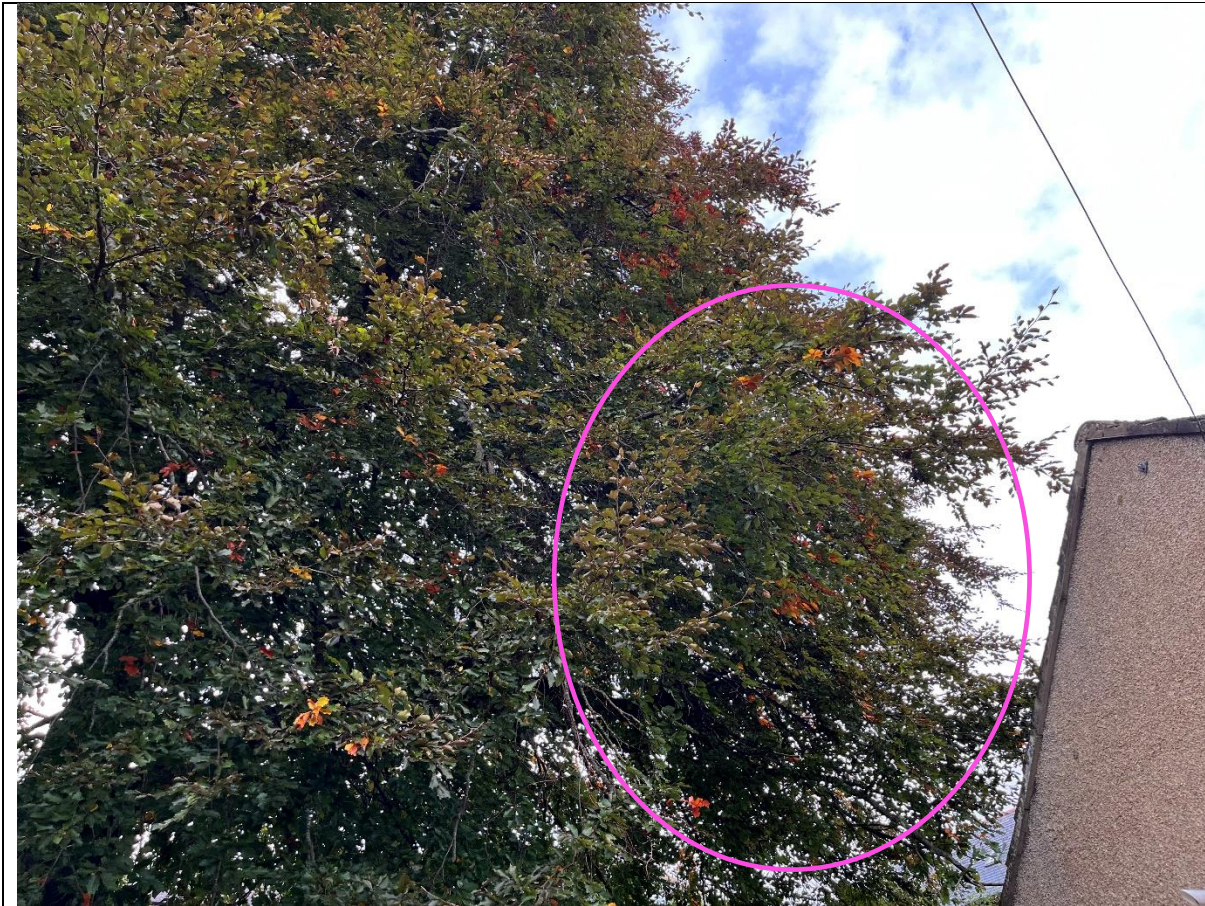
9. Section of the crown to be pruned back 3m from number 43
