Countryside Consultants
Architects & Planners

The Shambles, Hexham

Column Condition Survey N1 - N2 - N3

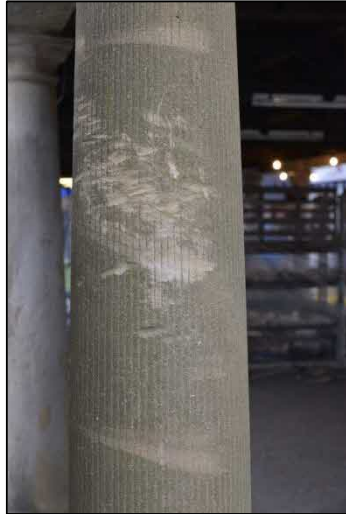
N1

HEAD
Original
Heavily eroded
Replace

COLUMN
Scuffed area
Brush back with
brass brush parallel
to the fluting

BASE
Recent
Solve standing water
Remove green moss
with DOFF cleaning

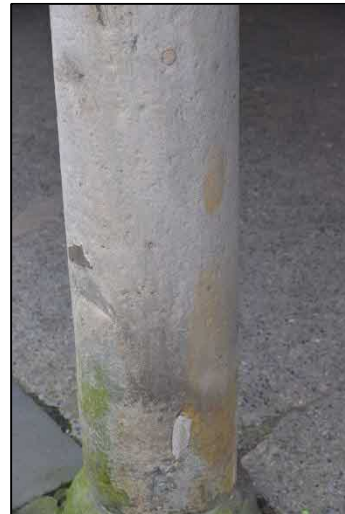
N2

HEAD
Original
Heavily eroded
Replace

COLUMN
Original
Retain indent
repair at base
Minor NHL plastic
repair required

BASE
Original
Repair not required
Remove green
moss with DOFF
cleaning

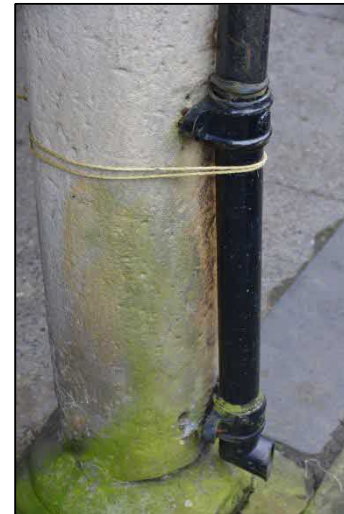
N3

HEAD
Original
NE corner lost
Replace

COLUMN
Original
Okay condition
Rainwater fixing
holes to be
reformed using
NHL plastic repair

BASE
Original
repaired
Detail lost
Replace

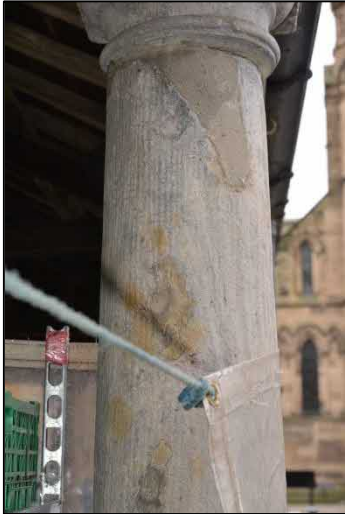
N4

HEAD
Original
No repair
required

COLUMN
Original
Out of alignment
Realign
Cut out poor
patching
Replace with NHL
plastic repair

BASE
Original
Poor condition
Replace

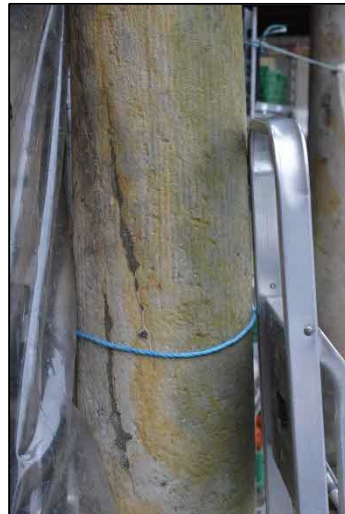
N5

HEAD
Original
Minor NHL
plastic repair
required to
bottom rib

COLUMN
Original
Cut out poor
patching
Replace with NHL
plastic repair
Stone indent
repair
required at base

BASE
Original
Poor condition
Replace

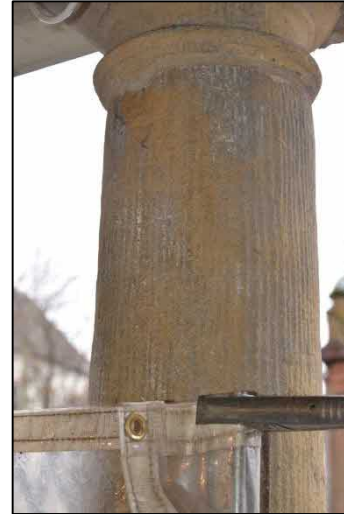
N6

HEAD
Original
No repair
required
Realign

COLUMN
Original
Cut out poor
patching
Replace
with NHL plastic
stone repair
Stone indent
repair required at
base

BASE
Original
Retain

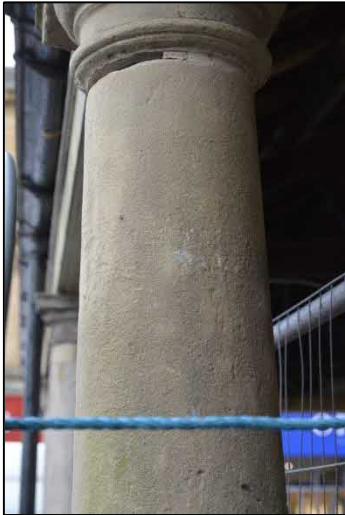
N7 work carried out in 2022

HEAD
Original
NHL plastic
repair to top rib
Realign

COLUMN
Original
Hit by car
Realign
Large indent
required at base

BASE
Original
Retain

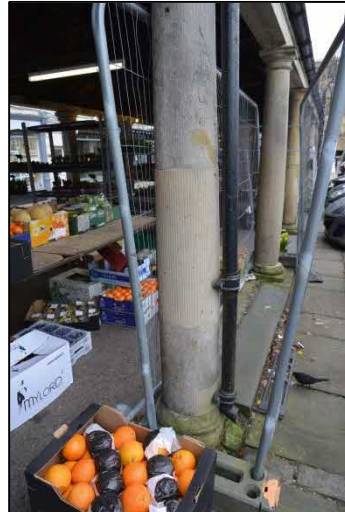
N8

HEAD
Original
Cut to
accommodate
rainwater pipe
Retain

COLUMN
Original
Heavily repaired
recent middle
section NHL plastic
repair to small hole

BASE
Original
Retain

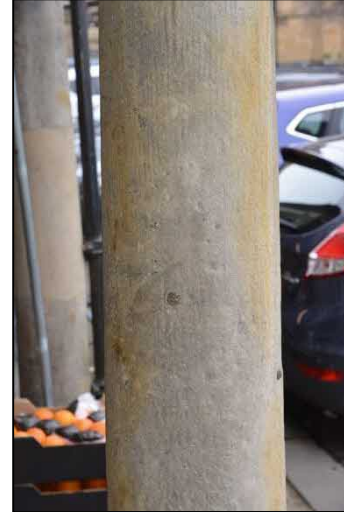
N9

HEAD
Original
Retain

COLUMN
Original
Indent required
at top

BASE
Original
Retain

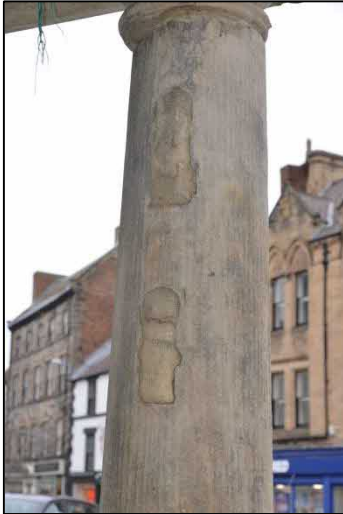
N10

HEAD
Original
Badly chipped
on E side

COLUMN
Original
Large indent
required at base
Cut out poor
patching
Replace with NHL
plastic repair

BASE
Original
Retain
Requires DOFF
cleaning

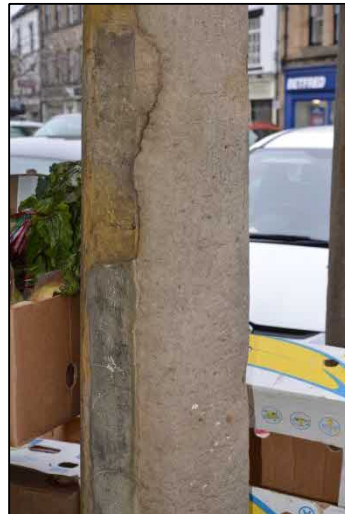
E1

HEAD
Original
Heavily
damaged
Replace

COLUMN
Original
Heavily damaged
Replace

BASE
Original
Heavily damaged
Replace

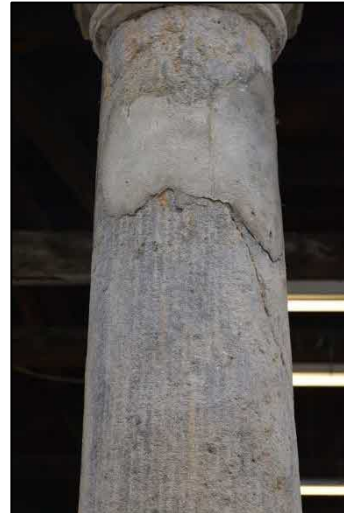
E2

HEAD
Original
Heavily
damaged
Replace

COLUMN
Possibly original
Heavily damaged
Poorly repaired
Replace

BASE
Original
Replace

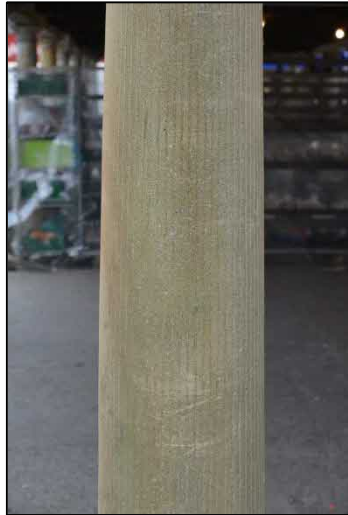
W1

HEAD
Original
Heavily
damaged
Replace

COLUMN
Recent
Retain

BASE
Recent
Retain

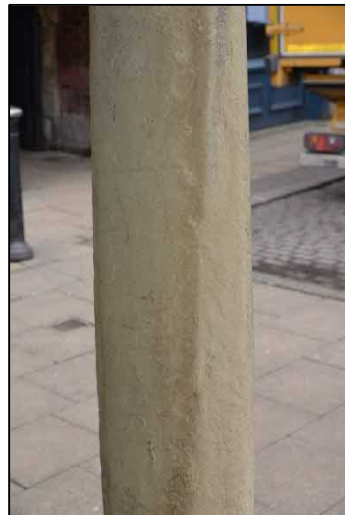
W2

HEAD
Original
Cut out poor
mortar repair
Replace with
NHL plastic
repair

COLUMN
Original
Retain

BASE
Original
Retain

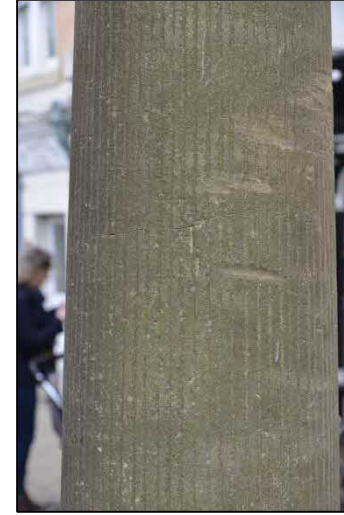
S1

HEAD
Original
Recent vehicle
damage
Replace

COLUMN
Recent
Recent vehicle
damage
Major crack
Replace top
section (900 mm)

BASE
Original
Heavily
damaged
Poorly repaired
Replace

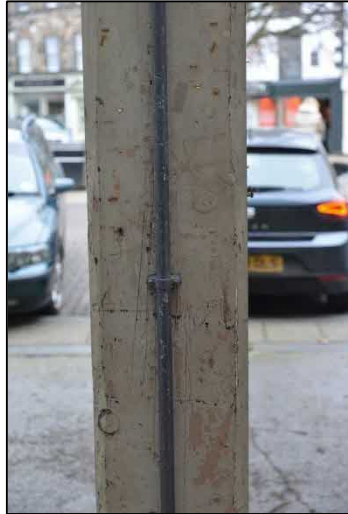
S2

HEAD
Recent
No repair
required

COLUMN
Recent
No repair
required

BASE
Recent
Insert stone
plinth

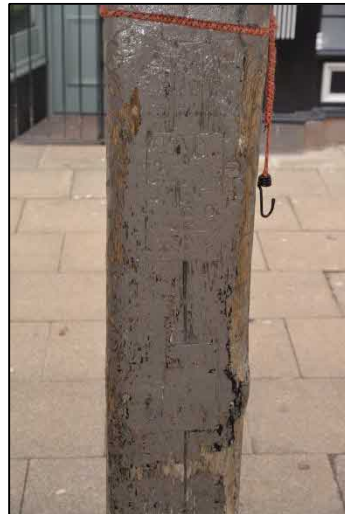
S3

HEAD
Original
No repair
required

COLUMN
Original
Heavily repaired
No repair
required

BASE
Original
Wet rot at level of
concrete
Cut out rotten
timber
Replace
Insert stone
plinth

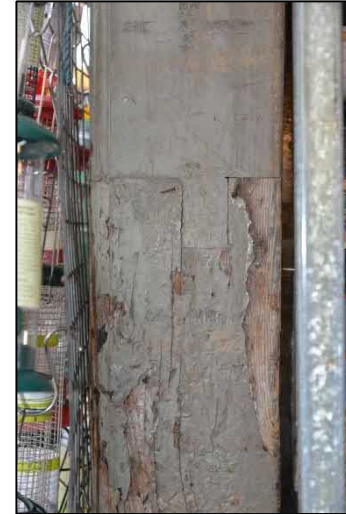
S4

HEAD
Original
Wet rot in SW
corner
Replace S and
W sections

COLUMN
Original
Heavily repaired
No repair
required

BASE
Original
Heavily eroded
from water
damage
Insert stone
plinth

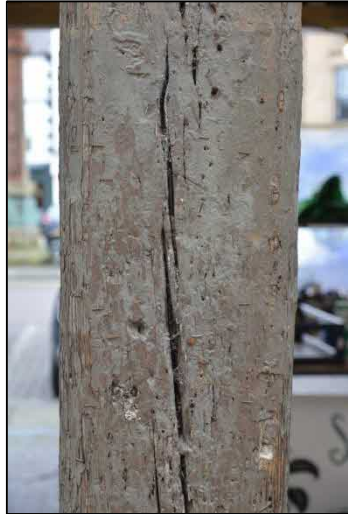
S5

HEAD
Original
No repair
required

COLUMN
Original
Heavy erosion and
splitting
No repair required

BASE
Original
Recent good repair
Insert stone plinth

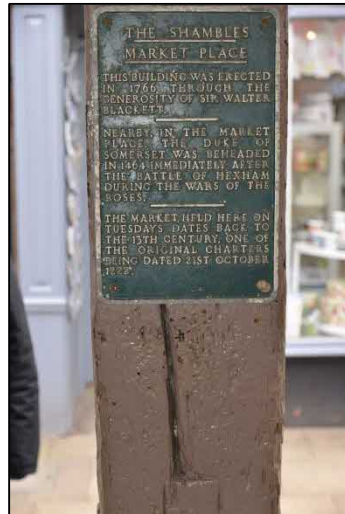
S6

HEAD
Original
No repair
required

COLUMN
Original
Heavy erosion and
splitting
No repair required

BASE
Original
Heavily eroded
Insert stone plinth

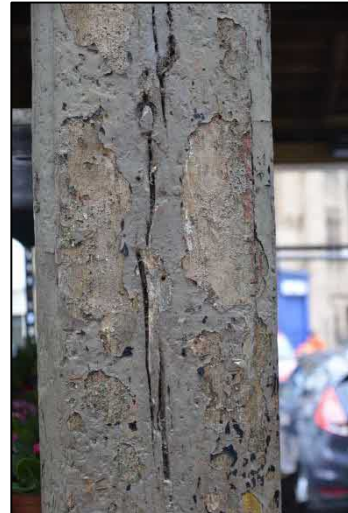
S7

HEAD
Original
Poorly painted
No repair
required

COLUMN
Original
Heavy erosion and
splitting
No repair required

BASE
Original
Heavily eroded
Insert stone plinth

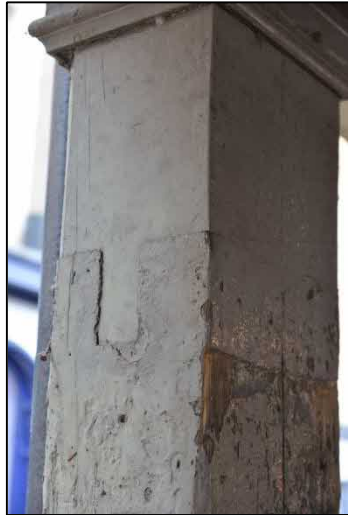
S8

HEAD
Original
No repair
required

COLUMN
Original lower
section
Upper section
replaced
No repair required

BASE
Original eroded
Insert stone plinth

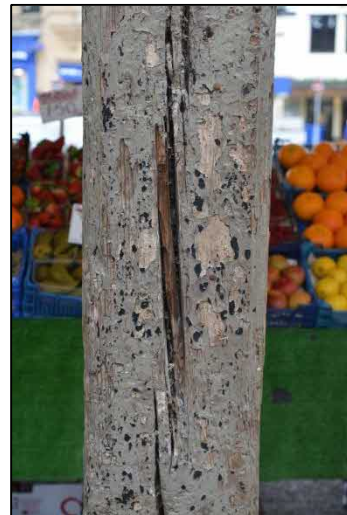
S9

HEAD
Original
No repair
required

COLUMN
Original
Heavily eroded
and split
Large indent
required across
splitting (450 mm
tall by 150 mm
wide)

BASE
Original
Light erosion
Insert stone plinth

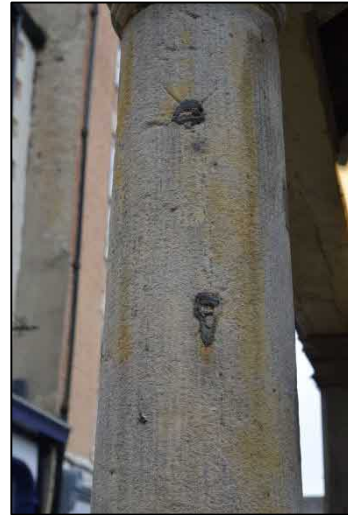
S10

HEAD
Original
Replace

COLUMN
Original
Indent required at
base
Remove iron and
lead fixings.
Replace with NHL
plastic repair

BASE
Original
Replace
