Job no: 23/17
Client: Northumberland County Council
Project: The Shambles Market, Hexham
Date: 11th October 2023
Present: Ray Loughhead of Loughhead Roofing Contractors
Ian Wells of Countryside Consultants
Author: Ian Wells

THE SHAMBLES CONSERVATION PROJECT ROOFING INVESTIGATION

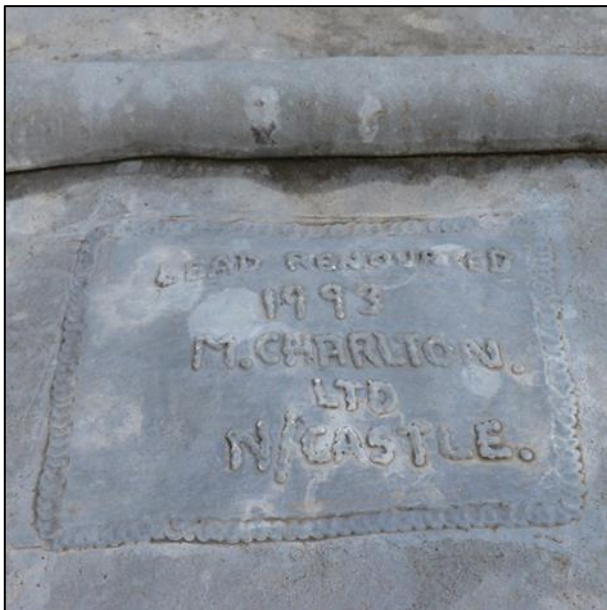
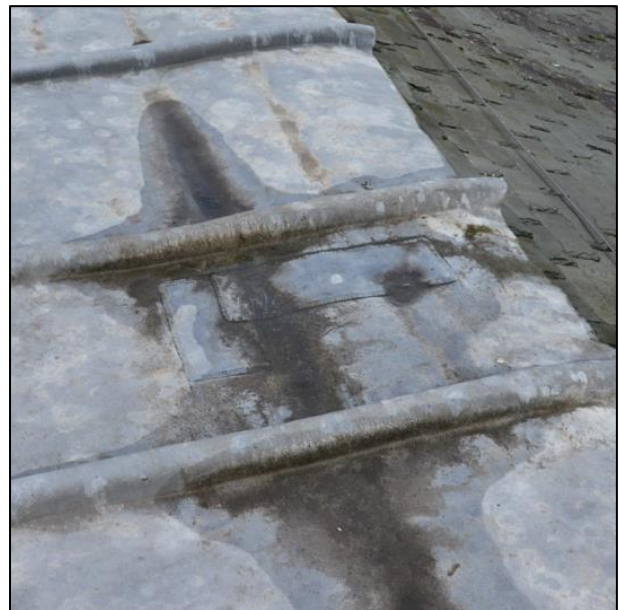
Since the report was written it has been reported that Matthew Charlton's of Hexham archive documents report that the building was re-weathered with newly cut slates in 1911. Today's visit has found a small plaque which says that the leadwork was repaired in 1993. The aim is to get the roof in good fettle for the next fifty years.

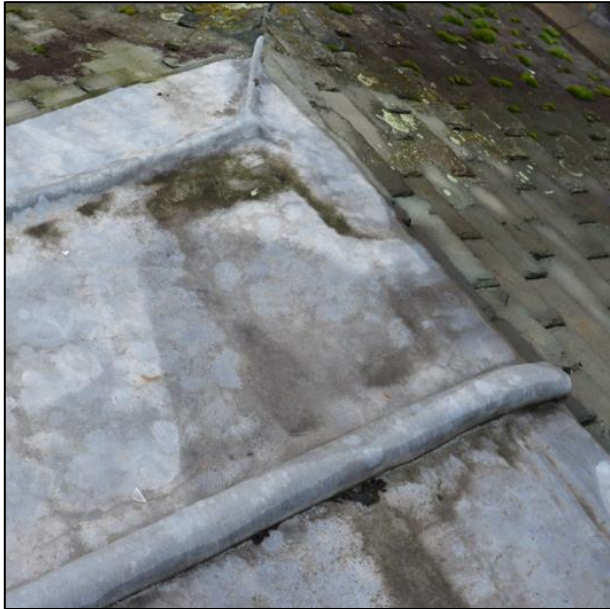
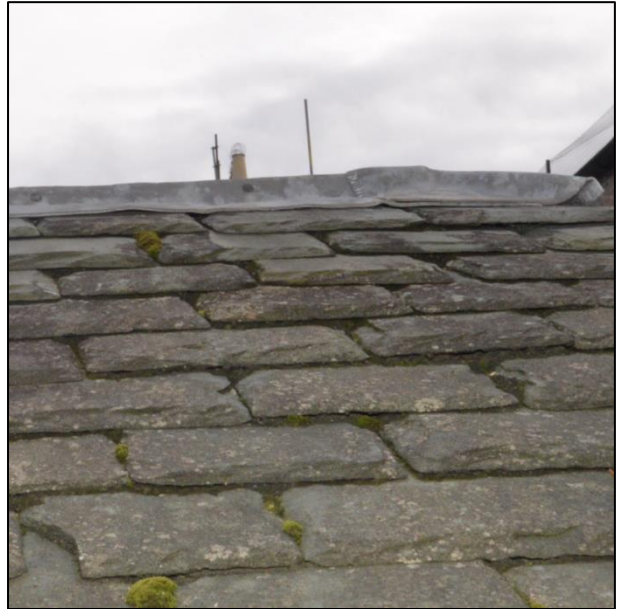
This all appears to be code 6 or 7 lead sheet, in good condition without any splits or cracks. The lead has dips in it where the water is holding, but none are leaking. The various repairs all appear to date from 1993, when the plaque was welded on, they were done by a good welder and they do not appear to have decayed in any way. There must be copper clips incorporated into the open rope formed rolls. Recently the odd brick and plastic vapes appear to have been thrown on to the roof and access to install Christmas lights is known to have occurred, but have caused no lead damage.

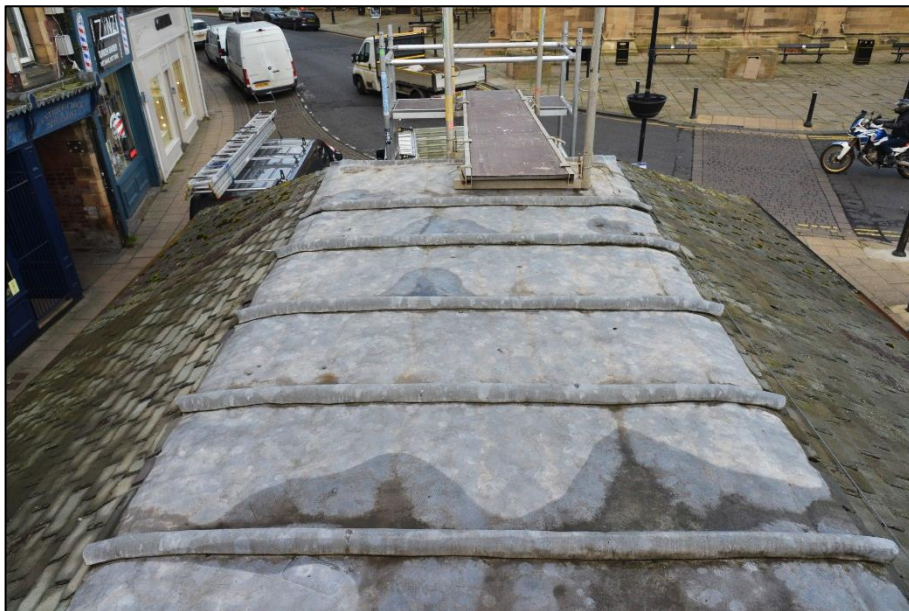
The east and west end panels of lead have welded lead mitres at the corners, and they are fixed down using copper nails into the side of the final rolls.

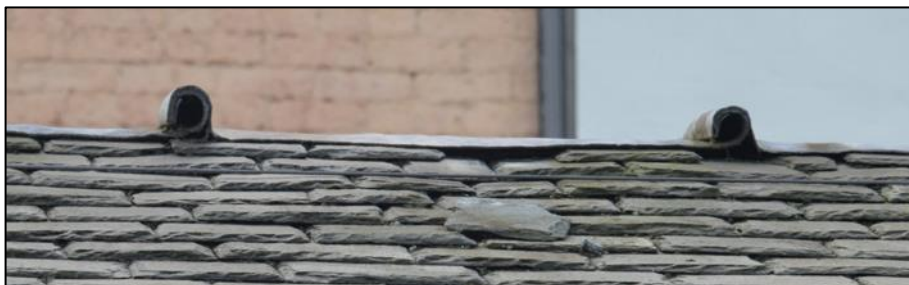
The standing water seem to coincide with the locations of the damaged and deflecting trusses.

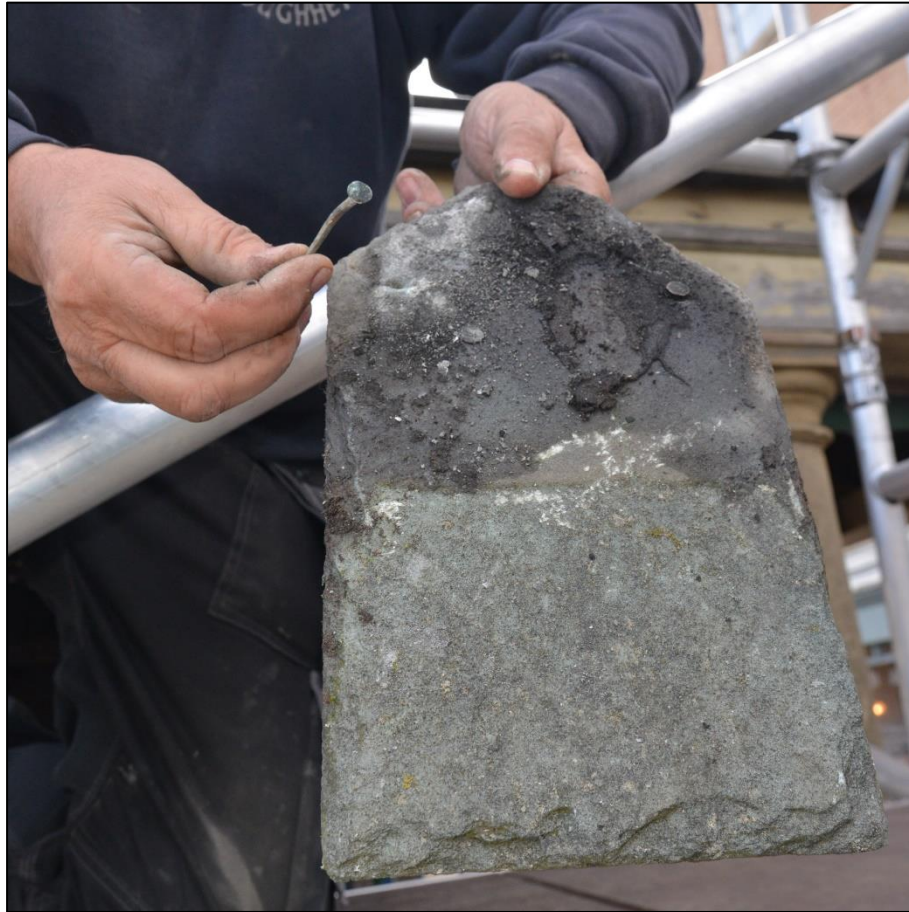
The slates are between 250 and 275mm long and twice nailed at the shoulder. The nails are copper and corrosion free. Some nails and some slates have broken especially at the eaves. The hips are mitred with lead soakers.

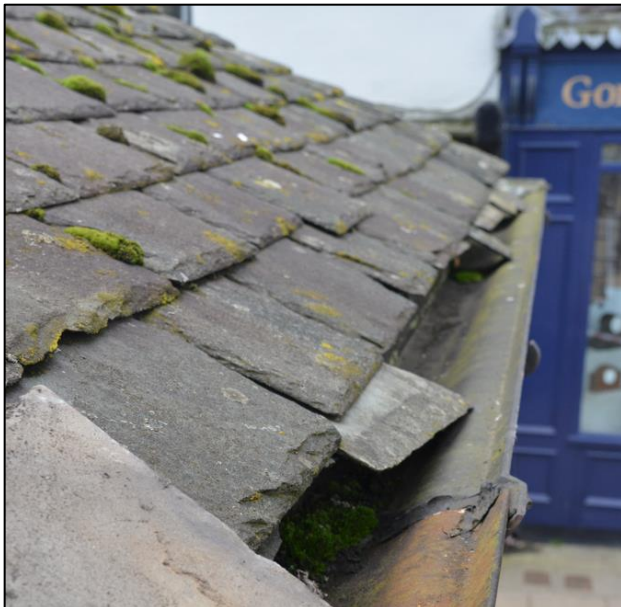
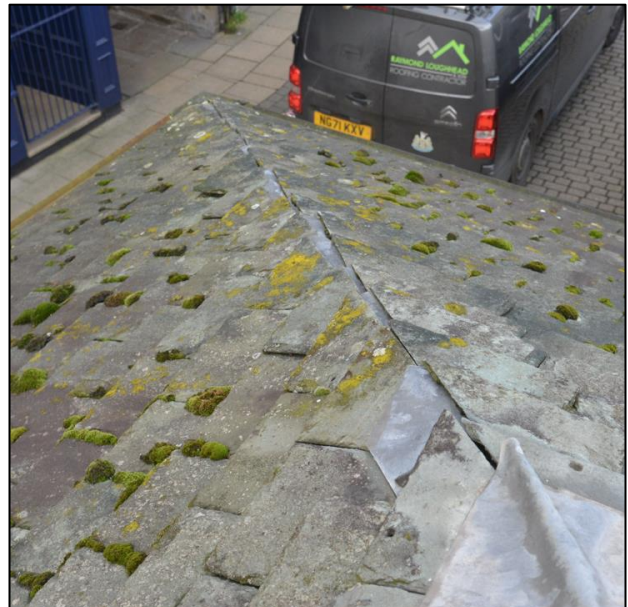
The bottom rows of slates have suffered worse from loosening nails in the lowest sarking boards, which will be the dampest boards.

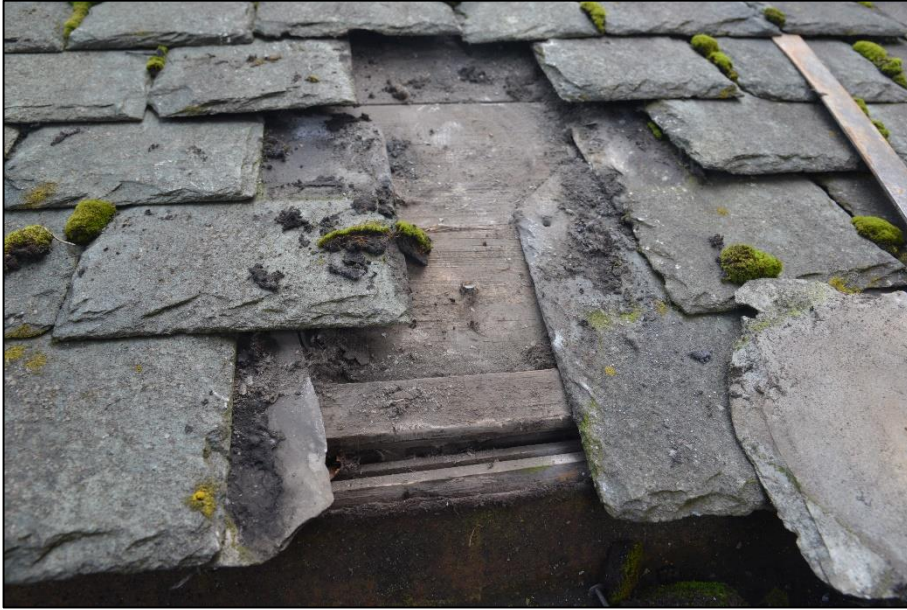
Ray opened up the base of the west pitch and found that here the boards and drip were in sound condition. However, we were not confident that the eaves boards were in good condition in most other locations. We will include for replacing 50% of the two lowest boards and all the drip, as water will trap behind it. The groove in the eaves fascia board in a water trap and should be corrected.

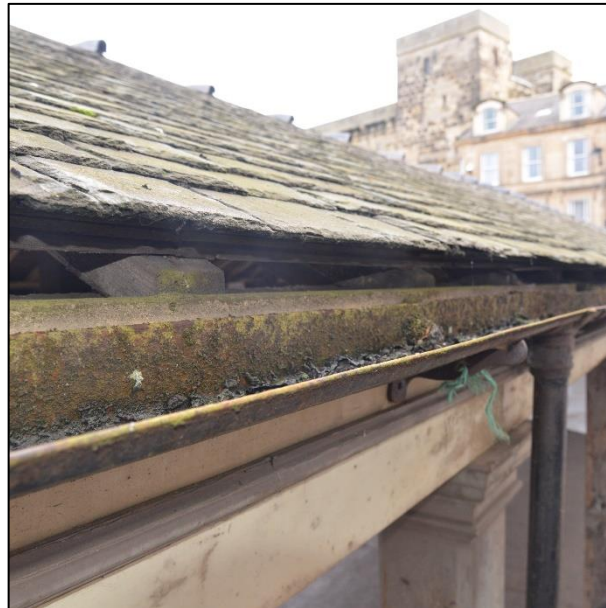
The south eaves fascia boards are suffering from very poor or missing fixings and the sarking board stopping short of the rafter ends. The fascia boards are twisting out of the vertical plane.

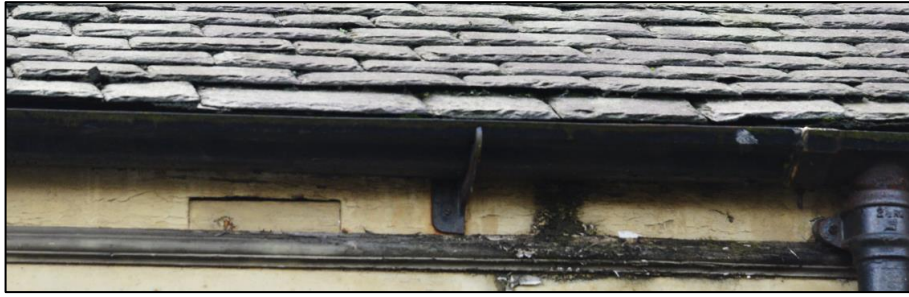
The upper fascia boards behind the gutter have some strange splices in and decay where water has not been caught by the gutters.
