Lime Tree Farm Ipswich Road Long Stratton Norfolk

Design Access Statement

Document reference: 22-38-DAS-01-00

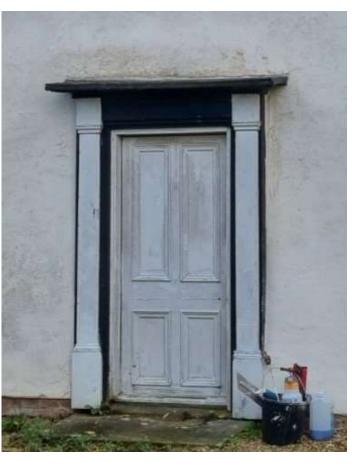
Figure 7 Pilastered Door

- 7.2 Conservation work to the timber frame will be carried out with due regard for the historic features of the property. The pilastered doorcase will be repaired and restored. Rotten timbers will be replaced with new timbers scarfed in. The introduction of a DPC will ensure the sole plate remains free from damp, which as been the cause of damage to the timber frame.

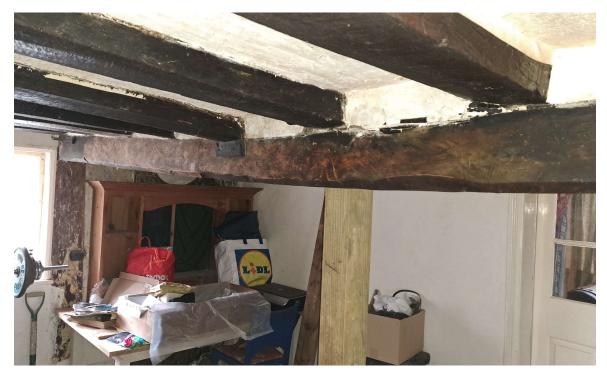
Figure 8 Propped Beam

- 7.1 The failing oak beam in the living room, which is currently propped at mid span, will be replaced with a new oak beam. The original timber will be used elsewhere in the restoration of the property.

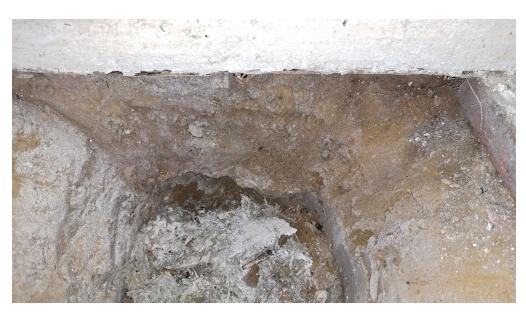
Figure 9 Trial Pit - No Foundations

- 7.4 Underpinning due to lack of substantive foundations will remediate the settlement in the north-west corner of the property and facilitate the introduction of an insulated floor slab.

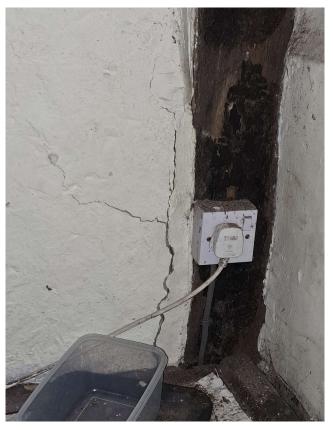
- 6.1 The older timber framed part of the property is currently in state of disrepair with defects to the fabric and the structure which comprise its habitability presently and its structural stability going forward. Defects include but are not limited to:
 - Compromised cross beam in the living (ref annex A)
 - Absence of foundations and damp-proof course (ref annex A)
 - Rotted timbers including the sole plate and tenoned timber posted (ref annex A)
 - Impermeable OPC render causing cracking and damp ingress (ref annex A)
 - Settlement to the north-west corner (ref annex A)

Figure 10 Cracking in North-West Corner
