ASHLEY LARGENT ASSOCIATES
BUILDING DESIGN AND CONSULTING ENGINEERS

Our Ref: **H059/AL/01**

Date: **1st Nov 2022**

Proposed Alterations & Extensions to 23 & 24 Park Cottages Church Road, Tattingstone - Structural Considerations

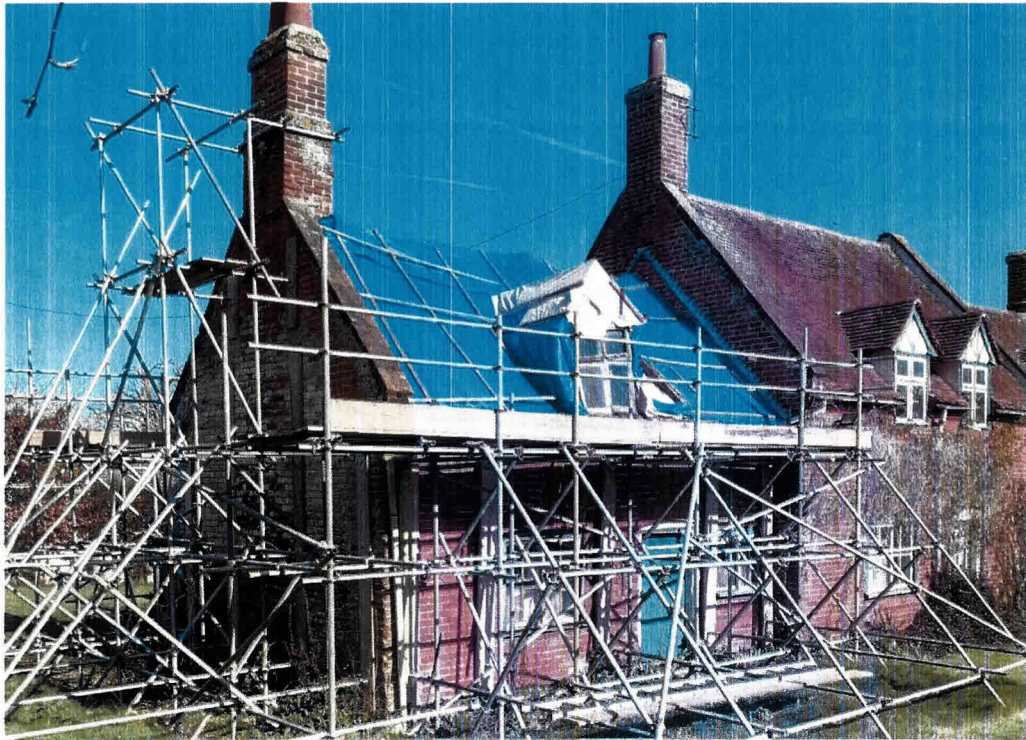
It was quite apparent that no 24, the derelict and smaller of the two cottages, was suffering with significant structural failure, by the undulating roof line and *bulging* external masonry walls. The roof tiles had been stripped, the roof framework covered with tarpaulin, and a temporary scaffolding support had been installed around the property to prevent further structural deflections.

Temporary Scaffolding Installed Around Cottage (View from South/Front)

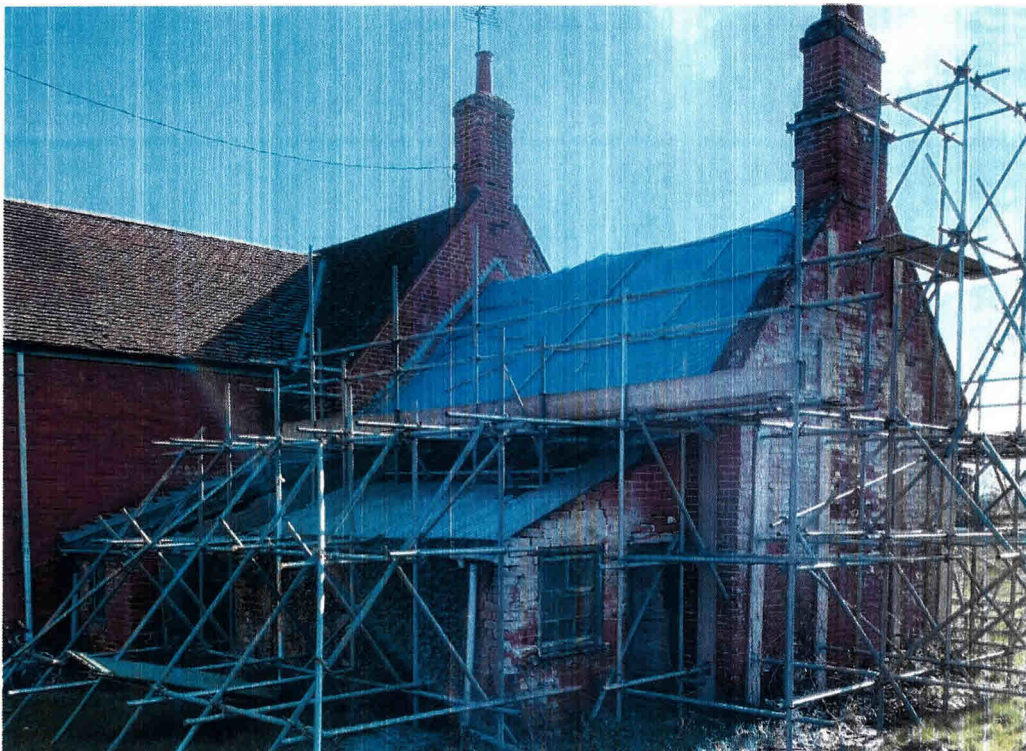
Temporary Scaffolding Installed Around Cottage (View from North/Rear)

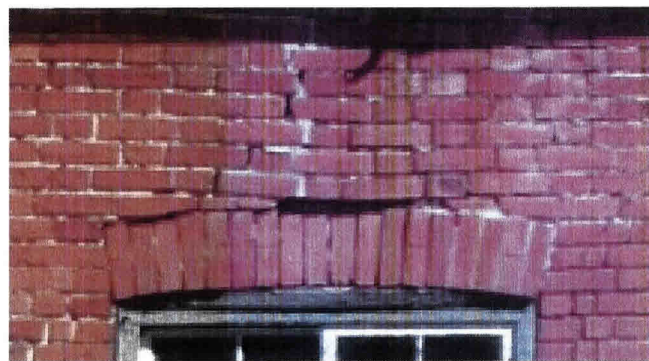
The arched lintels to the door and window openings on the south/front elevation had dropped and need to be reconstructed.

Dropped Masonry Arch to South Elevation

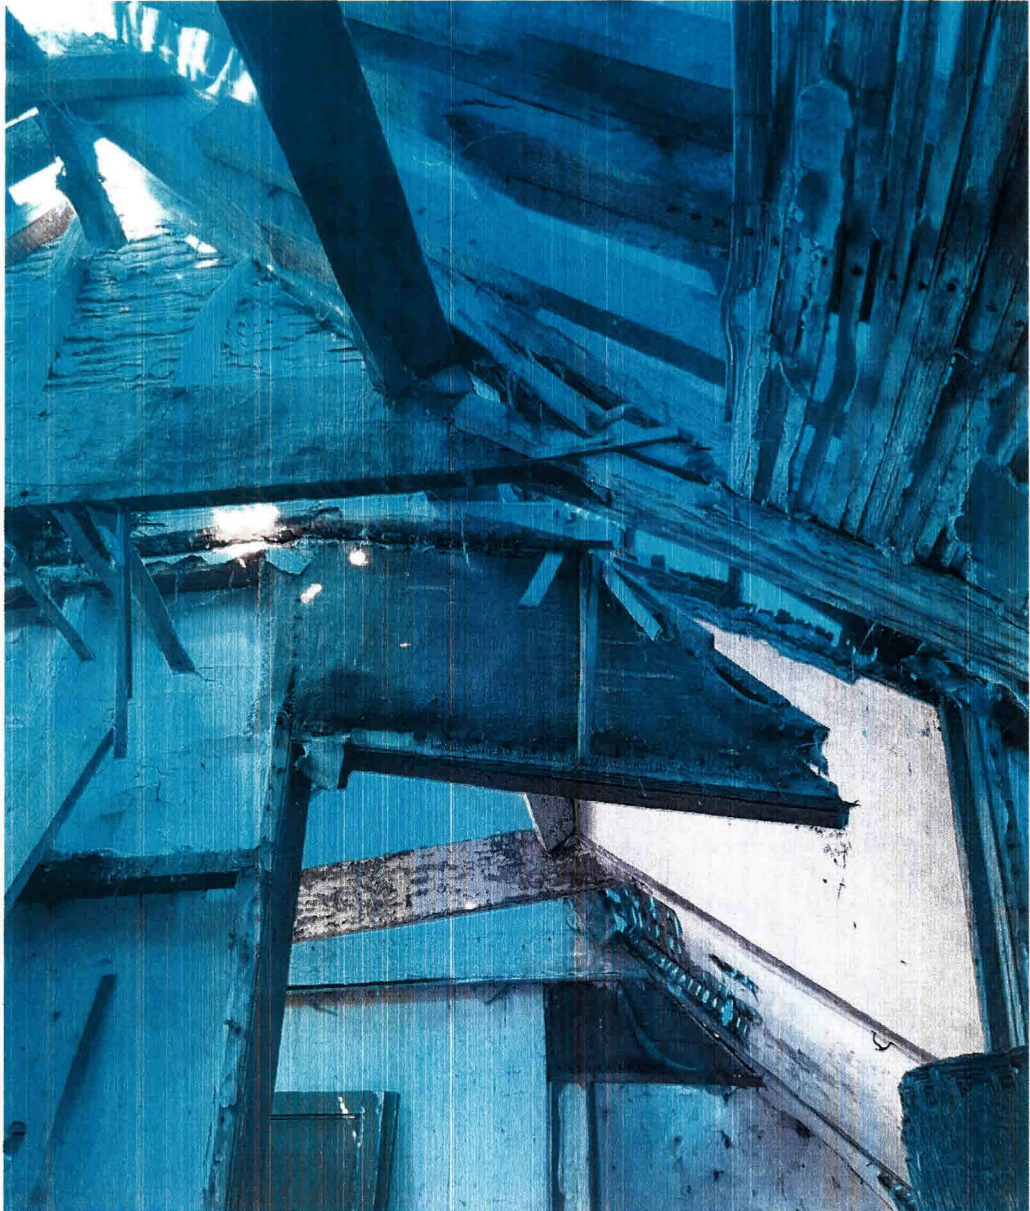
The roof structure is suffering with significant structural deformations, namely lateral spread at eaves level which has been primarily caused by the bending failure of the principal rafters on the central two principal frames.

The structural capacity of the *undersized* principal rafters has been reduced further at the position where the applied bending moment is at its greatest, by the cross-section reduction for both the

collar mortice and the elongated birds-mouth for the clasped purlin. This structural inadequacy has resulted in excessive bending deflection on the common rafters and in turn the roof coverings failing. Evidence of further damage due to water egress was apparent.

Structural Failure of Principal Rafter
(Note – Mortice for collar and elongated birds' mouth over clasped purlin,
plus further failing principle frame beyond)

Unfortunately, due to the amount of deformation and structural damage to the roof timbers, there would be no possibility to retain the existing roof structure and only a very few timbers remain that would be suitable for reuse.

The new roof should be detailed and constructed using typical traditional timber frame detailing – common rafters with a mid-slope purlin, supported off primary rafters with a raised collar. The effective rafter cross section capacity at this critical intersection should be checked to resist the applied bending stresses. The introduction of a sheathing board to the roof is envisaged to give overall robustness and practical member enhancement.

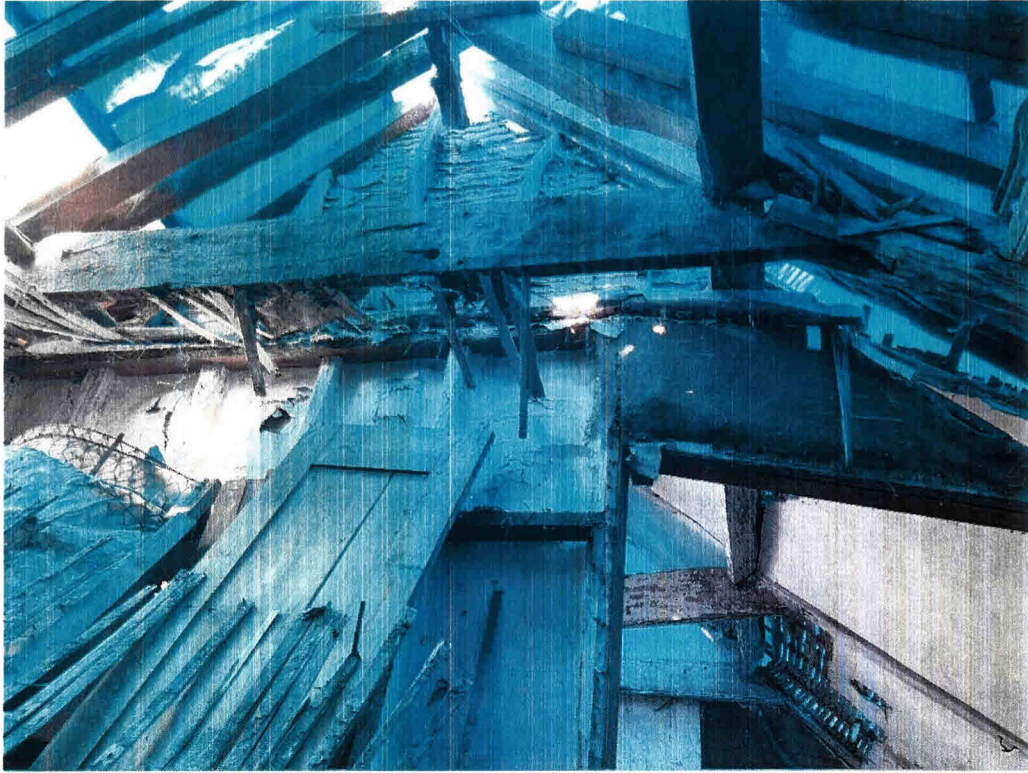
Structural Failure of Principal Rafters & Frames

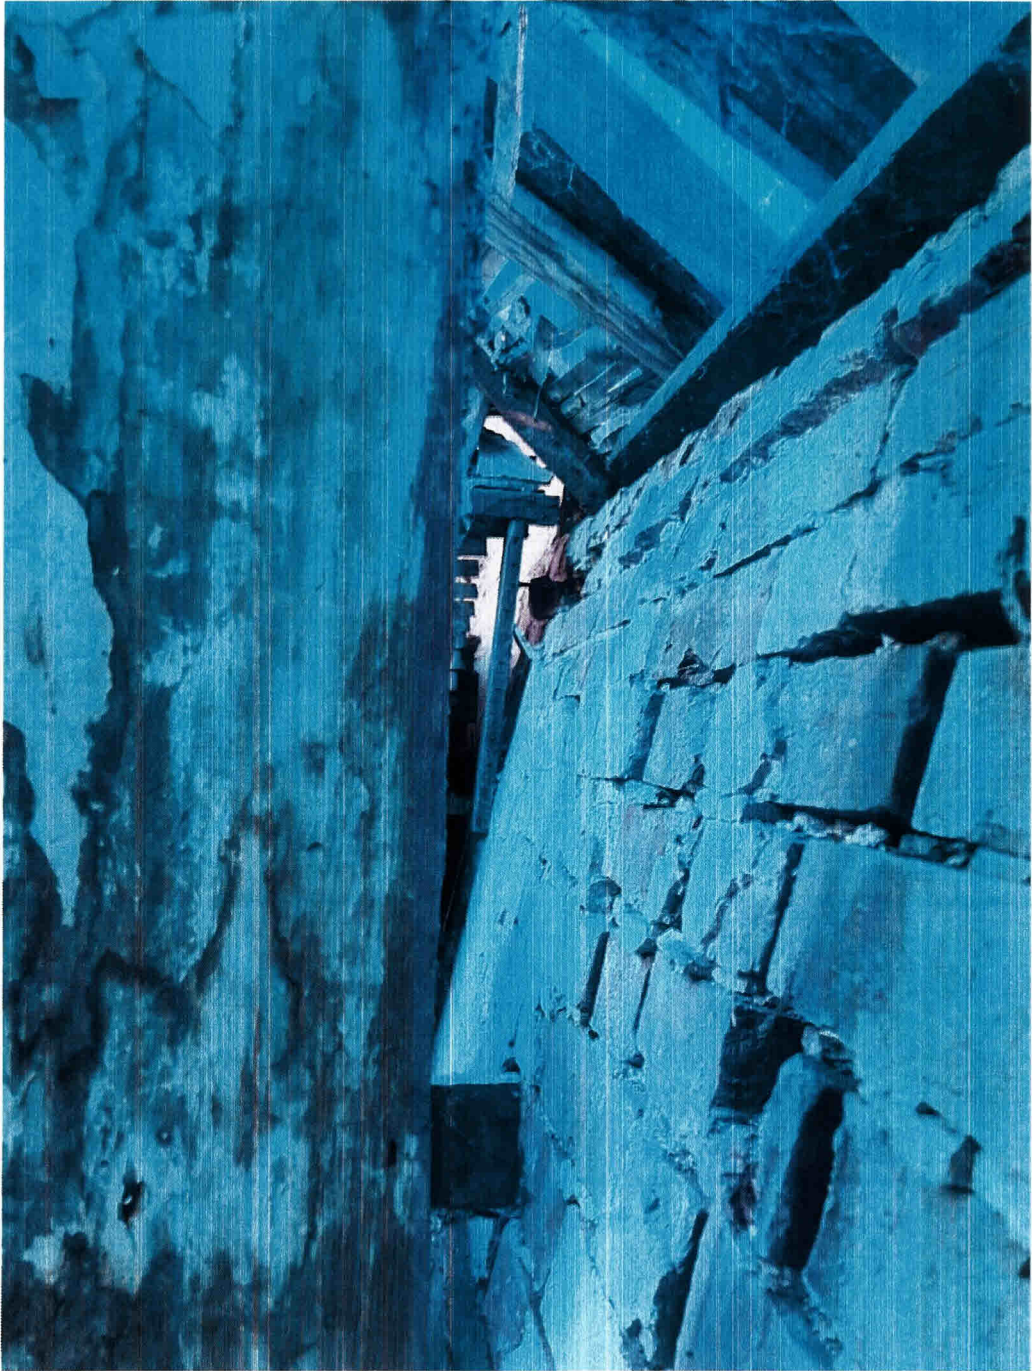
The lateral spread of the roof, along with the lack of any horizontal restraint at eaves level has displaced the wall plate and pushed out the top of the masonry walls.

The *flexible* nature of such a masonry wall has allowed the top of the wall to excessively deflect laterally, due the unplanned horizontal forces from the failing roof structure. This transposed horizontal movement is also noticed on the lower lean-to at the rear and has resulted in the lower masonry structure being separated away from the main cottage. The now displaced alignment of the wall plate is resulting in the vertical load from the roof being applied far beyond the centroid of the walls and this eccentricity loading without significant structural intervention will certainly in time result in collapse.

Extent of lateral movement (spread) of top of wall and wall plate

The walls to the cottage require a large amount of repair and replacement to be structurally sound to support the replacement roof structure, and additional remedial ties would need to be installed at floor and ideally eaves level. Further substantial steel framing would be required to immobilise the structural movement and resist the eccentric wall loading, however it is envisaged that would not be aesthetically pleasing, and furthermore difficult to conceal in such a small and basic building. Due to the amount of work, associated risk and temporary works required, it would be much more practical to consider rebuilding the walls.
