**Part Discharge of Condition 3 and
Discharge of Condition 5
of
Listed Building Consent, DC/22/02688**

Roof Repair Works

**Woodlands Farm
Bildeston Road
Ringshall
IP14 2LY**

Revised 20th October 2023

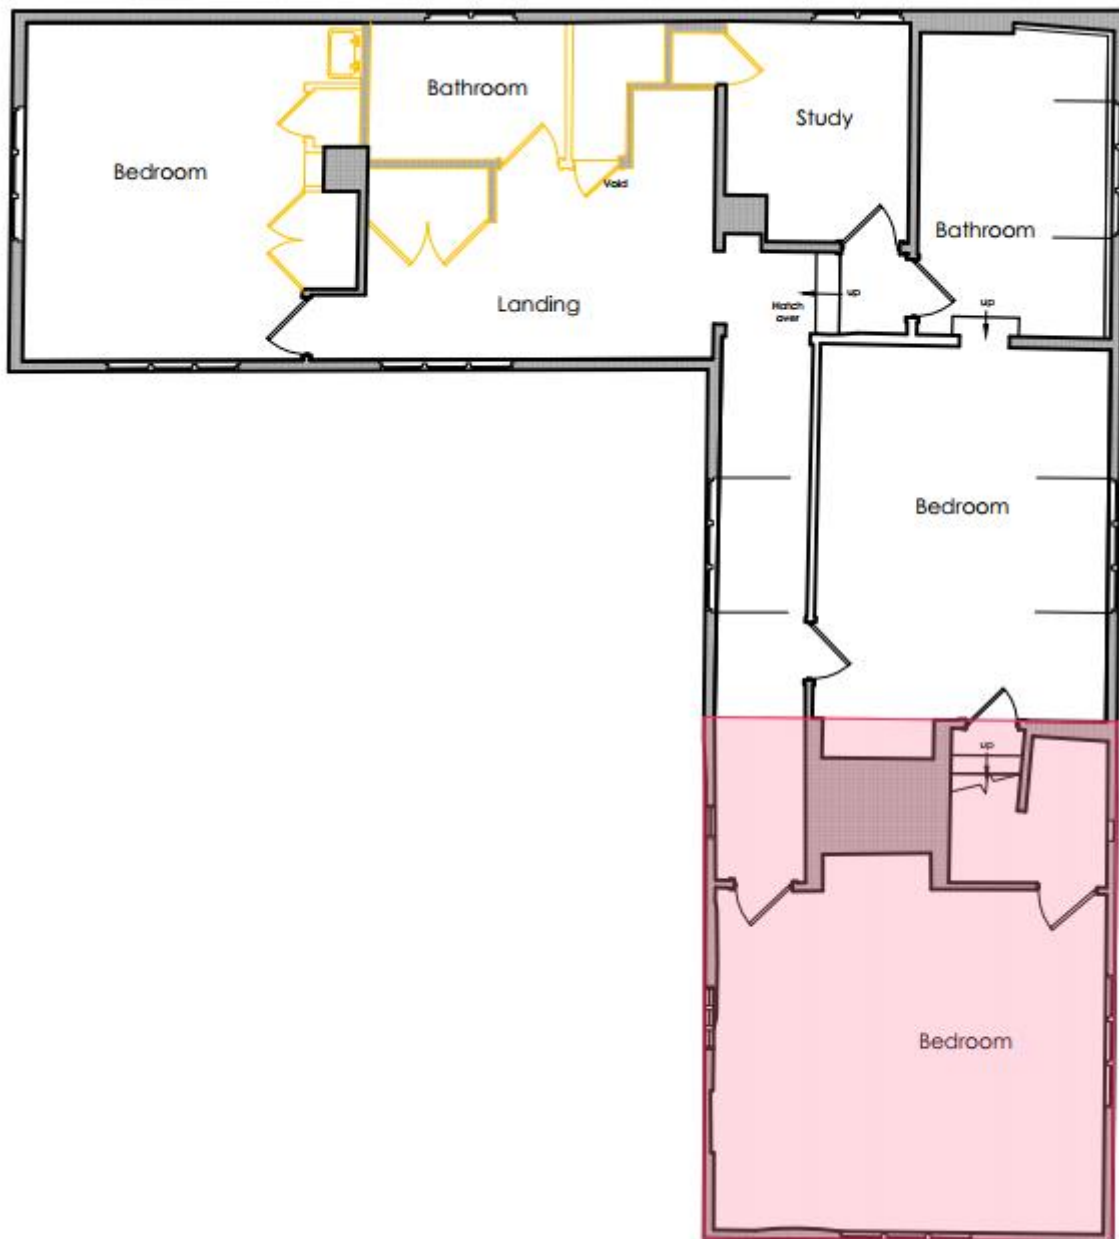
This application is concerned solely with the higher roof area, to the C17 Range.

Following removal of the existing clay peg tiles to this section the structure was found to be in moderate/poor condition. The affected area is shaded pink below:

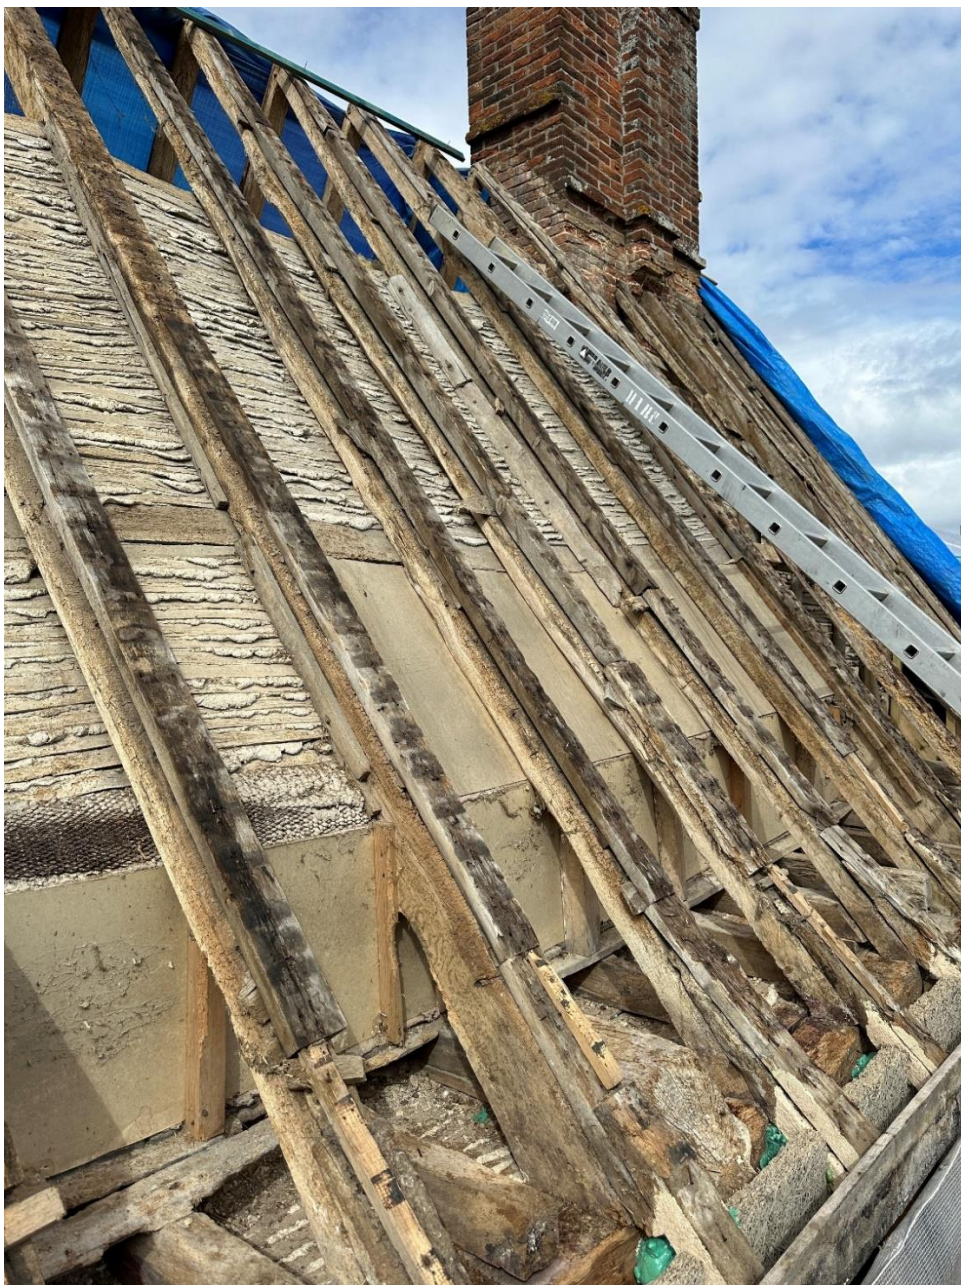
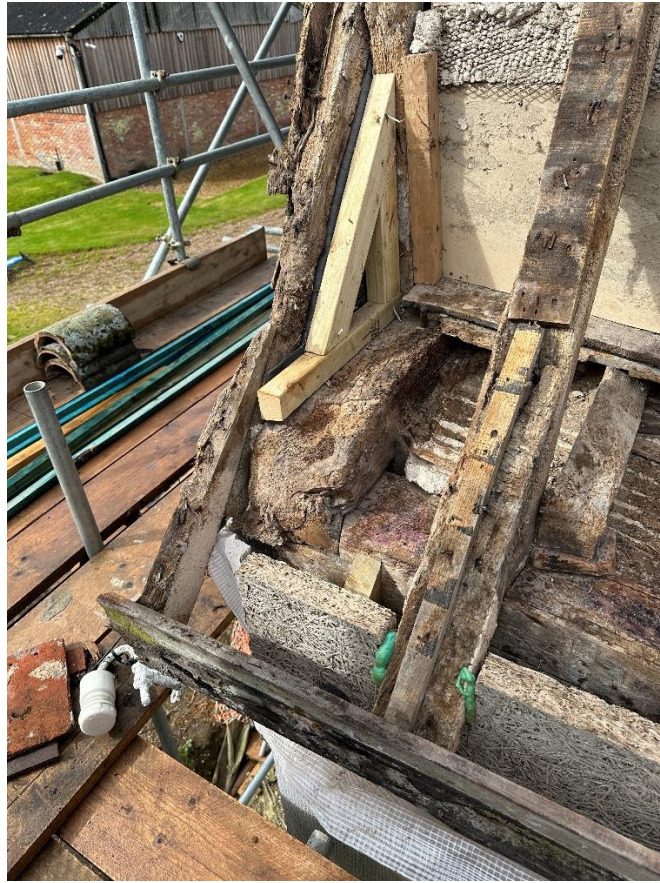
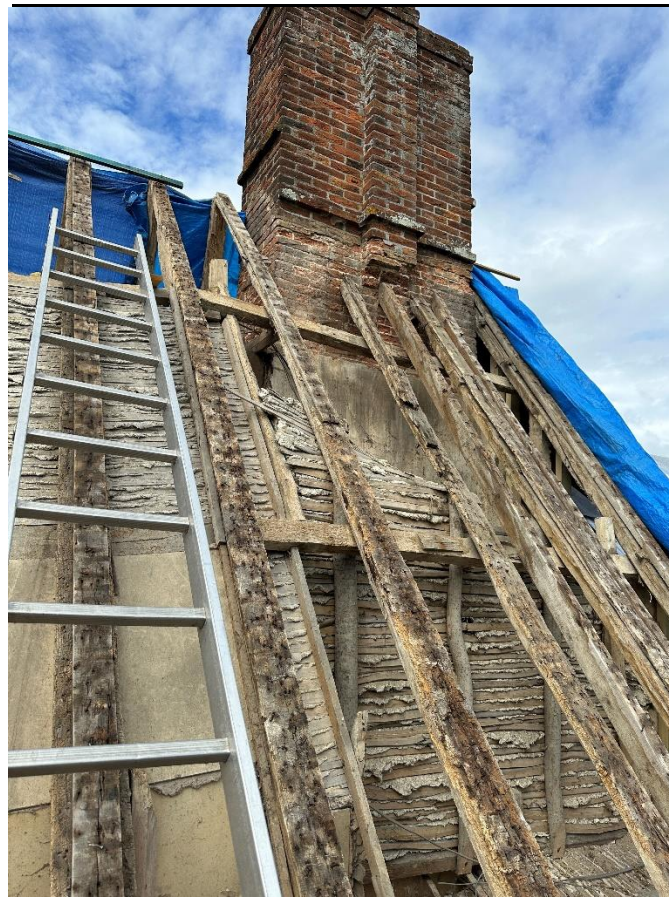
However, the roof structure to this part appears original with pairs of rafters, half lapped and pegged at the ridge. Rafters are cut onto the wall plate with shaped sprocket pieces added to the tops to form the rafter feet and roof overhang. There are C19/20 modifications with softwood levelling pieces fixed on to of the rafters.

There is significant wet roof decay to rafter feet and supplementary levelling pieces, Decay to the wall plate and rafters is limited although there is evidence or wood boring insect infestations. Also around the chimney caused by long standing leaks.

Advice from the structural engineers is that the existing roof framework is reasonably sound but requires strengthening. Their email advice dated 15th August 2023 is attached to this application.

Essentially this proposes new softwood rafters positioned beside the existing rafters, new horizontal softwood collars besides existing ceiling joists, together with steel strapping, diagonally across the rafters to both roof slopes.

A new Code 5 lead flashing with Code 3 lead soakers will be provided to the roof abutment around the chimney stack.

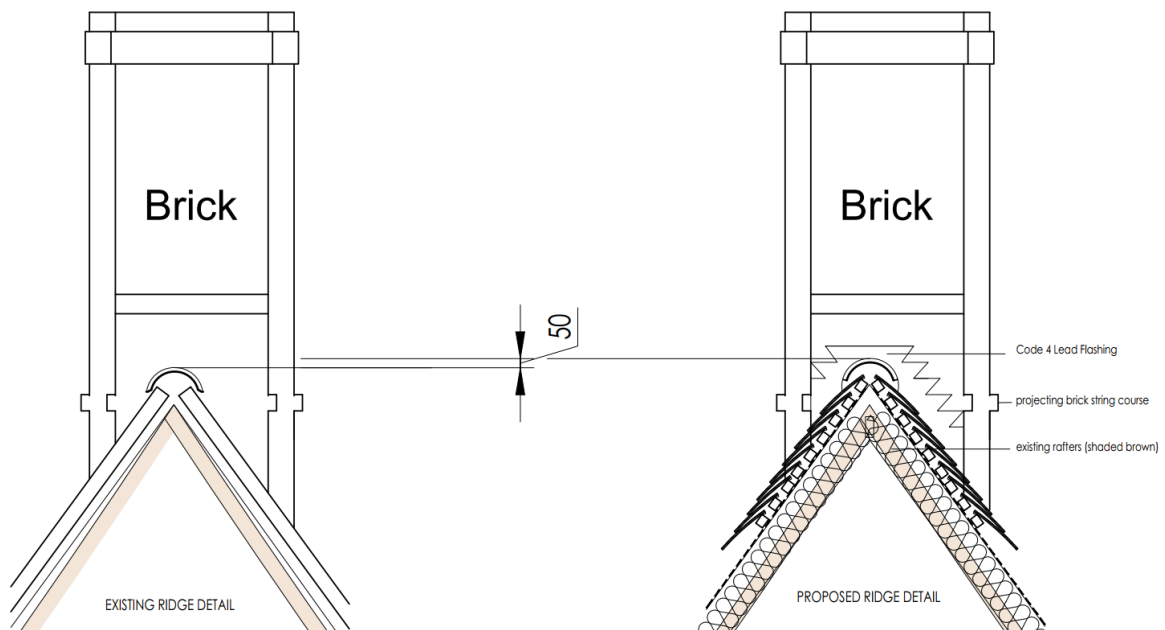
The existing roof profile was flat. The existing, 'deflected' rafters, had been levelled with softwood firring pieces placed on top. These were not continuous length, but pieced section, and suffered wet rot decay and rusted nail fixings. They were therefore not suitable for re-fixing tile battens.

Given the structural engineers advice, the new supplementary rafters ensure a safe, stable roof construction and fixing for the roof covering. Although the roof surface is marginally increased, this is estimated to be 50mm only.

This amounts to approximately 1 brick course so the chimney projecting string courses will remain unaffected and visible. This is currently approx 250mm above the existing roof ridge tiles. At the chimney abutment, approx. 450mm.
