# Arboricultural Appraisal Report

## Subsidence Damage Investigation at:

25 Lime Tree Avenue  
York  
YO32 4BE

CLIENT:	Crawford & Company
CLIENT REF:	SU2204182
MWA REF:	SUB230531-13300
MWA CONSULTANT:	John Graham B.Sc. Hons PhD
REPORT DATE:	10/07/2023

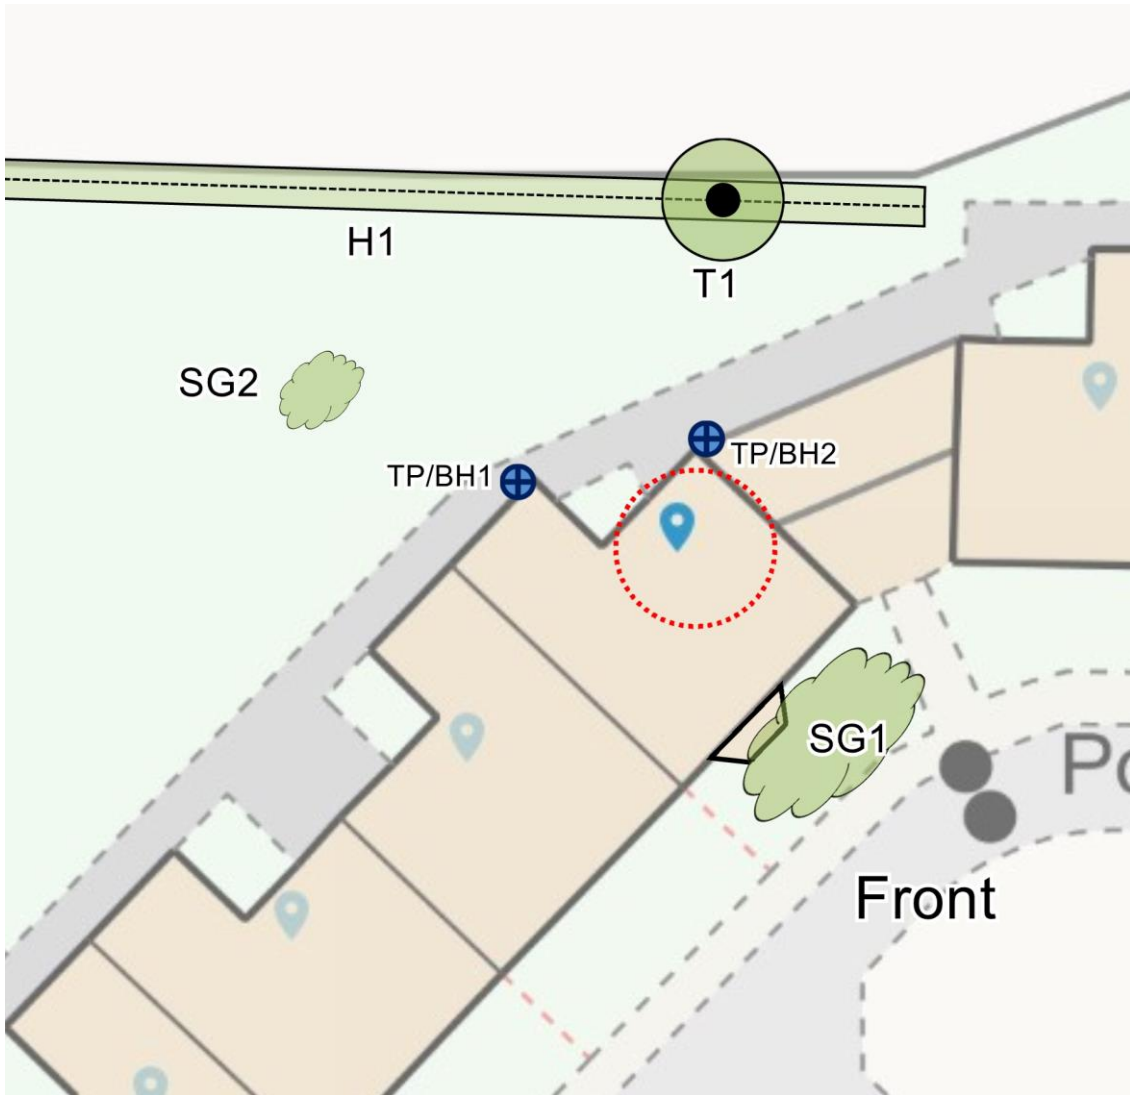
Site Plan

Approximate areas of damage

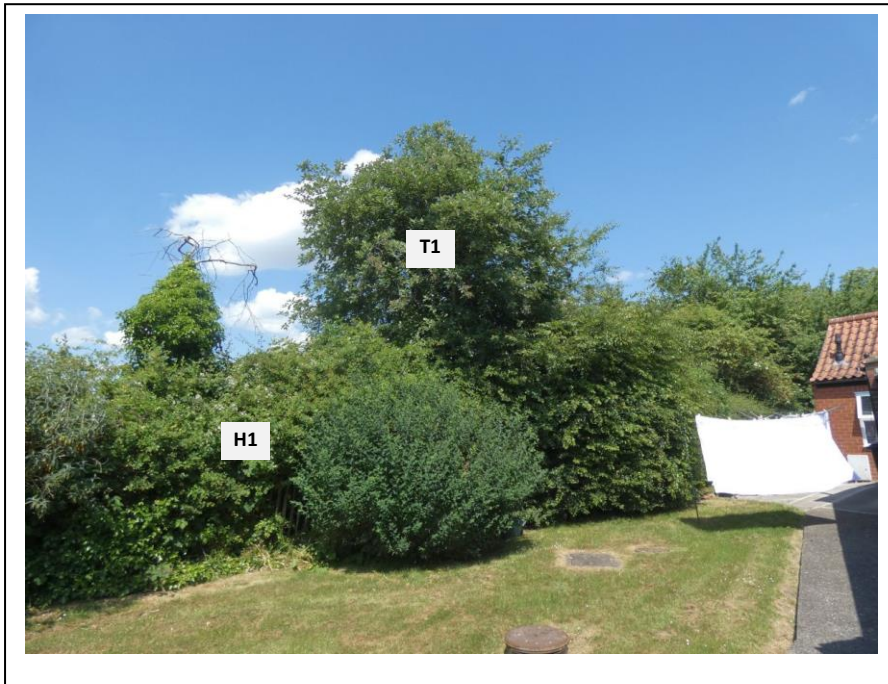
View of rear

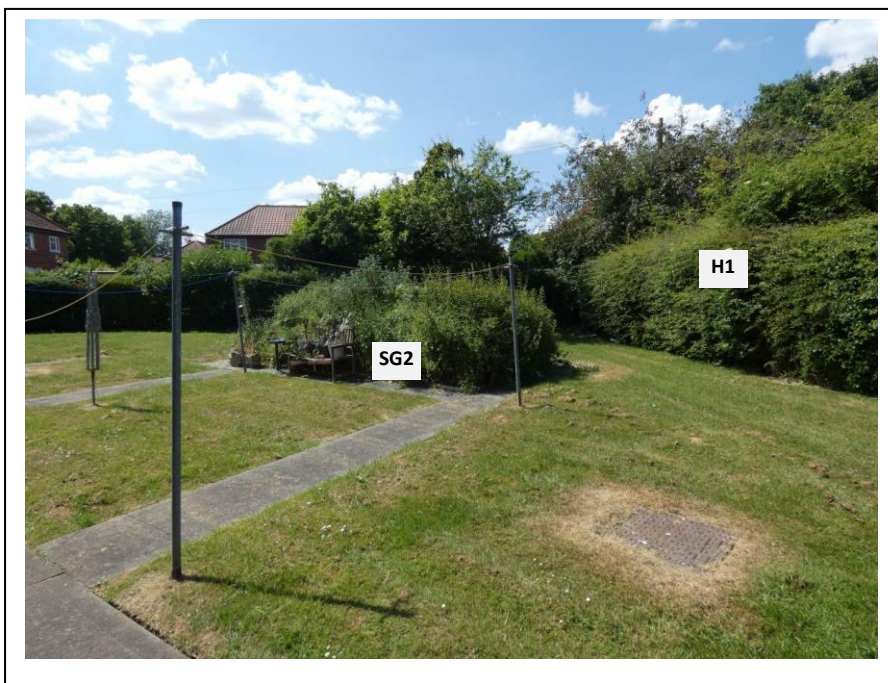
View of rear
