Cheynes Farm, Warren Lane, Cottered, Herts. SG9 9QD.
Historic building recording and analysis of the buildings. Recorded 09 11 2022.

This report describes and analyses the historic fabric and records of the buildings under study. This report adheres to Historic England Level 3 as outlined in Historic England. Understanding Historic Buildings – A guide to good recording practice. 2017. Page 25.

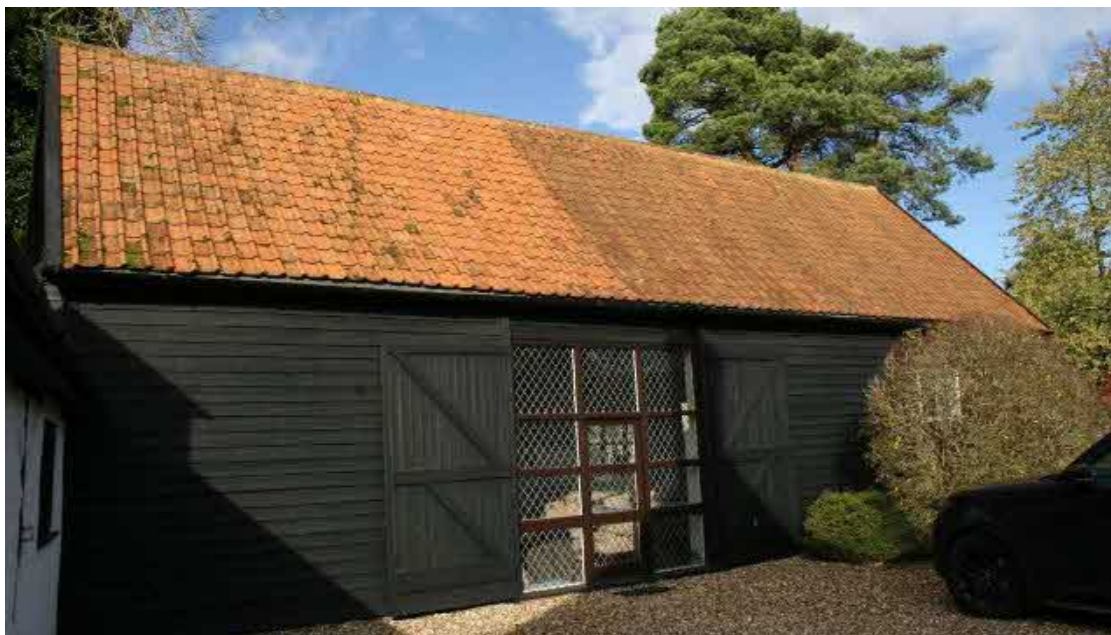
The south elevation of the Listed Barn.

Despite being Listed as C17th there is very little fabric to suggest a date this early. All the exterior weather-boarding is LC20th bandsawn or circular and fixed with mild steel nails. The roof is clad with single Roman tiles (not pan tiles as noted in the Listing). All the glazing is double glazed with applied taped leaded comes. There are no original external features. To the rear (north elevation) is an outshot under a catslide roof and these were most often engine bays to house a barn engine in the EC19th. It now is the setting for an internal fireplace inserted as part of the conversion.

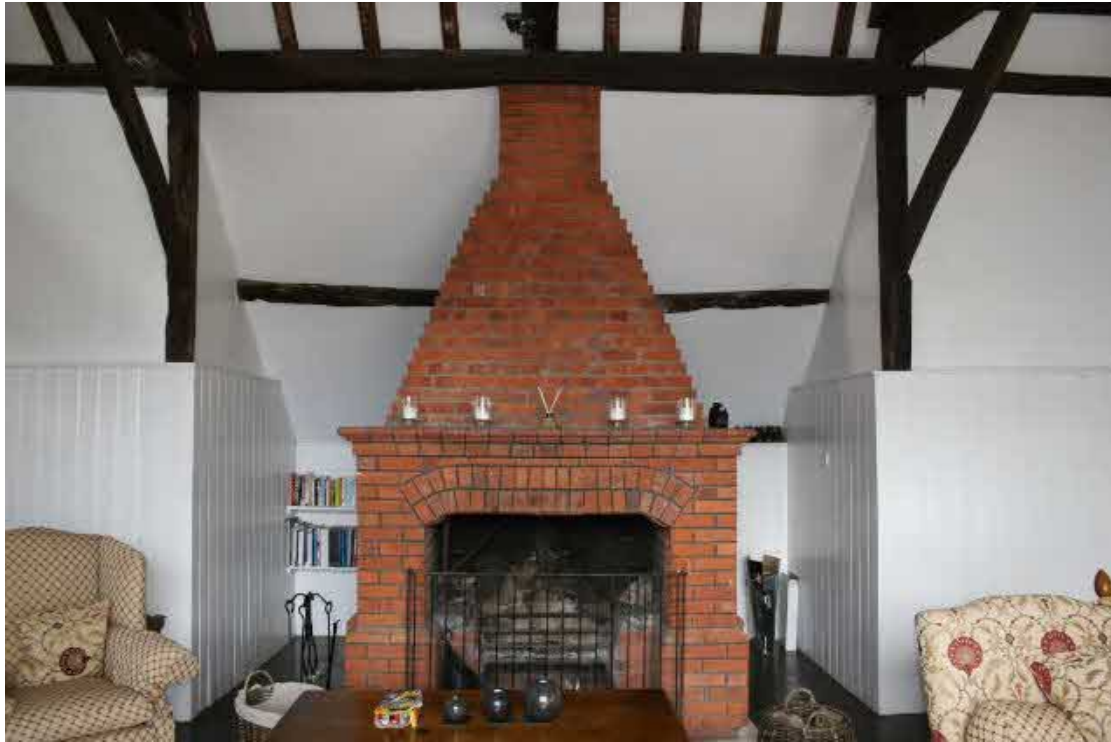
Detail of the LC20th fireplace. Looking N.

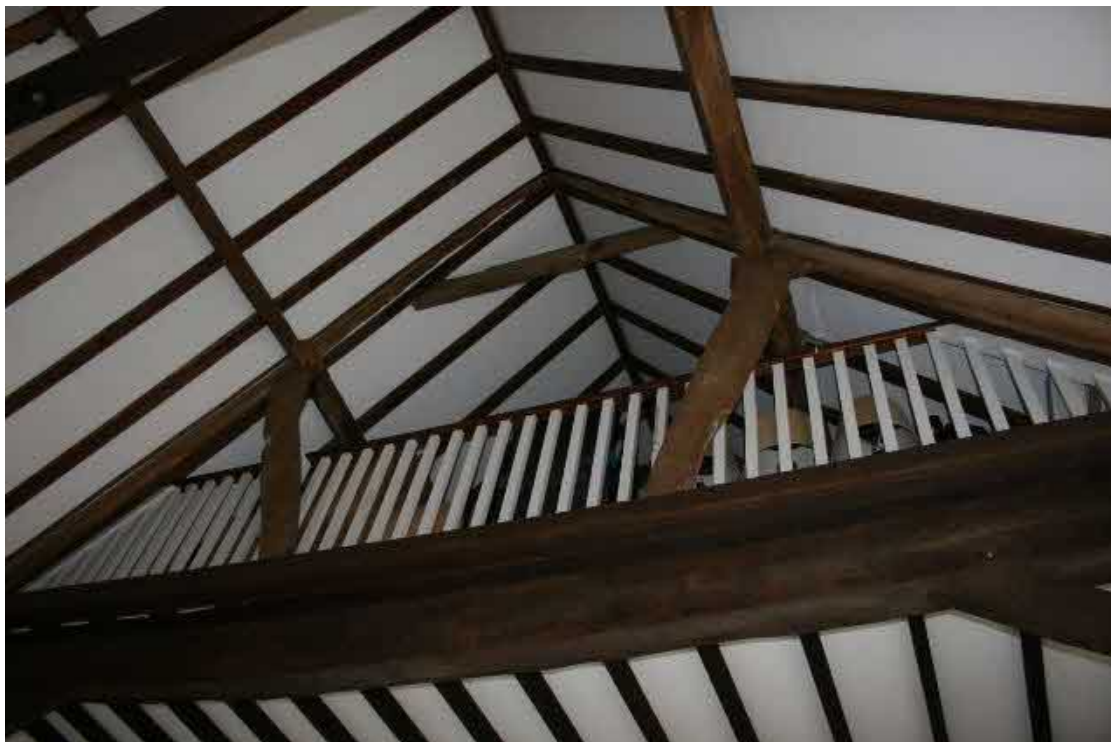
Looking up at the mezzanine floor. The queen posts appear upside down.

The roof structure has been renovated and largely replaced with softwood. The trusses have variety of raking queen posts that more resemble reused braces that have been used upside down. Some have been paired with straight struts with evidence of iron strapping.

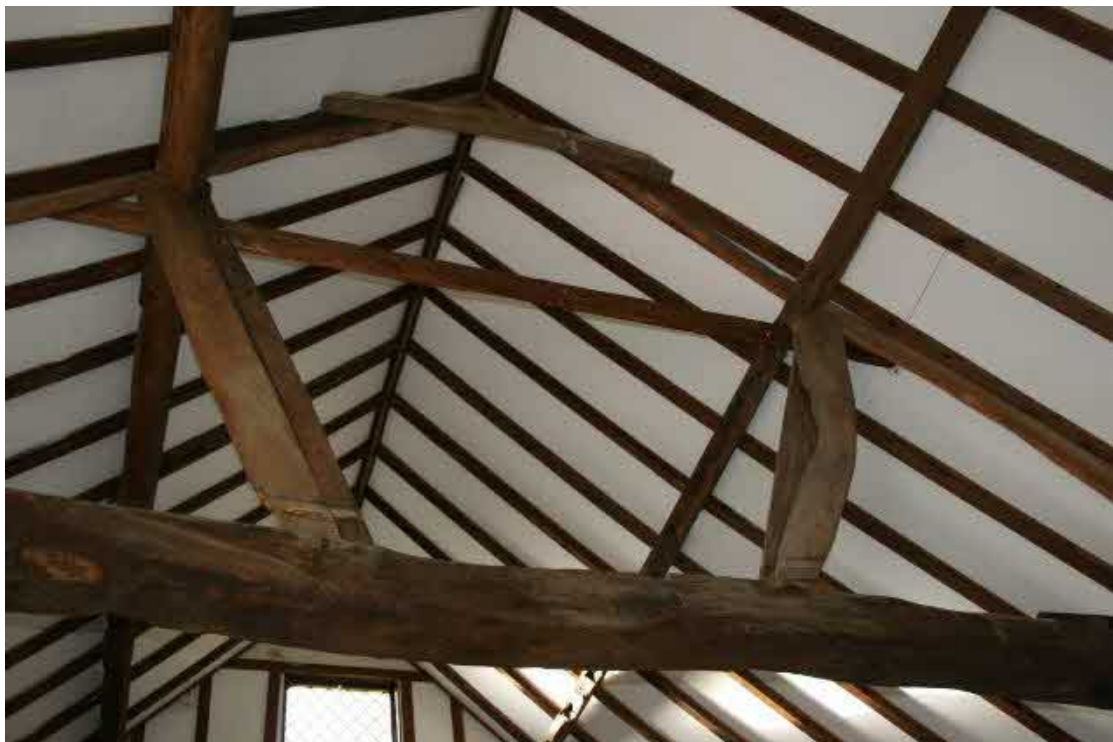
Detail of the westernmost Truss looking NW.

The roof is a simple clasped side purlin structure with raking queen struts where all the tie-beams and purlins appear reused from a variety of earlier buildings.

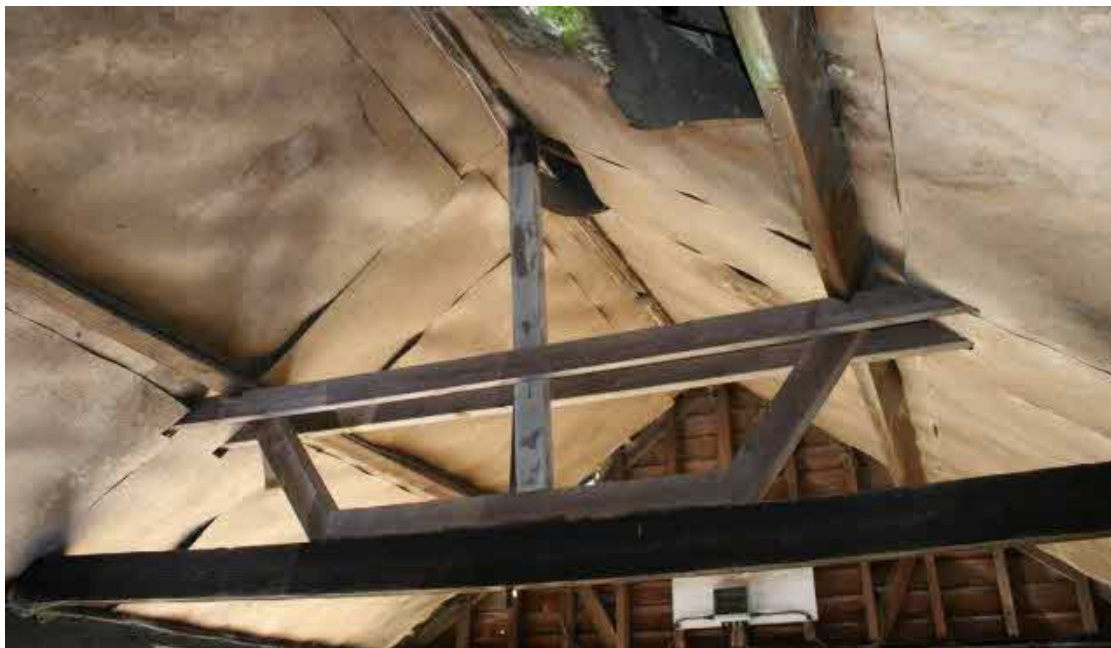
Looking N in the roof structure.

The roof has a king bolt truss which has been extensively repaired and reinforced because the king bolt is no longer connected. Additional horizontal and raking struts have been inserted and the collars doubled up to support very heavy, inserted side purlins. The roof has been boarded over to prevent debris from falling on the cars.

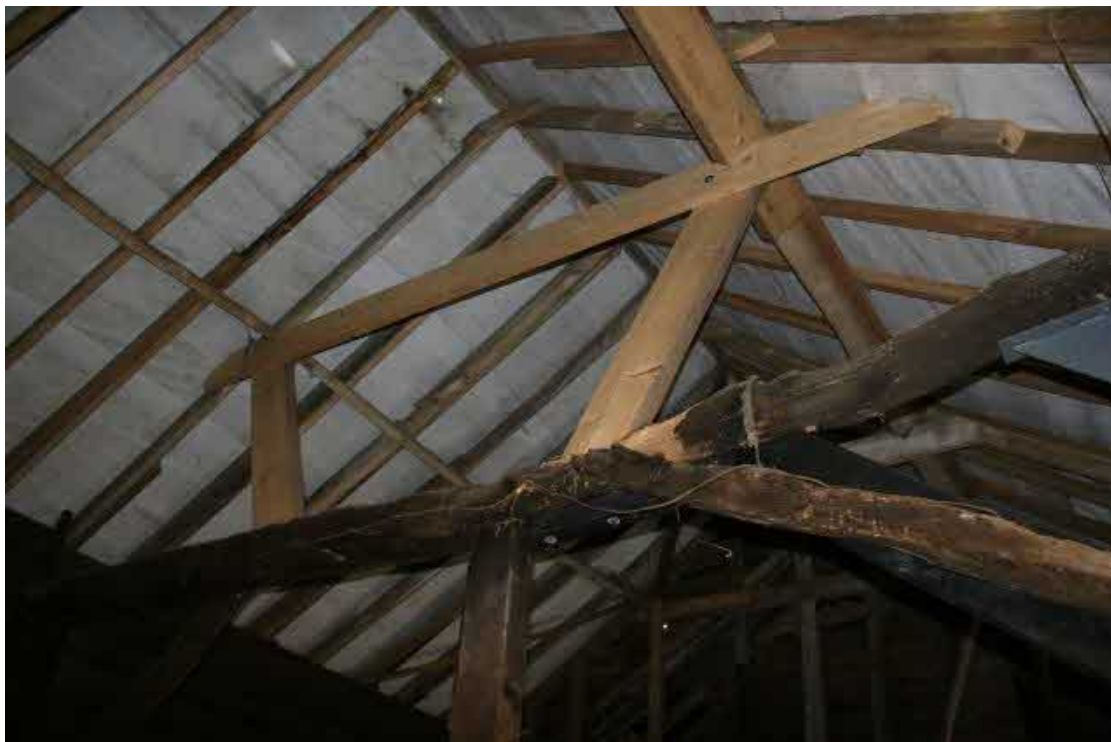
Looking E in the roof of the Workshop.

The roof of the Workshop is entirely LC20th but with a vain attempt to preserve the original waney elm e-beams, both of which have subsequently failed.

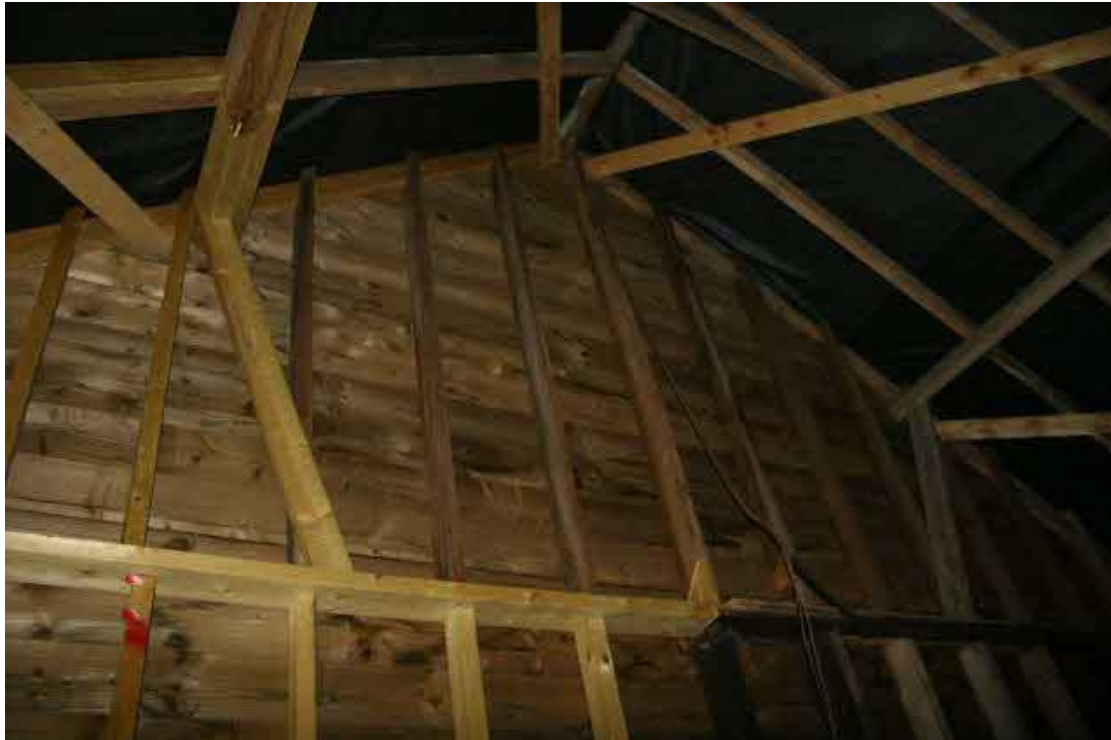
The west wall has been largely replaced in the LC20th.

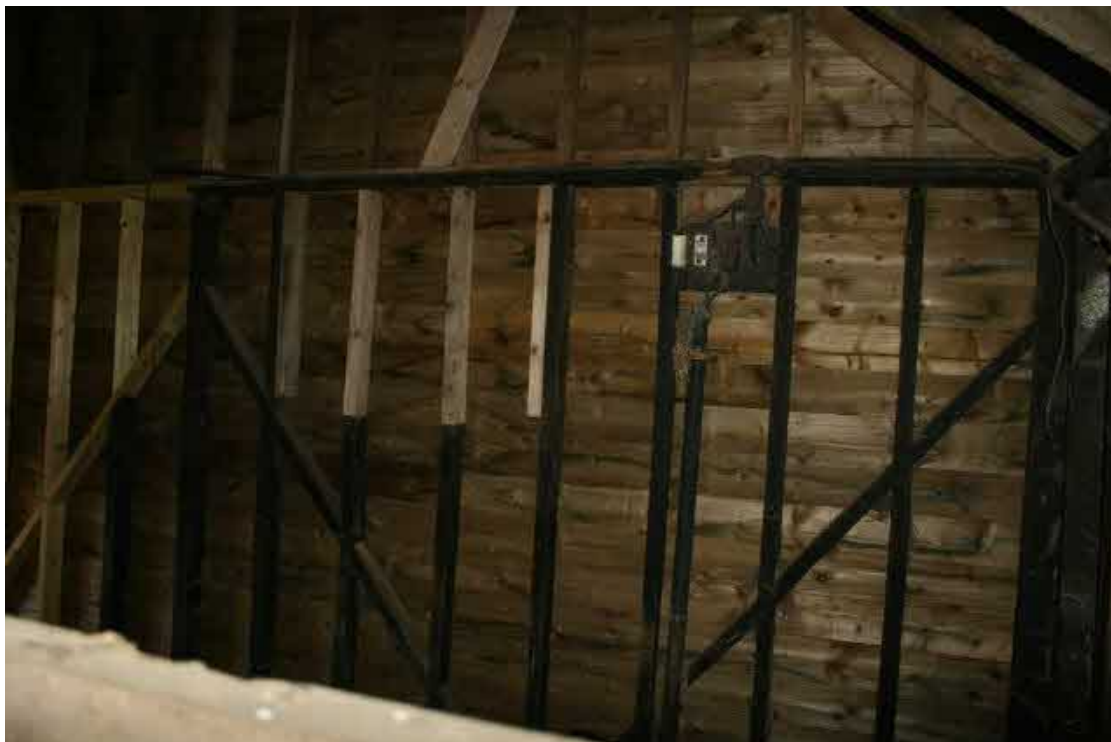
Sections of older C20th framing have been conserved.

The walls have been largely replaced with metric cut softwood in the LC20th. For some reason, there are some sections of MC20th 2x4in studs have been retained but are now eroded.

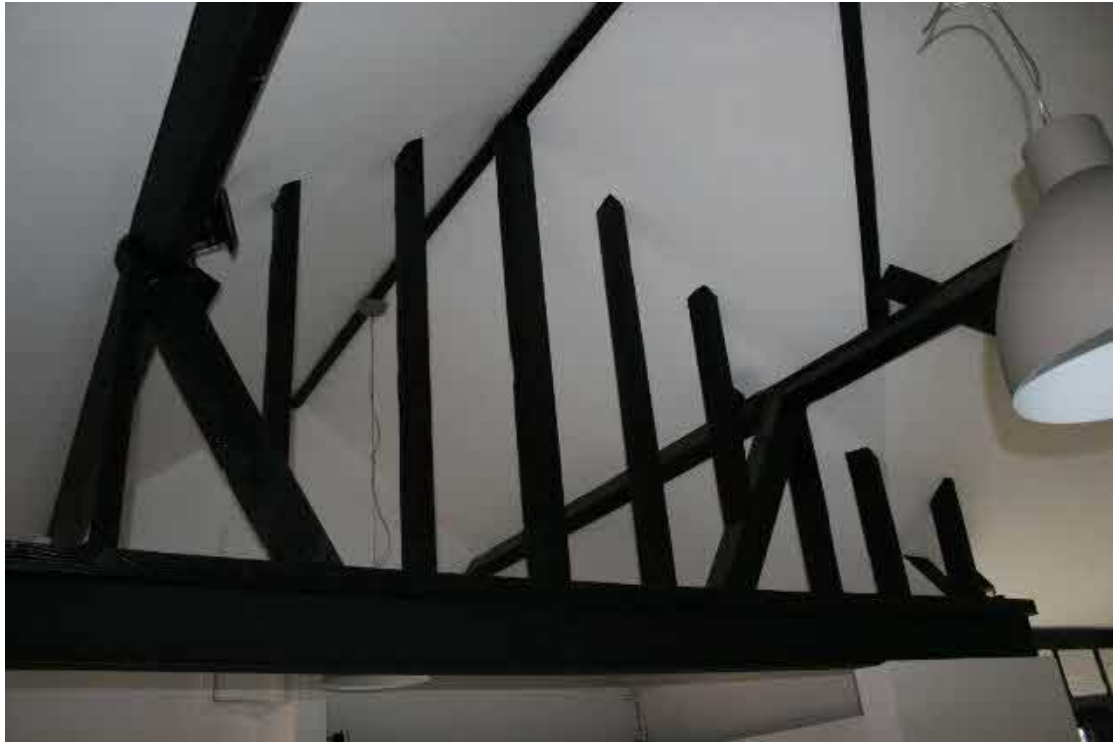
Detail of the southern truss. Only the principal timbers are C19th. Looking SW.

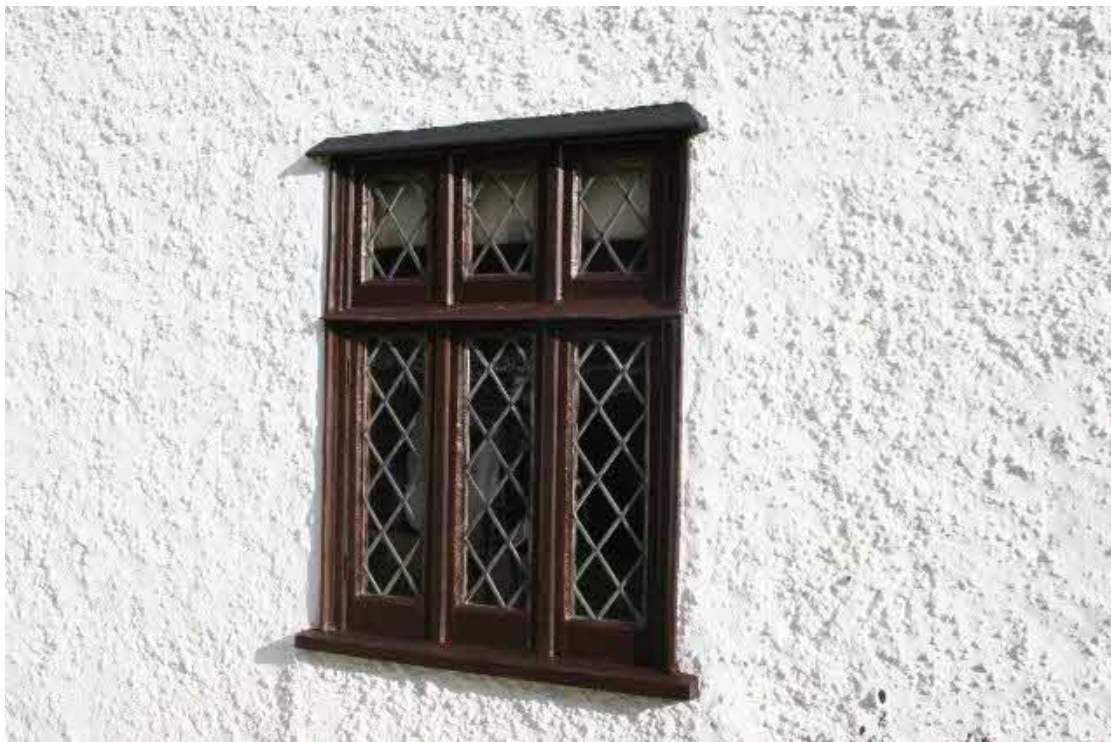
Detail of one of the ground floor windows.

All the external features are LC20th. The windows are LC20th well crafted oak casements with leaded lights, in places replaced with leaded taped panes. Many of these have suffered from water damage from condensation and would benefit from repair or replacement.

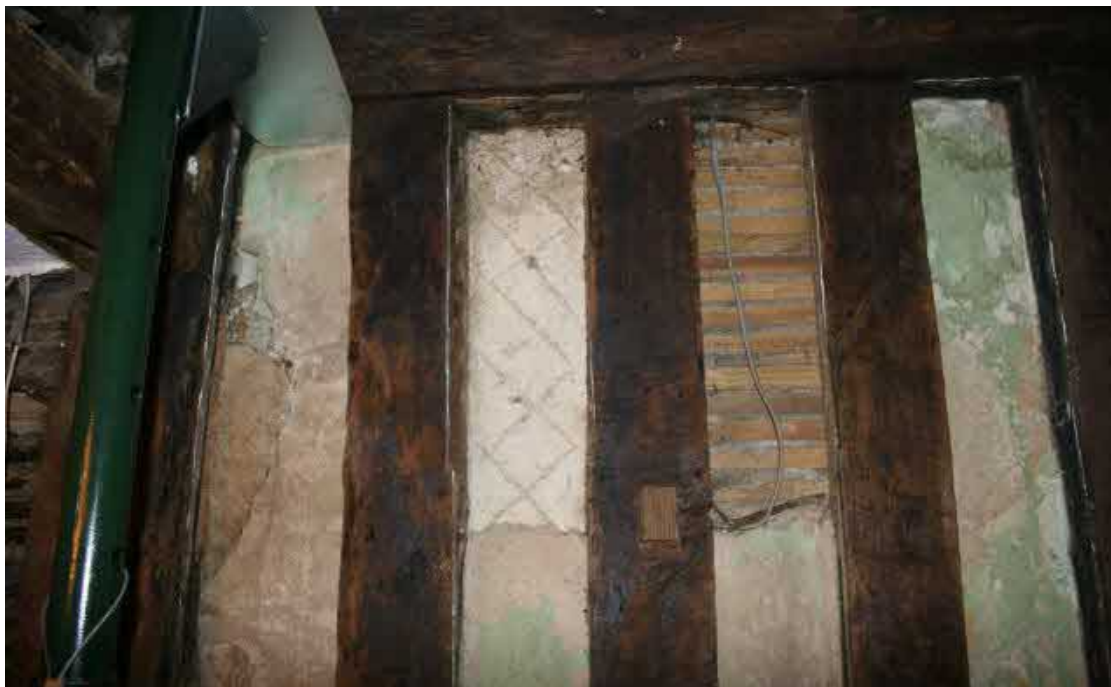
Lath and daub finish on the east wall.

Originally, the panels would have been finished flush with wa le and daub. When this failed it was replaced with lath and daub and a section diamond pa ern scratch coat remains in the east wall. This would have then been floated over with lime plaster. This would have le a very thin wall and would be a very cold room so it must have been ba ened out and lath and plastered over on the inside. This is indicated by a few widely spaced nail holes. In the LC20th this was removed and the panels side battened and packed with insulation and plasterboard. There must have been a lobby for the front door in the west wall.

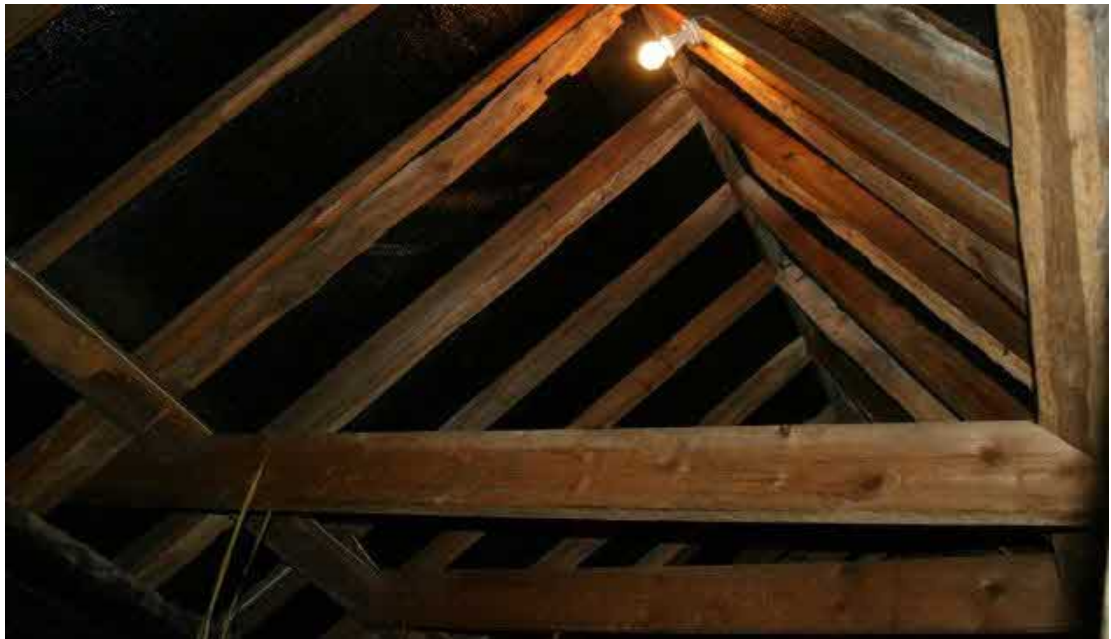
Detail of the roof over the main range. Looking N.

The roof over the main range retains a tie-beam from a crown post roof, cambered and morticed in the middle. The remaining roof is EC19th structure and design and is a simple clasped side purlin roof with plank collars and birdsmouthed struts. It has been extensively repaired in the LC20th with machined softwood timbers, retaining the C19th rafters and also a phase of EC20th machined softwood rafters. There is a fresh asphalt membrane which may have been a like for like repair in 1994 as in general these were only installed between 1965 and 1985 before breathable membranes became supplanted.

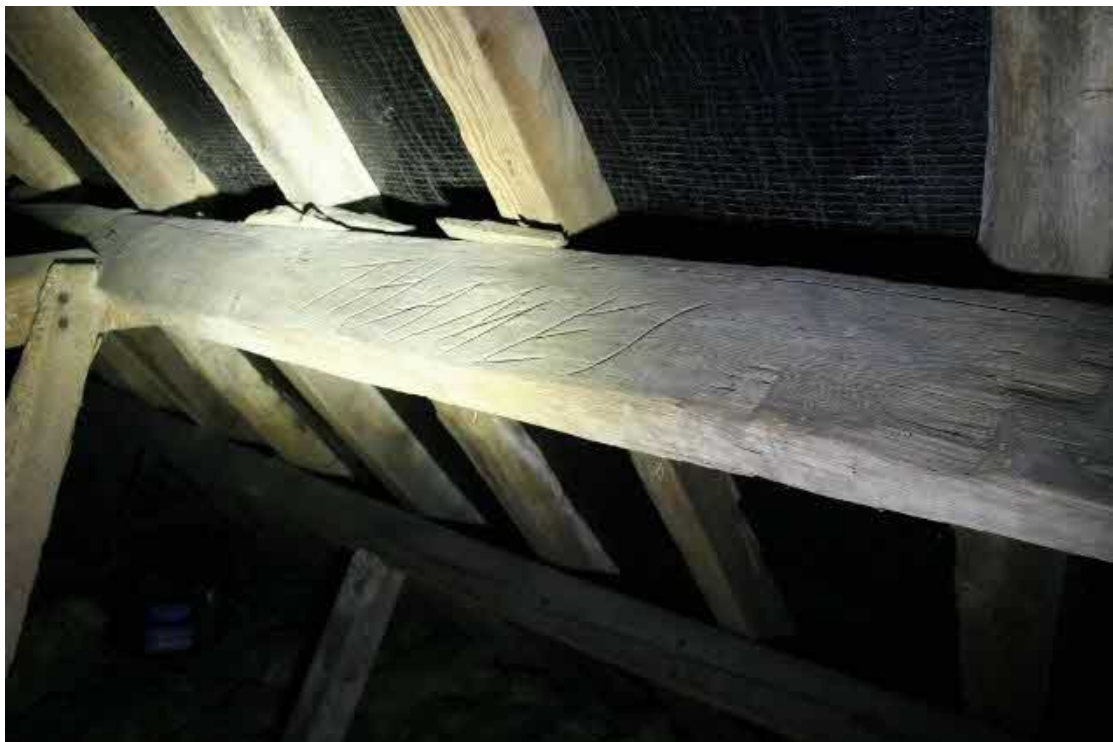
Side purlin with bracking mark 'Thames'.

Some of the C19th members have bracking marks and one of the purlins is marked Thames with a race knife. One of the collars is inverted.
