Jackdaws Ford, Chelsworth

Application for Discharge and Partial Discharge of Conditions relating to:  
Listed Building Consent: DC/23/01551

Timber Frame Repairs (Condition 3, full discharge):

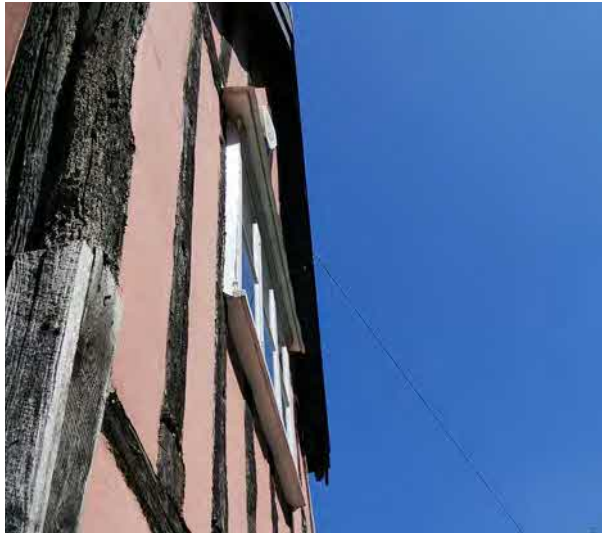
It appears that the historic render at Jackdaws Ford was 50-60mm thick, as evidenced by the 50-60mm protrusion of the two south-facing windows in the timber frame that apparently pre-date the removal of the historic over-frame render in the late 19th century. (See photographs on the next page). This thickness matches the proposed thickness of the 40mm woodfibre boards + lime render, which means that the proposed wall build up will relate well to the existing 19th century window reveals and cills.

*First floor western crossing 19th Century window, showing 60mm protrusion beyond timber frame*

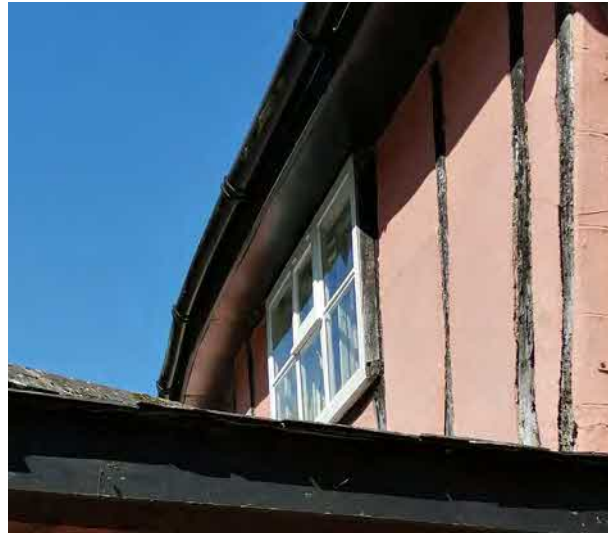
*19th Century window above butcher's shop roof, showing 50mm protrusion beyond timber frame*

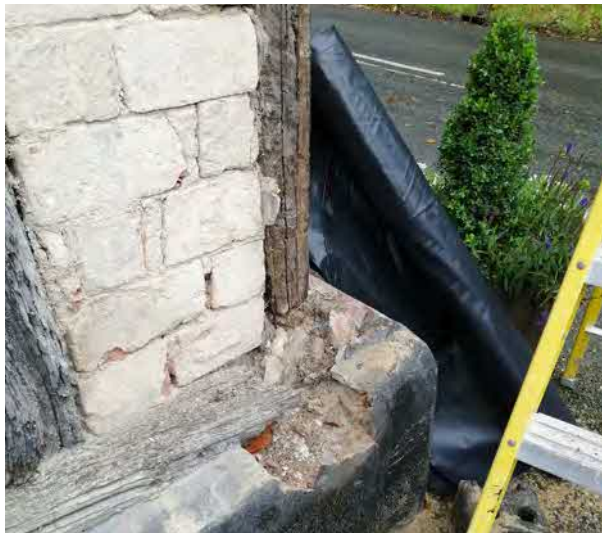
*Southwestern corner of house, showing required repair/strengthening of corner post and sole plate*

- On the west side, the two corner posts are to be strengthened/improved by replacing decayed earlier repair furrings with new partner furrings.
- On the west side, two small sections of replacement sole plate are to be spliced in with half-lap joints where the current sole plate has decayed. Slate is to be driven in below the sole plate in limited areas.

All frame repairs are to be made with air-dried oak, though kiln-dried oak may be substituted in limited circumstances if sufficiently-sized air-dried oak is not available.

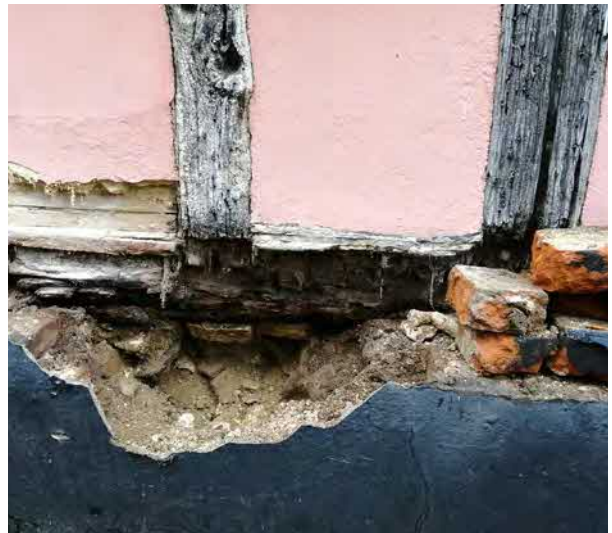
- On the south side, the existing sole plate and the bottom of several studs have suffered serious decay due to water being trapped in the timber by a concrete and brick haunching on the exterior and a concrete floor slab on the interior, so the sole plate requires replacement. We had considered cutting off the bottom of the studs and raising the sole plate to be above concrete slab level, but some of the tenon shoulders at the bottom of the existing posts survive. Therefore, we propose to install the new sole plate to match the location and size of the existing sole plate and to partner new timber studs to the bottom of the decayed studs. The plinth/haunching detail will also be altered as shown in the enclosed drawing.

*Decayed sole plate at south side of western crossing to be replaced*

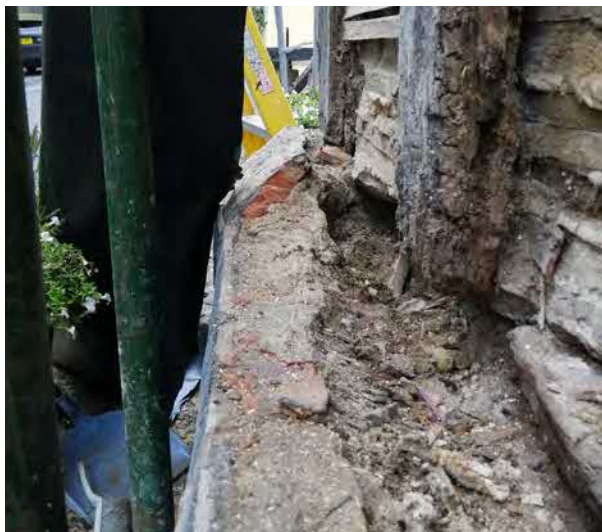
*Concrete and brick plinth at south side of western crossing currently traps water against sole plate*

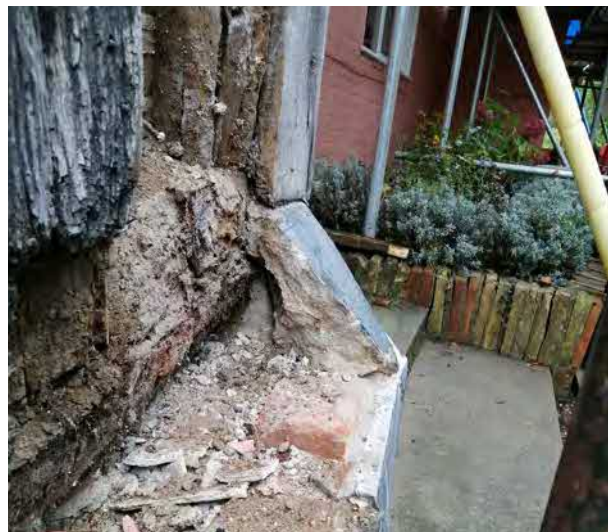
*Decayed sole plate at south side of western crossing to be replaced*
