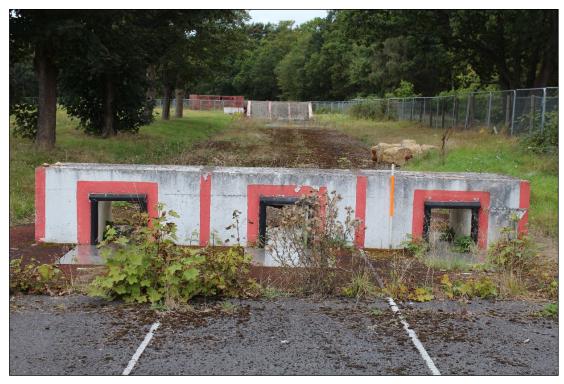
Photo 29: Apparatus Feature B1, viewed from the east

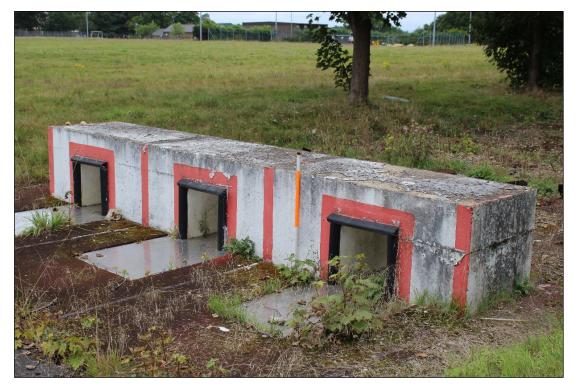
Photo 30: Apparatus Feature B1, viewed from the north-east

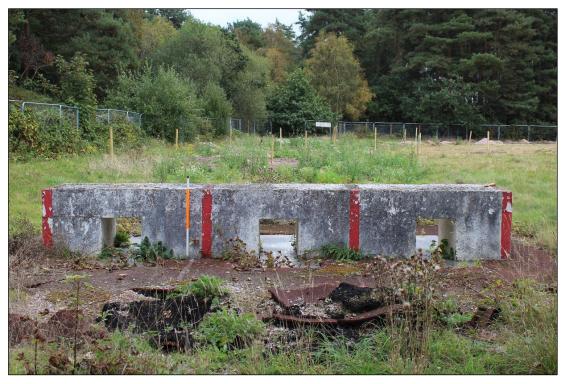
Photo 31: Apparatus Feature B1, viewed from the west

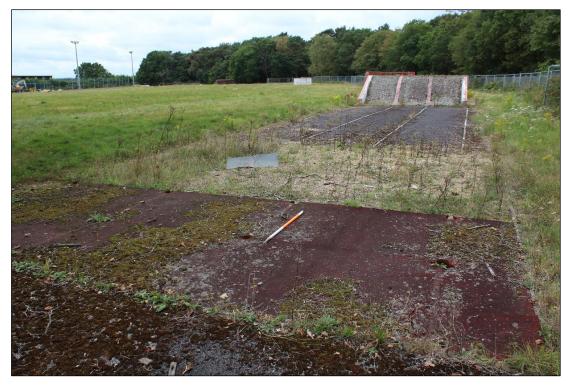
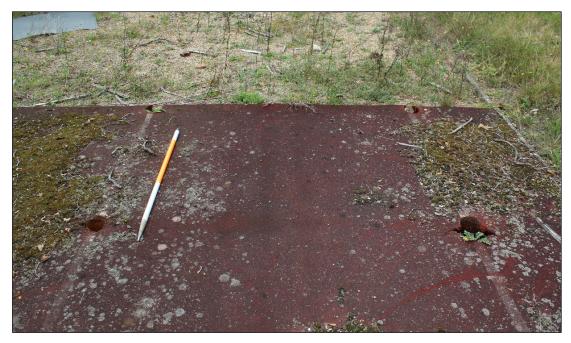
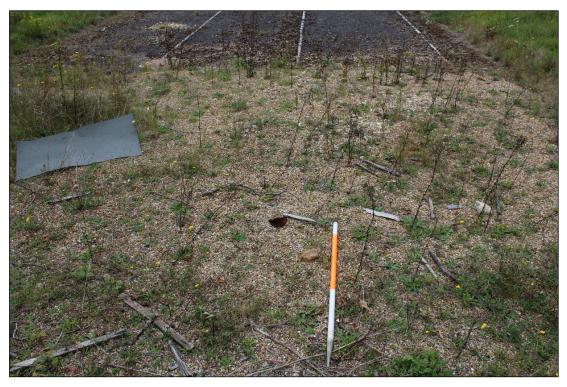
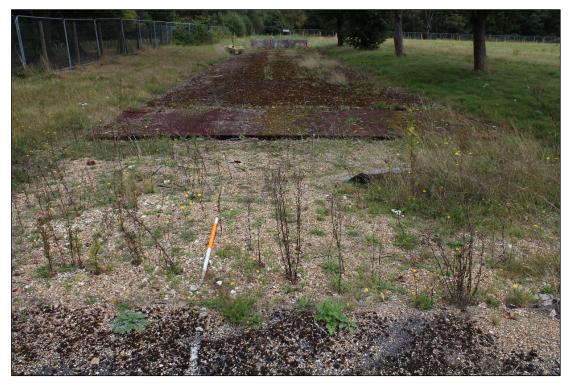
3.25. The second surviving feature within Area 2 consists of a level area, the eastern half of which is an area of matting and the western half of which is gravel-surfaced (Photos 32–35). The area is covered with a series of regularly-spaced post holes, indicating that there were likely timber posts forming the obstacle. The exact nature of the obstacle is unclear, but the regular positioning of the post holes and shadows evident on historic Google Earth imagery suggest that it may have been a 'monkey bar'-type obstacle.

Photo 32: Apparatus Feature B2, viewed from the north-east

Photo 33: Matted area with postholes forming the eastern half of Apparatus Feature B2, viewed from the east

Photo 34: Gravel area with postholes forming the western half of Apparatus Feature B2, viewed from the east

Photo 35: Apparatus Feature B2, viewed from the west

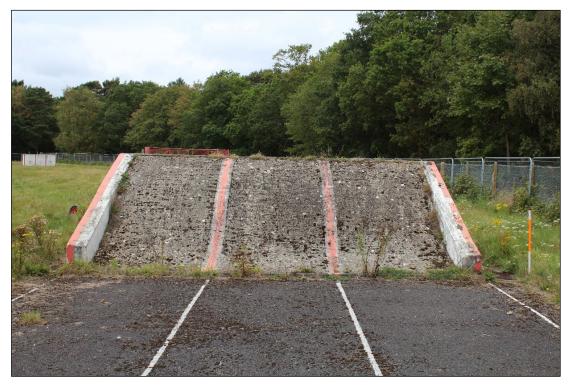
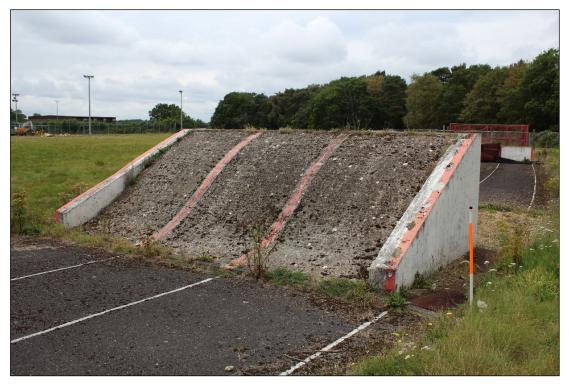
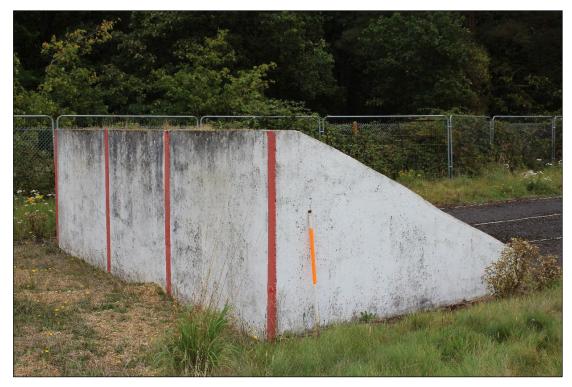
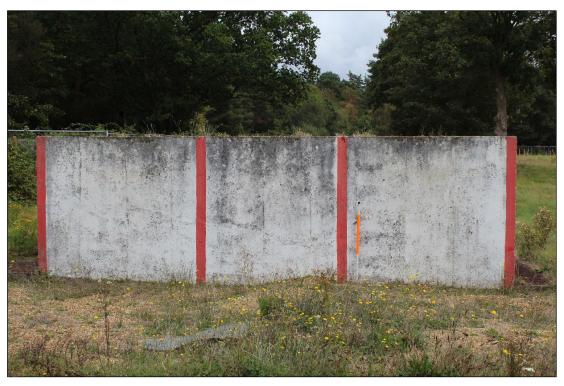
3.26. The third surviving obstacle within Area B consists of a ramp feature. It is presumably of brick or concrete block construction. It is rendered and painted to divide the feature into three lanes (Photos 36–39). The ramp is approximately 1.85m tall at its highest (western) end. There is an area of sand/gravel to the west of the ramp, presumably forming a landing area (Photos 38 and 39).

Photo 36: Apparatus Feature B3, viewed from the east

Photo 37: Apparatus Feature B3, viewed from the north-east

Photo 38: Apparatus Feature B3, viewed from the south-west

Photo 39: Apparatus Feature B3, viewed from the west.

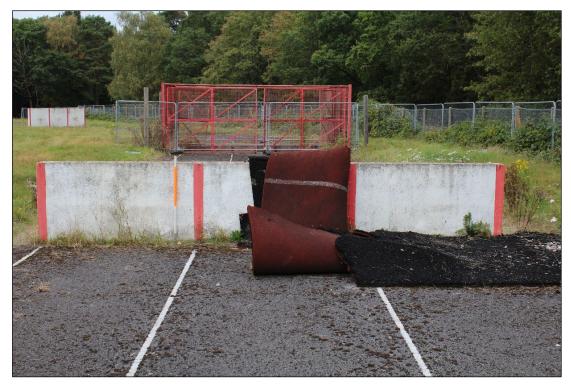
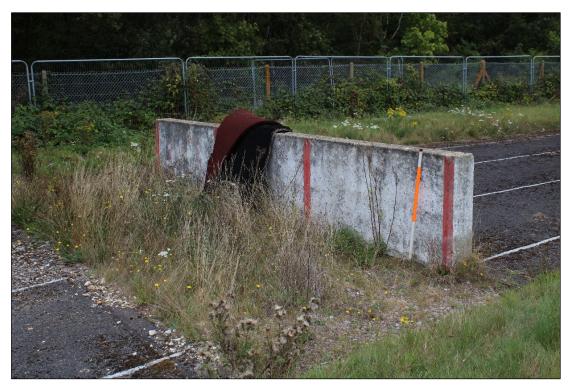
Photo 40: Apparatus Feature B4, viewed from the east

Photo 41: Apparatus Feature B4, viewed from the south-west

3.27. The fourth remaining obstacle within Area B consists of a low, 1m tall wall. It is presumably of concrete block construction. It has been rendered and painted to divide it into three lanes (Photos 40 and 41).

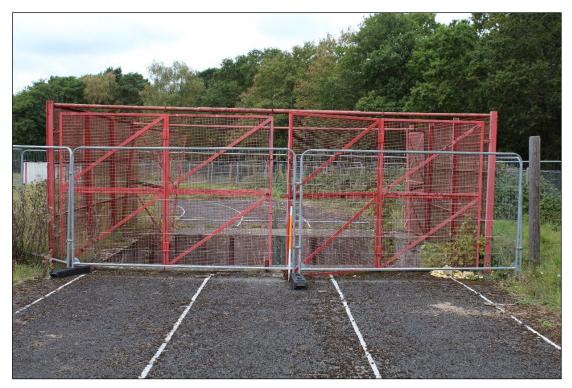
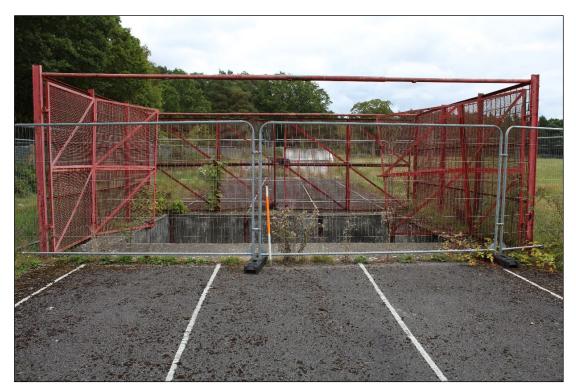
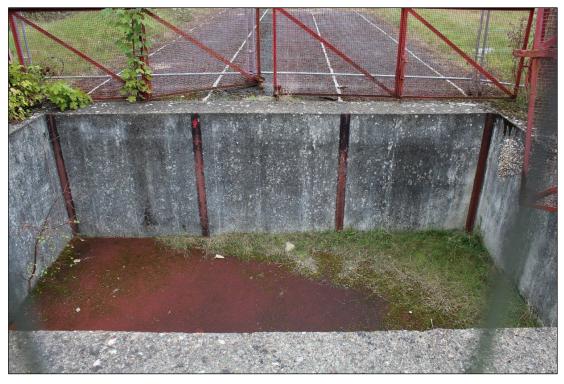
- 3.28. The fifth surviving obstacle in Area B consists of a deep, concrete-lined pit. This pit is enclosed by metal fences and gates, presumably in order to restrict access when the training ground was not in use (Photos 42–44). The base of the pit has a lining of safety matting.
- 3.29. It is assumed that this feature would have been filled with water, although it is notable that the interior walls of the pit have the same painted lines dividing it into three lanes as seen on previous features; it is not clear why these would be required if the pit was filled with water.

Photo 42: Apparatus Feature B5, viewed from the east

Photo 43: Apparatus Feature B5, viewed from the west

Photo 44: Apparatus Feature B5, viewed from the west

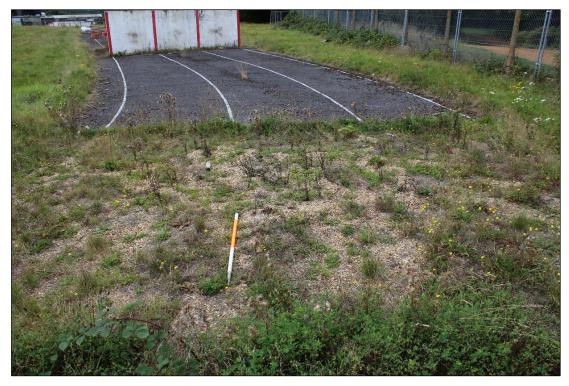
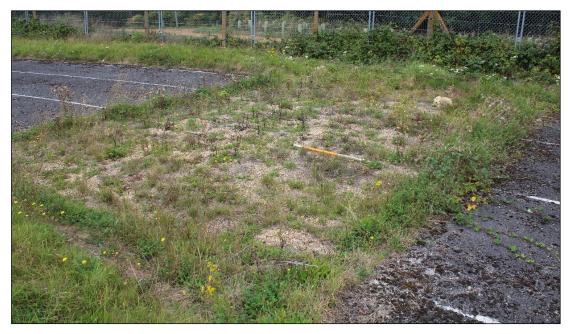
3.30. The sixth surviving obstacle in Area B comprises a large area of gravel measuring around 3m by 2.5m in plan (Photos 46 and 47). The purpose of this obstacle is unclear. It is possible that it may originally have been covered with a temporary covering such as netting or tarpaulin for participants to crawl under. Historic Google Earth imagery suggests that the start of the obstacle incorporated a single monkey bar from which to swing over the gravel area.

Photo 45: Apparatus Feature B6, viewed from the north-east

Photo 46: Apparatus Feature B6, viewed from the south-east

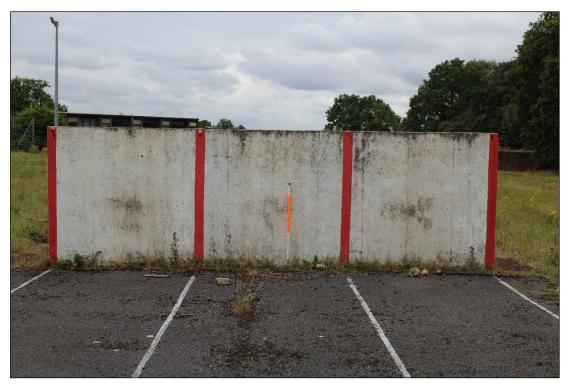
Photo 47: Apparatus Feature B7, viewed from the north-east

3.31. The seventh obstacle surviving in Area B comprises a *c*. 1.9m tall wall. This is probably of concrete block construction and has been rendered and painted (Photo

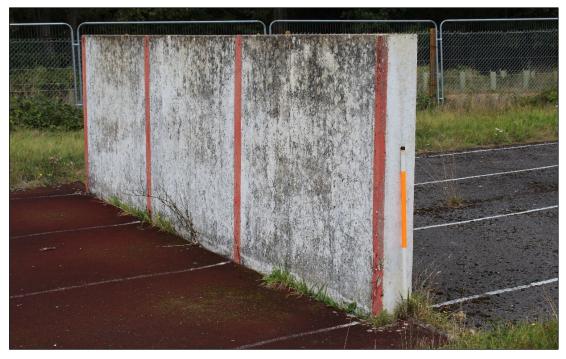
Photo 48: Apparatus Feature B7, viewed from the south

47). There is an area of safety matting to the western side of the wall, to provide a protected landing (Photo 48).

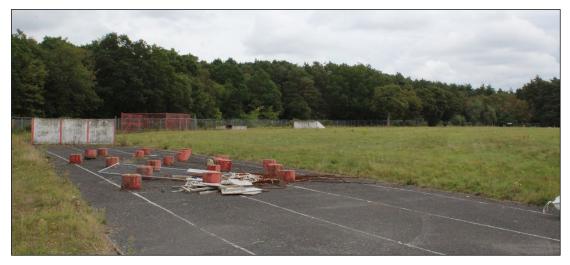
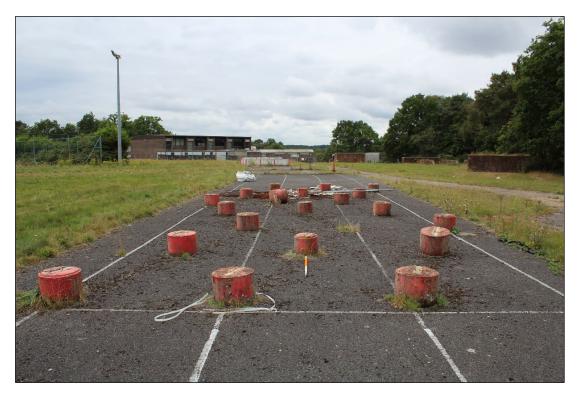
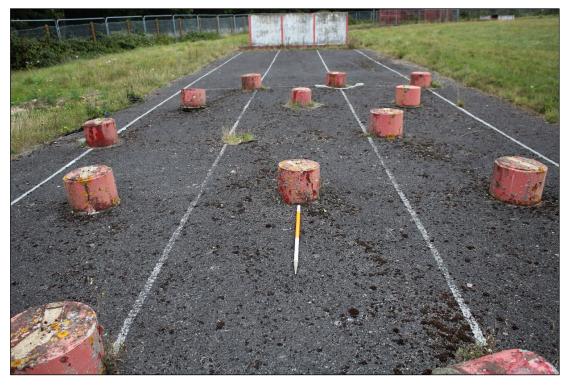
3.32. The eighth obstacle surviving within Area B comprises an area of cylindrical concrete blocks, laid out across all three of the running lanes (Photos 49–51). Historic Google Earth Aerial Imagery (Fig. 7) shows zig-zag balance beams running between the concrete blocks, the scars of which are visible on the block tops (Photo 52).

Photo 49: Apparatus Feature B8, viewed from the south-west

Photo 50: Apparatus Feature B8, viewed from the south-west

Photo 51: Apparatus Feature B8, showing evidence for metal beams, viewed from the south

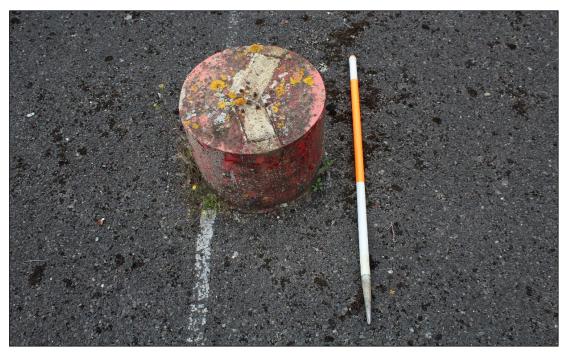
Photo 52: Apparatus Feature B8, example of post which supported balance beam

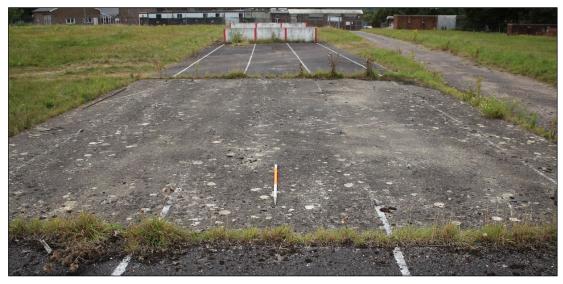
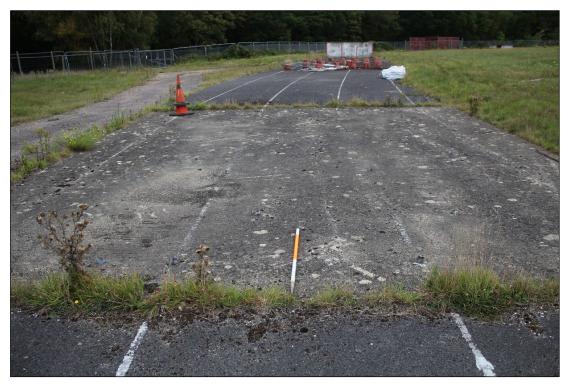
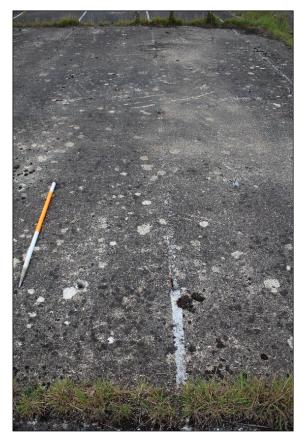
3.33. The ninth obstacle surviving within Area B comprises a concrete foundation/pad measuring approximately 3.5m by 3m. There are metal posts set sporadically across the foundation; these have been cut off (Photos 53–55). The purpose and function of

this obstacle is unclear but it may have been a metal-framed climbing obstacle or perhaps a slalom course. Historic Google Earth Aerial Imagery depicts a hairpin course layout over the area but this does not aid in the interpretation of this obstacle.

Photo 53: Apparatus Feature B9, viewed from the north-east

Photo 54: Apparatus Feature B9, viewed from the south-west

Photo 55: Apparatus Feature B9, viewed from the north-east

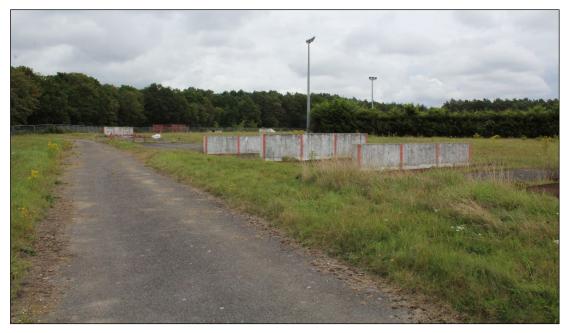
3.34. The tenth surviving obstacle in Area B marks the end/finish of the running track. The obstacle comprises of a set of three walls, each set on a broadly north/south axis. The outer two walls are approximately 1m high, with the inner wall being slightly higher at 1.2m. There is an area of safety matting to the western side of each wall. (Photos 56–64).

Photo 56: Apparatus Feature B10, viewed from the south-west

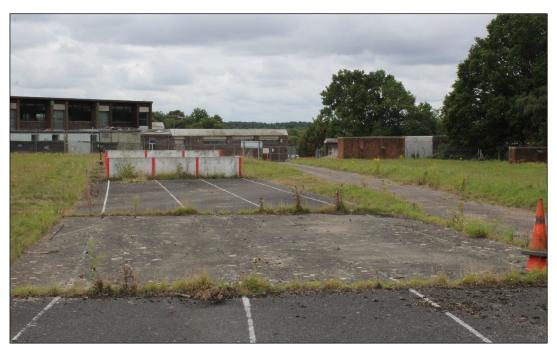
Photo 57: Apparatus Features B9 and B10, viewed from the north-east
