Roundabout Cottage, 62 High Street

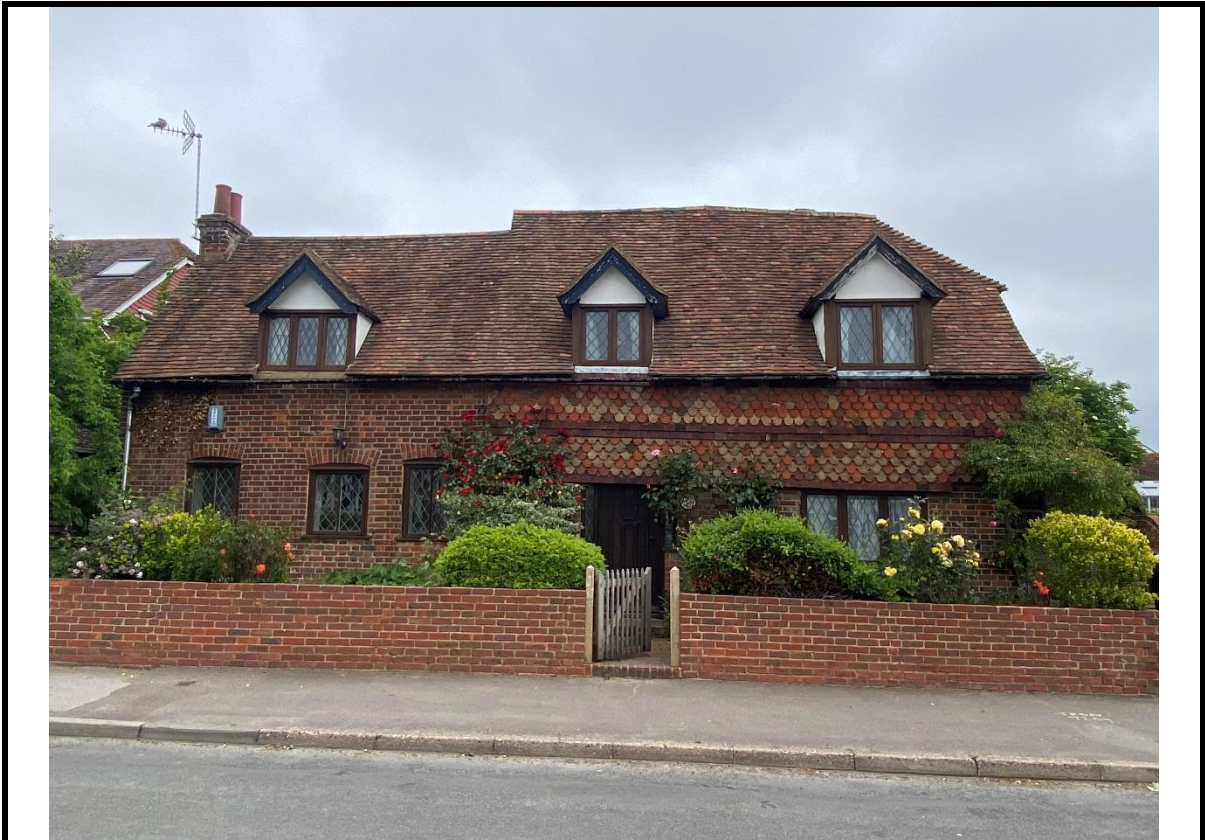
**PHOTO 1 – Principal (South) Elevation including 7no. windows and front door to be replaced.**

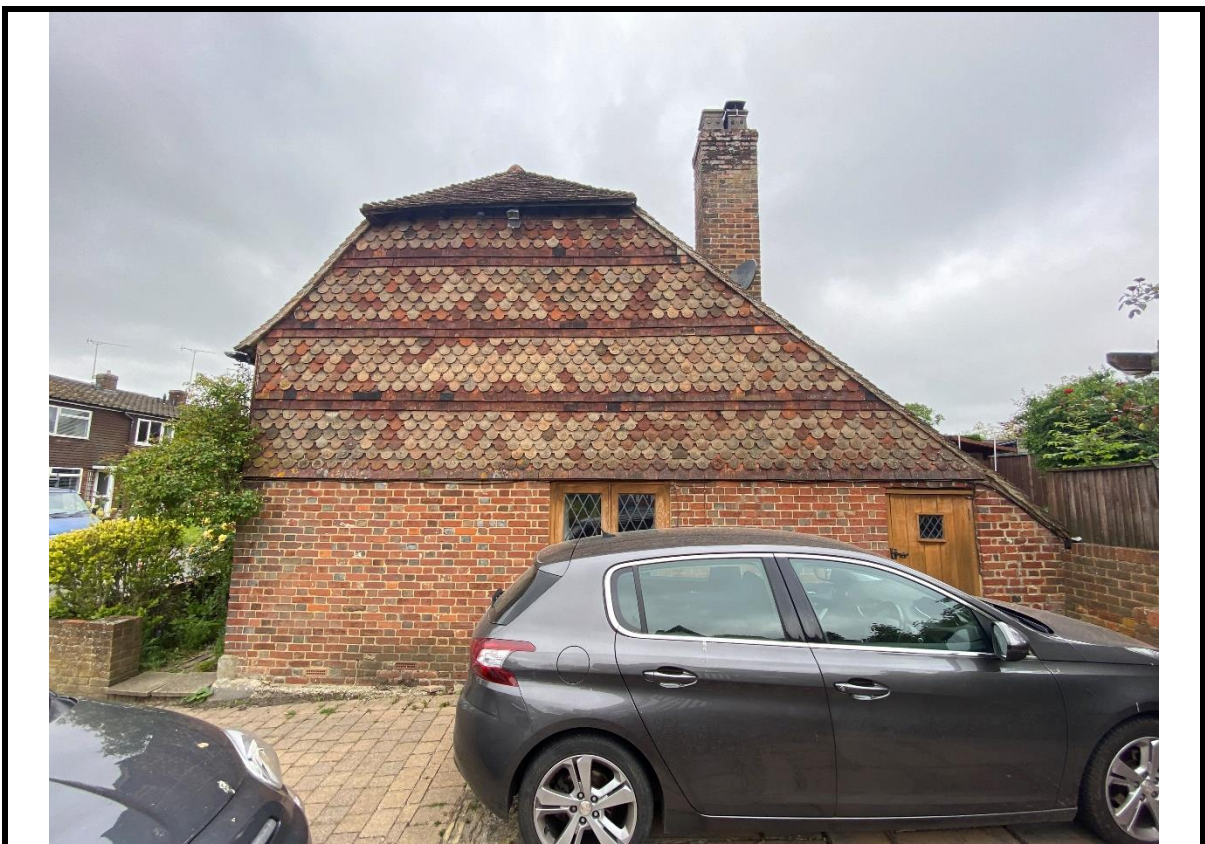
**PHOTO 2 – Side (Eastern) Elevation including side door to be replaced.**

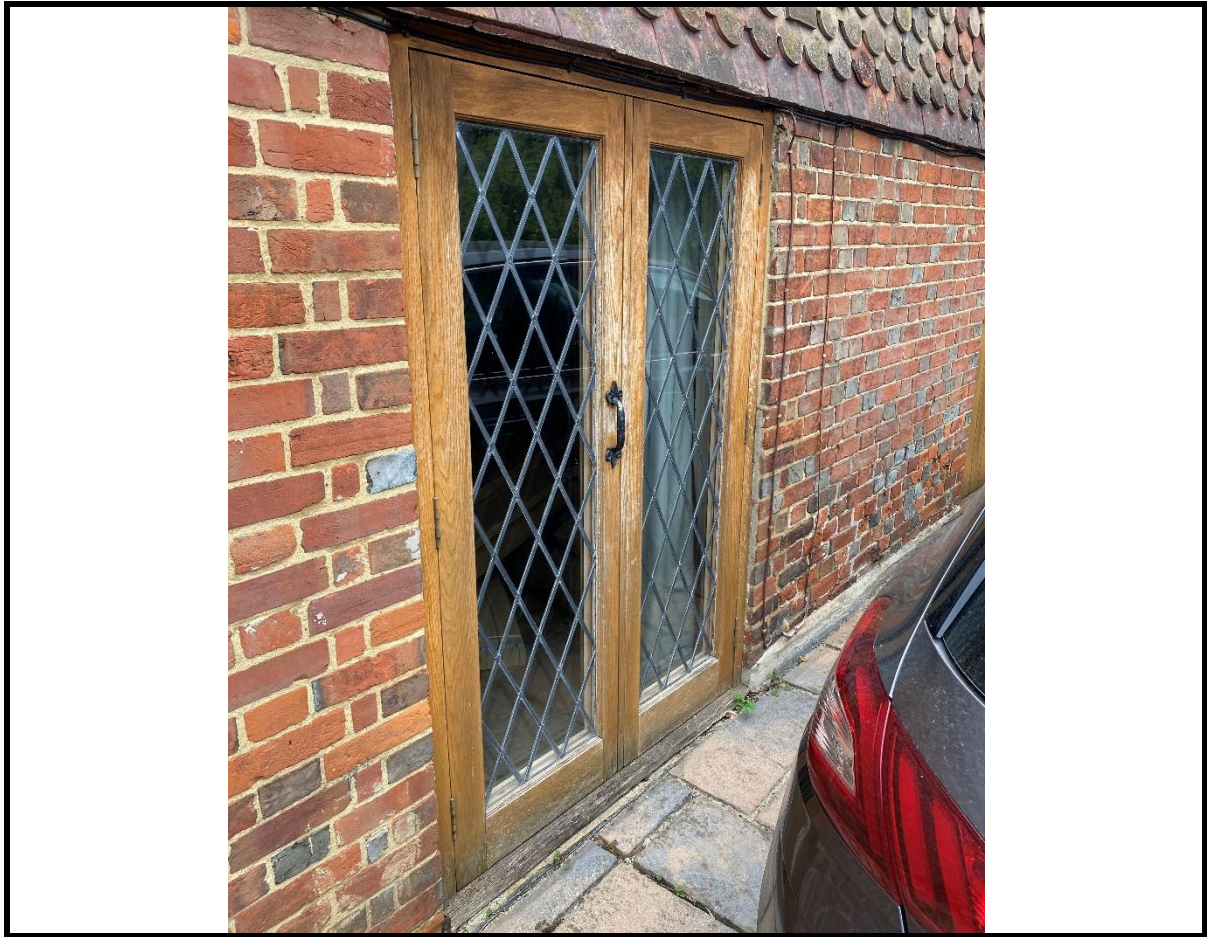
**PHOTO 3 – Side door to be replaced on Eastern Elevation**

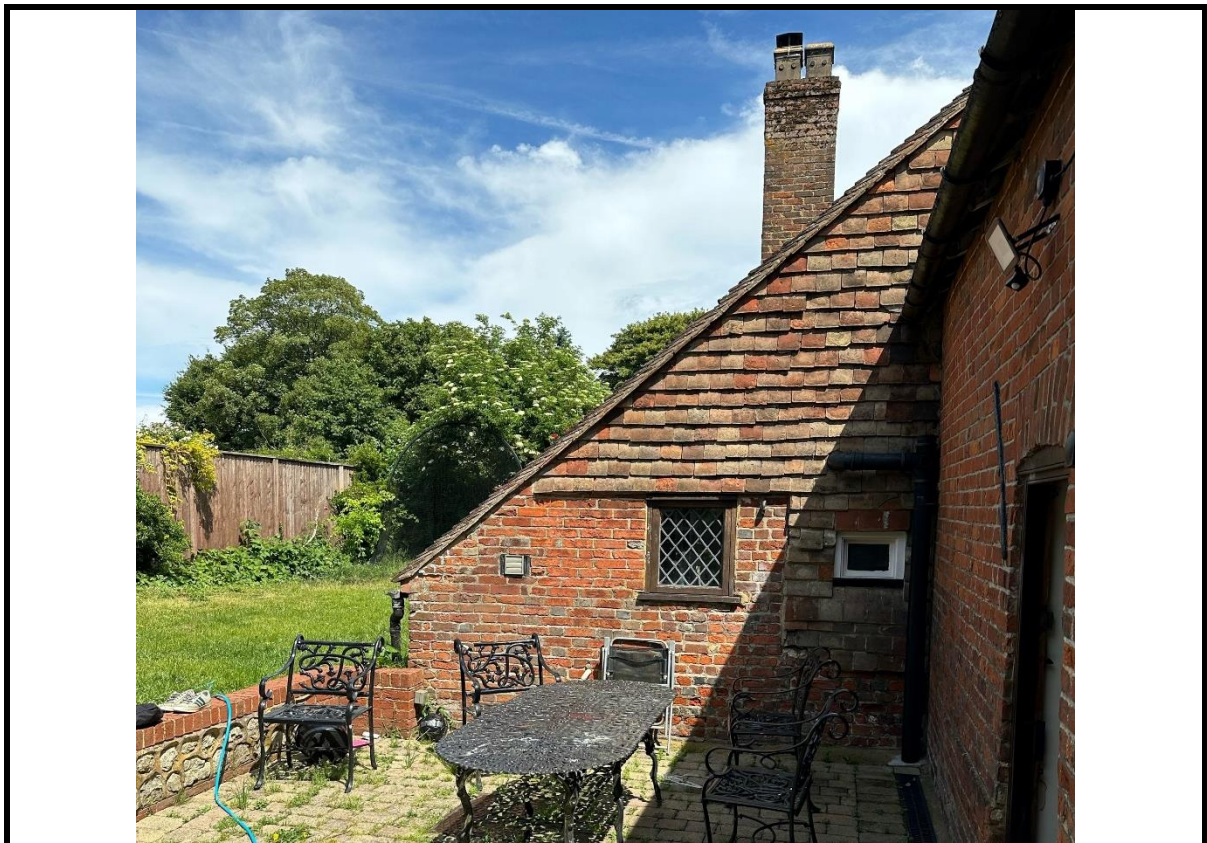
**PHOTO 4 – Rear (North) Elevation 1no. window to be replaced.**

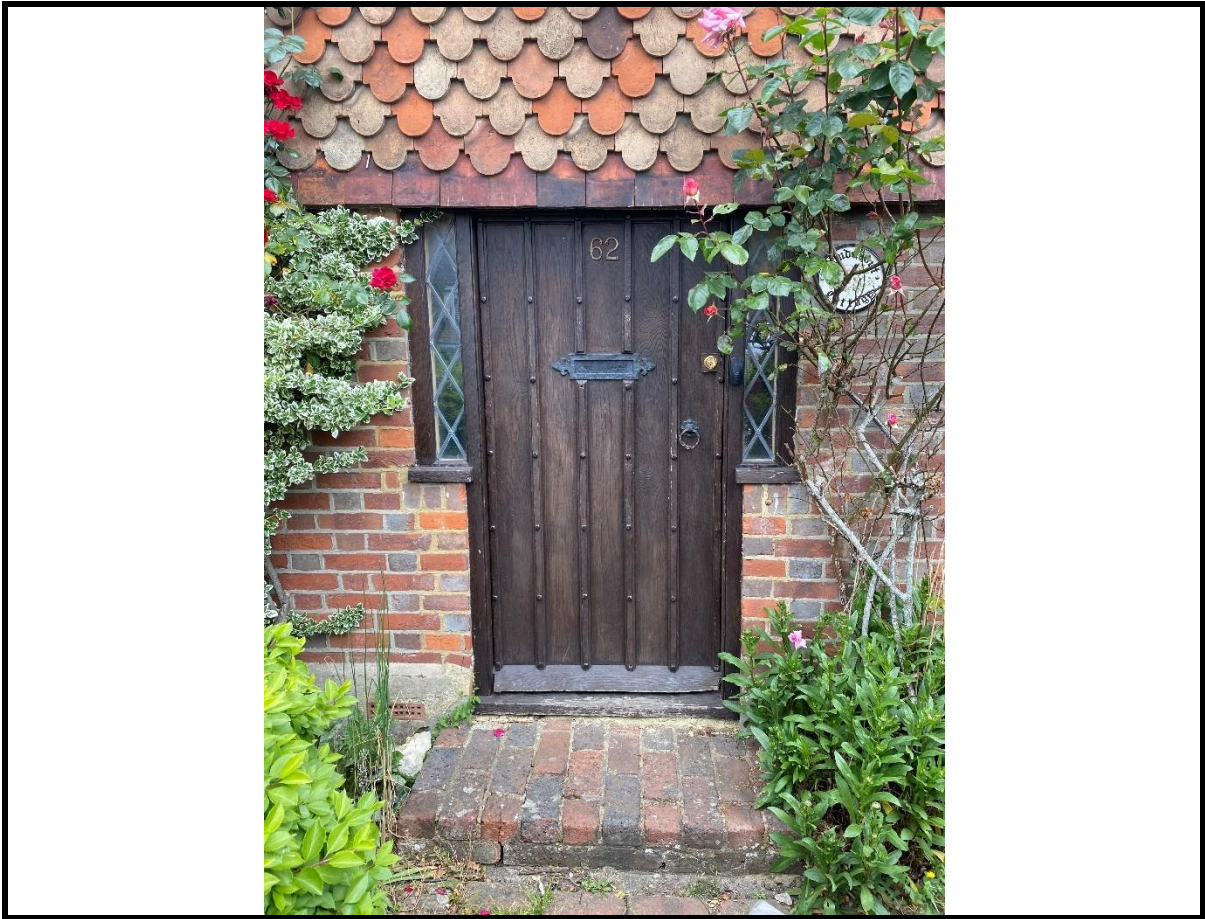
**PHOTO 5 – Front door on Principal (South) elevation.**

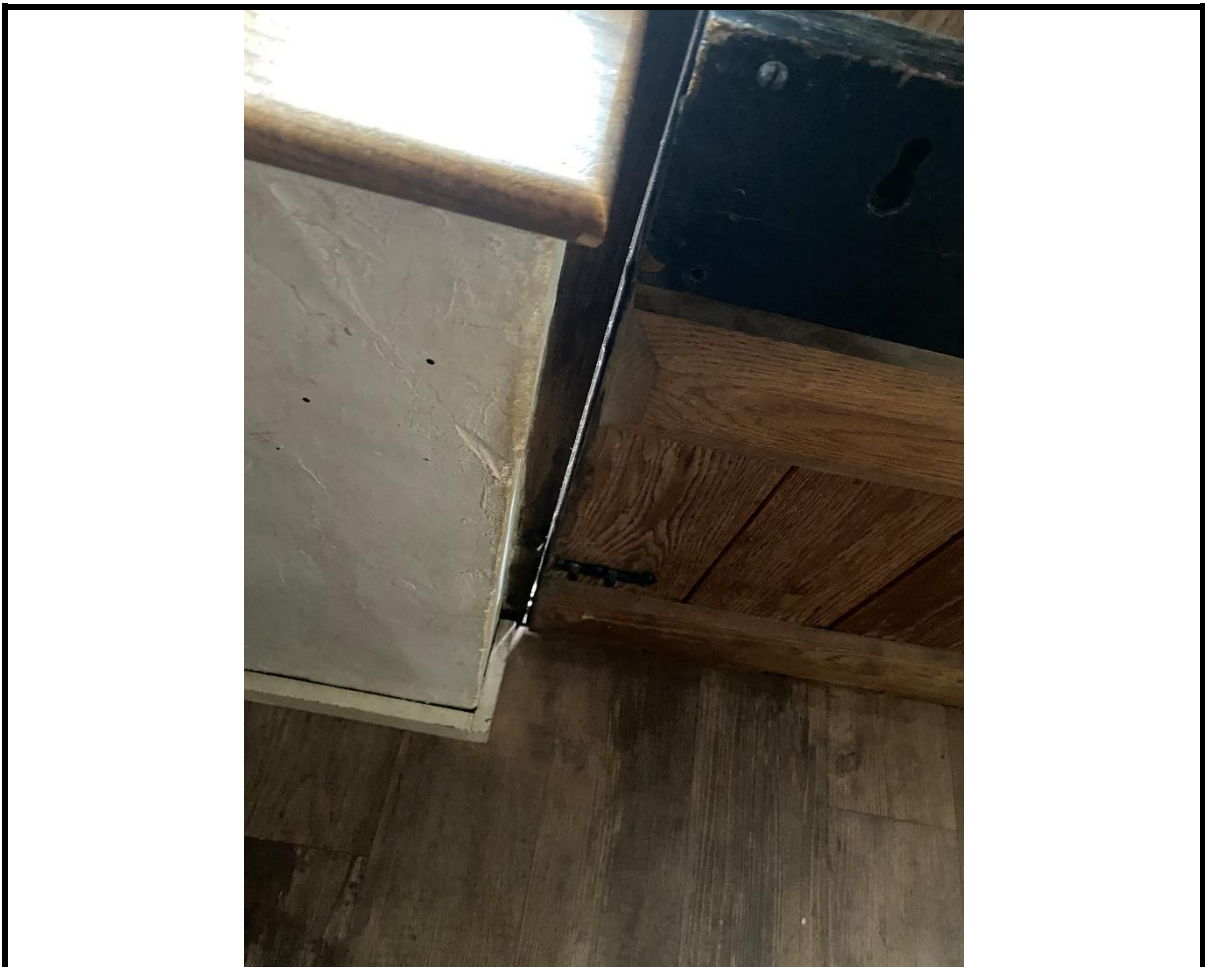
**PHOTO 6 – Evidence of warped front door no longer closing properly.**

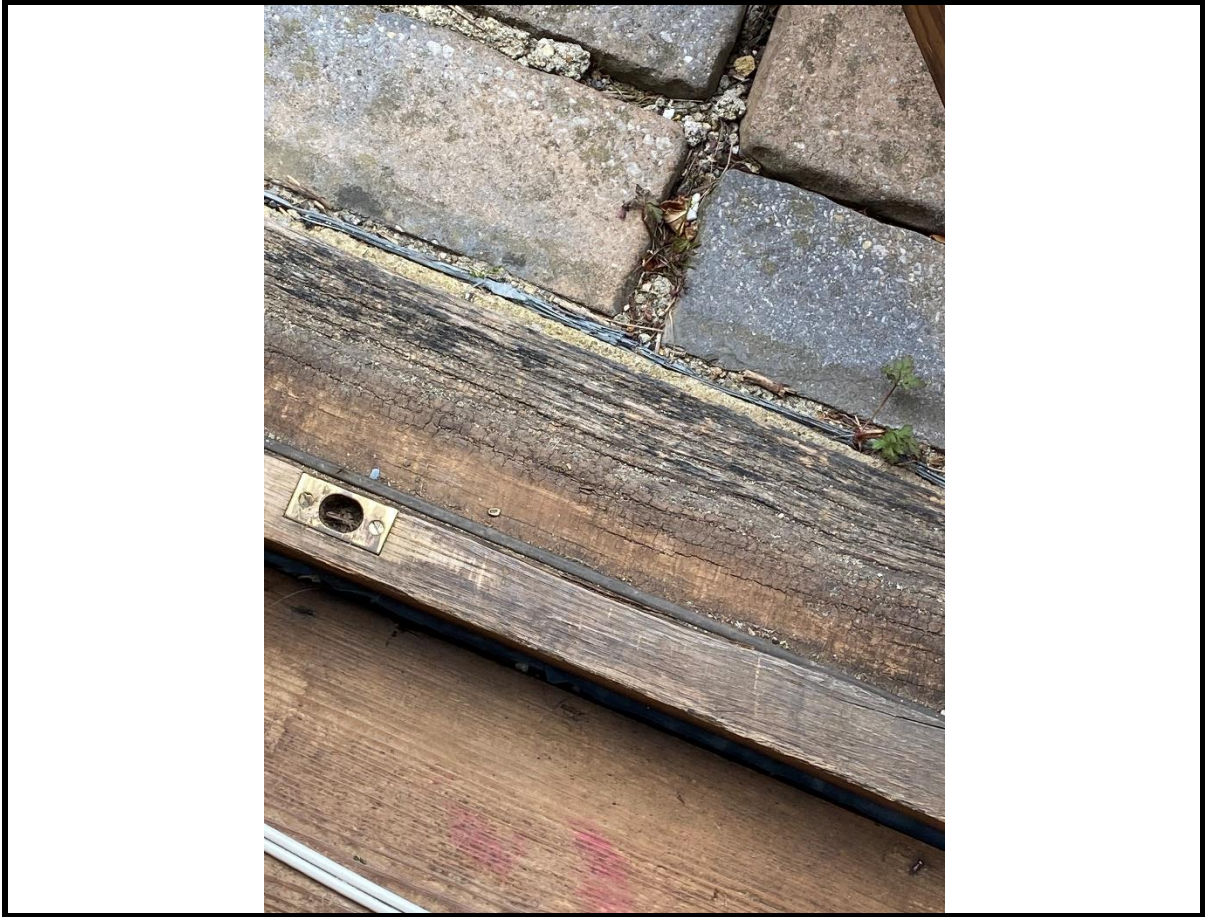
**PHOTO 7 – Side door decay and warping causing issues closing.**

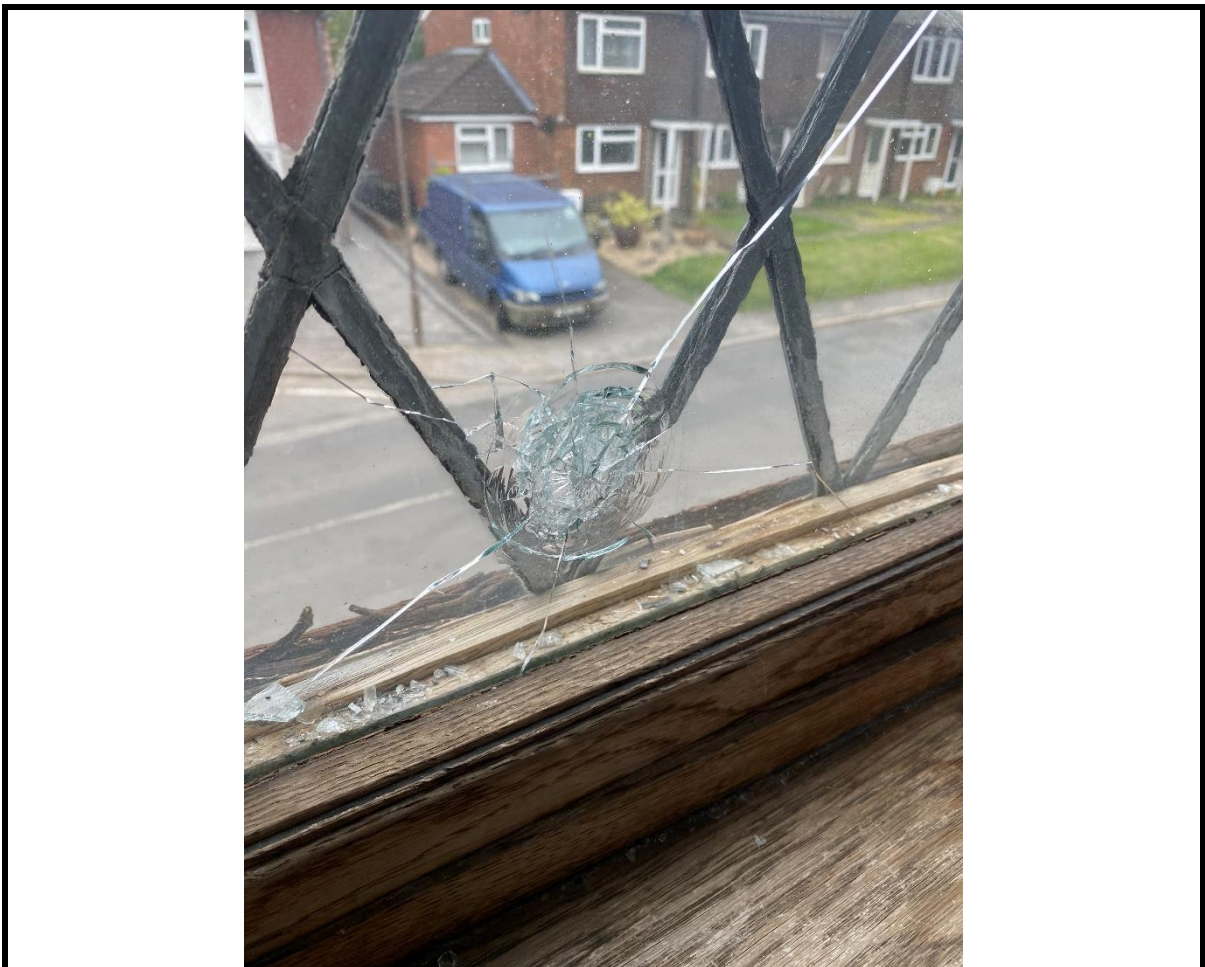
**PHOTO 8 – Criminal damage to first floor window on principal elevation**

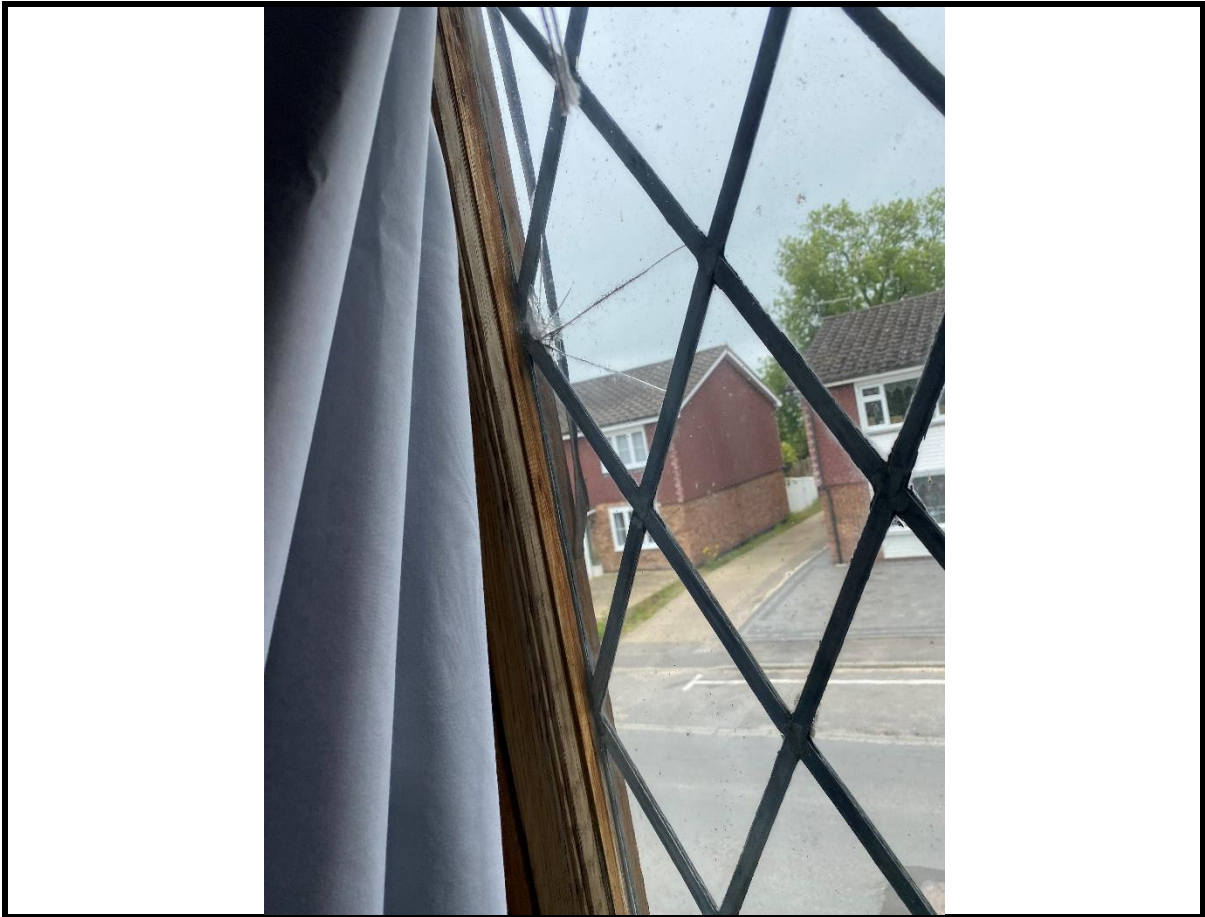
**PHOTO 9 – Criminal damage to first floor window on principal elevation**

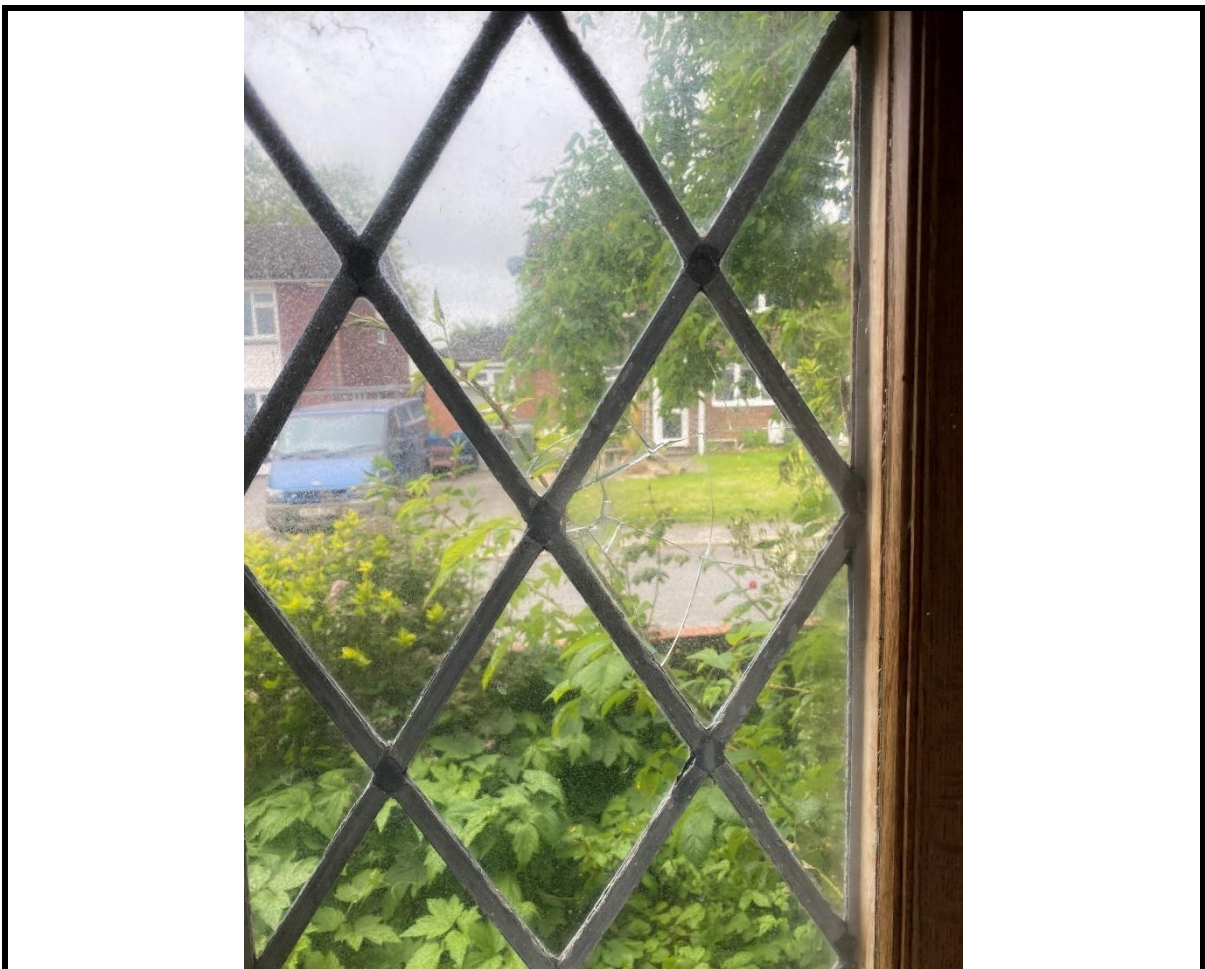
**PHOTO 10 – Criminal damage to ground floor window on principal elevation**
